Marine Accident Report

Report on the investigation of

the fire onboard

Star Princess

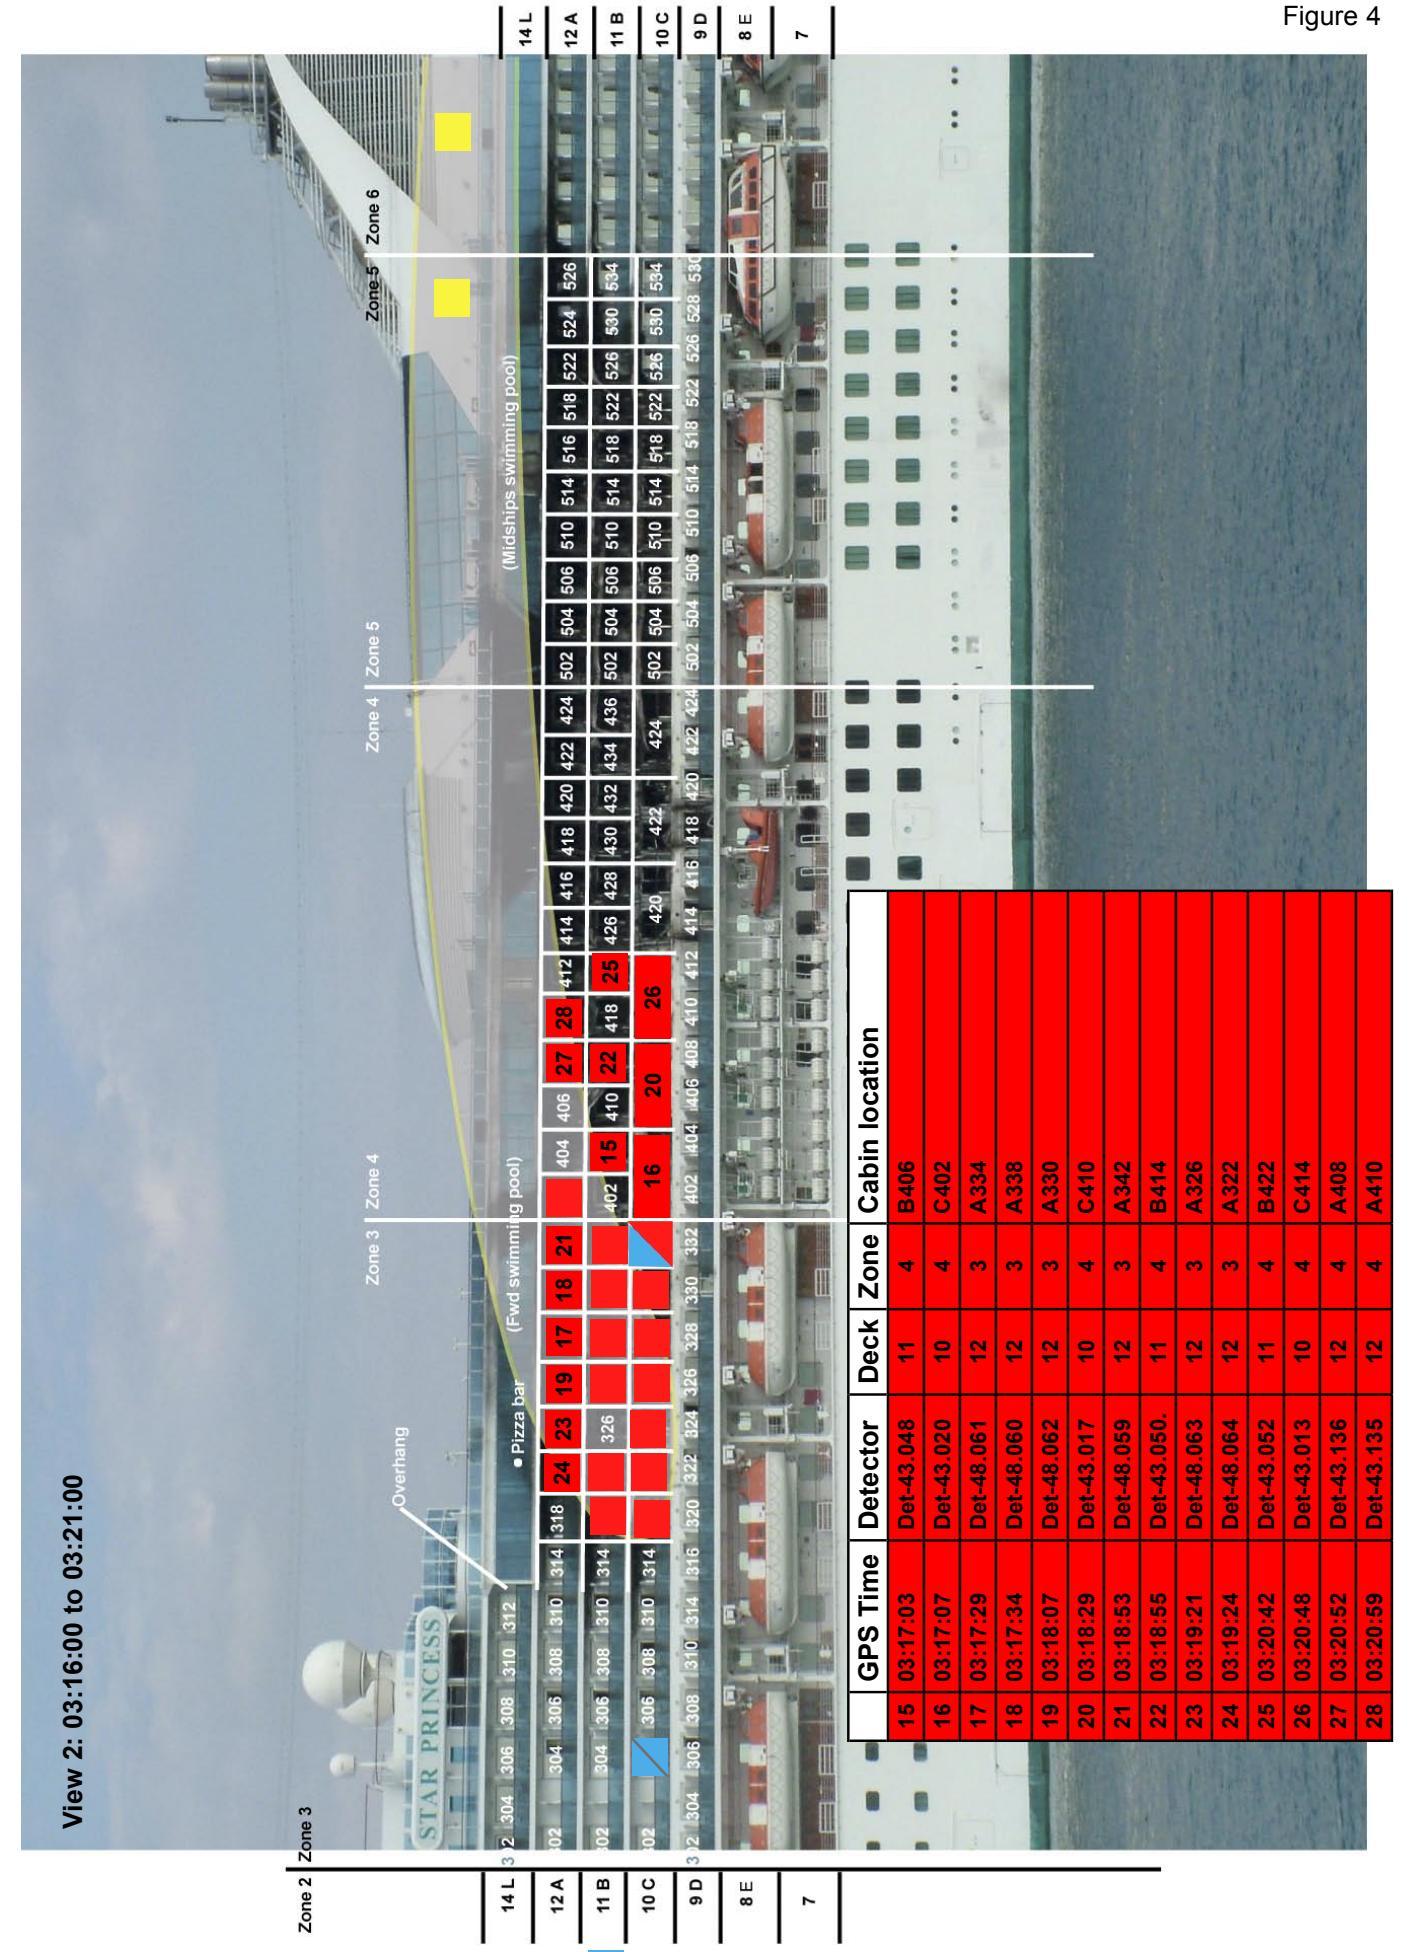
Figure 3

Figures 3 to 6 show the activation of smoke and heat alarms recorded on the vessel's fire detection system, and a chronology of significant events is at **Table 1** below:

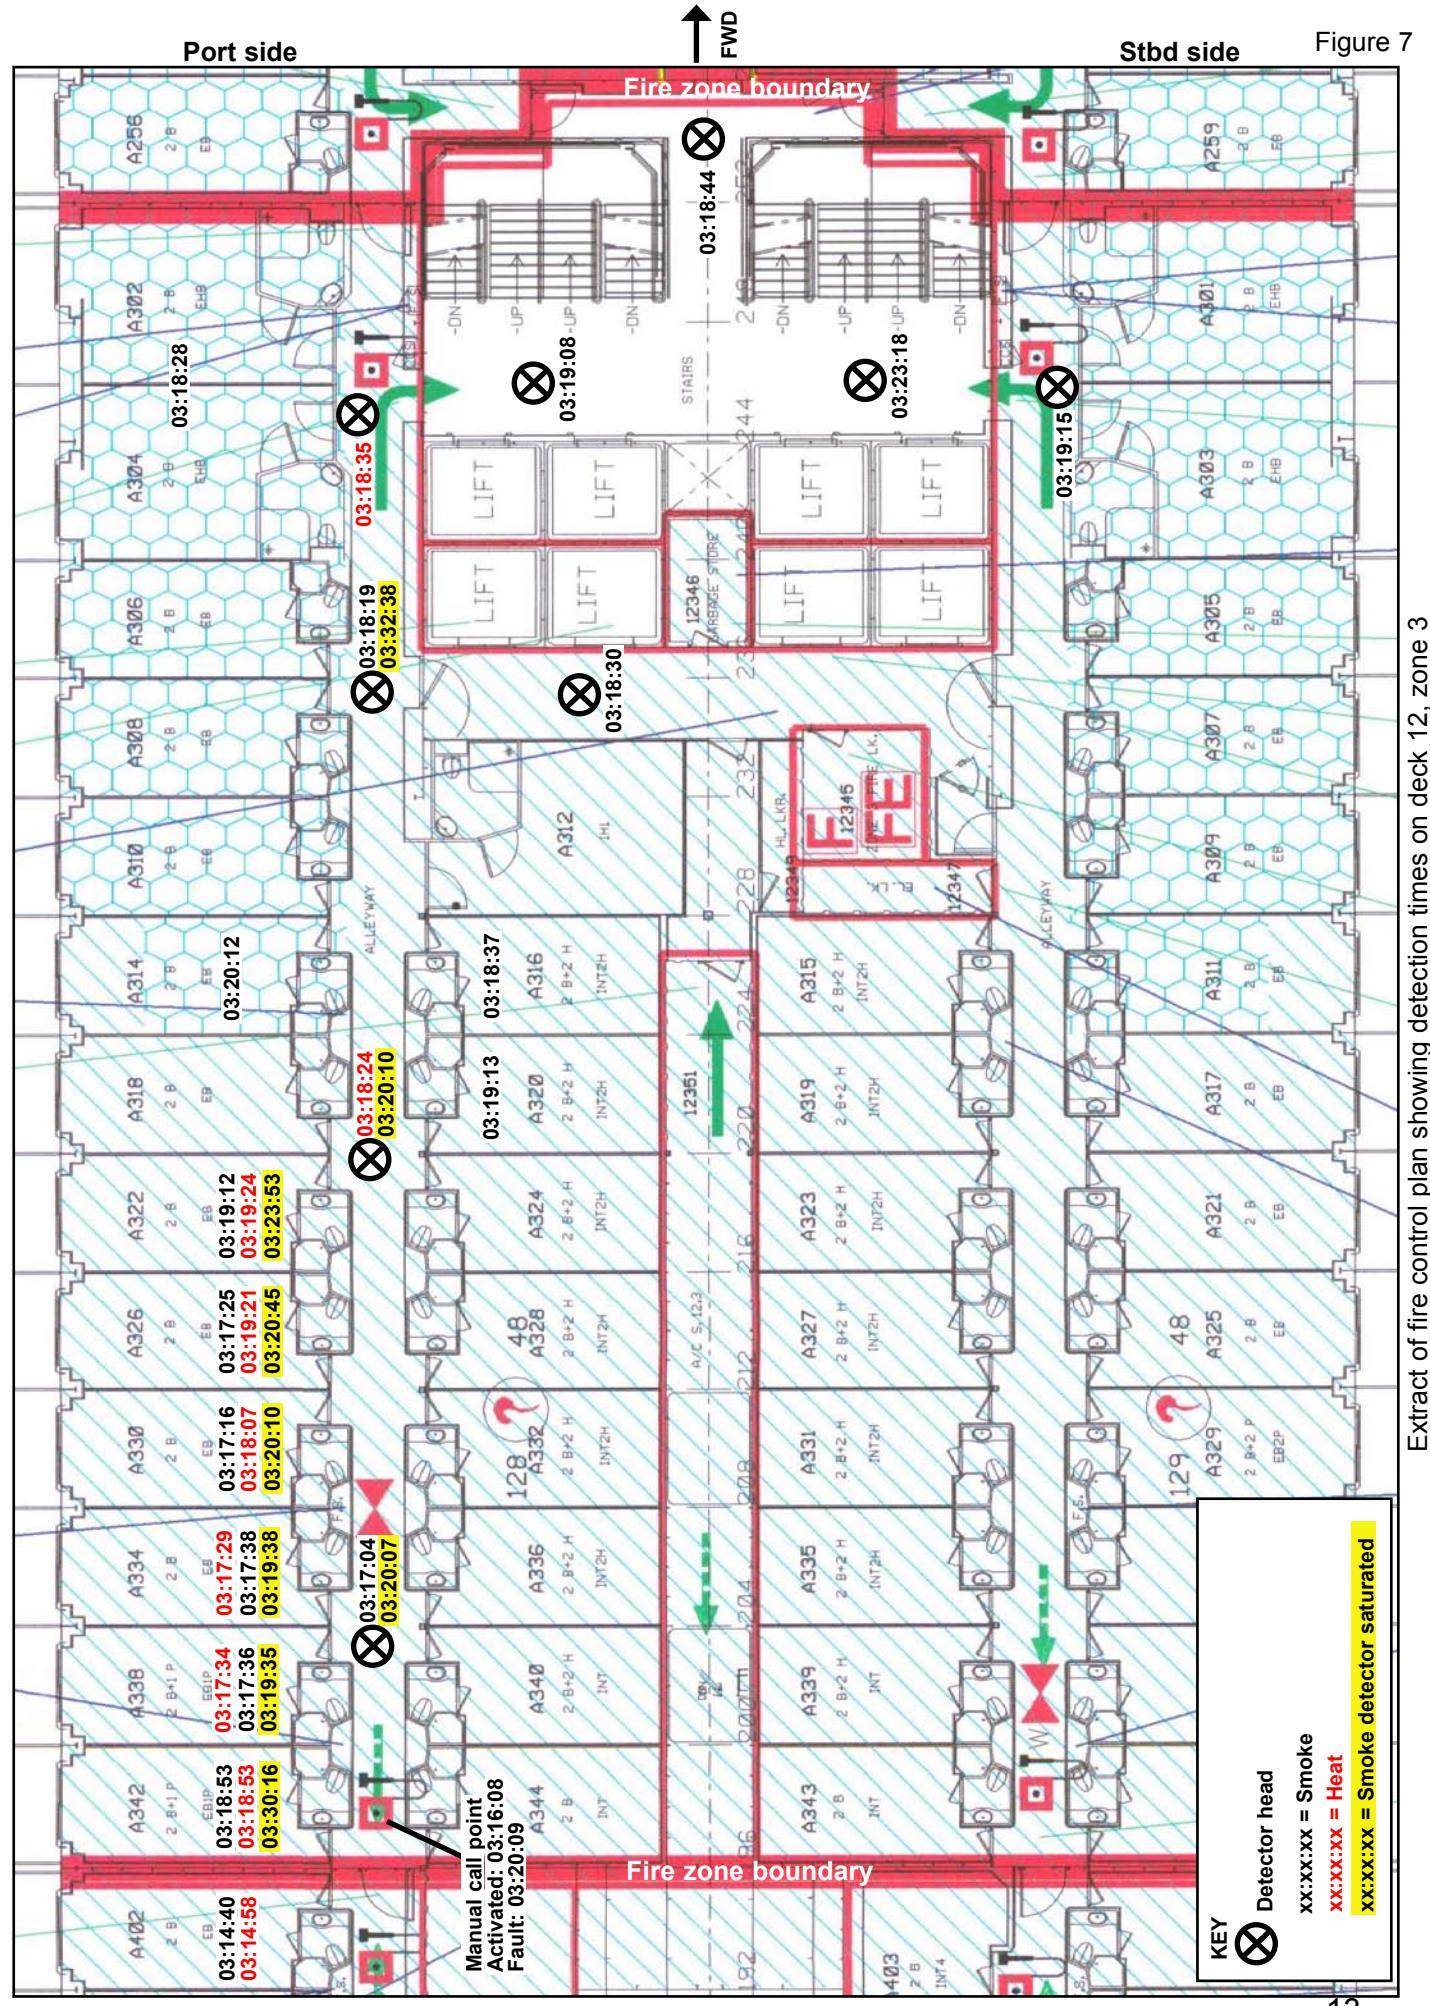
Extract of fire control plan showing detection times on deck 12, zone

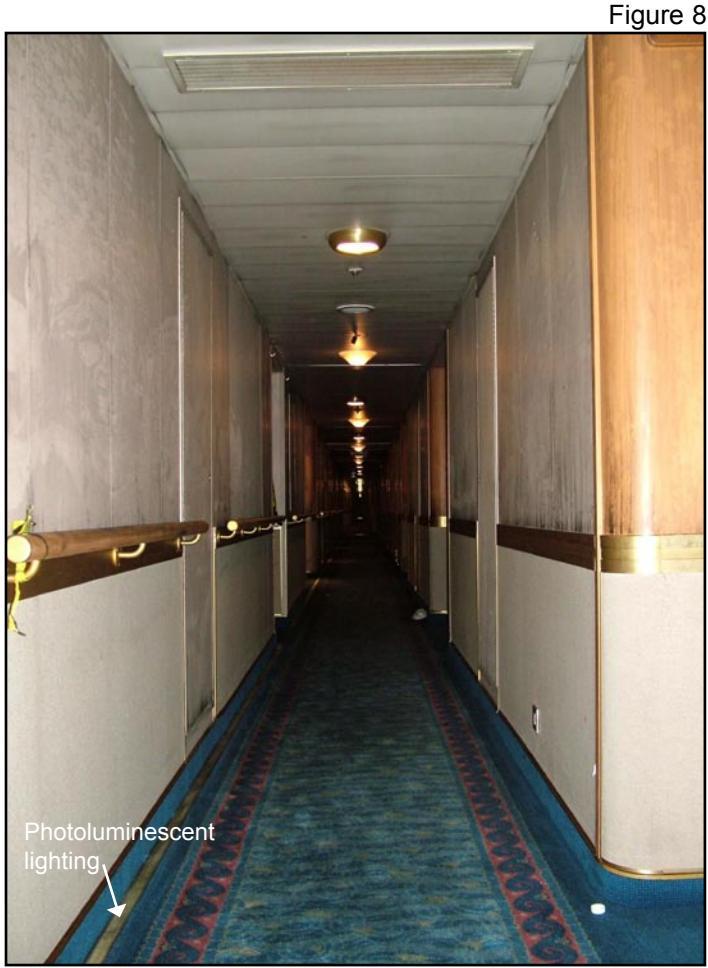
As the last of the passengers were leaving, or preparing to leave, their staterooms in zone 3 on deck 12, the alleyway became engulfed in thick, black smoke. The smoke, which appeared to have entered the alleyway towards its aft end, contained large orange flames and glowing embers, and forced members of the assessment party who had proceeded to the area and rigged a hose, to retreat from the alleyway to the

Alleyway in deck 12, zone 3

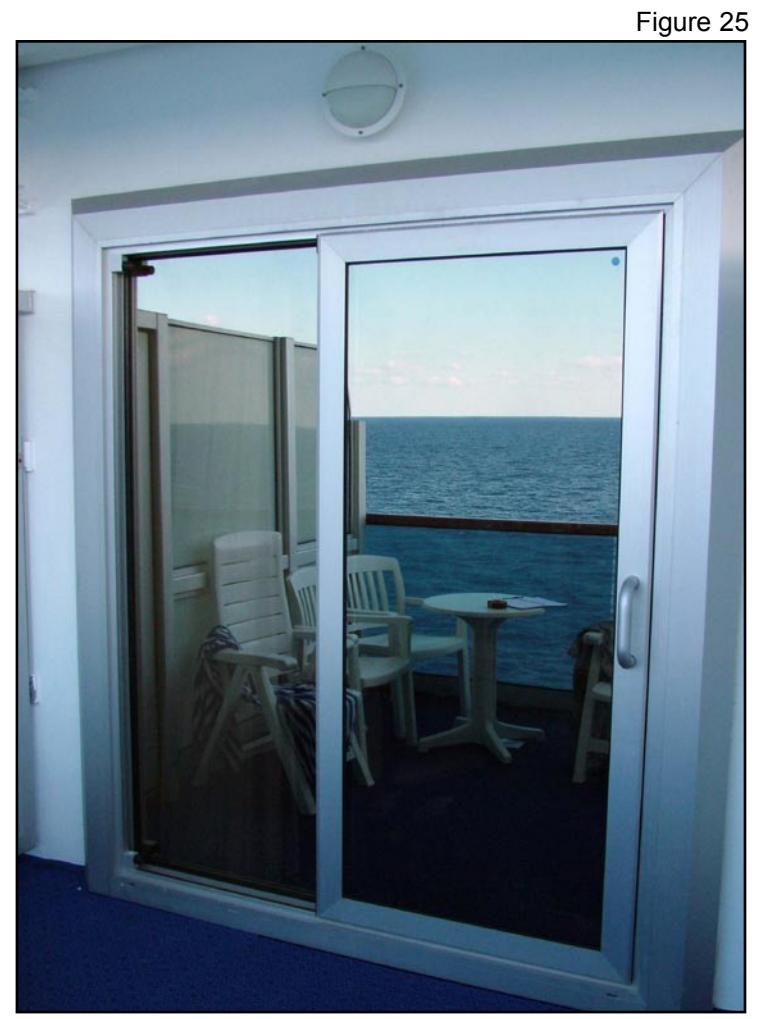
Balcony doors

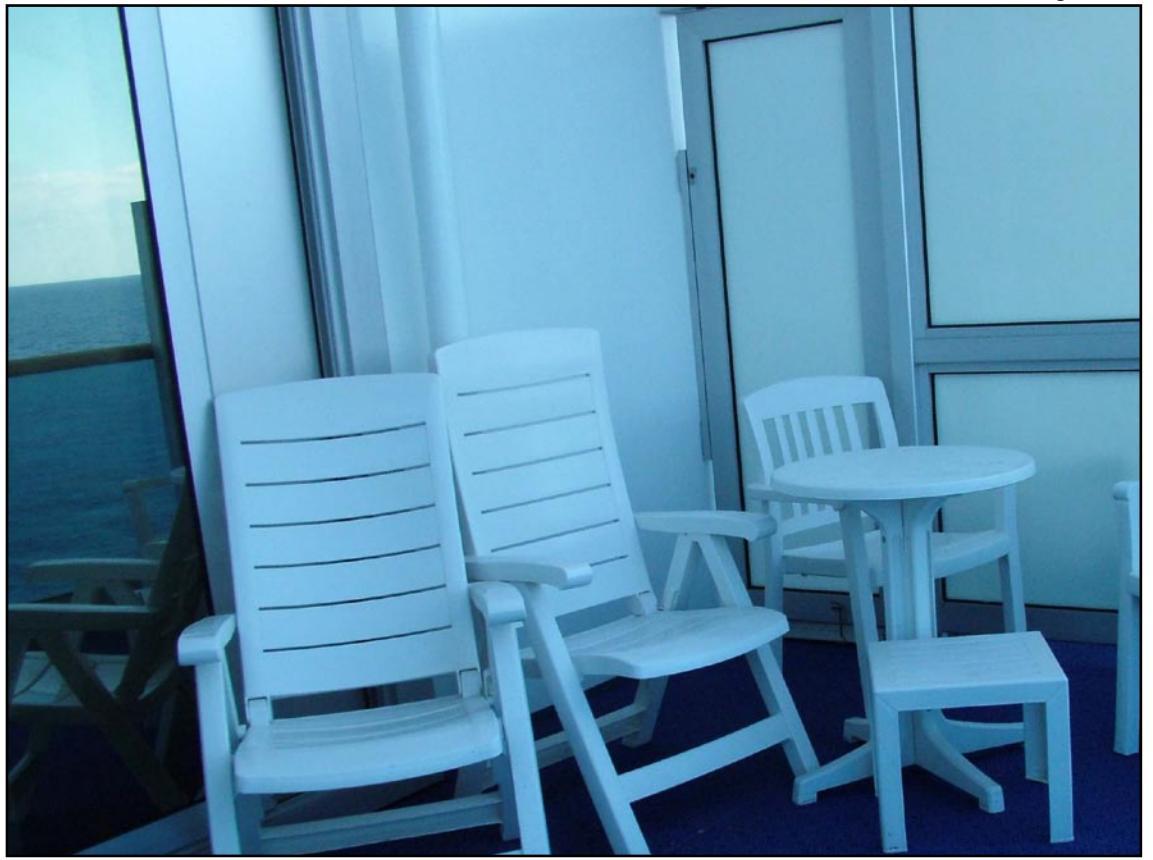
Figure 26

Balconies were separated by vertical partitions (Figure 26), which had small gaps at the deck and deckhead. The partitions provided privacy and shelter, and were fitted with a door, which could be locked by a universal square-ended 'T' bar shaped key. The partitions were constructed from 8mm polycarbonate sheet, secured in an aluminium framework. This was one of several types of material used by Fincantieri for balcony partitions, and *Star Princess* was one of 19 ships on which it had used the material. The materials the shipbuilder used on the balconies of other vessels included: acrylic, acrylic –polycarbonate mixtures, and aluminium composite. Materials known to be used for balcony partitions by other ship builders includes glass, steel, high pressure laminated boards, galvanised sheet, and plywood.

The decks of the balconies on board *Star Princess* were covered with a polypropylene tile (Figure 26). On decks 9 and 10, the tile was laid on top of a flexible screed coated with polyurethane self-levelling paint, but on decks 11 and 12 it was laid on top of a painted metal deck. Polypropylene tiles were laid on top of the deck coatings to provide a non slip finish and allow surface water to drain. This was one of three types of deck covering used by Fincantieri for this purpose, the others were teak, and a teak effect resin. A balustrade was fitted at the outboard edge, consisting of glass panels topped with a hardwood rail.

Balcony partitions, furniture and deck tiles

Lightweight plastic chairs, table and footstools (**Figure 26**) of the type commonly available for outdoor recreational use were provided for each balcony. The first heat detectors to activate were in staterooms C316 and C318, and items on the balcony of stateroom C316 at the time included two large cotton towels provided by the ship and draped over the plastic chairs, a bathing suit, and a pair of water shoes, all of which had been on the balcony for several hours. The passengers in C318 were smokers, and the last occasion a cigarette was smoked on the balcony was shortly after midnight. The cigarette end was then extinguished in an ashtray. The passengers in C318. The door in the partition between the stateroom balconies was unlocked, but it is not certain whether it was open or closed.
