United States Coast Guard

INVESTIGATION INTO THE CIRCUMSTANCES SURROUNDING THE PARASAILING ACCIDENT ON THE TIED HIGH 0.5 MILES OFF THE COAST OF OCEAN ISLE BEACH, NORTH CAROLINA ON AUGUST 28, 2009 WITH MULTIPLE LOSS OF LIFE

ACTION BY THE COMMANDANT

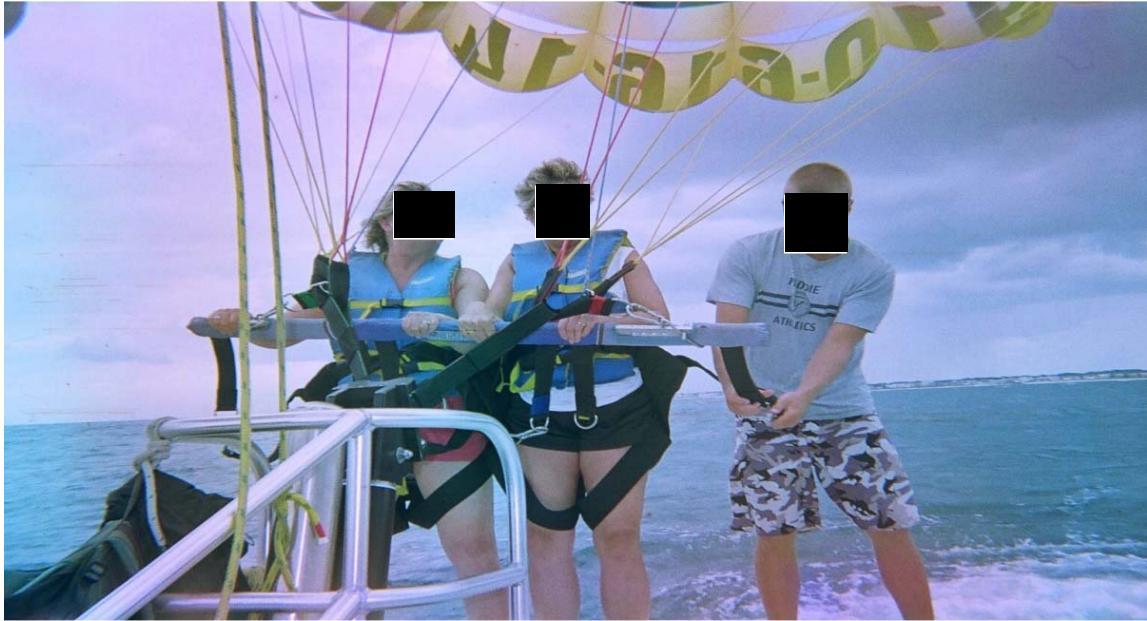
10. At about 1340, the master put the second set of passengers, Cynthia C. Woodcock and Lorrie D. Shoup, in tandem flight and reeled out about 500 feet of towline. However, due to the approaching storm, the wind speed increased from 12 to 17 mph to 19 to 25 mph. This change in weather conditions prompted the master to terminate the planned 15 minute tandem flight and decided to retrieve the two passengers.

Figure 3. Picture of Cynthia C. Woodcock and Lorrie D. Shoup being prepped for tandem flight

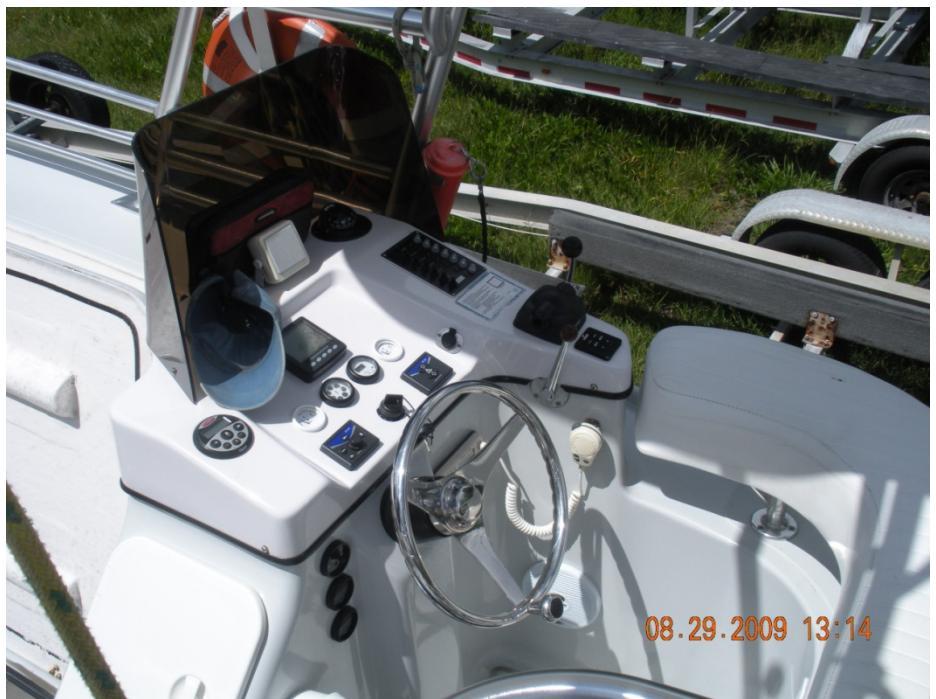
Figure 5. Winch control lever onboard the TIED HIGH (closest to steering helm)

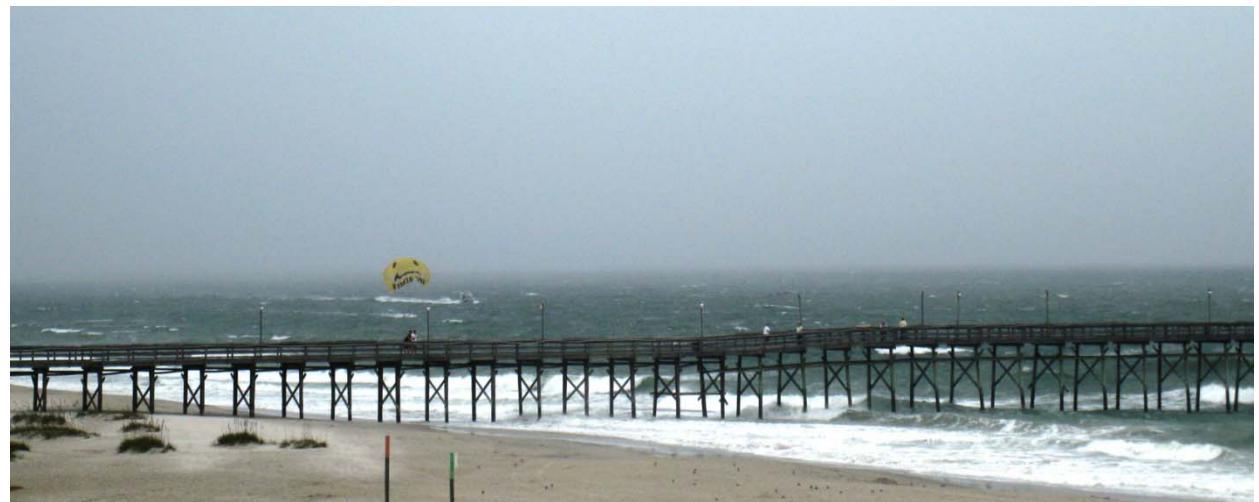
21. On the third rescue attempt, the deckhand was instructed by the master to once more jump from the bow of the TIED HIGH onto the parasail while traveling at the vessel's maximum speed in the choppy sea conditions. The deckhand jumped, successfully landed on the flight bar,

reached up with a knife, cut the shrouds and deflated the parasail. Now in the surf, the deckhand held onto the passengers and tried administering CPR.

Figure 8. Witness photo 1 of the third rescue attempt. Ocean Isle Beach Fishing Pier in foreground.

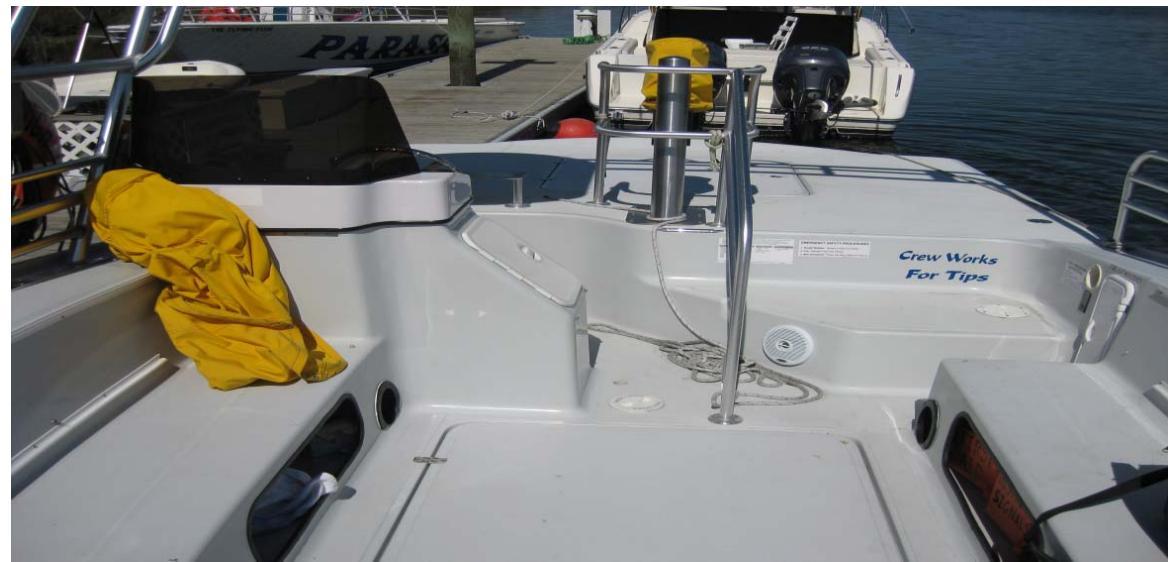
27. The TIED HIGH is a 31-foot, U.S. documented, Coast Guard inspected, small passenger vessel built in 2007 by Commercial Water Sports specifically for parasailing. The vessel is of Fiberglass Reinforced Plastic (FRP) construction and is equipped with a single Volvo Diesel engine model D6 capable of providing 310 horsepower. In calm seas, the vessel can obtain speeds of 30 mph in a full load condition (i.e., with a full load of crew, passengers, equipment and fuel). The vessel is outfitted with port and starboard fuel tanks with a total capacity of 74 gallons. The engine is located in an engine compartment below deck, just aft of the operating station along the centerline of the vessel. The vessel's winch, hydraulics and towline used for parasailing are also located in the engine compartment. The vessel's tow post is adjacent the operating station, centerline of the vessel, located just forward of the engine compartment hatch. Passenger seating arrangement is located forward of the operating station on the port and starboard side of the vessel. Passengers are put in flight and retrieved on the vessel's landing platform, which begins aft of the engine compartment hatch and continues to the stern.

Figure 13. Aft deck view of the TIED HIGH

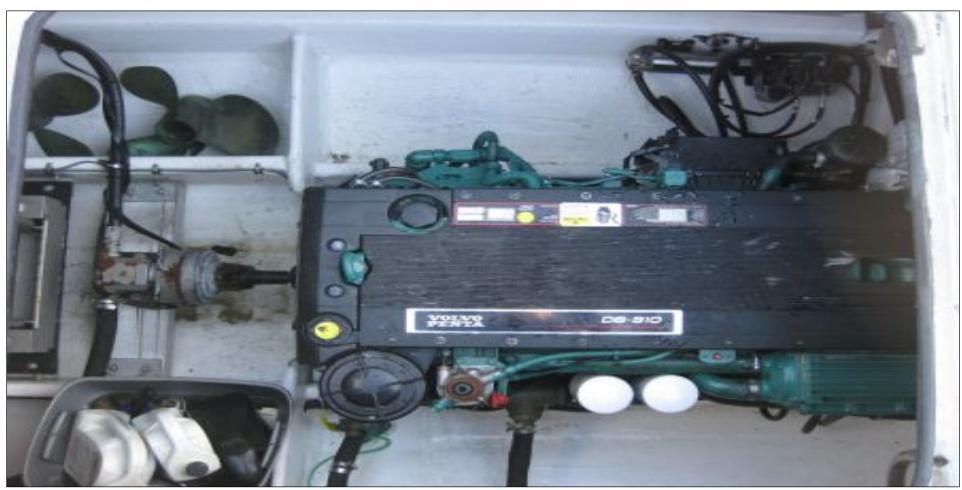
78. An inboard/outboard Volvo D6 engine built by Eckel Diesel LLC was installed onboard the TIED HIGH. The Volvo D6 is a 6-cylinder marine diesel engine with common rail high-pressure fuel injection, double overhead camshafts, 4 valves per cylinder, turbocharger, after cooler and a D6- 330 horse power, mechanical compressor with a 5.5 liters displacement. The fuel system is electronically controlled with common rail high-pressure fuel injection working at a pressure of 1,600 bars.

Figure 23. Photo of Volvo D-6 engine onboard the TIED HIGH

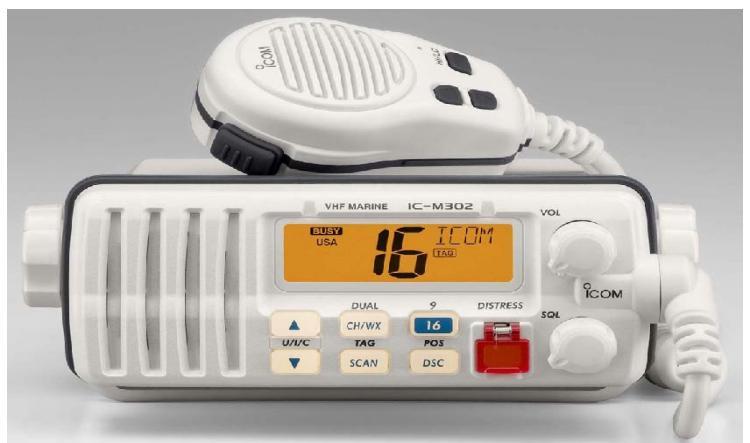
79. An ICOM, VHF Marine Transceiver, model IC-M302 was installed onboard the TIED HIGH. The IC-M302 is equipped with ten weather channels. These may be used to monitor broadcasts from the NWS or NOAA. The transceiver can detect a weather alert tone on the selected weather channel while receiving the channel during standby, on regular channel, or while scanning. The VHF radio onboard the TIED HIGH could receive weather alerts on 162.550 megahertz (i.e. NOAA weather channel one).

Figure 24. Photo of ICOM VHF radio, model IC-M302
