UNITED STATES COAST GUARD

REPORT OF INVESTIGATION INTO THE ELECTROCUTION OF A LICENSED THIRD ENGINEER ONBOARD THE S/R WILMINGTON OFFSHORE GALVESTON, TEXAS

ON 01/07/2009

MISLE ACTIVITY NUMBER: 3390690

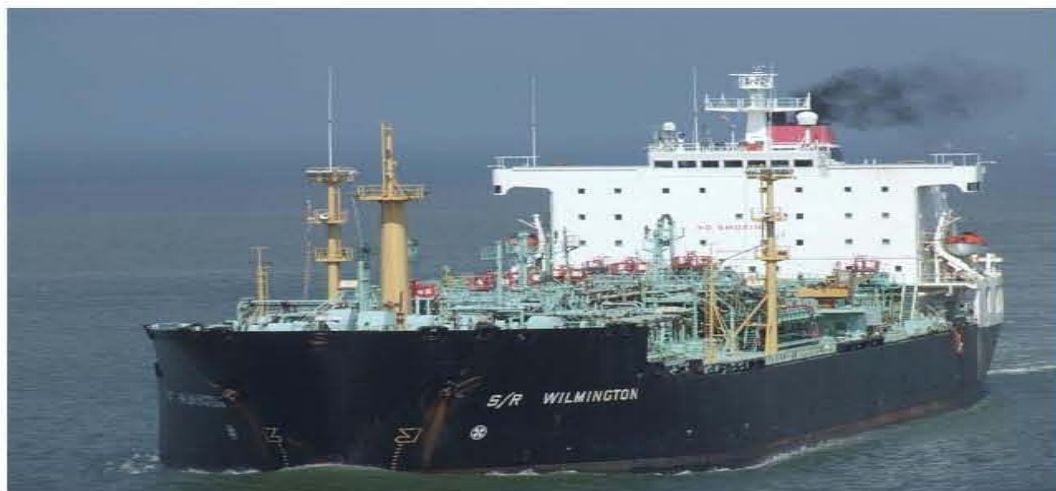
Figure 1: Photograph of Tank Vessel S/R WILMINGTON

1. The S/R WILMINGTON is a 617.2-foot chemical tanker. The vessel is owned and operated by SeaRiver Maritime, Inc. a subsidiary of Exxon-Mobil. The ship is certificated to carry cargo under 46 Code of Federal Regulations, Subchapters D and O. The construction of the vessel began on December 14, 1982, at Avondale Shipyard in New Orleans, Louisiana, and the vessel was delivered for service on July 12, 1984. The vessel's plans for construction were submitted to and reviewed by United States Coast Guard Marine Safety Center (ECN 3390690-35 [REDACTED]).

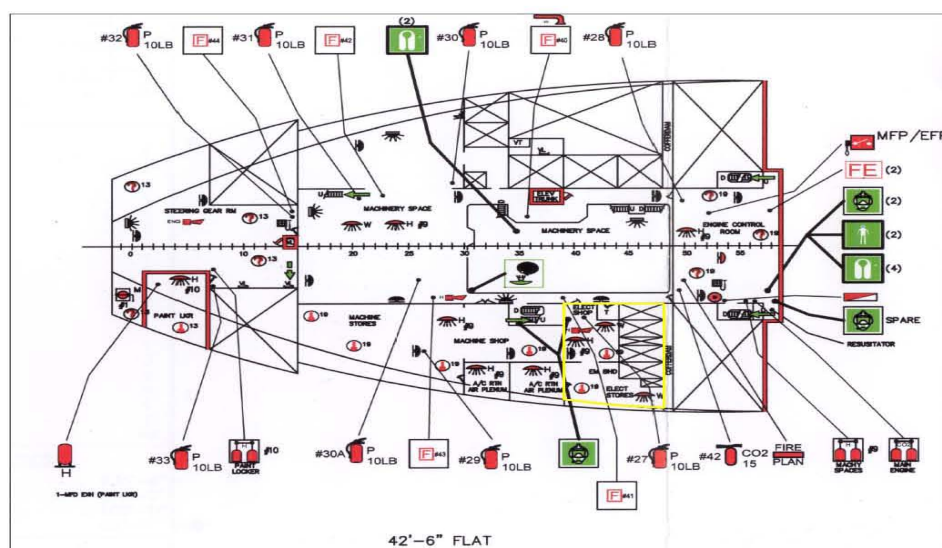
11. At 1352, ██████████ and ██████████ removed the circuit breaker and took the breaker to the ship's electrical workshop for further investigation. The electrical workshop is located one compartment aft of the engine room main control room on the starboard side. The electrical workshop is located three (3) decks below the main deck and adjacent to the main machinery space. Figure 3 depicts the workshop's location on the vessel (ECN 3390690-34-██████████).

Figure 3: Depiction of Electrical Workshop location onboard the S/R WILMINGTON (workshop highlighted in yellow)
