UNITED STATES COAST GUARD

INVESTIGATION INTO THE CIRCUMSTANCES
SURROUNDING THE EXPLOSION, FIRE, AND SINKING OF
THE UNINSPECTED FISH PROCESSING VESSEL

GALAXY

OFFICIAL NUMBER 576981, IN THE BERING SEA ON
OCTOBER 20, 2002, WITH TWO PERSONS DECEASED AND
ONE PERSON MISSING AND PRESUMED DEAD

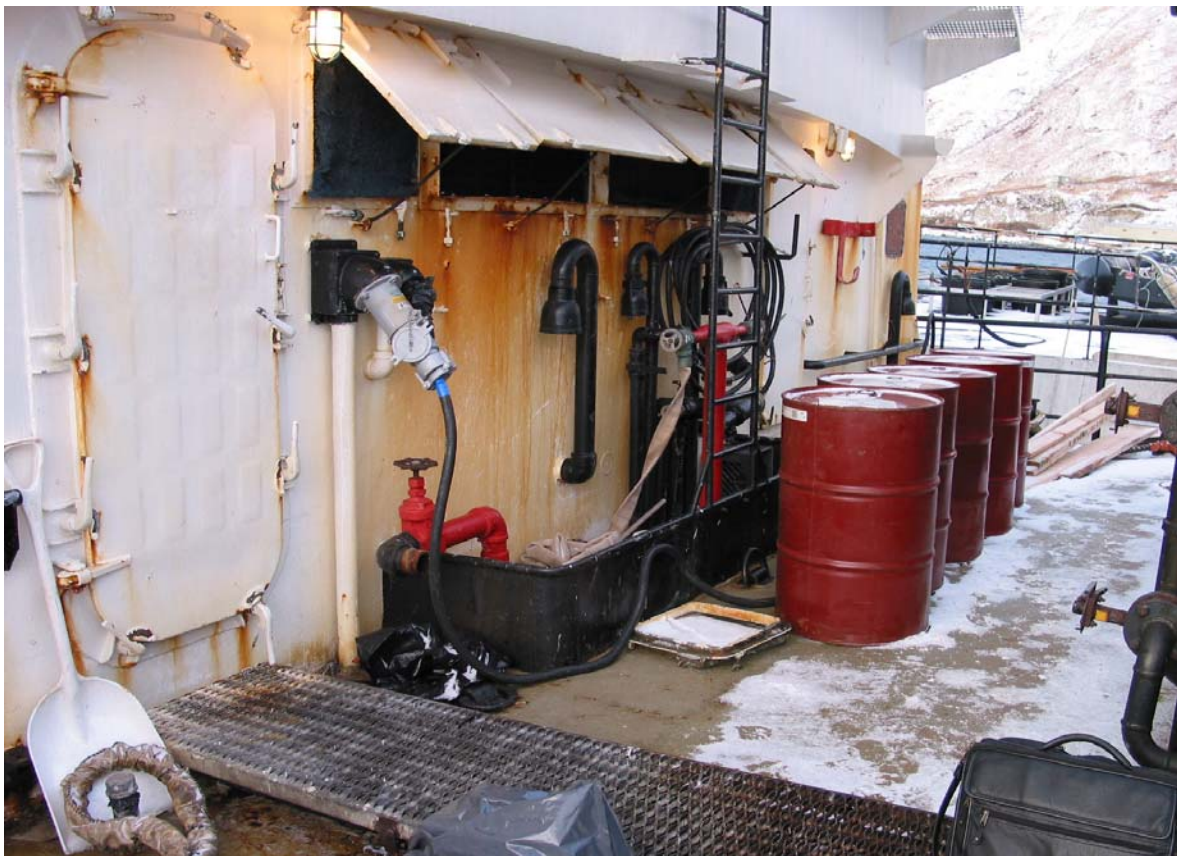
Figure (7): Photo of Previous Ventilation Closures for Engine Room taken December 2001

Ventilation: The engine space was equipped with both supply and ventilation fans. The engine room vents were located on the forward wheelhouse bulkhead. There was also a ventilation fan on the upper stack. The engine room ventilation closures were altered in 2002. The original design, shown in Figure (7), closed by simply moving the support arm out of the way and allowing the cover to drop down into place over the ventilation duct. With the new installation, fabricated inserts had to be dropped down into place by reaching inside the vent cowling.

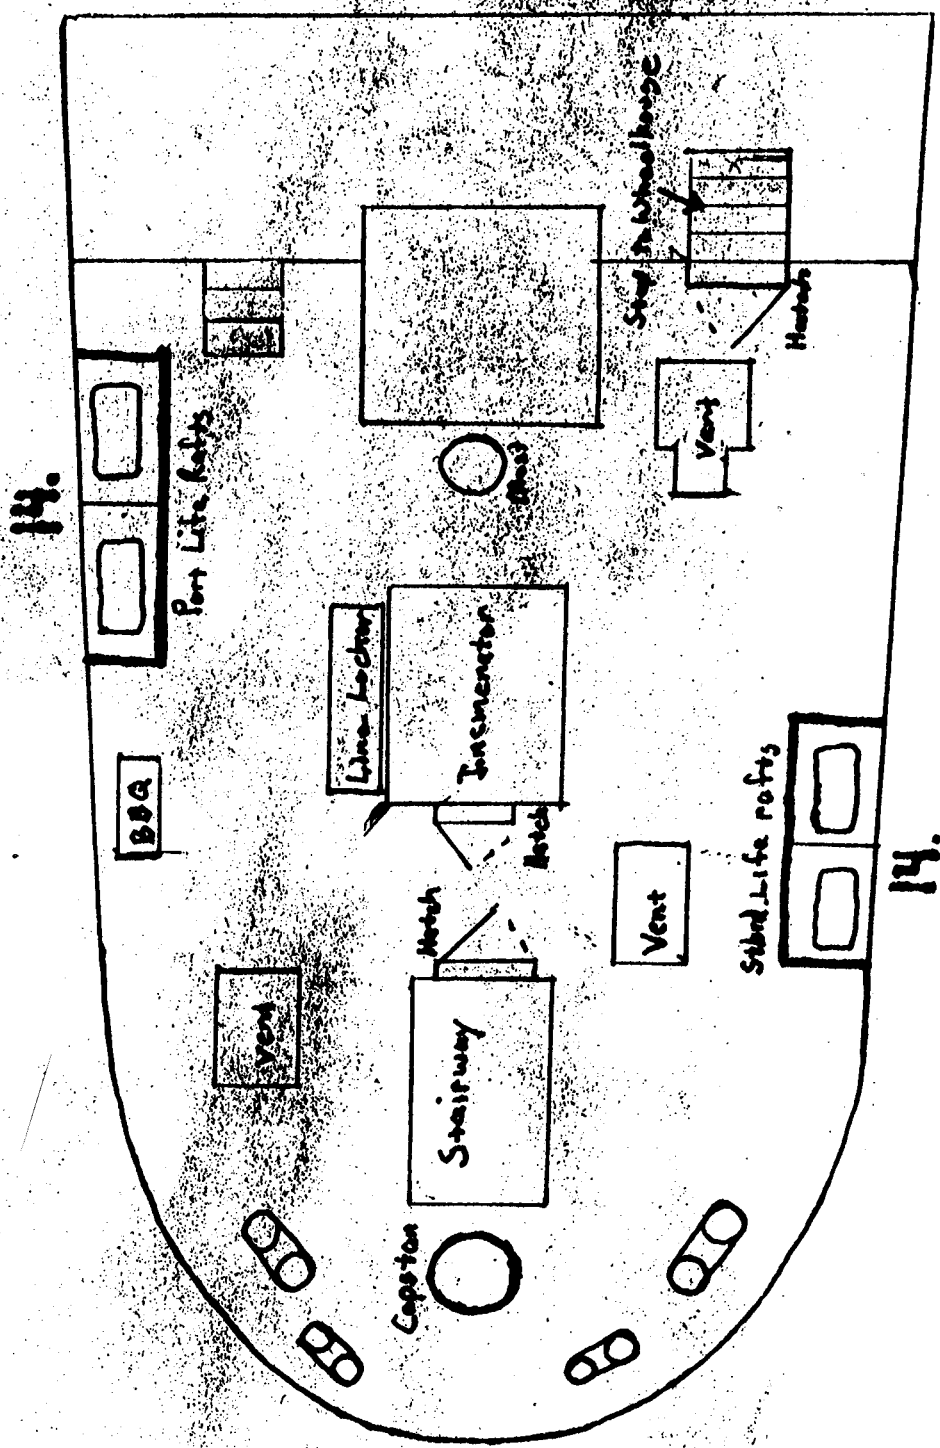
Figure (16): Top Deck Arrangement*
 * Picture depicts four rafts. Vessel only had two rafts

A steel box on the top deck held three 12-volt 8D batteries charged by a Ratelco 1827 B constant voltage regulator and a McCarron VMI battery charger. A catwalk forward of the house was accessed by a vertical ladder from the work deck. A port and starboard liferaft, two Jacob's ladders (stowed in a box forward of the port side liferaft) and an Emergency Position Indicator Radio Beacon (EPIRB) were also located on the top deck.

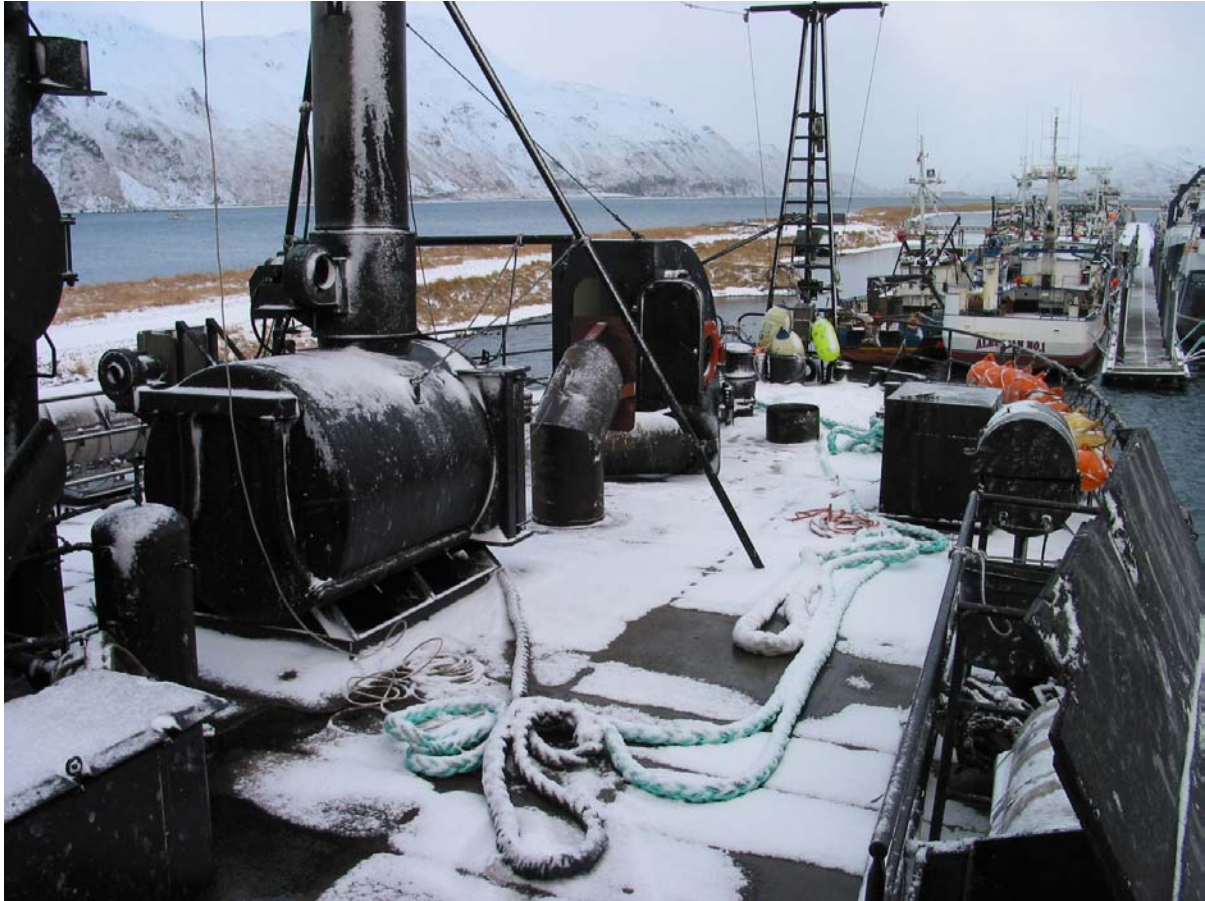
Figure (19): Photo of the Top Deck Aft Mast taken in December 2001

mast sighted the lights of a fishing vessel. The lights turned out to be the F/V BLUE PACIFIC. The crew members continued to wait and then spotted another set of lights approximately 10 minutes later. The second vessel sighted was the F/V GLACIER BAY. The three waited on the aft mast for approximately 1 to 1.5 hour(s). The aft mast is depicted below in Figure (19)
