## **FINDINGS OF CONCERN**

### **Ninth Coast Guard District**

Findings of Concern 003-23

## **REPAIR HISTORY VERIFICATION OF PROPELLER BLADE(S)**

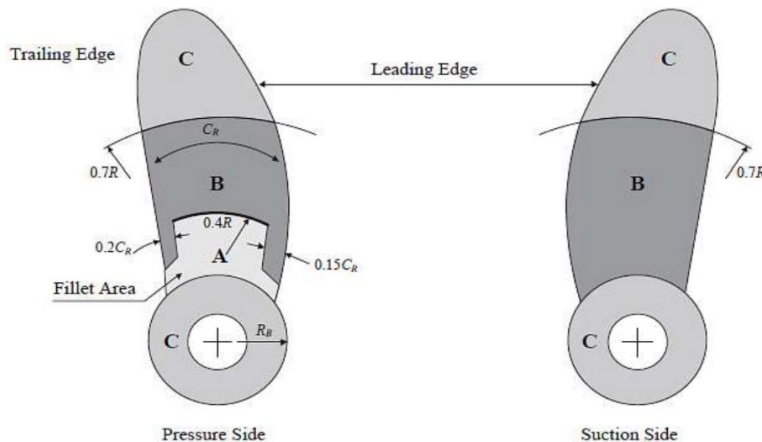
Propeller zones are different areas within the physical propeller blade that experience varying stresses when operating. Typically, Zone A is the region with the highest operating stresses, Zone B is a region where operating stresses may be high, and Zone C is the region where operating stresses are low.

*Figure 1: A depiction of propeller blade severity zones for low skew propellers.*

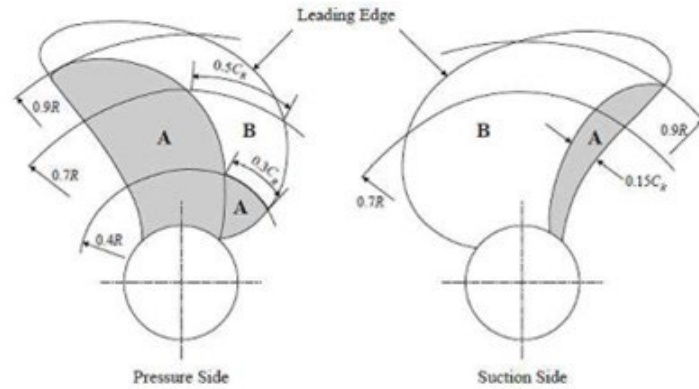
*Figure 2: A depiction of propellor blade severity zones for high skew propellers.*
