# Safety Alert for Schat-Harding Winch W80(W Series)

# **W80 SAFETY ALERT KNOWLEDGE**

### Failure of Large Planetary / Reduction Gear Components of LSA Winch Equipment

# Millom West and Calder

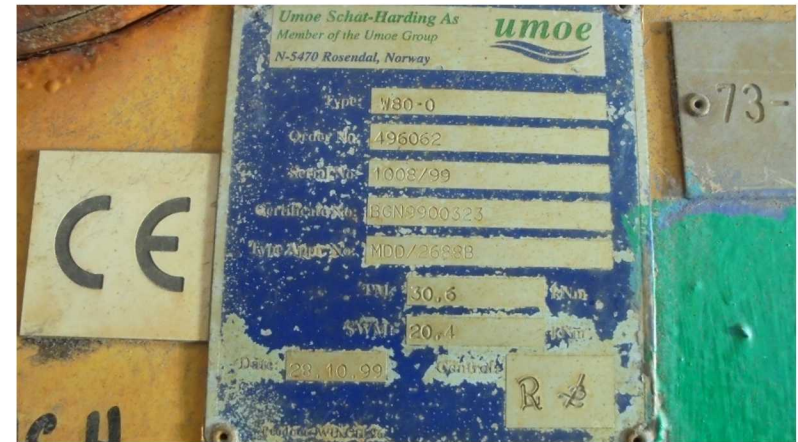
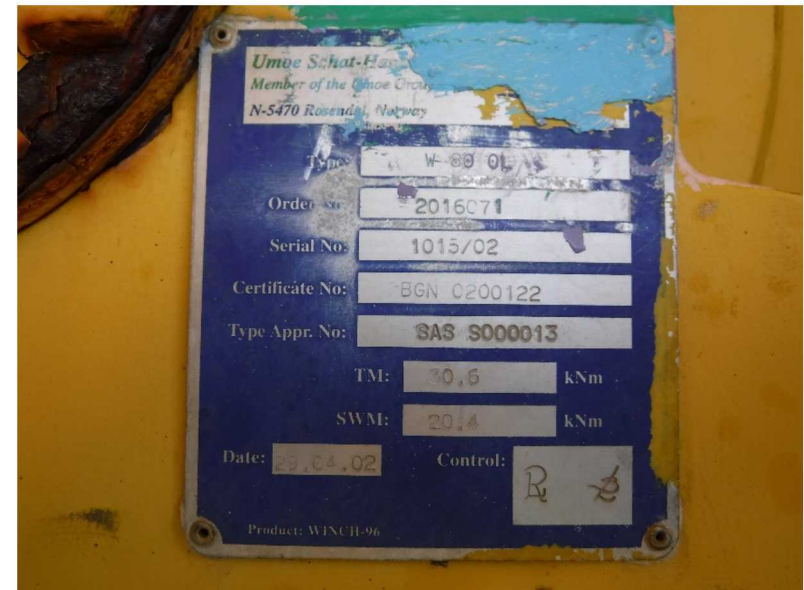
## Millom West and Calder

If no access port exists (MW to be checked), a mag drill would need to be used to open an access port through the case lifting point. A Borescope can then be used to see whether the oil bung of the brevine gear is in place and give comfort that no oil has leaked.

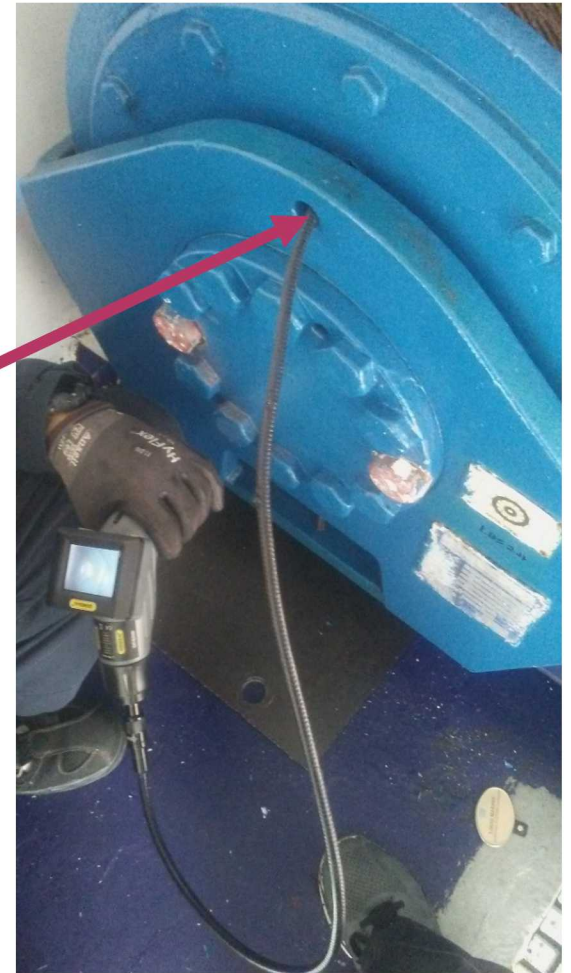
## Example of Leaking Brevini Gear Unit

Photos taken on another customer's asset on a larger model winch (W120) 02 June 2020, indicating oil bung compromised and oil leaking from the planetary gearbox. Winch subsequently taken out of service

Given the impact of a Brevini gear failure SSI recommend an inspection and offer the following plan of action:

- 1) Undertake an inspection of the gear using the above method at the earliest available opportunity
- 2) Inspection can be undertaken offshore but recommend return to workshop for overhaul
- 3) Load tests in the interim period to be undertaken with caution with maintenance pendants attached from the outside of the TEMSPC before accessing to fill with load test bags.

Should any investigation discover oil has leaked, discussions to be undertaken on the safety of an overload test, with the activity being fully risk assessed.
