PROCEEDINGS

OF THE MARINE SAFETY COUNCIL

Collision Under the Golden Gate . . .

COLLISION UNDER THE GOLDEN GATE

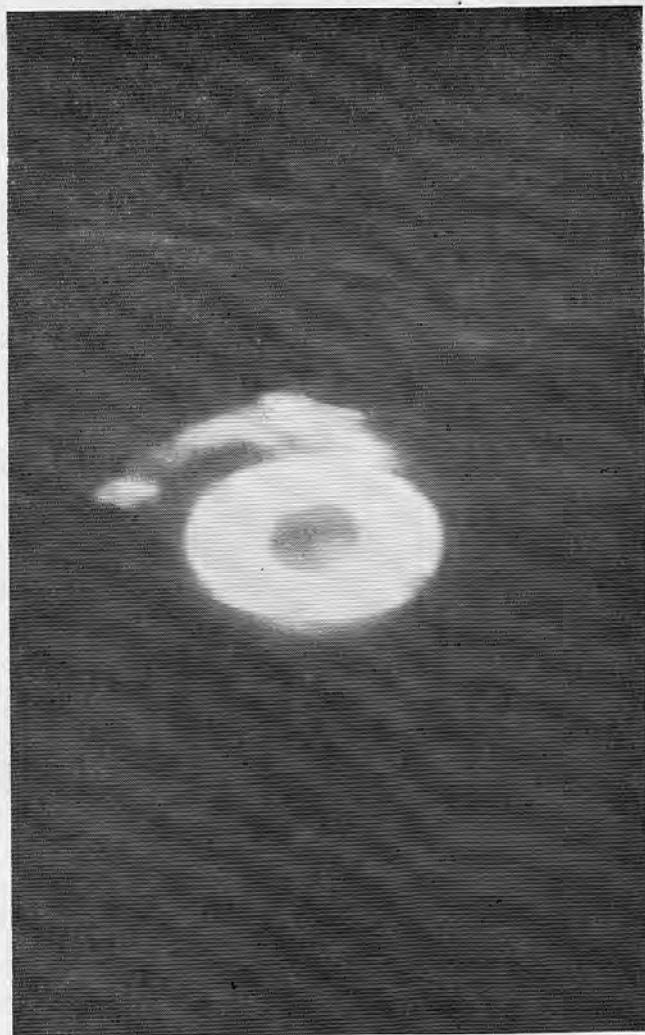
The picture at the right evokes some idea of the smallness of a man alone in the vast ocean. This man was lucky; many, many others have not been. Don't be the man overboard! ⚓

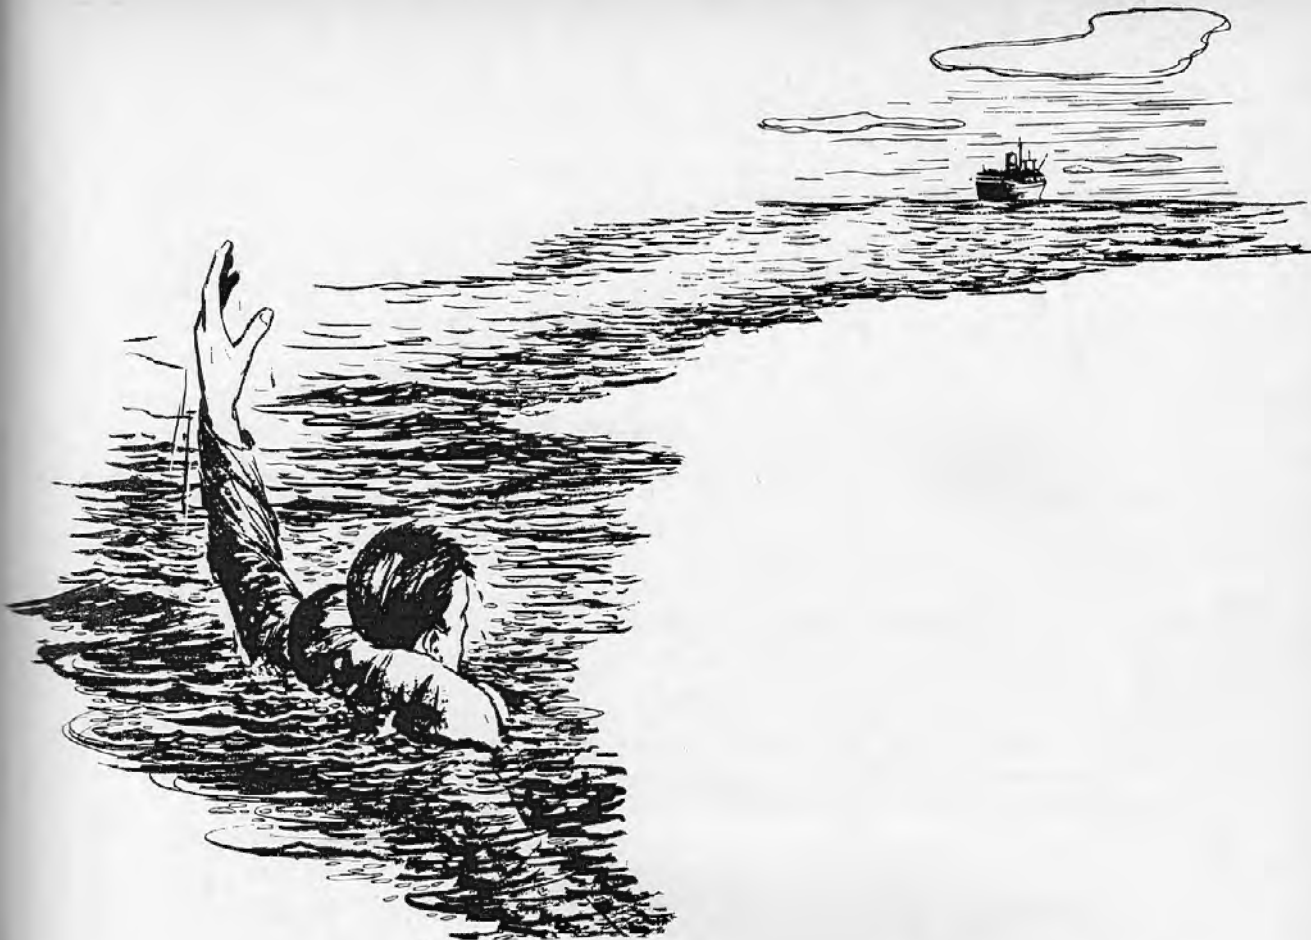
Lack of attention or carelessness on the part of the individual was determined to be a major factor in 14 instances. Such an excuse, however, does not allow a supervisor to evade the responsibility of ensuring that his men understand the dangers of being aboard a ship at sea. Unfortunately, all the indoctrination in the world sometimes has little value in saving a life. Four of the men overboard were apparently intentional actions. In each, mental depression was indicated. Drunkenness accounts for two of these possible suicides and drug use is inferred in another.
