Explosion and Fire on Offshore Platform . . .

EXPLOSION AND FIRE ON OFFSHORE PLATFORM

At 1605 on that day, explosions and fire ripped the Chambers and Kennedy Offshore Oil Platform about 12 miles south of Galveston, Tex. The fire resulted in the deaths of five workmen on the platform and four men on board the M/V *Carryback* which was moored below the platform. In addition, six platform workmen were injured, the platform and the vessel were severely damaged and Galveston beaches were moderately polluted by oil.

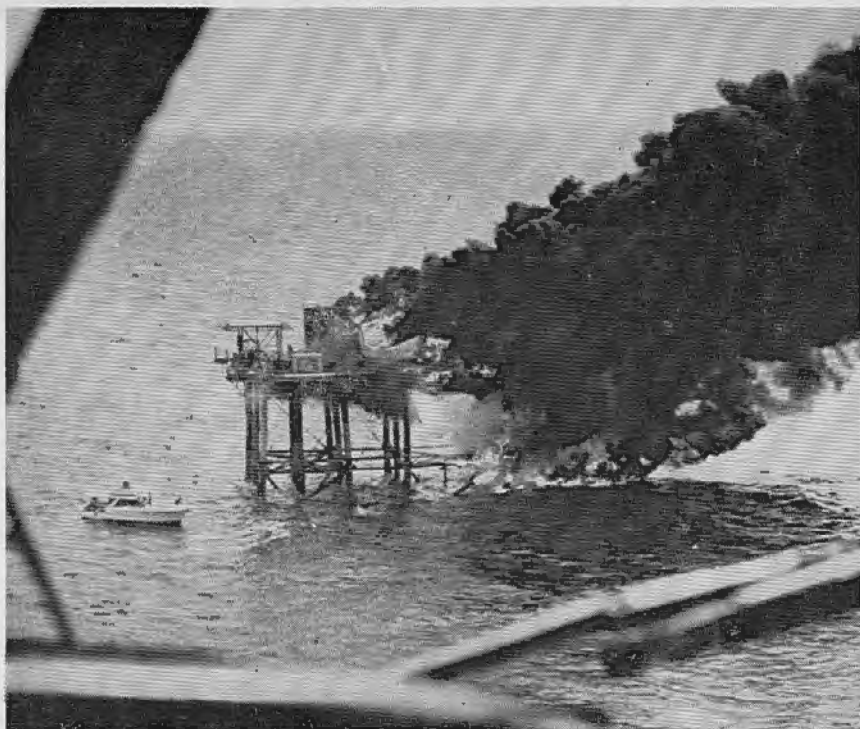
The pleasure craft Princess Patsy, operated by Mr. Edward Holdgraf, witnessed the explosions and fire and approached the platform from the windward. Holdgraf's meritorious action in rescuing 15 survivors was cited by the Coast Guard Marine Board of Investigation.
