PROCEEDINGS

Marine Casualties— Prevention Through Legislation . . .

SS African Star and M/V Midwest Cities and Tow; Collision and Fire . . .

M/V *MIDWEST CITIES* AND-ON THE MISSISSIPPI RIVER ON MARCH 16, 1968

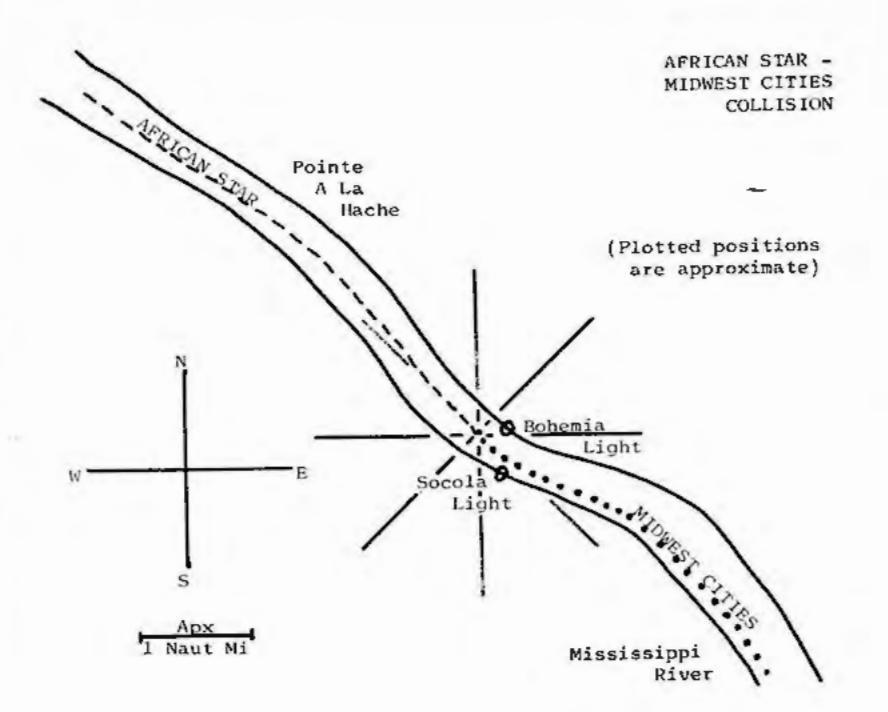
Severely scorched by the burning oil which quickly spread from the Intercity barge, the African Star lists to starboard after members of her crew valiantly maneuvered the vessel to shore.
