## **PROCEEDINGS** OF THE MARINE SAFETY COUNCIL

Vol. 31, No. 10

October 1974

# 13 Minutes

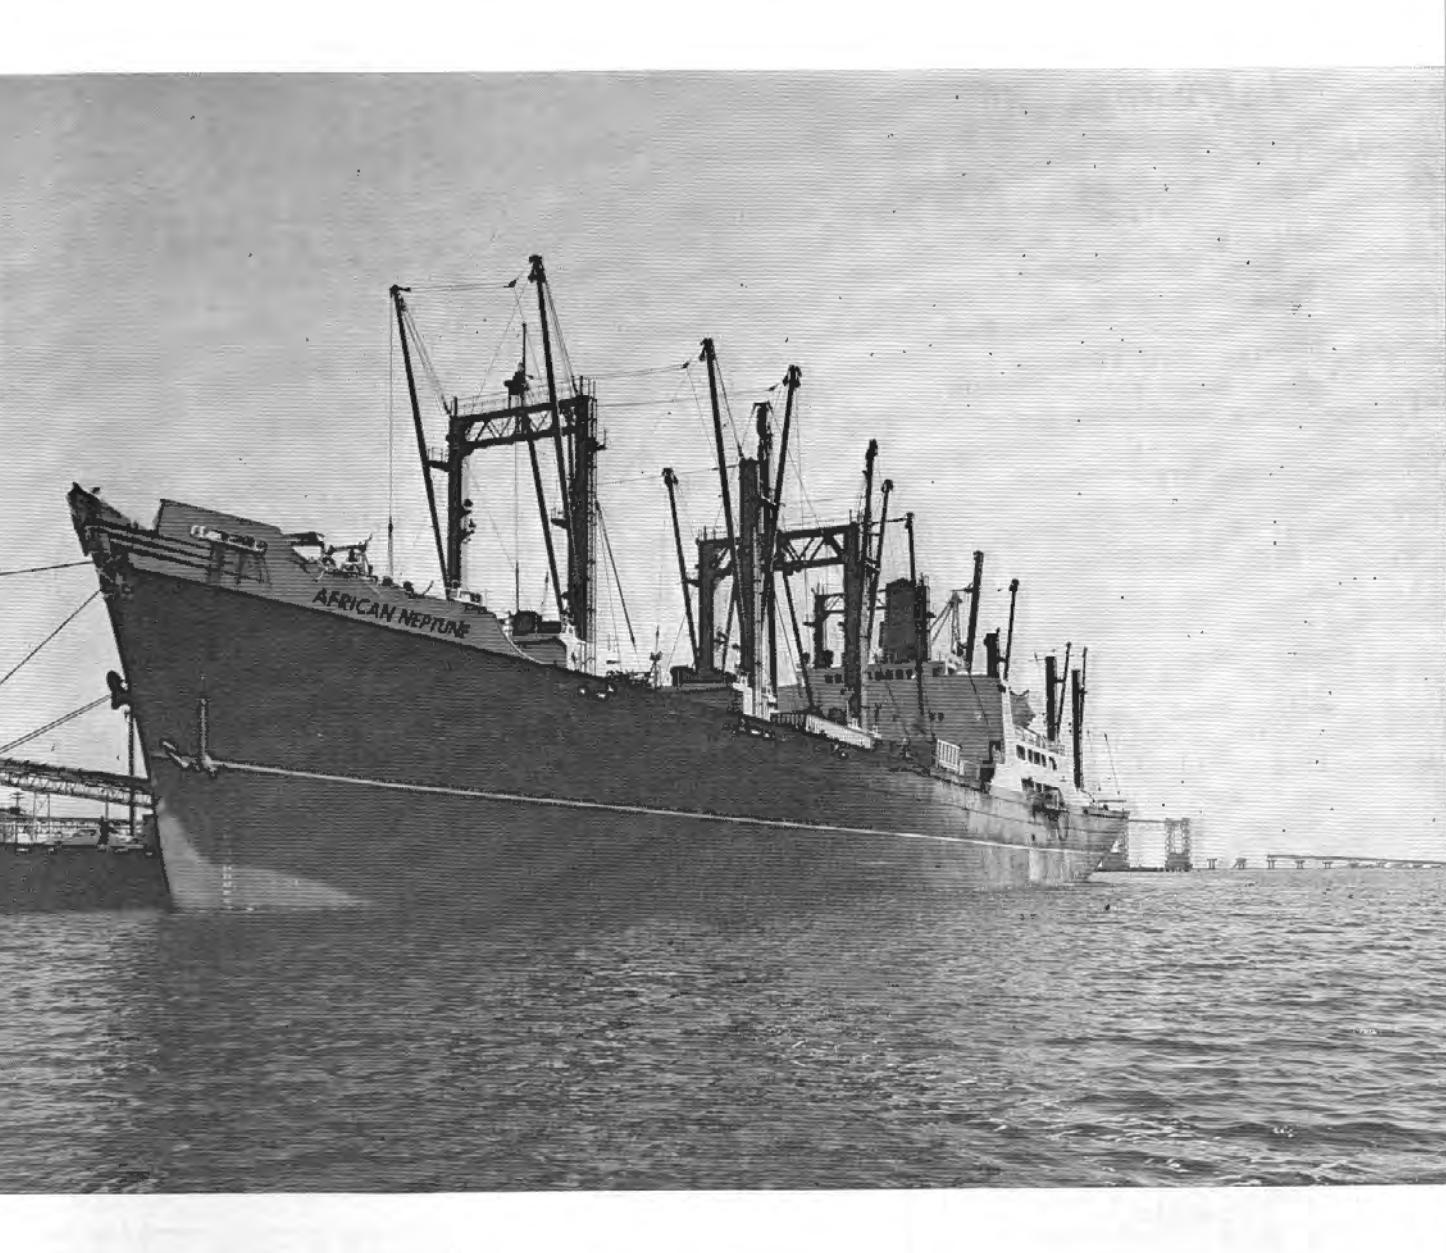
#### FRONT COVER

This photograph, taken the day after the casualty that claimed 10 lives, shows both the minor damage incurred by the *African Neptune* and the bridge she struck.
