PROCEEDINGS

OF THE MARINE SAFETY COUNCIL

Steel Vendor Stranding . . .

THE LOSS OF THE STEEL VENDOR

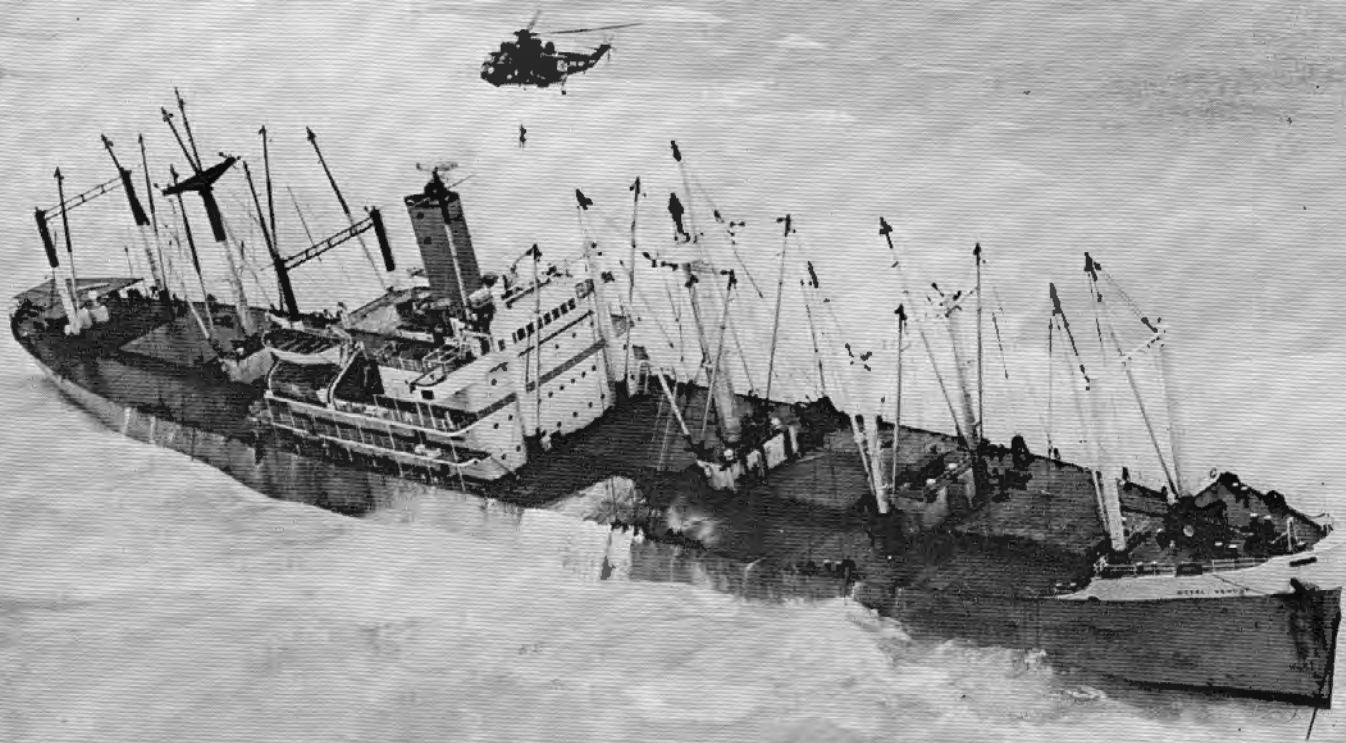
Photographs of the stranded SS *Steel Vendor* during evacuation of her crew appear on our front and back covers this issue. Having been adrift without power for two days, the ship found herself some 90 miles south of her estimated position, and she was driven onto the Loaita Bank shoal by heavy seas and strong winds. The crew members were evacuated by helicopters from the British Aircraft Carrier HMS *Eagle*. Only one person was injured.
