PROCEEDINGS

OF THE MARINE SAFETY COUNCIL

Acid Spill

Where Did All the Acid Go?

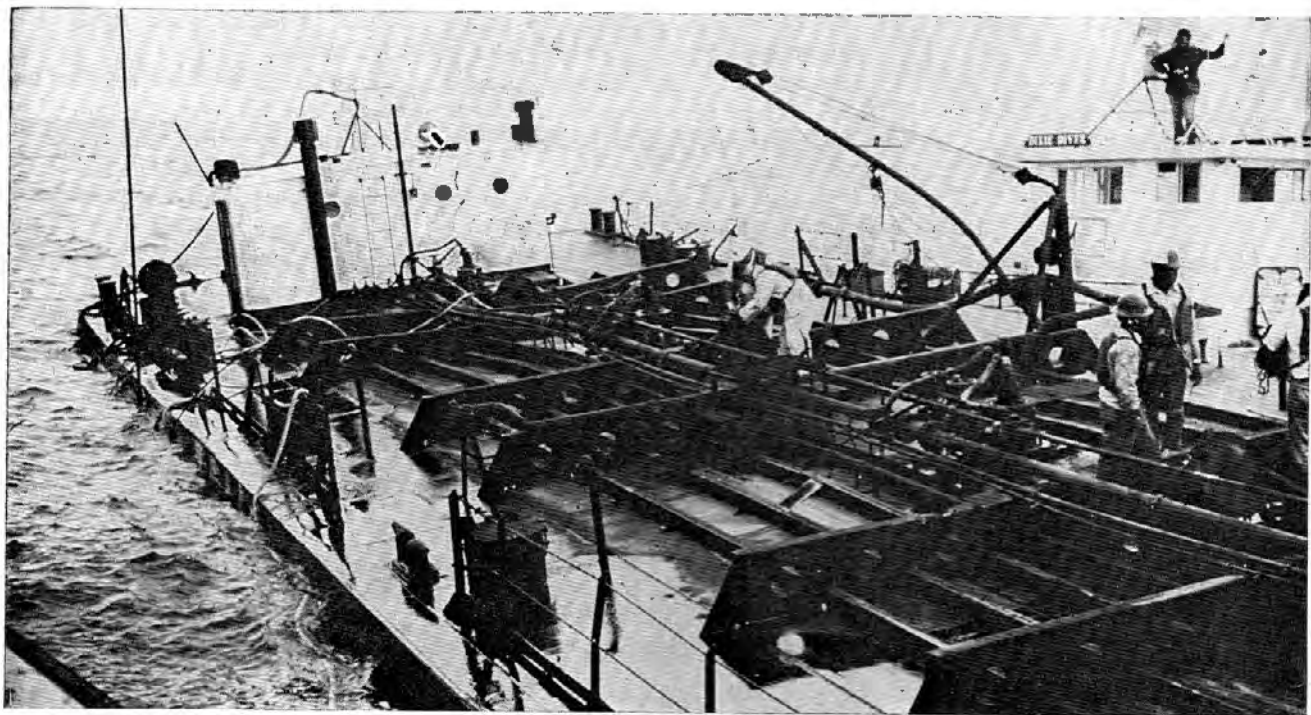
On August 18, 1976, the MT Big Mama with tank barge AC 38 in tow, was underway in the lower Chesapeake Bay en route from Claymont, Del., to Hopewell, Va. At approximately 0540 EDT, about 30 miles north of Norfolk, the barge capsized.

The tug then proceeded to the barge and found it floating in an inverted position, slightly down by the bow. Approximately 20 minutes after capsizing, the barge was seen to rise up with about a 4-foot increase in freeboard. It stayed up for about 30 minutes and then settled back into the water and remained in this condition until righted. It is assumed that the cargo escaped during that period.

After righting, the barge was boarded and examined. All the cargo hatches were open and the tanks full of water. The *Big Mama* towed the AC 38 to Norfolk where a thorough inspection was conducted. A 36-inch fracture was found in the forward starboard corner of the forward rake, and in the center of the fracture was a set-in area 18 inches long, creating an 8-inch hole. The first 18 inches of the fracture was old damage, which had occurred prior to the last hull painting. The set-in area was newer damage, presumably the result of a tug striking, though this could not be documented.

The Coast Guard investigating officer concluded that the proximate cause of the casualty was the hole in the forward rake. Water entered this hole as the AC 38 was first pushed and then towed, with the following wind and sea adding to the influx. As the forward rake filled with water, the barge trimmed by the bow and the range of stability decreased to a point where, when the AC 38 sheared to port and the hawser took a heavy

strain, the barge could not right itself and it rolled over. The damage to the cargo hatches and main deck was caused by the extreme reaction between the oleum and seawater as the acid escaped.

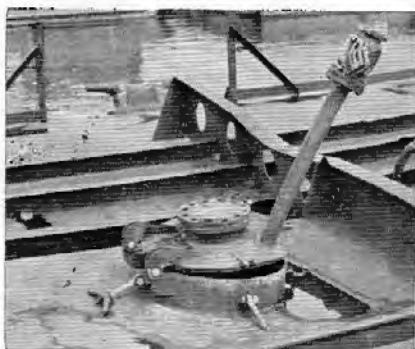
when questioned by the first Coast Guard response personnel arriving on scene, the towboat personnel "forgot" that the barge had vented tremendous quantities of vapor, and had been lifted up 4 feet in the water for 30 minutes, obviously releasing the cargo. (This fact only came to light at the official Coast Guard inquiry held 2 weeks later.)

accelerated recent corrosion around the cargo tank hatches.
