PROCEEDINGS

OF THE MARINE SAFETY COUNCIL

April 1978

Barge Blast Kills Four

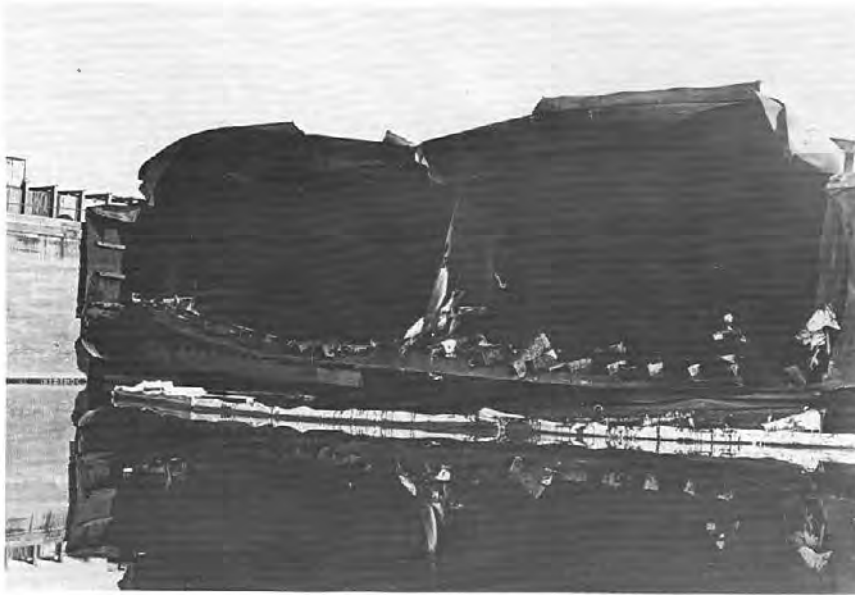
The Commandant, in his review of the casualty, concurred with the Marine Board in their determination that the proximate cause of the casualty was welding re-

cargo leakage, preparation, or repair work on the B-924 was a gas free certificate issued to the barge owners, nor was there any attempt made by the senior officer present to secure copies of a gas free certificate as required by 46 CFR 35.01-1. In addition, employees of the repair facility were allowed to enter cargo spaces and adjacent void compartments on the day prior to the casualty without a test conducted by a competent person as required by 29 CFR 1915.11.

pairs being undertaken on a tank barge that was not gas free. This resulted in the ignition of vapors from cargo and cargo residue in the No. 1 starboard wing void which spread fire throughout the forward section of the vessel and ignited volatile vapors causing an explosion. The disregard for federal regulations and unsafe practices on the part of the marine chemist and the owners of the vessel resulted in this fatal accident.

The Commandant concurred with the Marine Board's recommendation that the Coast Guard review standards relating to detailed procedures and responsibilities for the completion and handling of marine chemists' certificates. The Coast Guard will also conduct a complete review of the certification of marine chemists and their equipment, and the maintenance of related records.
