Proceedings

Vol. 44, No. 10

November 1987

- 251 Fire and Explosion on the Letitia Lykes**
Oxygen bottles began to explode, throwing
shrapnel thousands of feet in all directions
LCDR Christopher Walter

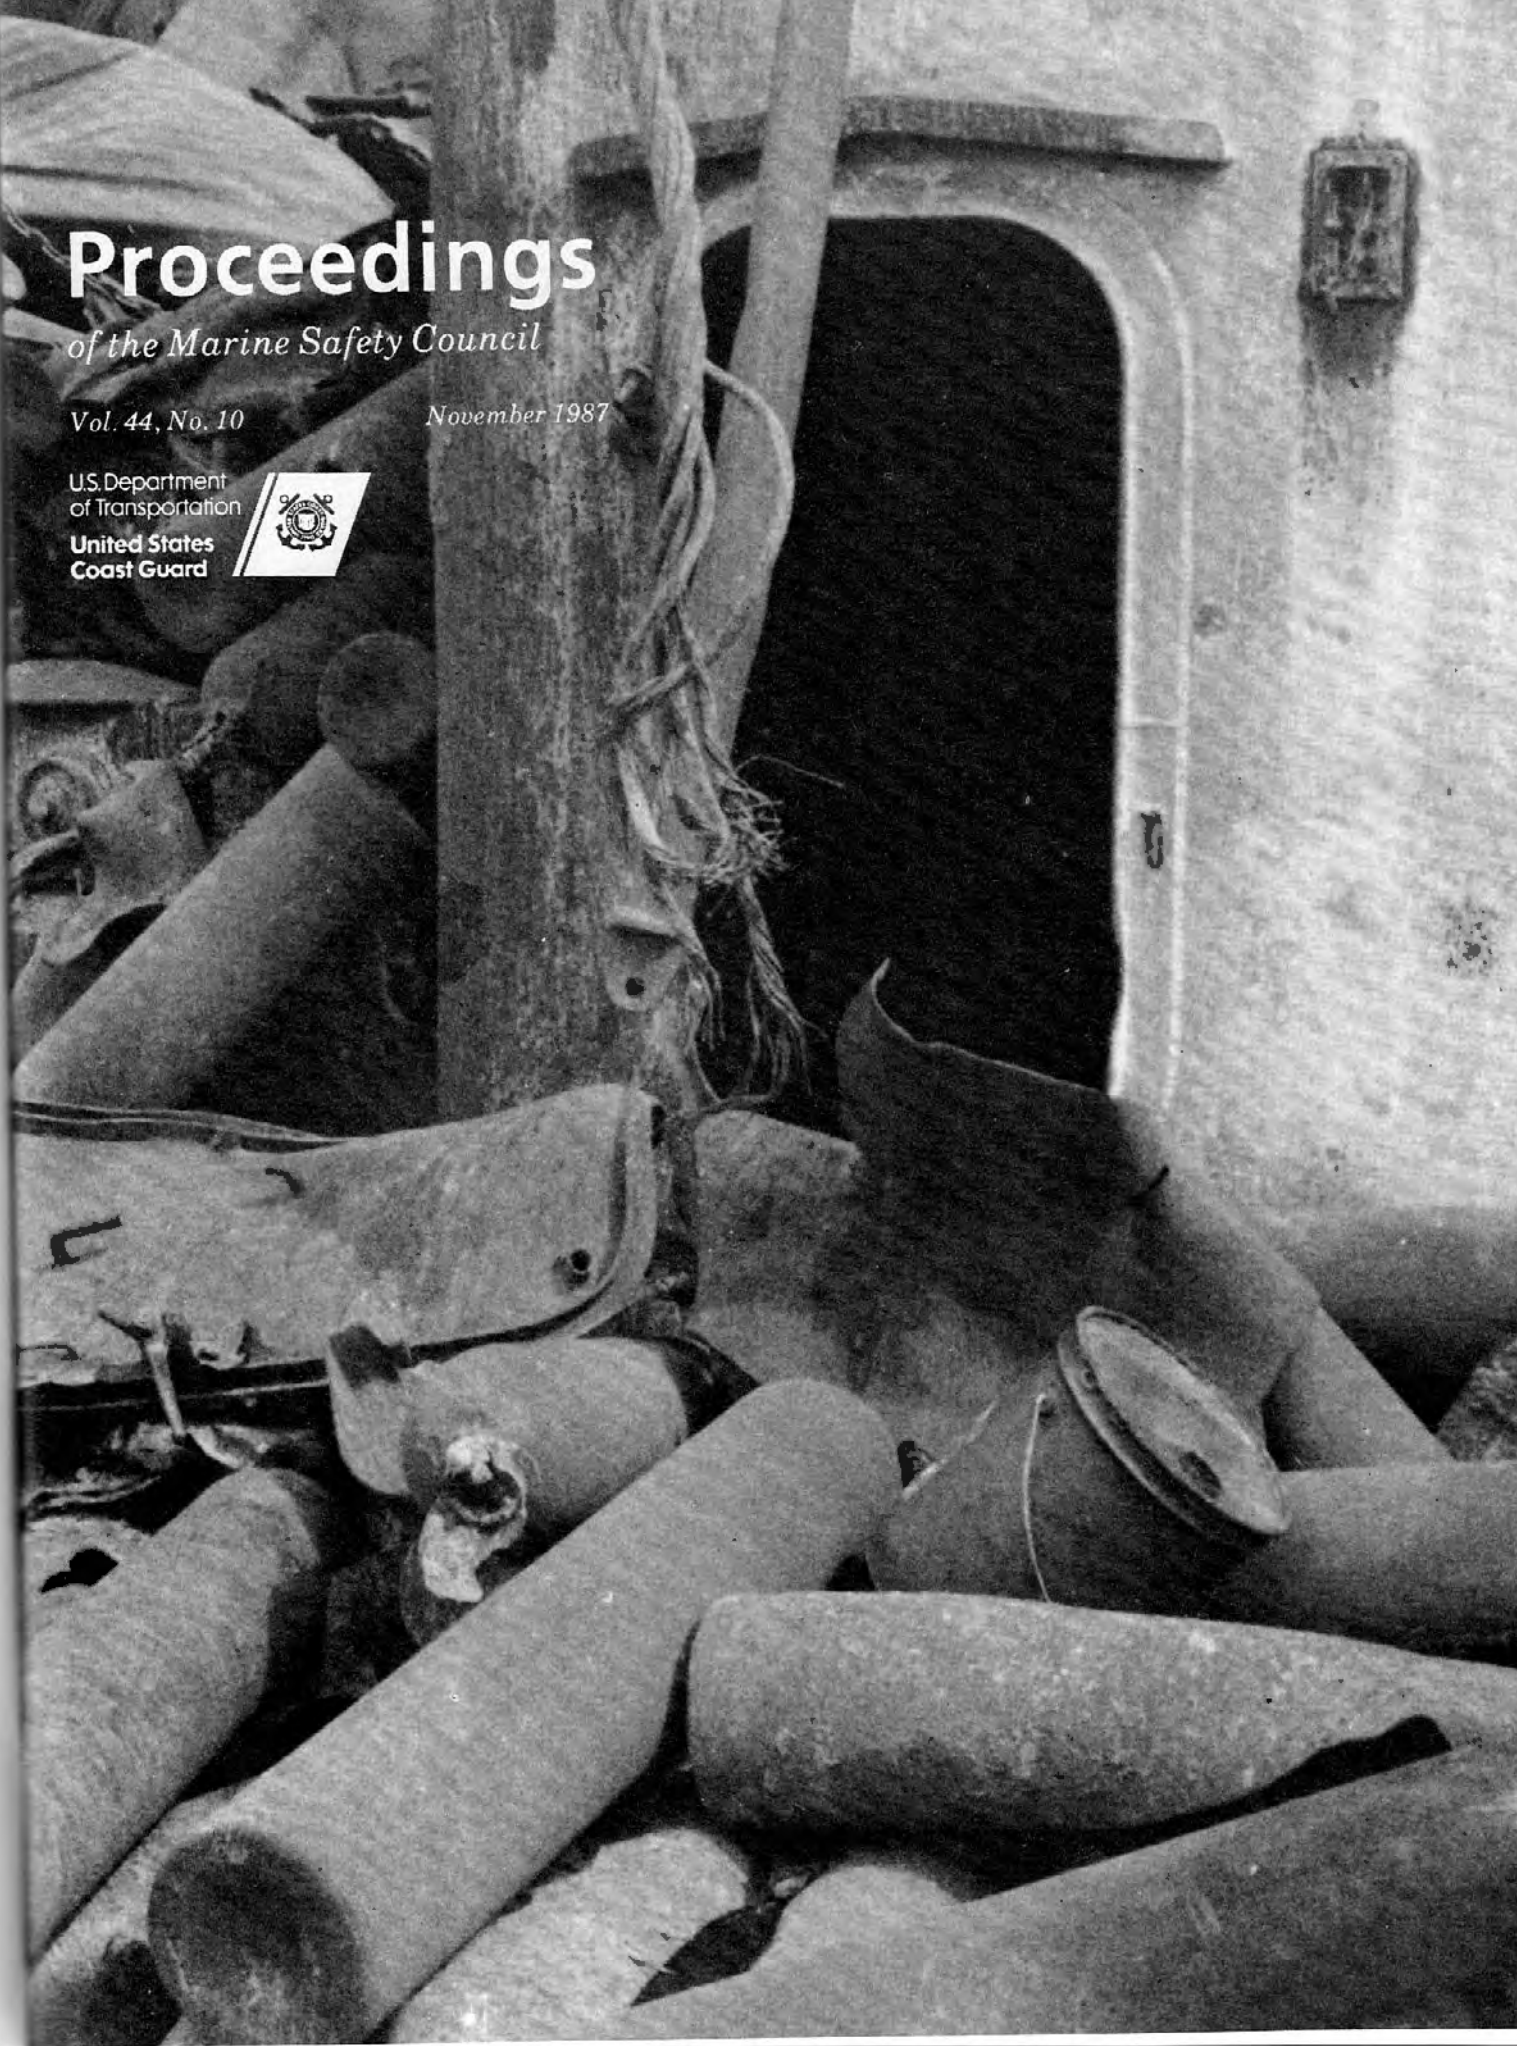
U.S. Coast Guard photo by LT William J. Uberti shows exploded bottles of compressed oxygen and nitrous oxide, as well as fire damage, aboard the Letitia Lykes.
