Final Report

Auger Lifeboat 6 Incident

Shell Oil Company
Houston, Texas, USA

Report No.: O-AP-FINV / BPADG (10165575)
July 9, 2020

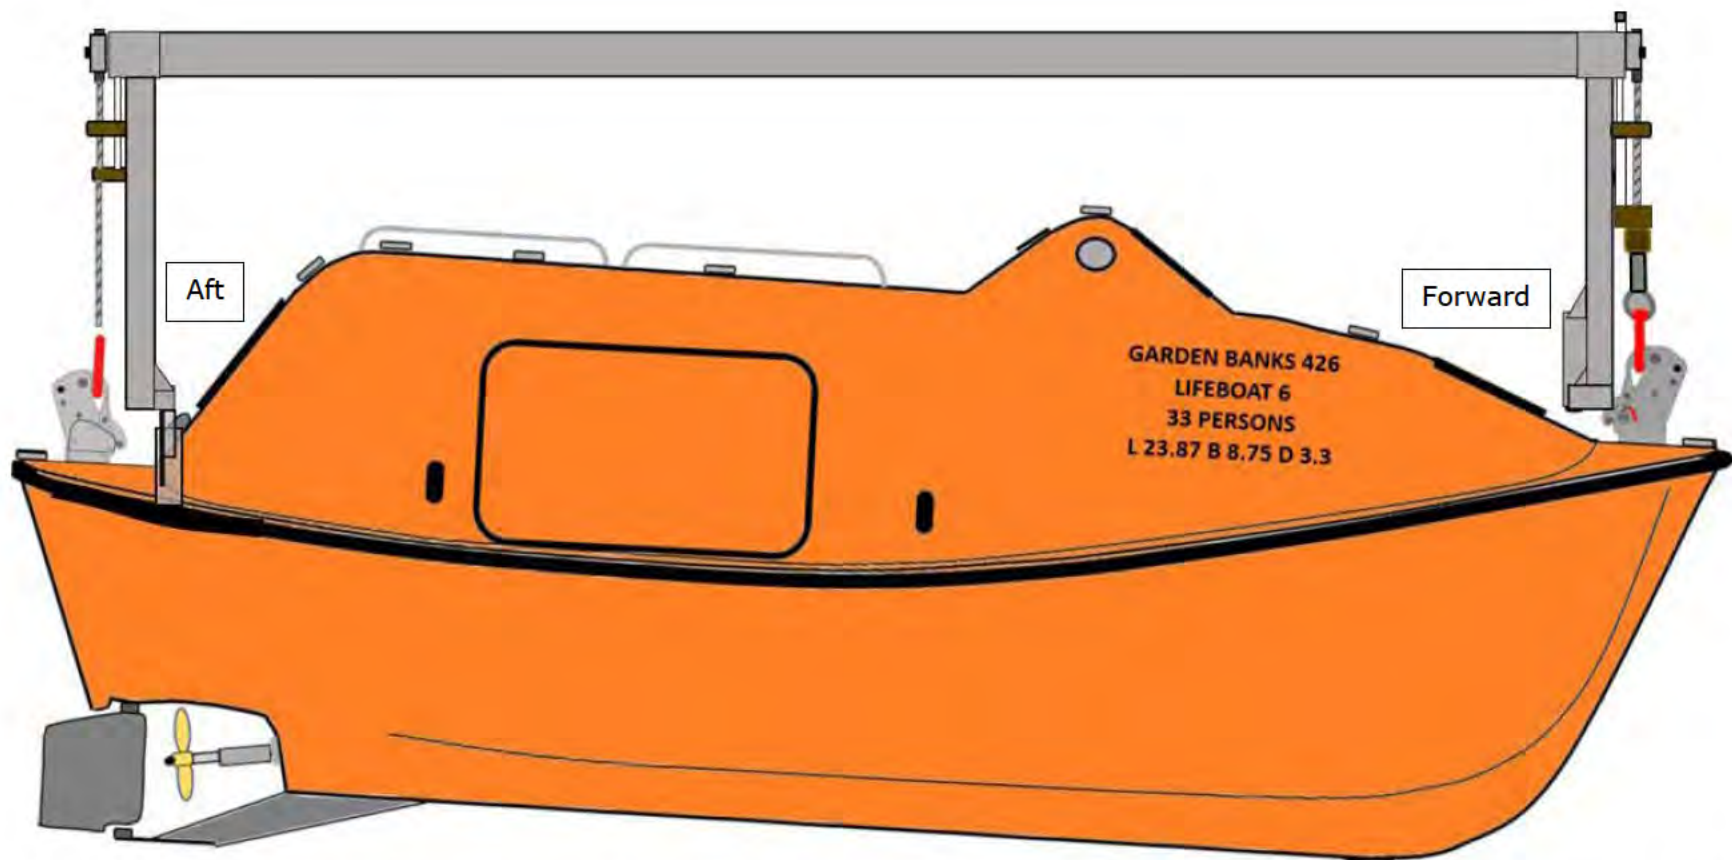
Figure 7. Drawing showing the contact between Lifeboat 6 and the bumpers based on the measurements of the twin fall cables that were performed after the incident. The aft is in contact with the bumpers; however, the forward is not in contact. Drawing designed by SOI.

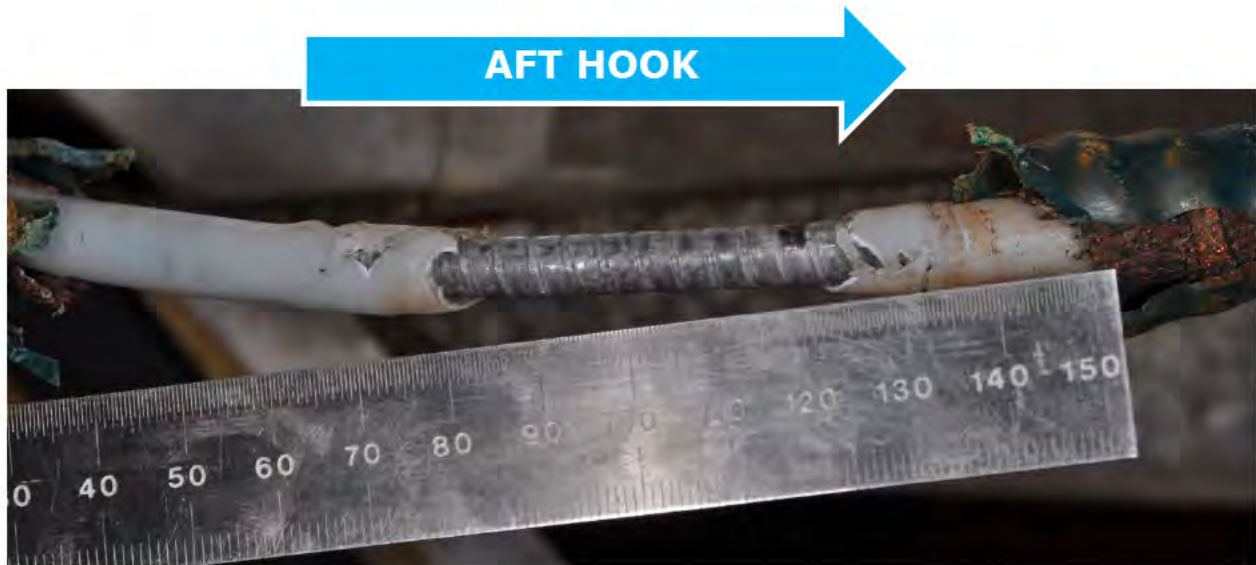
The results of the investigation indicate that the unintended release of the Subject Aft Hook of Lifeboat 6 was a result of a degraded and compromised aft control cable. The control cable exhibited significant corrosion, full penetration around the circumference, of the structural wire layer allowing for externally applied loads to rotate the locking shaft of the Subject Aft Hook to an open position.

Failure of the Subject Aft Cable is suspected of progressing in the following manner: (1) mechanical damage to the cover due to contact between the control cable and the helmsman's console, (2) water ingress leading to significant corrosion of the wire layer, (3) voluminous corrosion product resulting in fatigue of the cover layer and the cover opening further, and (4) buckling and elongation of the liner layer as a repetitive action associated with the functioning of the control cable. Due to the damage to the Subject Aft Cable, the locking shaft of the Subject Aft Hook was not fully closed (i.e. in a slightly more open position) requiring less rotation to release the hook. The compromised cover and wire layer would have allowed for external loads applied to the control cable to translate onto the inner member of the control cable that is directly linked to the locking shaft, thereby rotating the locking shaft to an open position.

Figure 19. Photograph of the Subject Aft Cable showing a failure of the outer layers exposing the inner member. The direction of the Subject Aft Hook is noted with the blue arrow. Ruler is in mm.

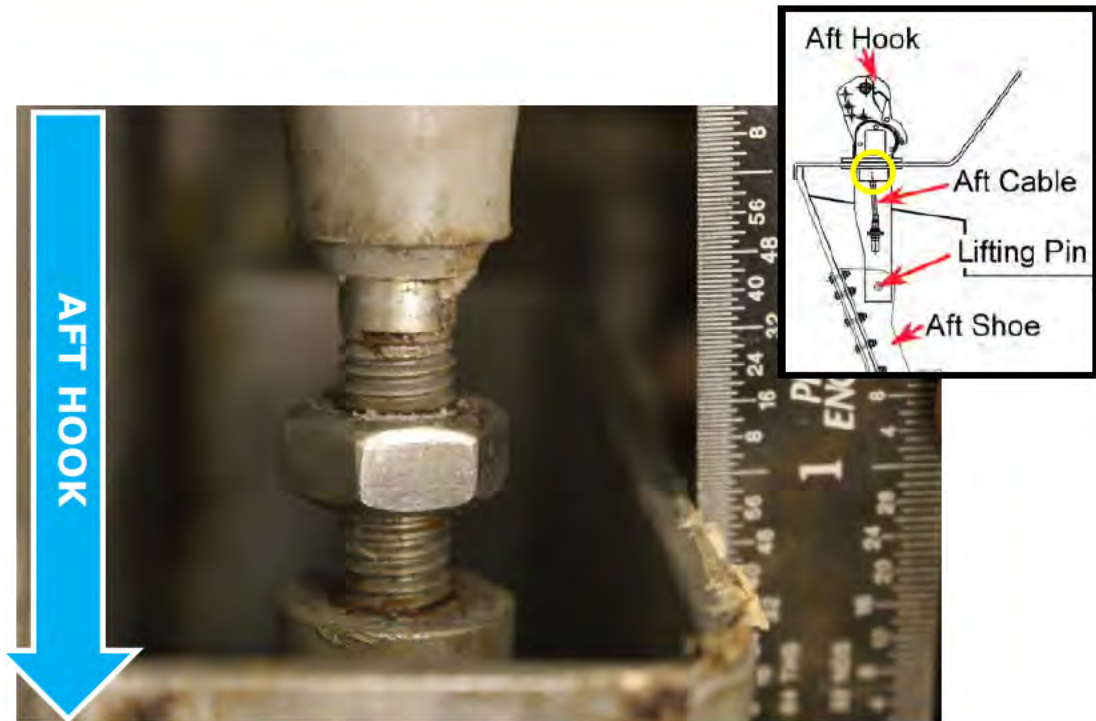
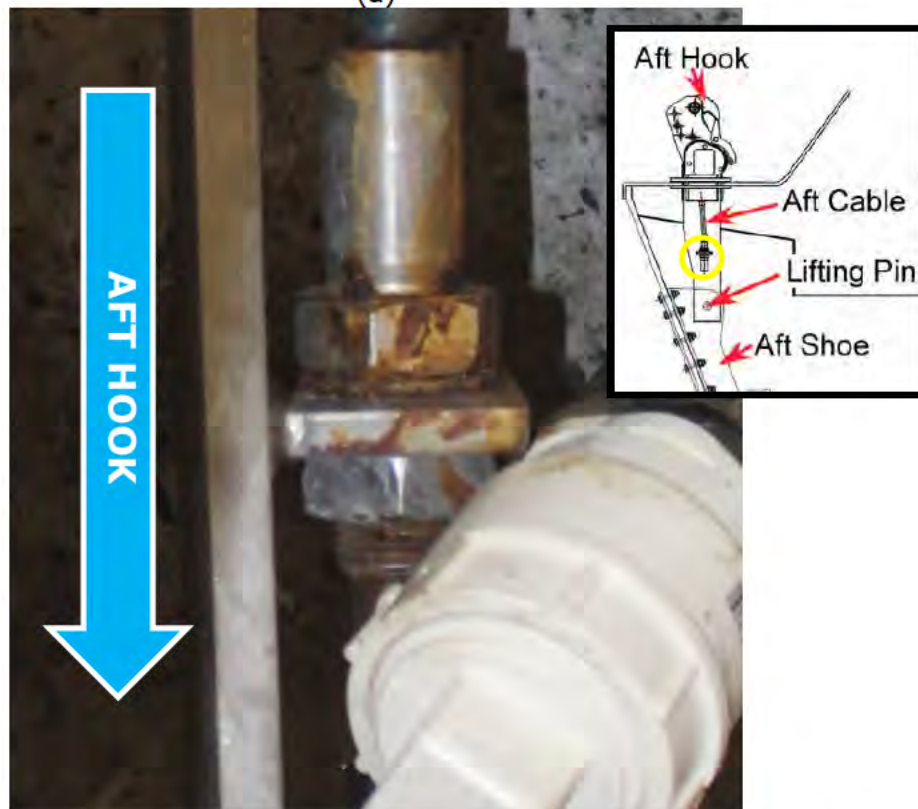
Figure 20. Photograph of the Subject Aft Hook showing the as-found condition of the threaded connections (a) at the clevis and (b) at the bulkhead nuts; the locations of the clevis and bulkhead nuts are shown in embedded schematic. Ruler in top image is in inches.

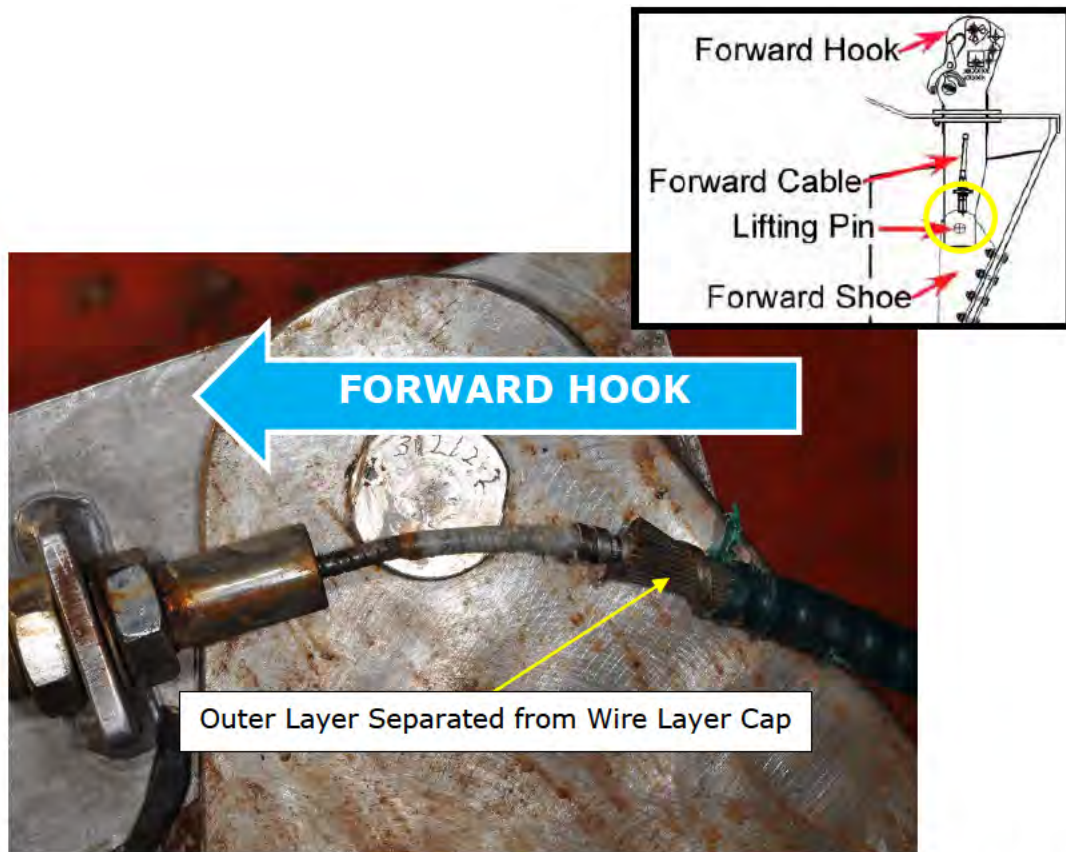
Figure 22. Photograph showing a separation of the outer layers from the conduit cap at the bulkhead nuts of the Subject Forward Cable; location shown in the embedded schematic. The direction of the Subject Forward Hook is noted with the blue arrow.

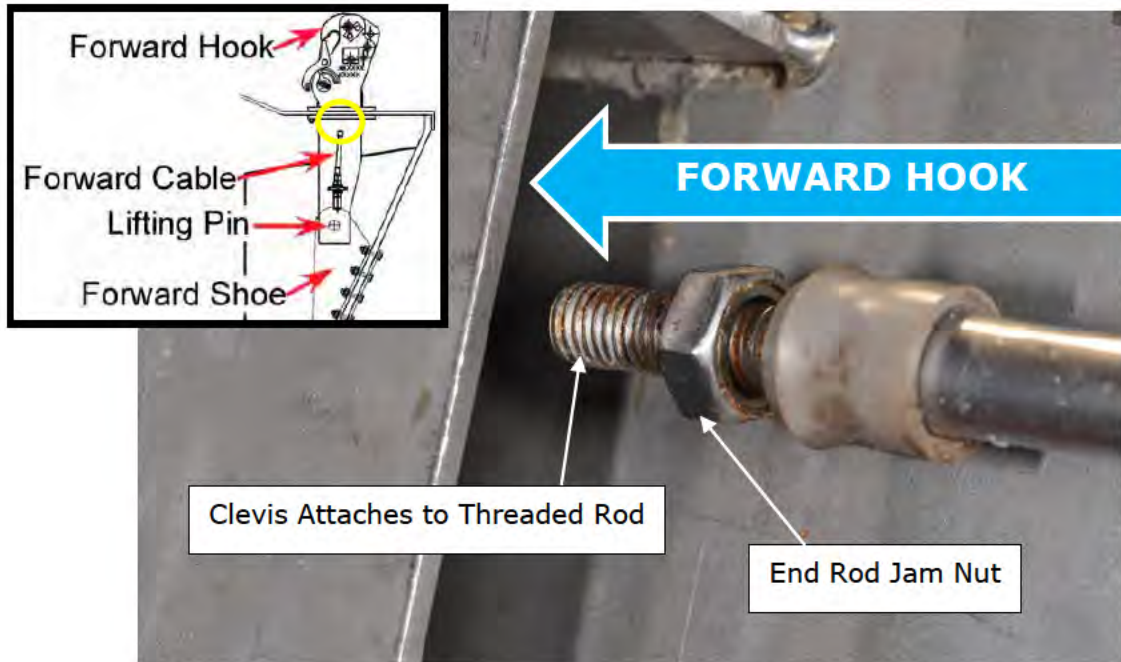
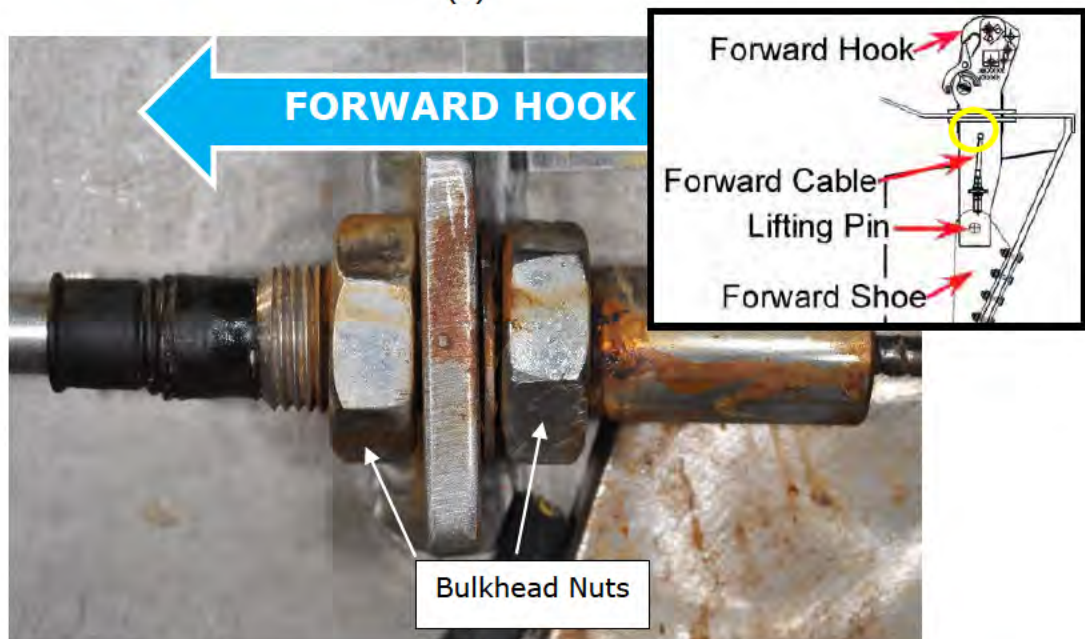
Figure 23. Photograph showing the as-found condition of the threaded connections of the Subject Forward Hook (a) at the clevis and (b) at the bulkhead nuts; the location of the clevis and bulkhead nuts are shown in the embedded schematic. The direction of the Subject Forward Hook is noted with the blue arrow.

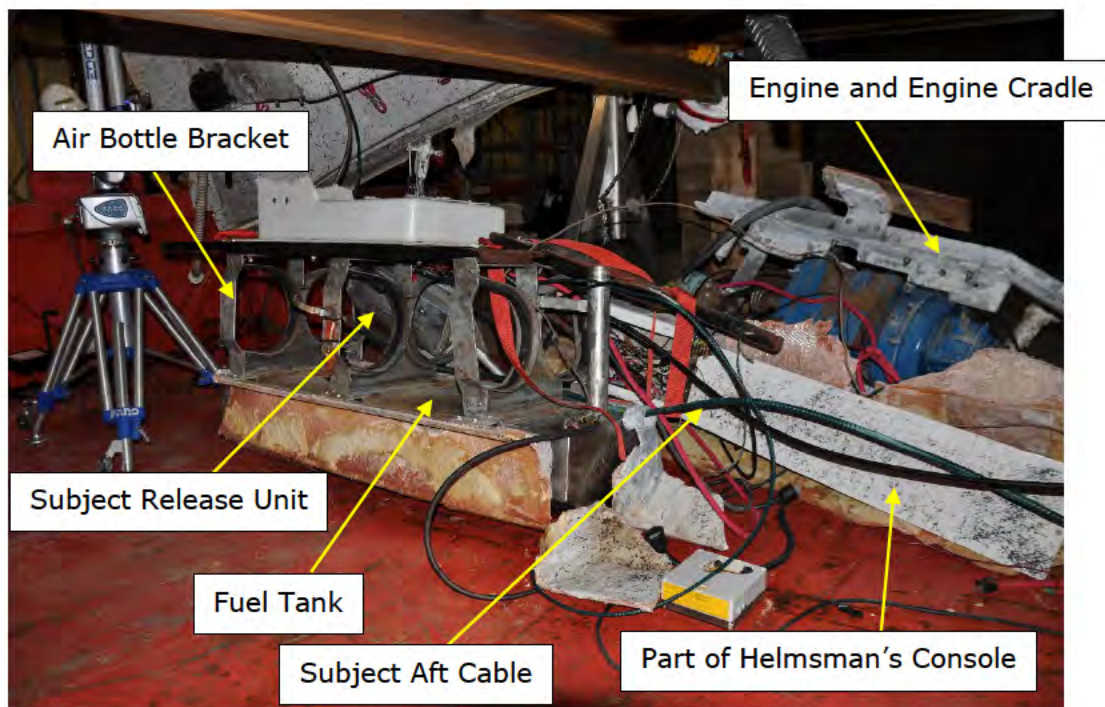
Figure 24. Photograph showing the as-found condition of the internal subject components of Lifeboat 6.

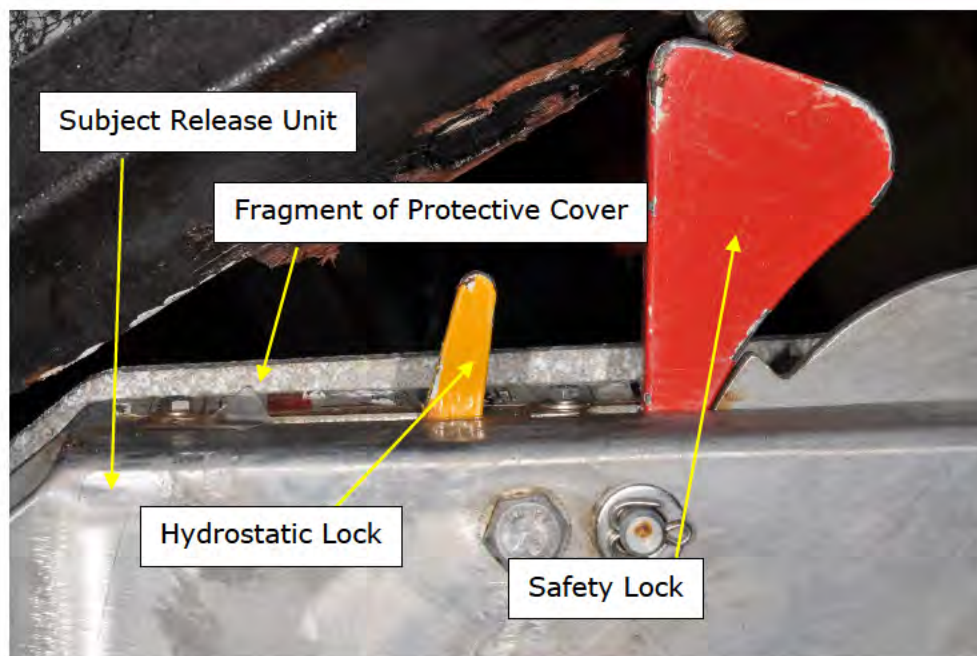
Figure 25. Photograph showing the as-found condition of the hydrostatic and safety locks on the Subject Release Unit of Lifeboat 6.

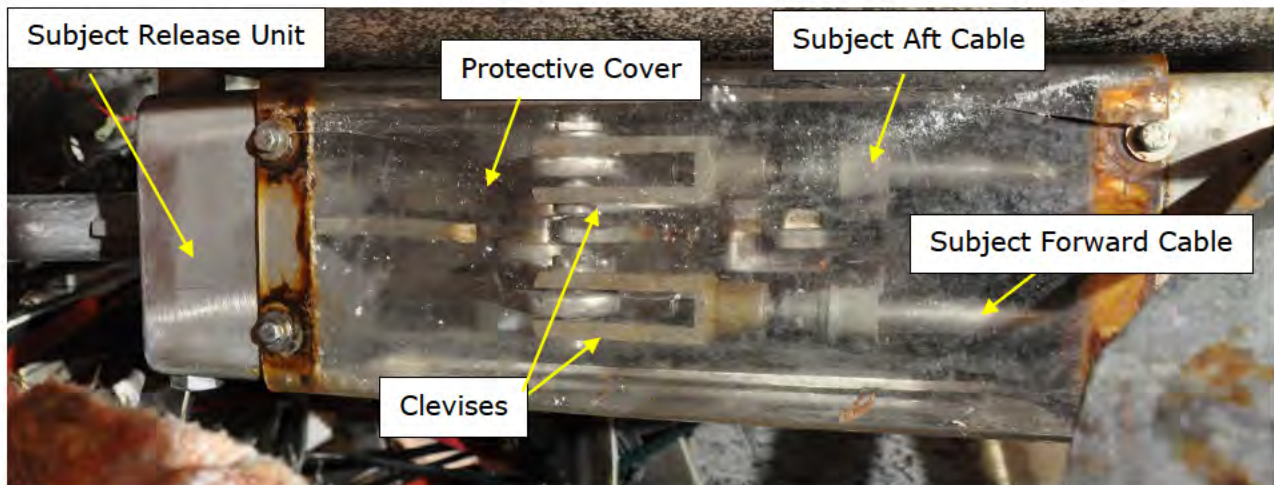
Figure 26. Photograph showing the as-found condition of the Subject Aft Cable and Subject Forward Cable clevises at the Subject Release Unit of Lifeboat 6.

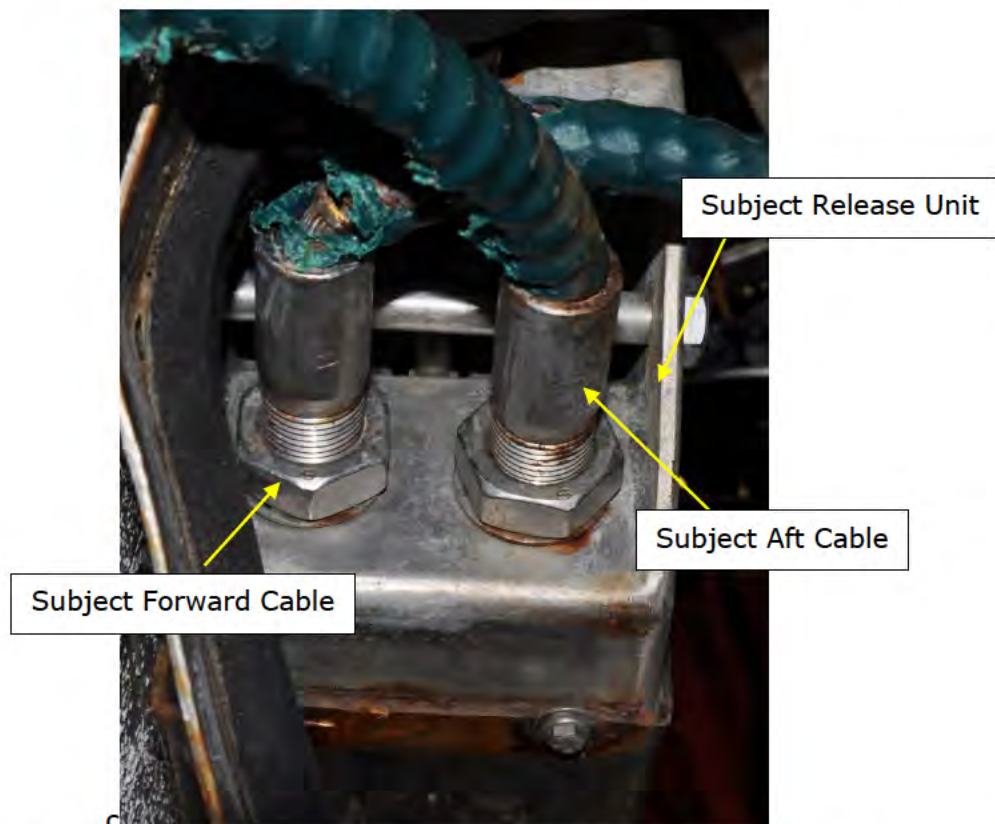
Figure 27. Photograph showing the as-found condition of the Subject Aft Cable and Subject Forward Subject at the bulkhead nuts of the Release Unit of Lifeboat 6.

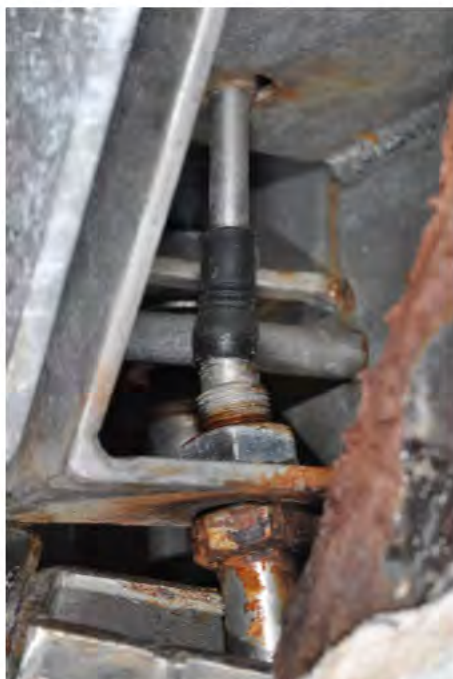
Figure 28. Photograph of the Subject Release Unit showing the as-found condition of the bulkhead nuts attaching the Subject Hydrostatic Cable to the Subject Release Unit.

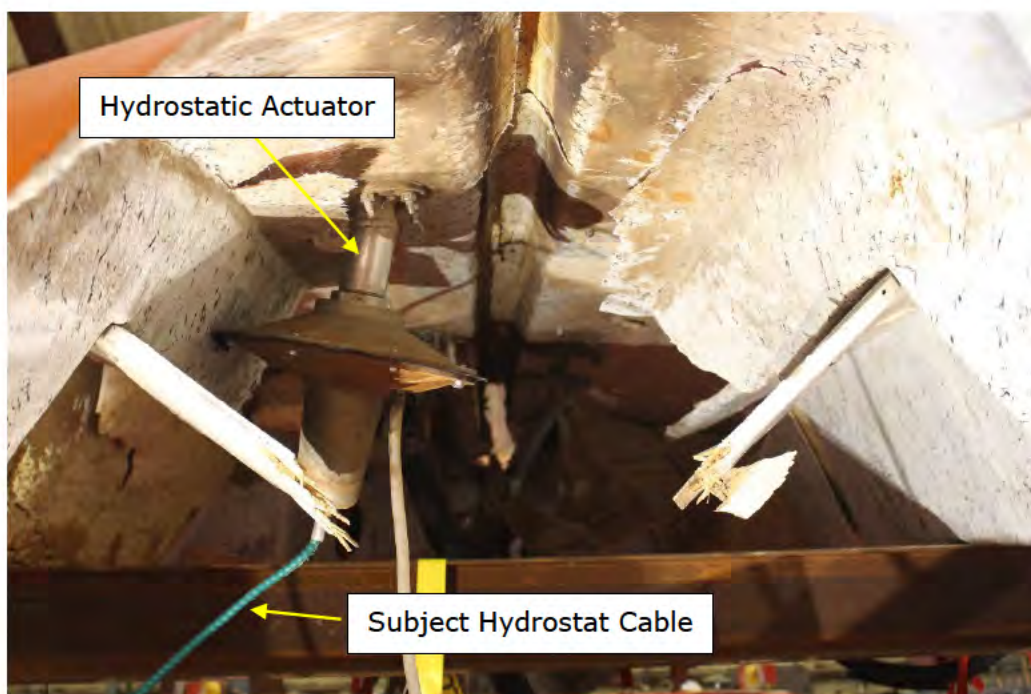
Figure 29. Photograph showing the as-found condition of the hydrostatic actuator of Lifeboat 6.

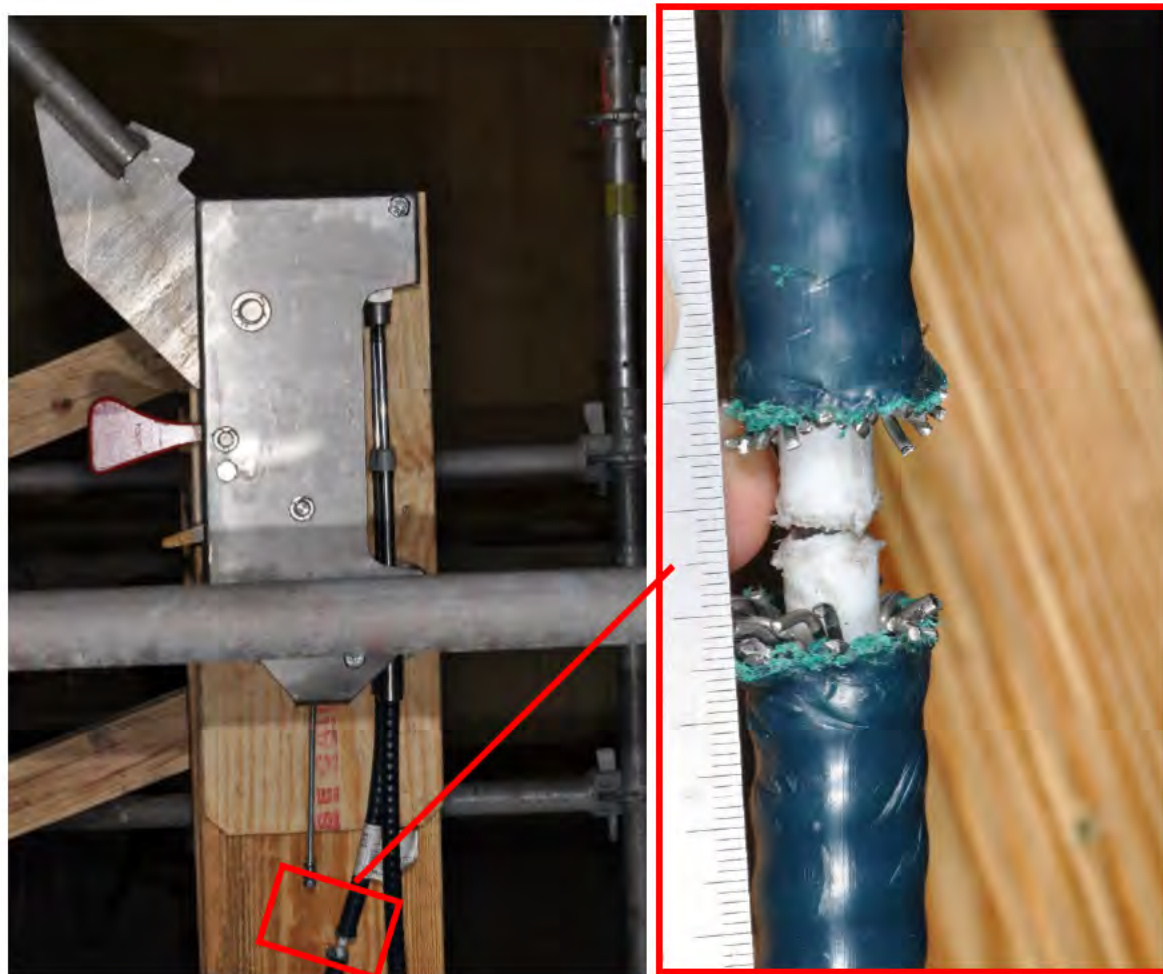
Figure 33. Photographs showing a failure in an Exemplar Cable when the wire layer and liner were severed at the approximate location of failure as on the Subject Aft Cable. Handle for the Exemplar Release Unit was in the open position. Ruler is in mm.

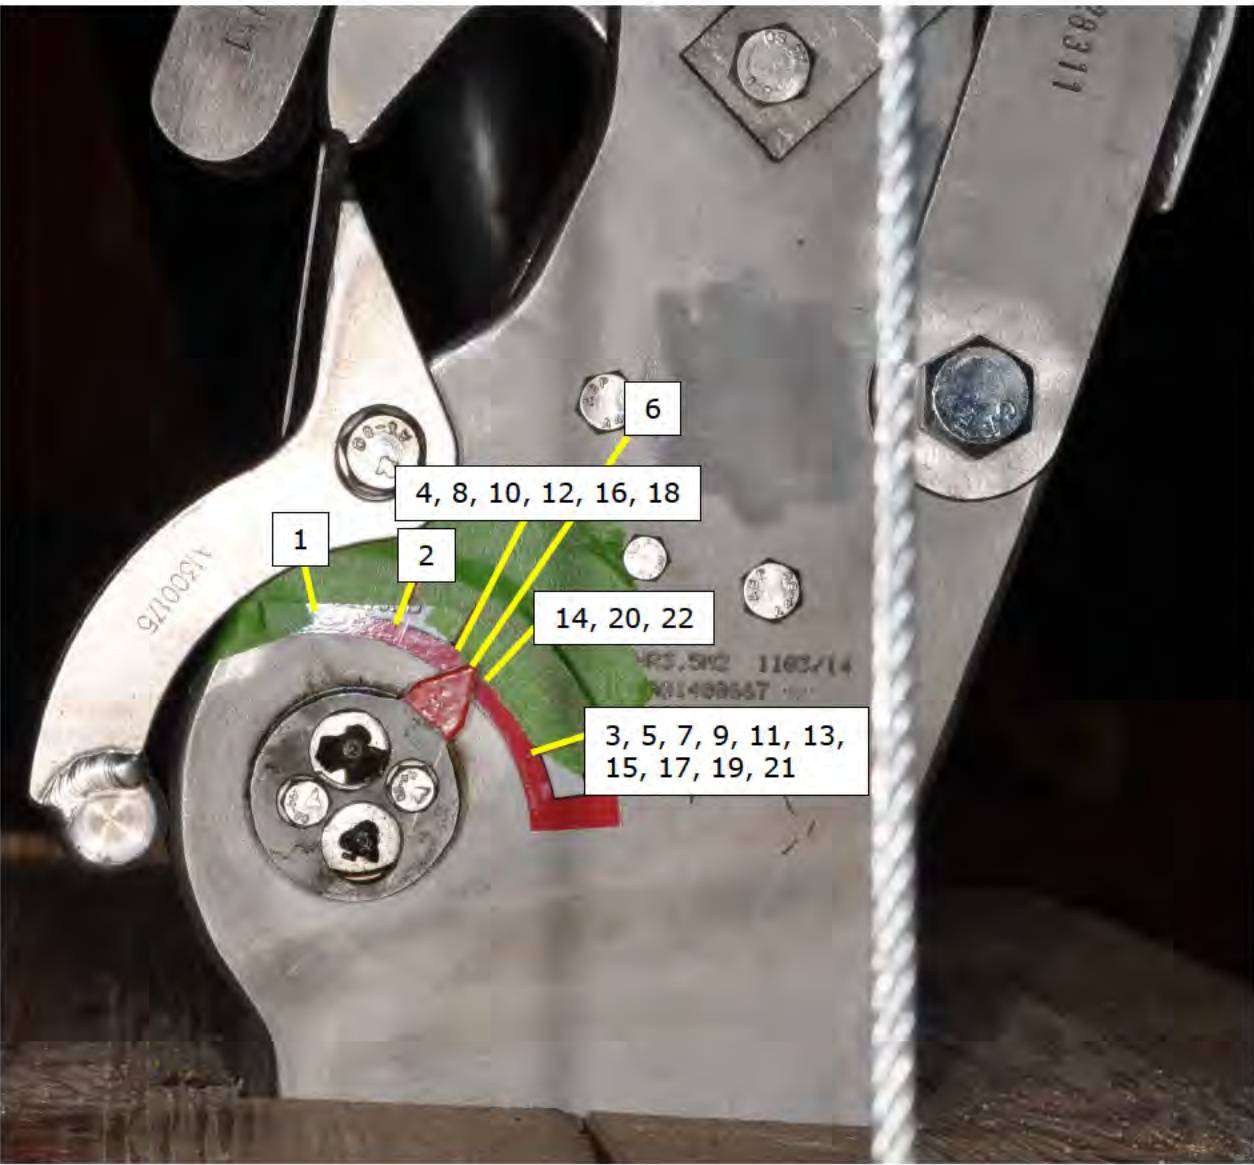
Figure 34. Photograph showing the orientations of the locking shaft indicator on the Exemplar Hook when the release handle for the Exemplar Release Unit was actuated into the open and close positions before and after the wire layer and liner of the Exemplar Cable were severed. The table summarizes the conditions of each step, with the columns detailing the position of the release handle of the Exemplar Release Unit, the action taken in the step, the measurement of the separation in the Exemplar Cable, and whether the locking shaft prevented the hook from rotating.

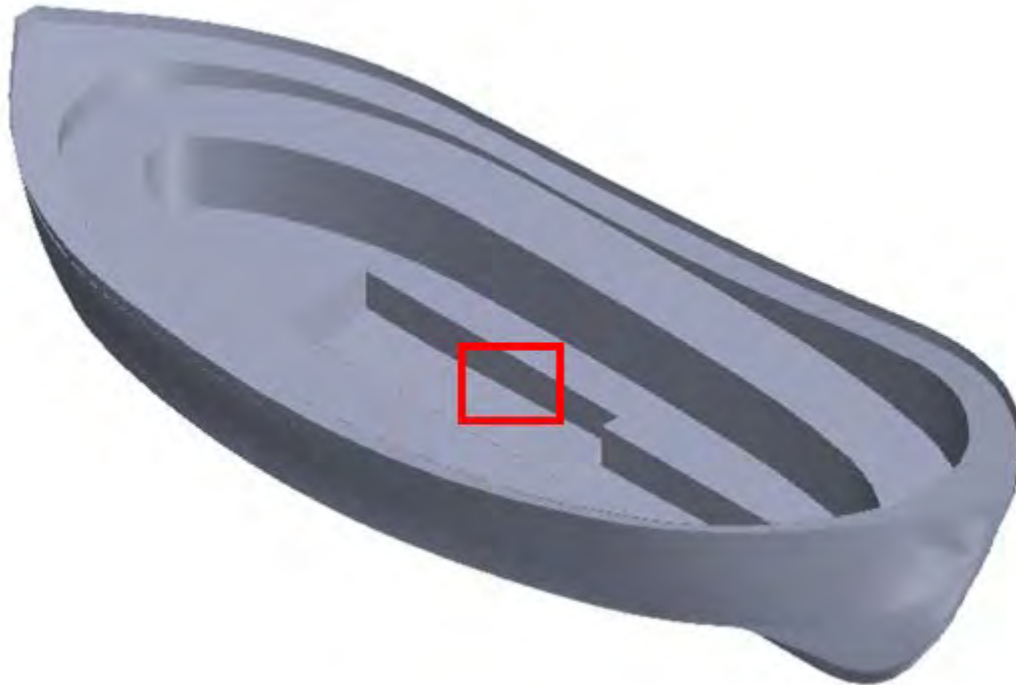
Figure 44. 3D representation of the approximate location of Sample C-1. The crack observed was located at the interior of boat at the fiberglass-engine mount interface.

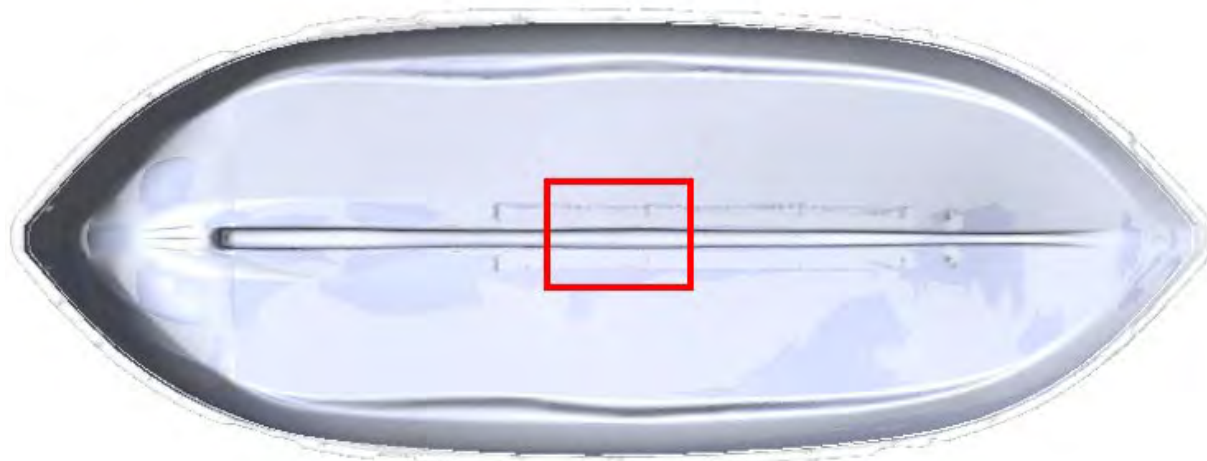
Figure 45. 3D representation of the approximate location of Sample C-2. The crack observed was located at the exterior of the hull on the keel of the boat. The crack propagated through the thickness of the keel.

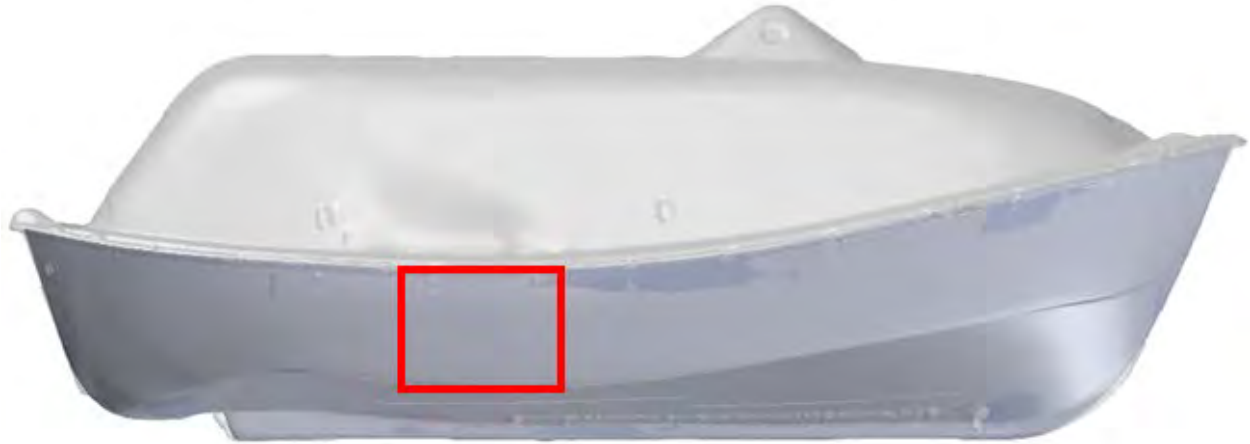
Figure 46. 3D representation of the approximate location of Sample C-3. The crack observed was located at the exterior of the hull on the starboard side. The crack ran from the hull-canopy interface towards the keel.

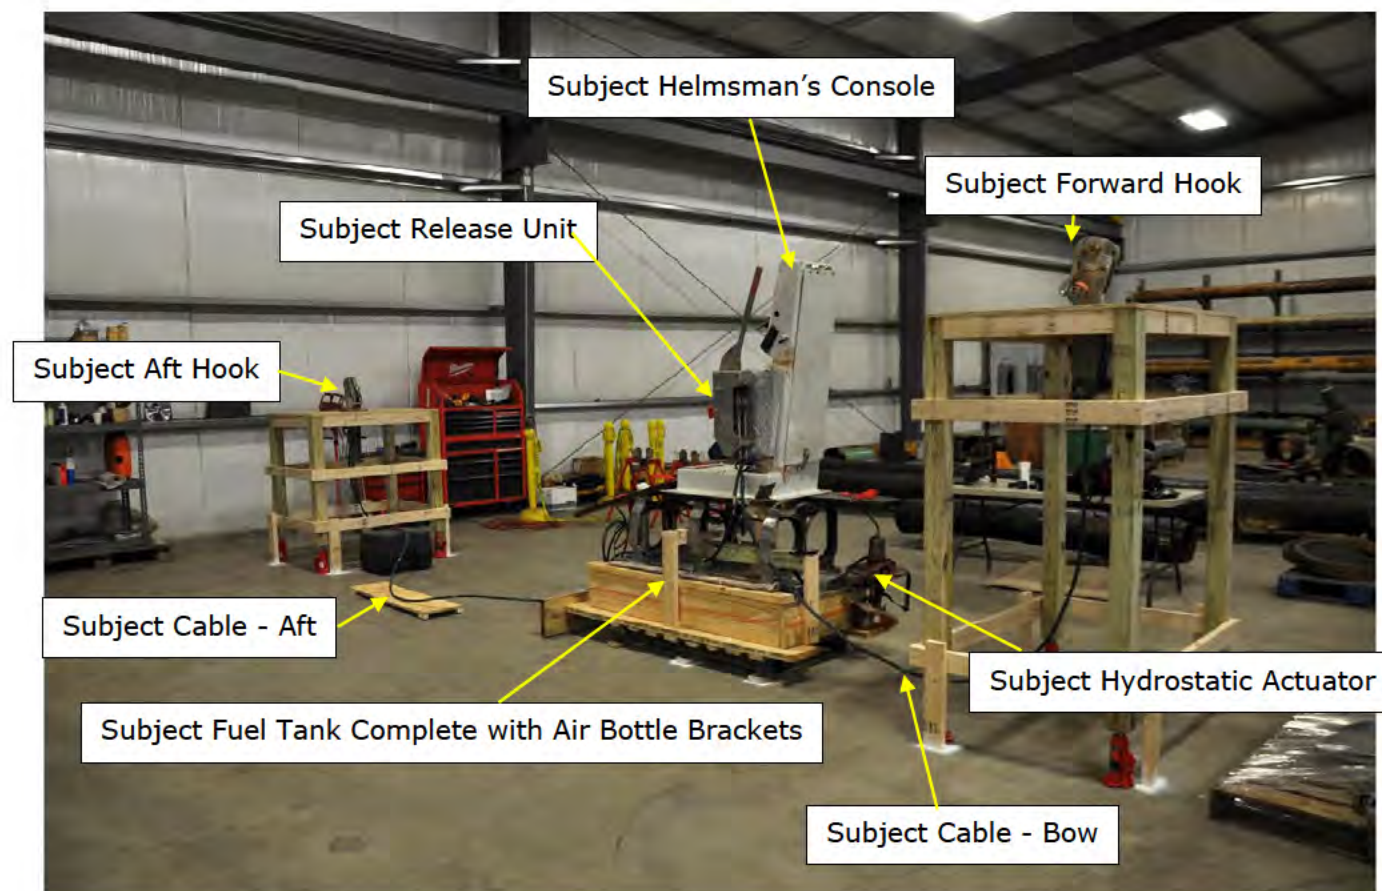
Figure 47. Photograph of the reconstruction of the relevant components from Lifeboat 6 located at DNV GL's warehouse.

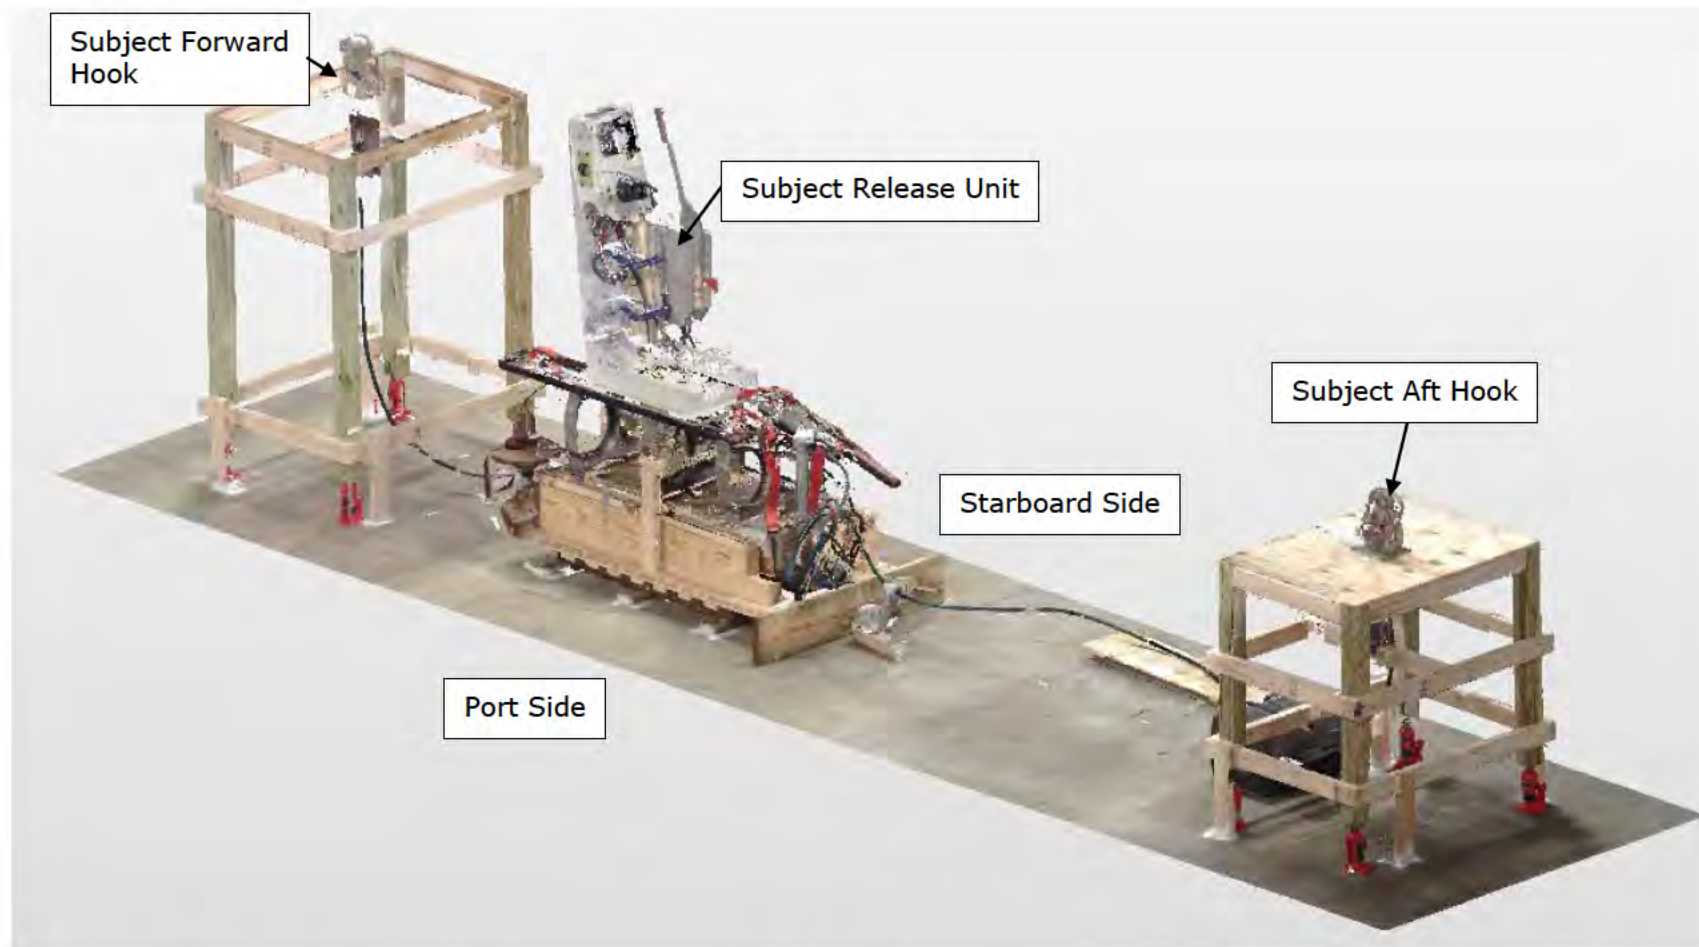
Figure 48. Laser scan showing the reconstruction of the relevant components from Lifeboat 6 at DNV GL's warehouse.

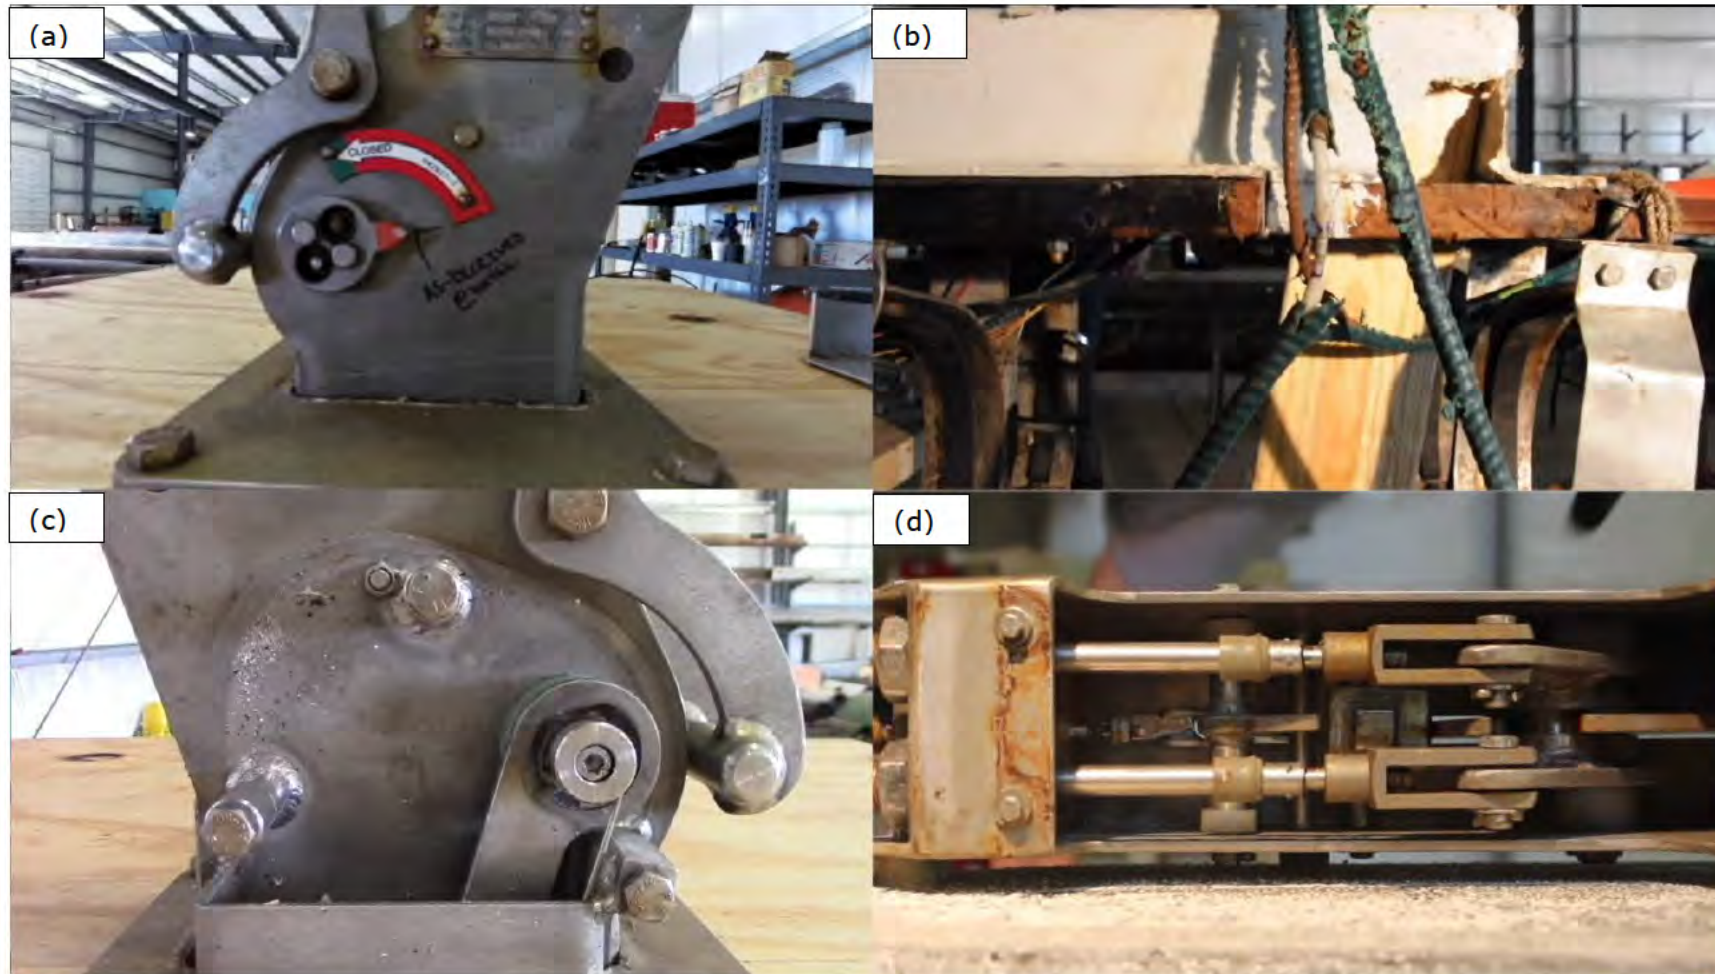
Figure 49. Screenshot of compiled digital recordings from a function test performed using the Subject Aft Hook, the Subject Aft Cable, and the Subject Release Unit. Four views are shown: (a) the port side of the Subject Aft Hook, (b) the break in the Subject Aft Cable located near the Subject Release Unit, (c) the starboard side of the Subject Aft Hook, and (d) the forward side of the Subject Release Unit (note this view is rotated 90° clockwise from its normal orientation).

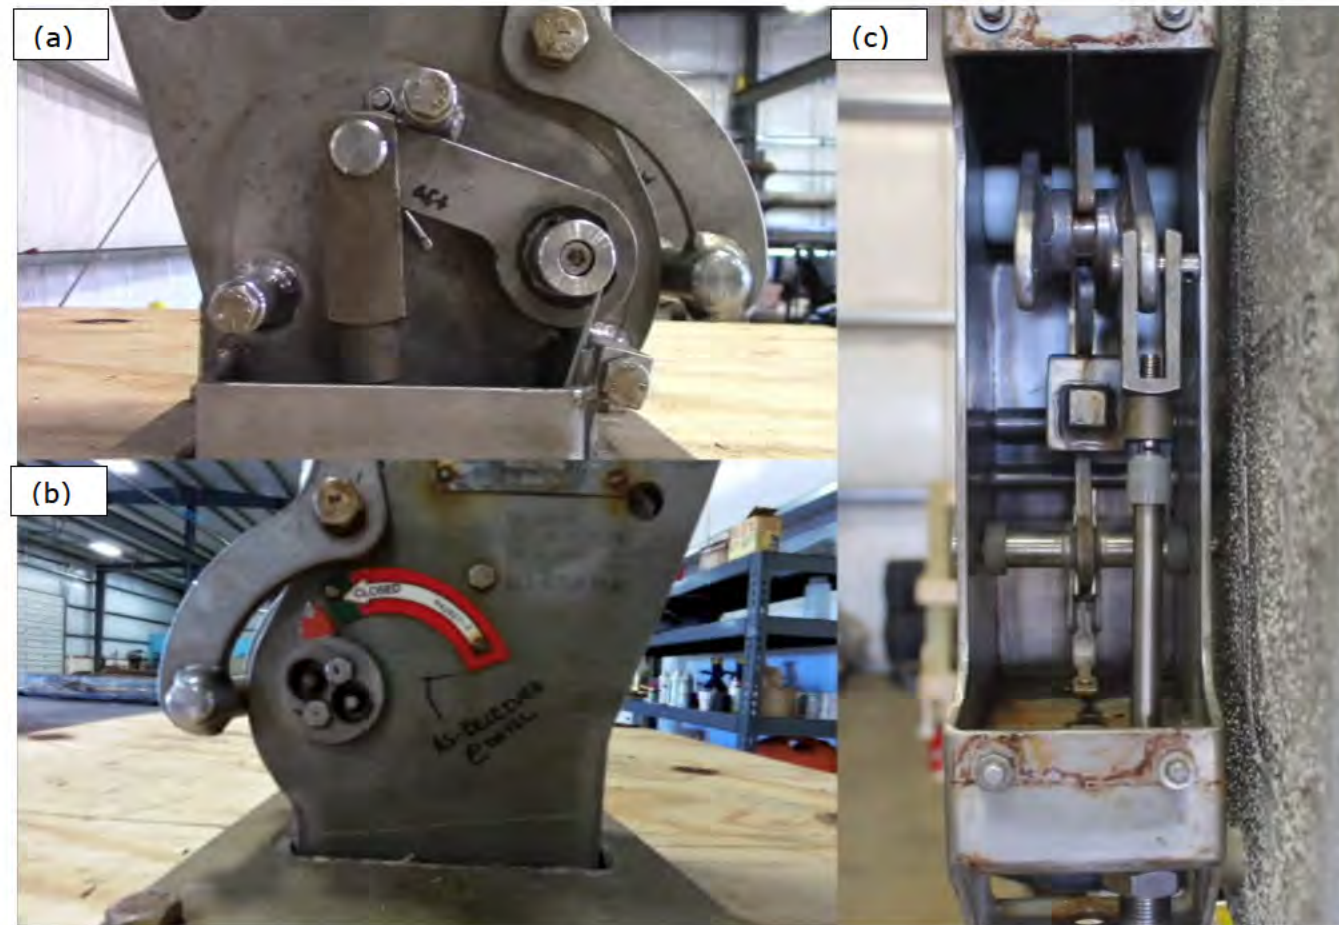
Figure 50. Screenshot of compiled digital recordings from a function test performed using the Subject Aft Hook, the Exemplar Cable, and the Subject Release Unit before moving the release handle of the Subject Release Unit. Three views are shown: (a) starboard side of the Subject Aft Hook, (b) the port side of the Subject Aft Hook, and (c) the forward side of the Subject Release Unit.

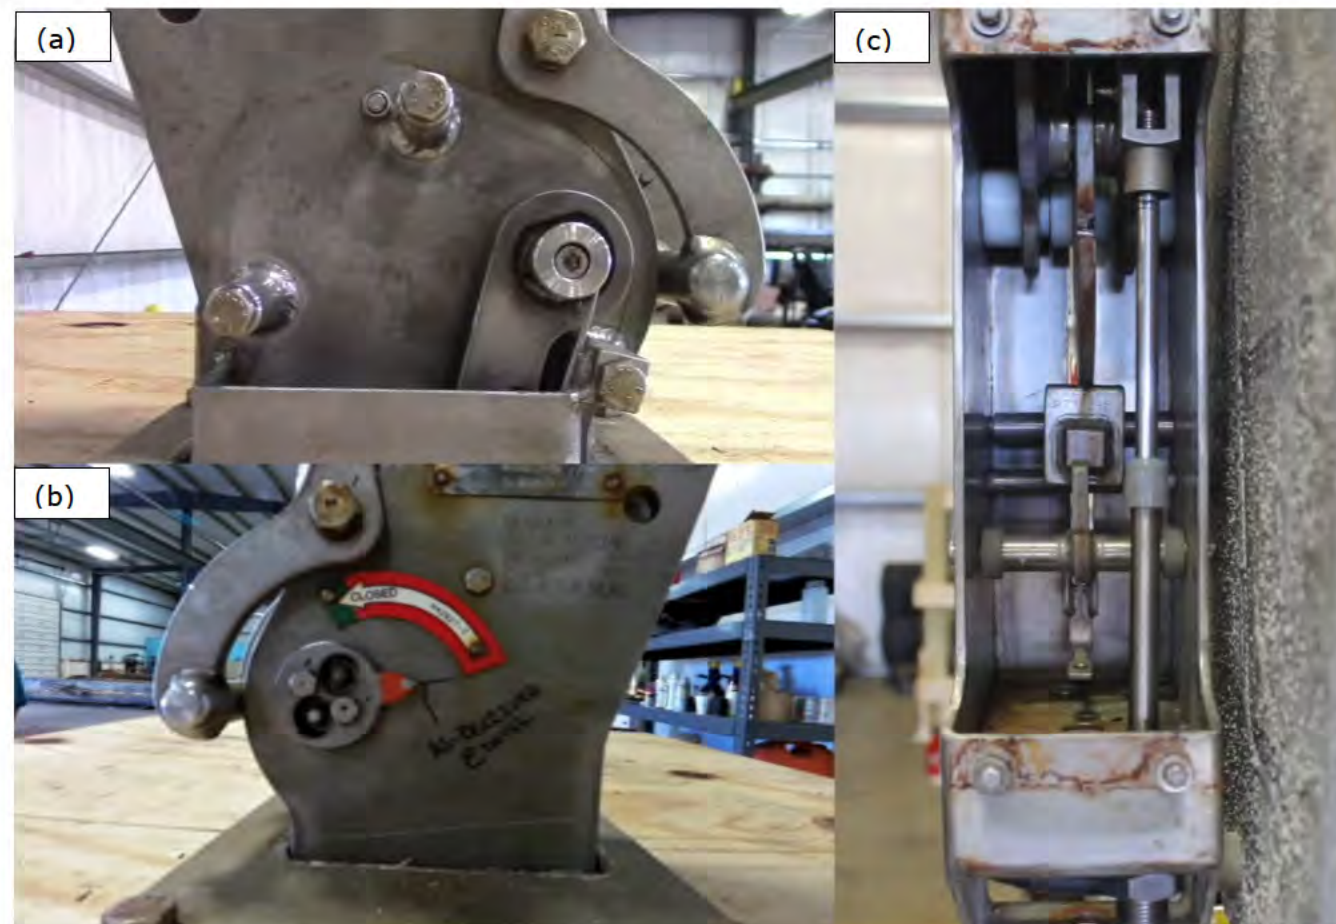
Figure 51. Screenshot of compiled digital recordings from a function test performed using the Subject Aft Hook, Exemplar Cable, and Subject Release Unit after moving the release handle of the Subject Release Unit. Three views are shown: (a) starboard side of the Subject Aft Hook, (b) the port side of the Subject Aft Hook, and (c) the forward side of the Subject Release Unit.
