Final Report

Auger Lifeboat 6 Incident

Shell Oil Company
Houston, Texas, USA

Report No.: O-AP-FINV / BPADG (10165575)
July 9, 2020

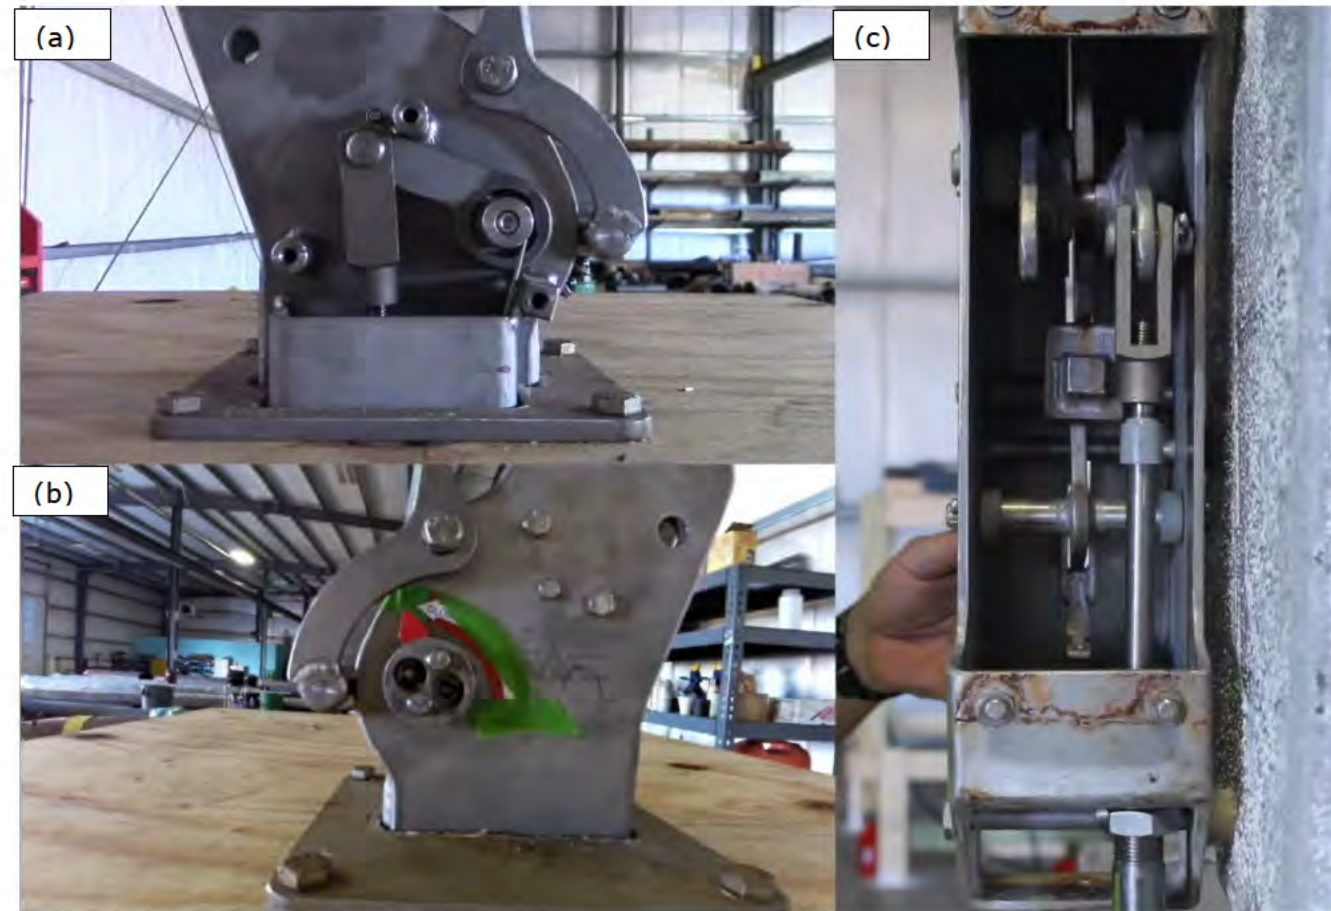
Figure 52. Screenshot of compiled digital recordings of a function test performed using the Exemplar Hook, Exemplar Cable, and Subject Release Unit before moving the release handle of the Subject Release Unit. Three views are shown: (a) starboard side of the Exemplar Hook, (b) the port side of the Exemplar Hook, and (c) the forward side of the Subject Release Unit.

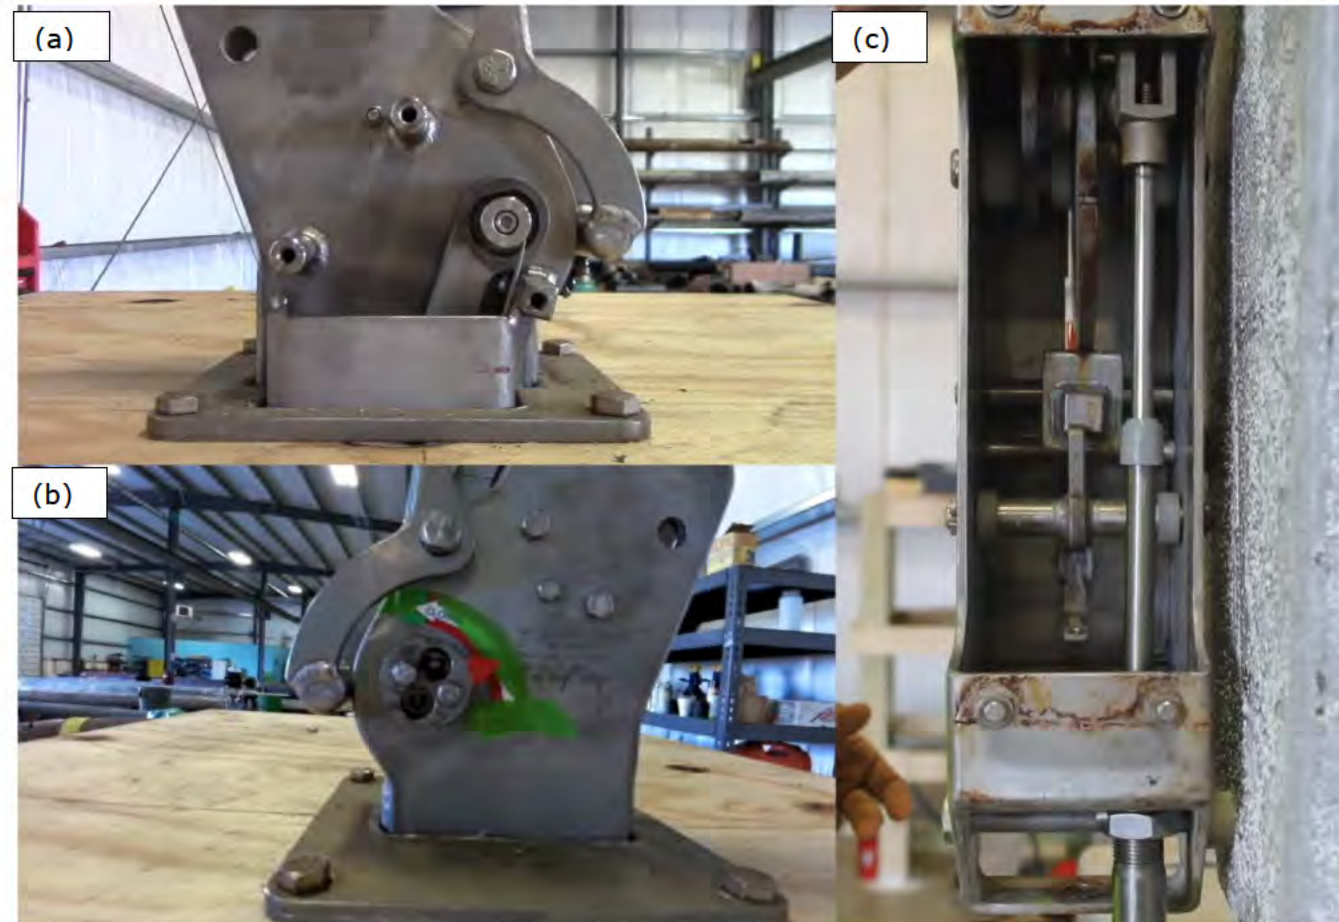
Figure 53. Screenshot of compiled digital recordings of a function test performed using the Exemplar Hook, Exemplar Cable, and Subject Release Unit after moving the release handle of the Subject Release Unit. Three views are shown: (a) starboard side of the Exemplar Hook, (b) the port side of the Exemplar Hook, and (c) the forward side of the Subject Release Unit.

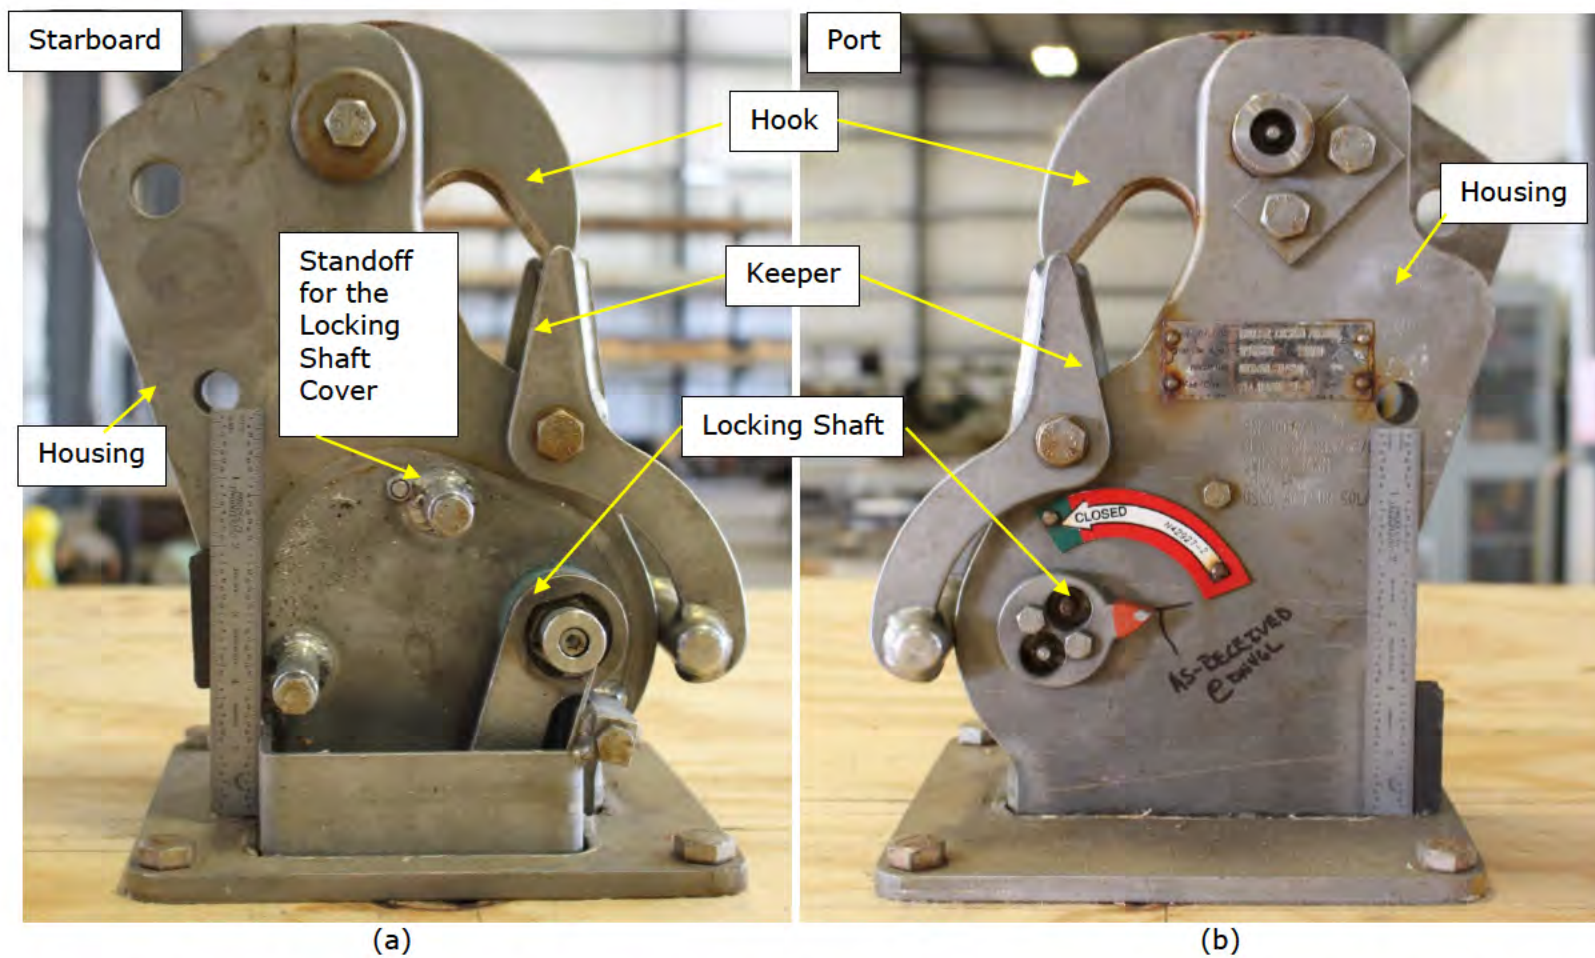
Figure 56. Photographs of the Subject Aft Hook with the locking shaft cover removed, viewed from (a) the starboard side and (b) the port side. Ruler is in inches.

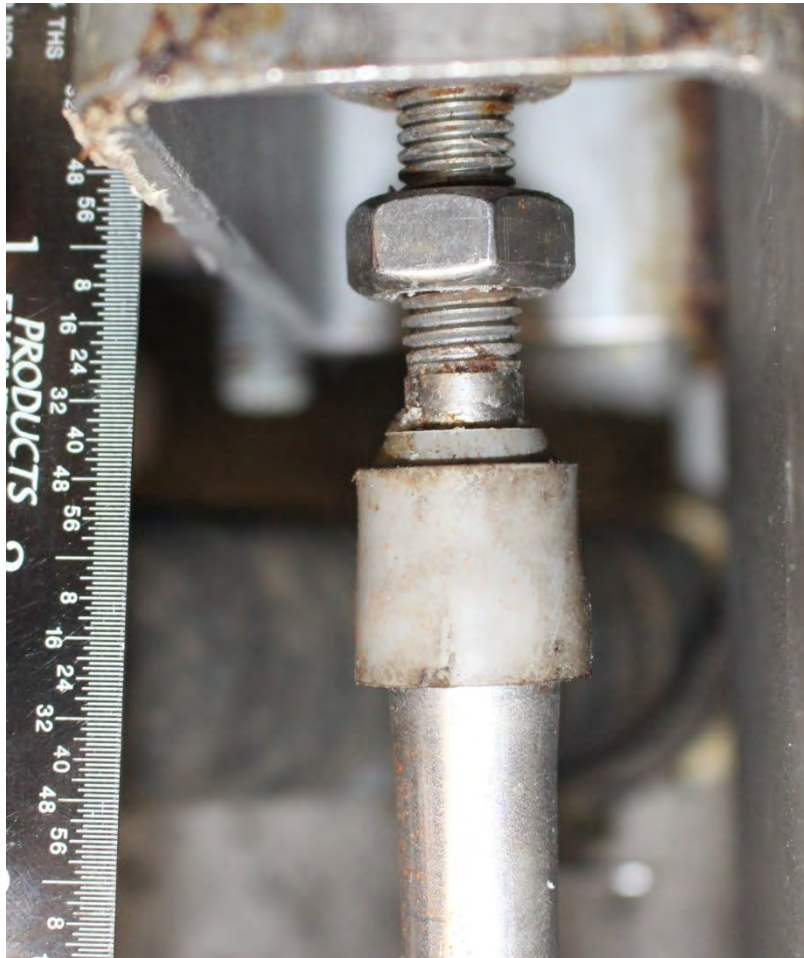
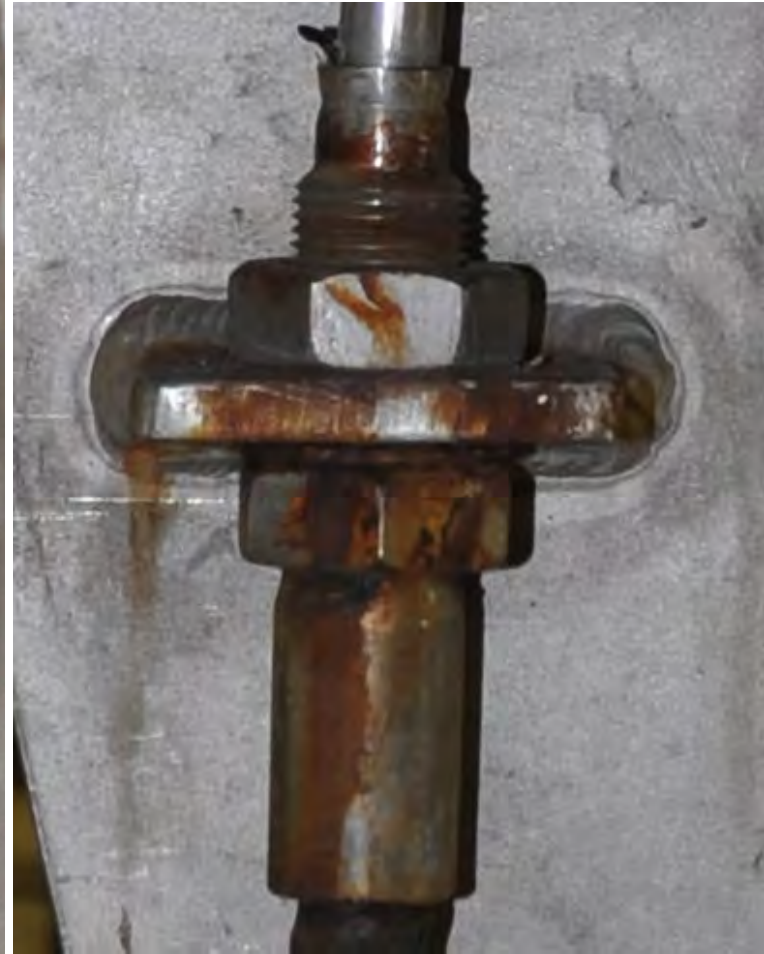
Figure 57. Photographs showing the as-found condition of the threaded connections of the Subject Aft Hook (a) at the clevis and (b) at the bulkhead nuts; the locations of the clevis and bulkhead nuts are shown in Figure 14. Ruler in left image is in inches.

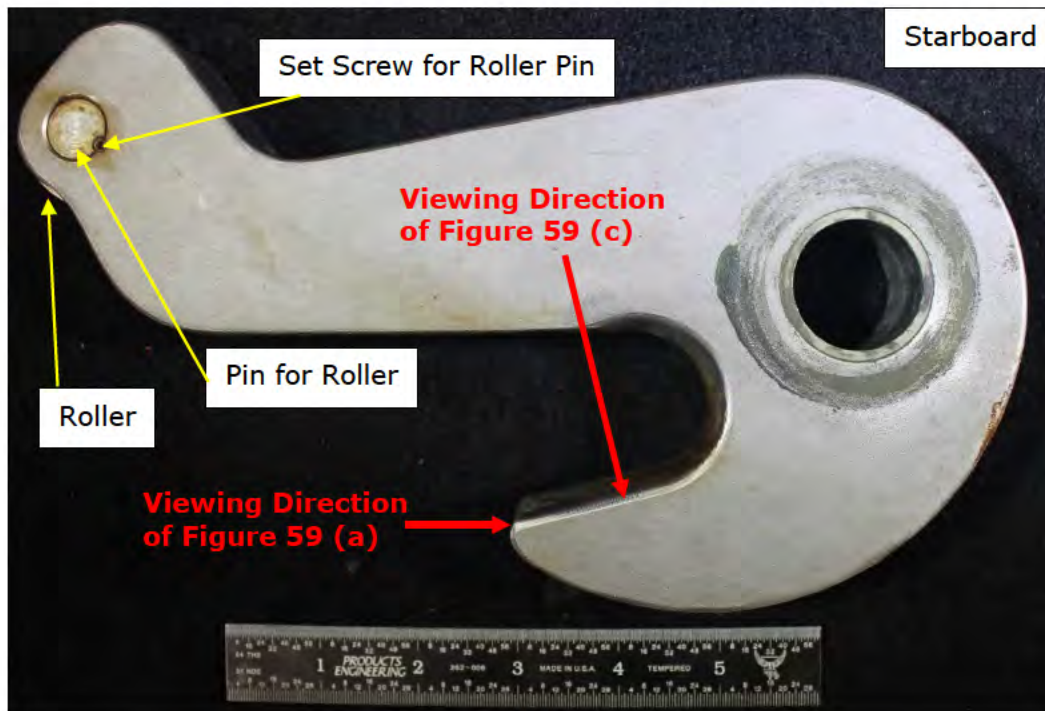
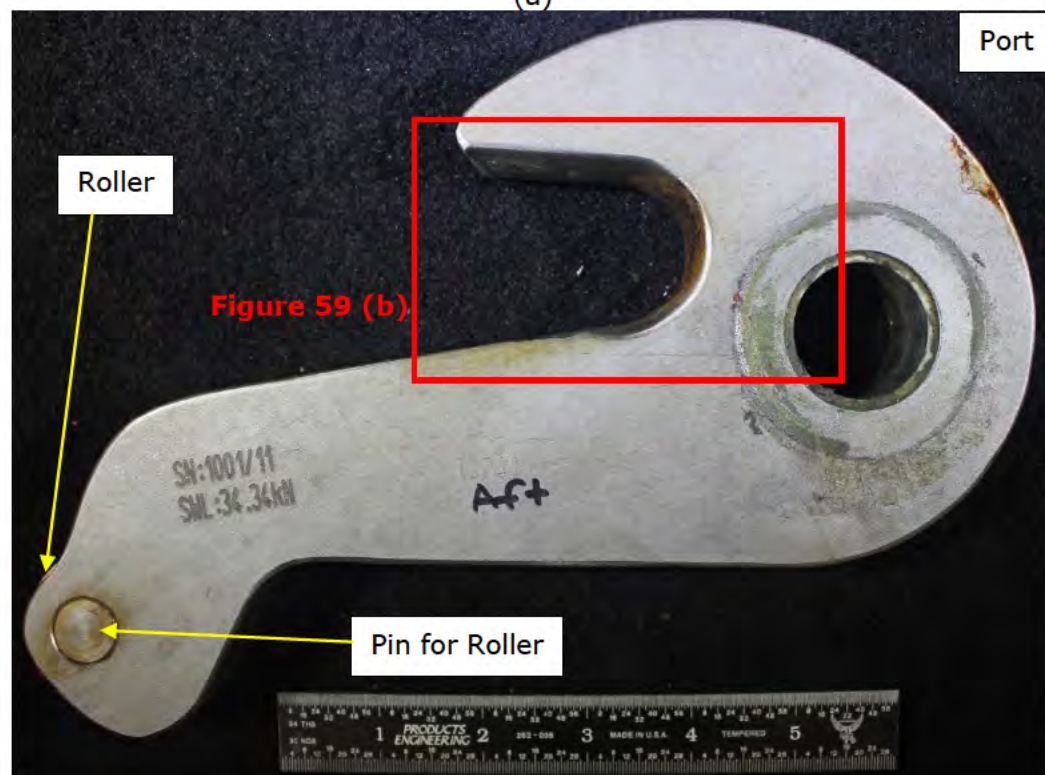
Figure 58. Photographs of the hook from the Subject Aft Hook assembly showing the (a) starboard side and (b) port side, after disassembly. Ruler is in inches.

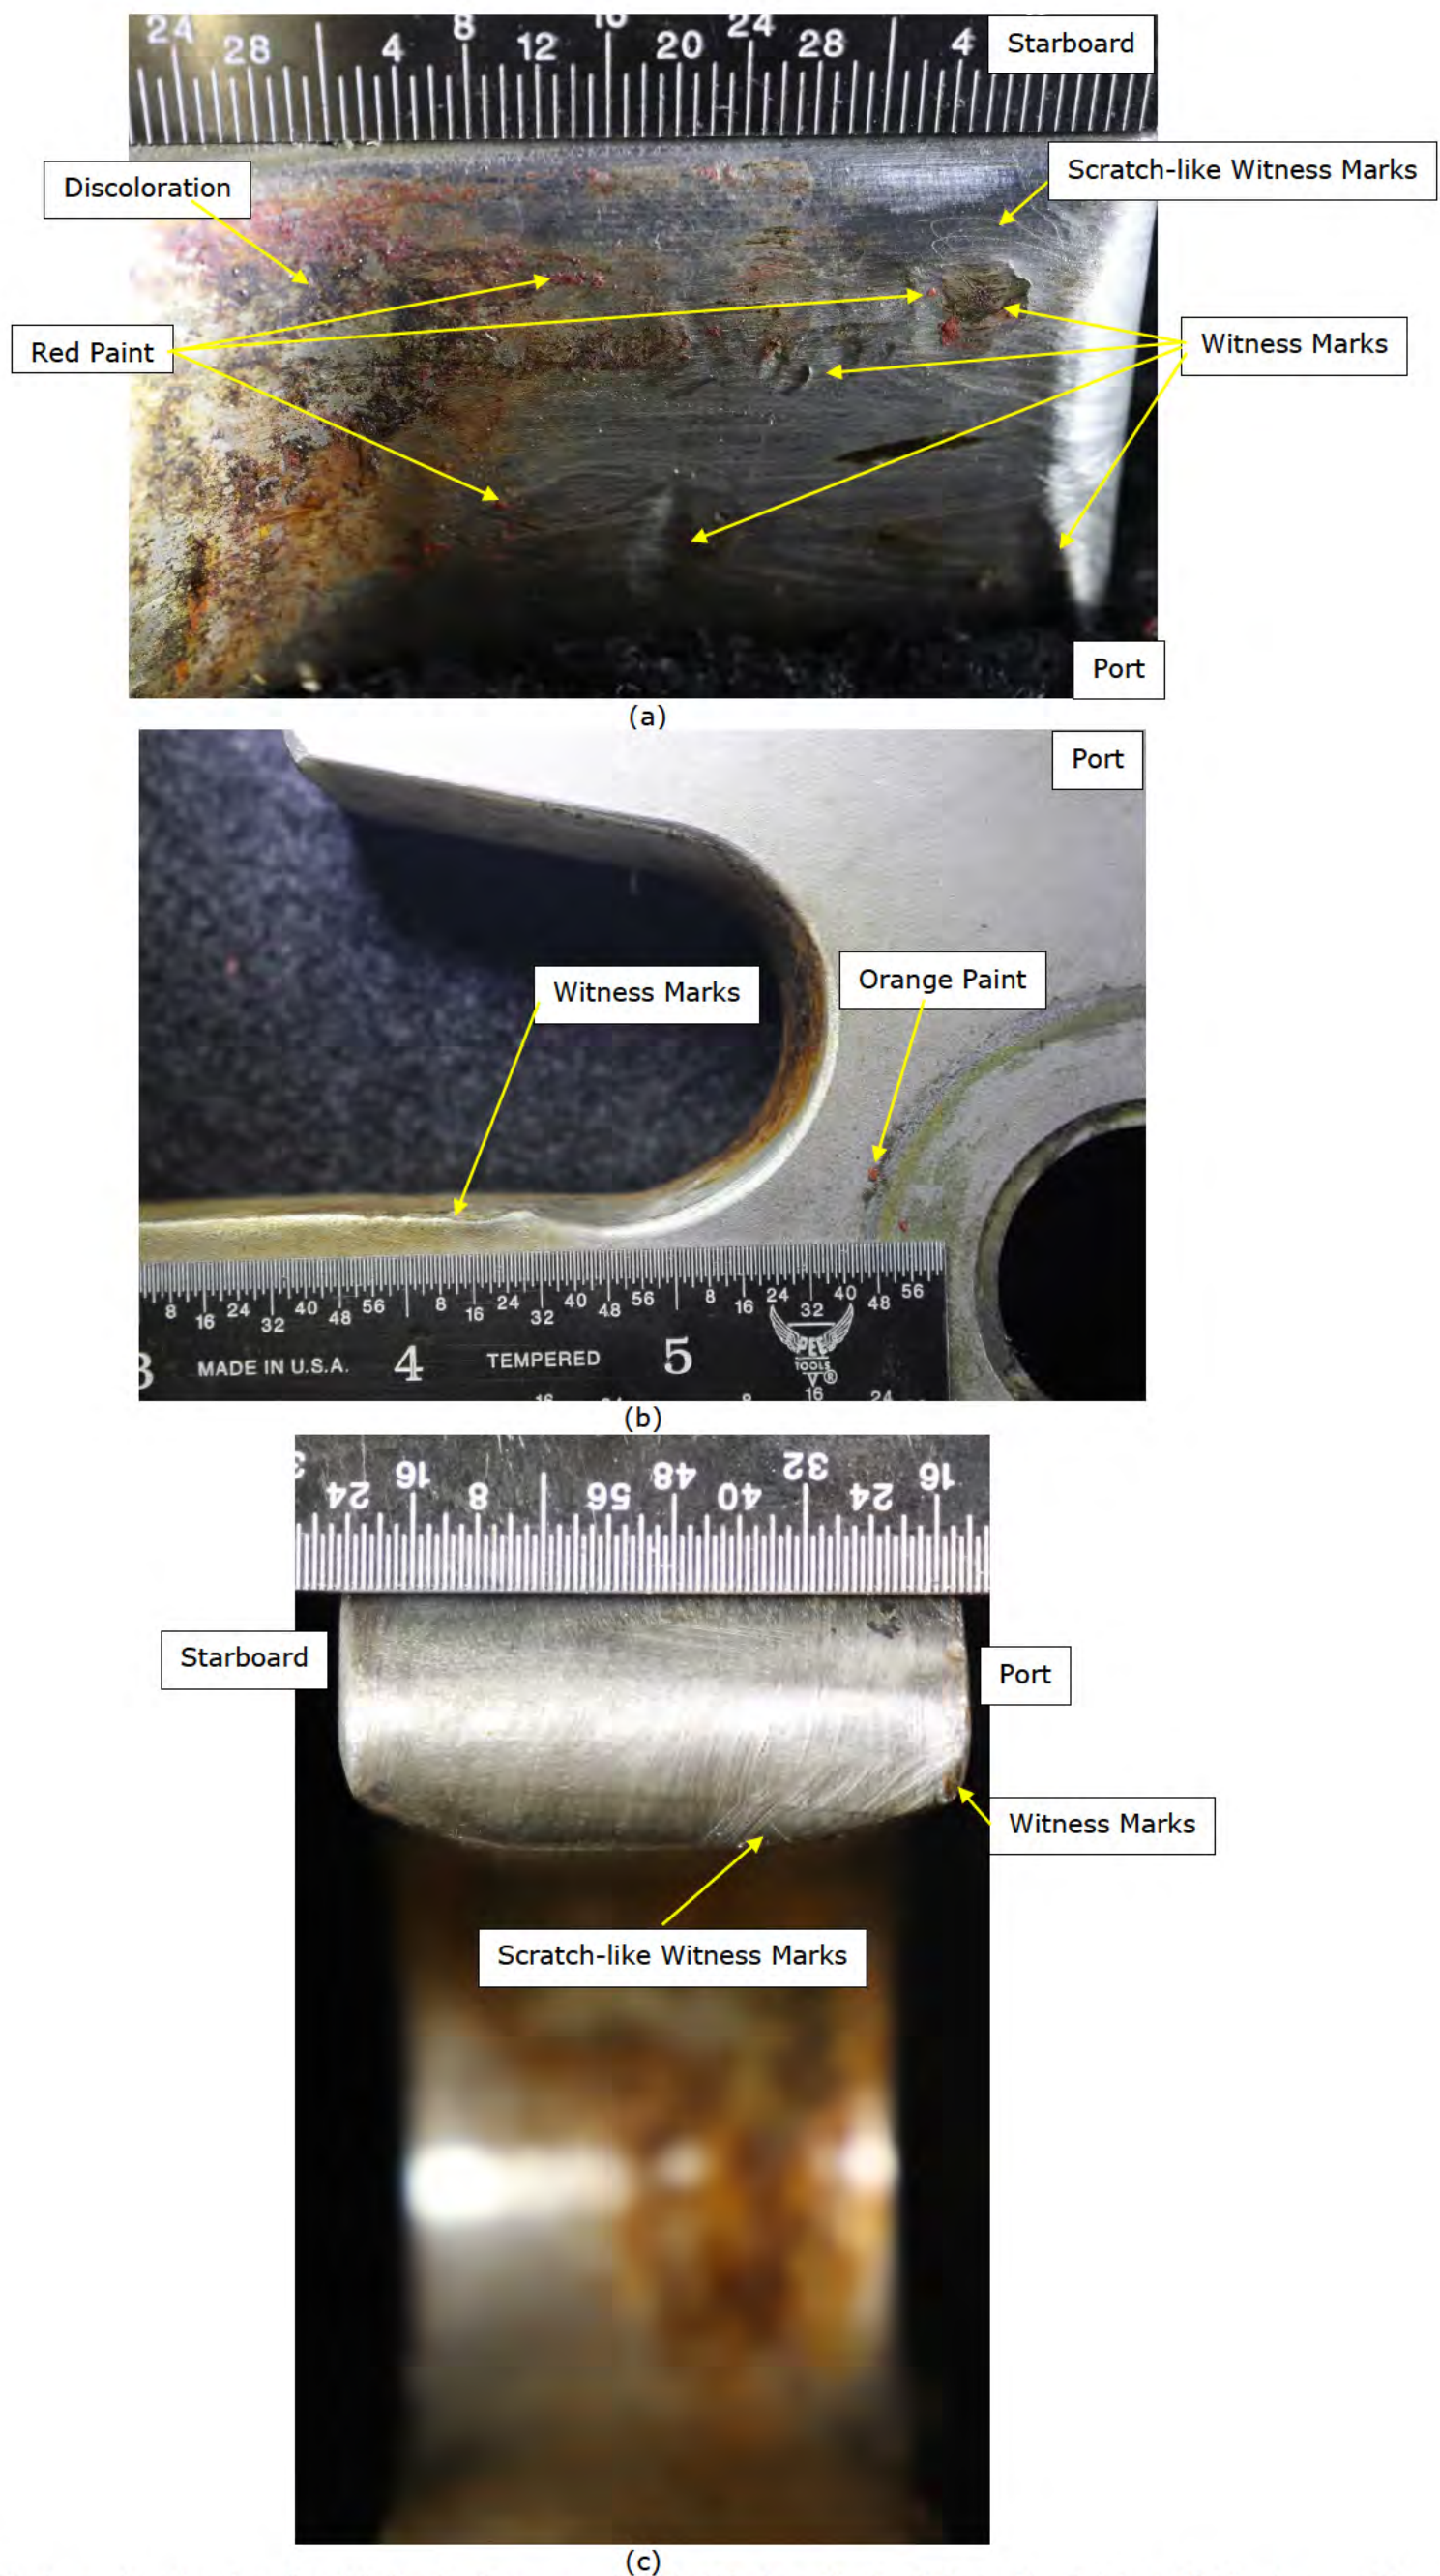
Figure 59. Photographs showing the details of witness marks identified on the hook from the Subject Aft Hook assembly at (a) the inside bend of the hook, (b) the edge of the bend as viewed from the port side, and (c) the point of the hook; locations and viewing directions shown in Figure 58 (a) and (b). Rulers are in inches.

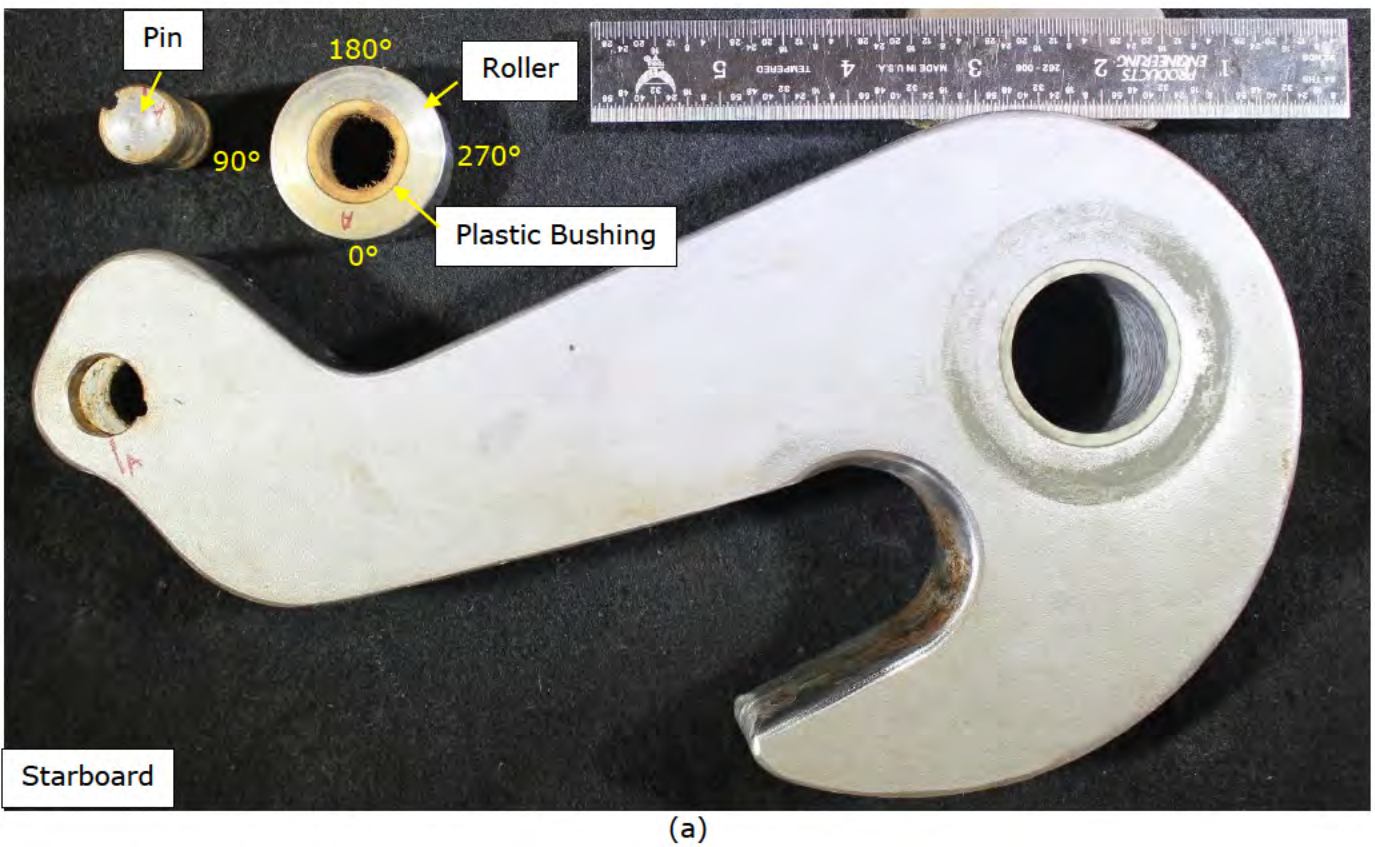
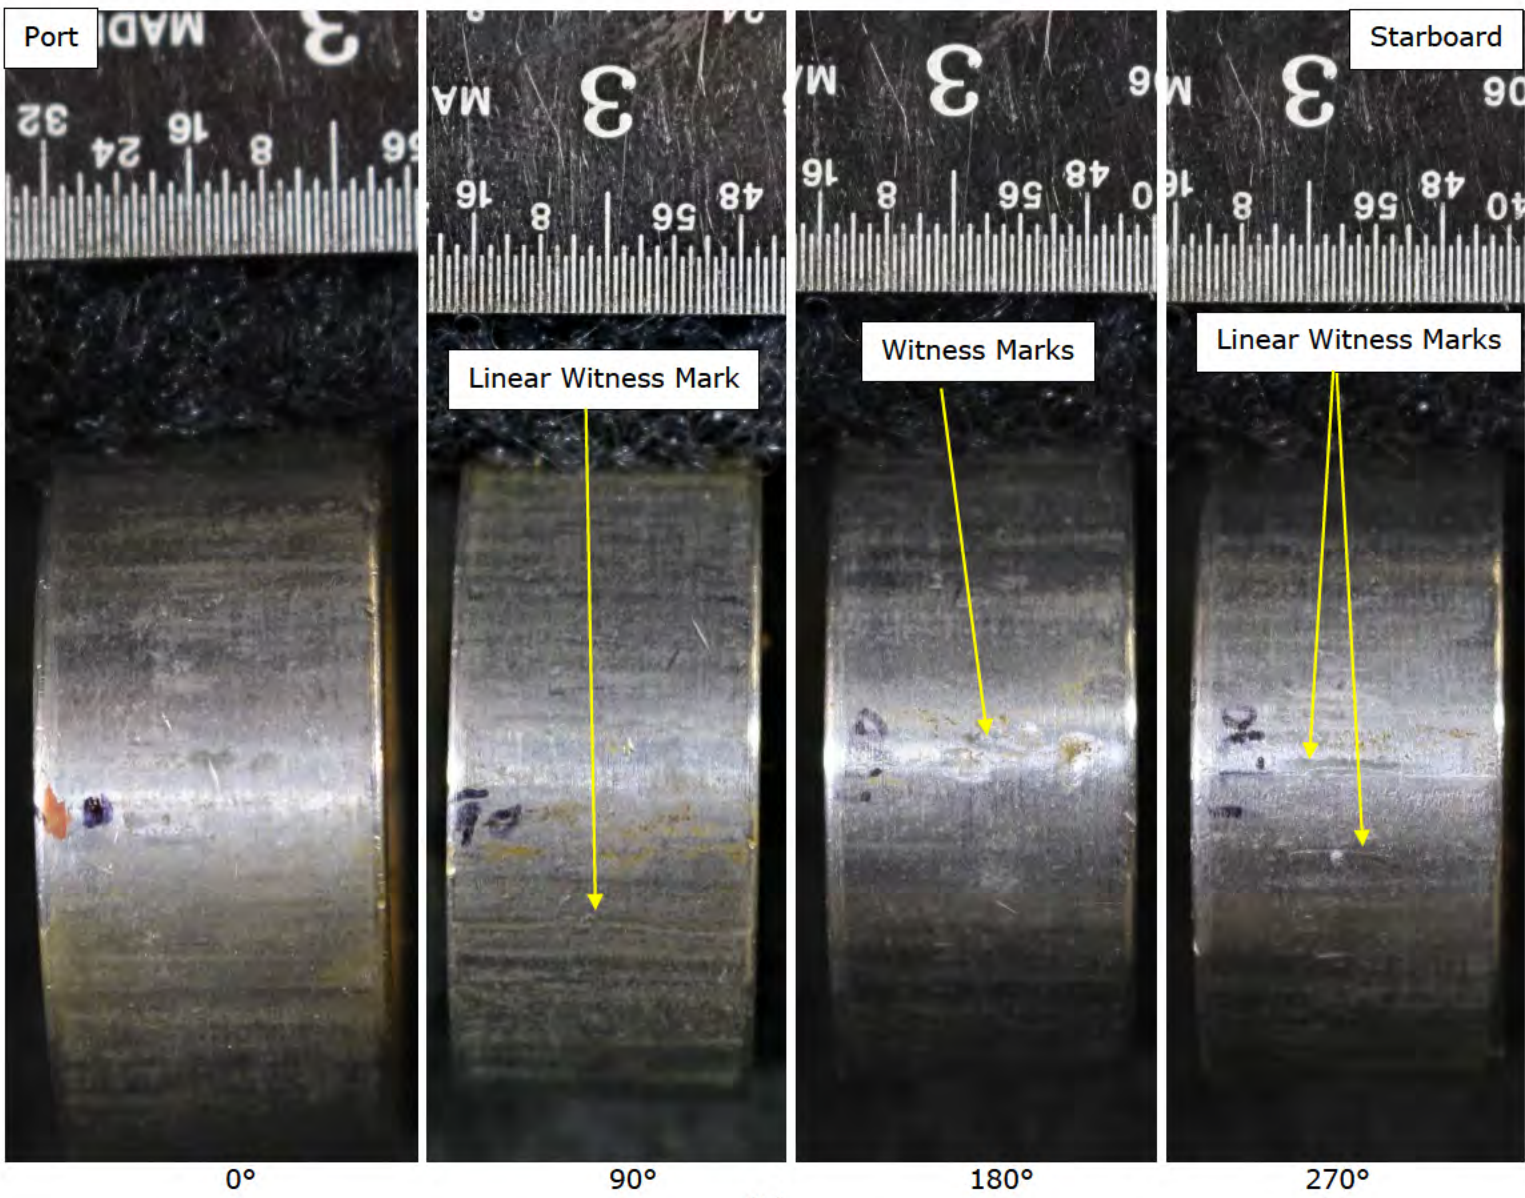
Figure 60. Photographs showing the hook from the Subject Aft Hook assembly (a) after removing the set screw, pin, and roller, as well as (b) the details of the witness marks present on the contact surface of the roller. Ruler is in inches.

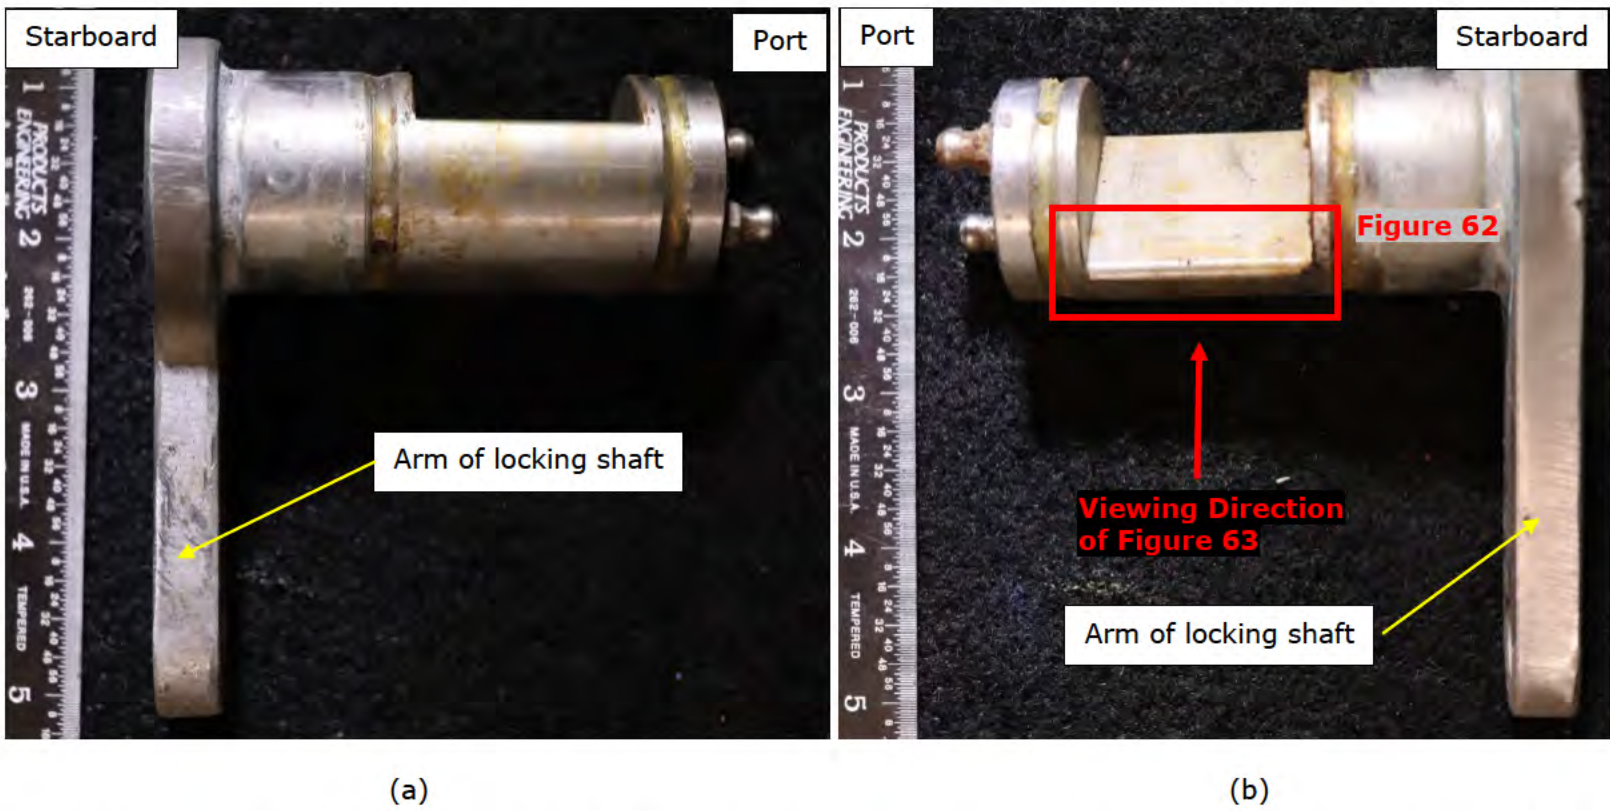
Figure 61. Photographs of the locking shaft from the Subject Aft Hook showing the (a) round side and (b) the flat, after disassembly. Rulers are in inches.

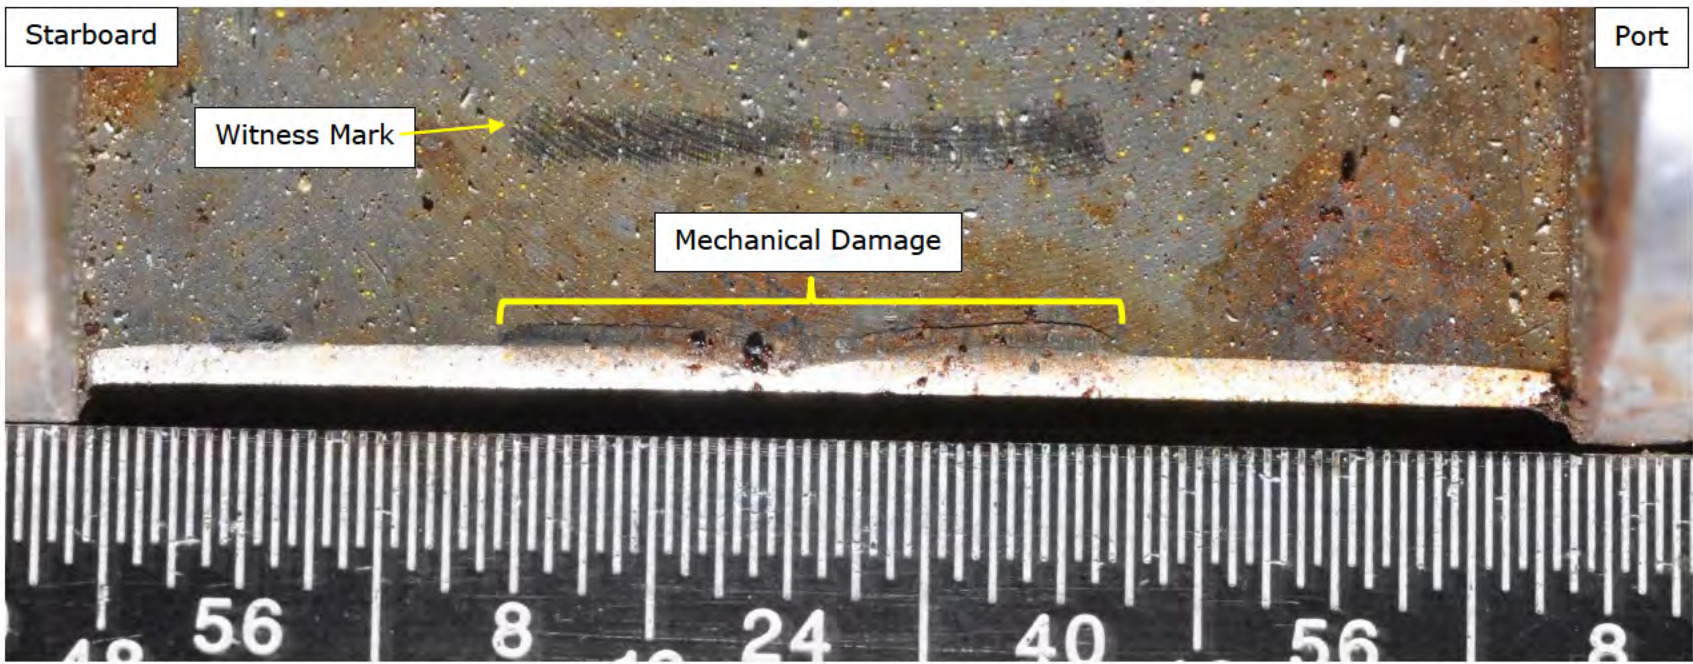
The primary difference between the Subject Aft Hook and the Subject Forward Hook was the mechanical damage to the round of the locking shaft from the Subject Aft Hook (see Figure 62). Small differences in the manner of construction were also noted (see Figure 64). Otherwise, comparable damage from service was identified on the other components.

Figure 62. Photograph of the locking shaft from the Subject Aft Hook showing the mechanical damage on the edge between the round and the flat of the locking shaft. Ruler is in inches.

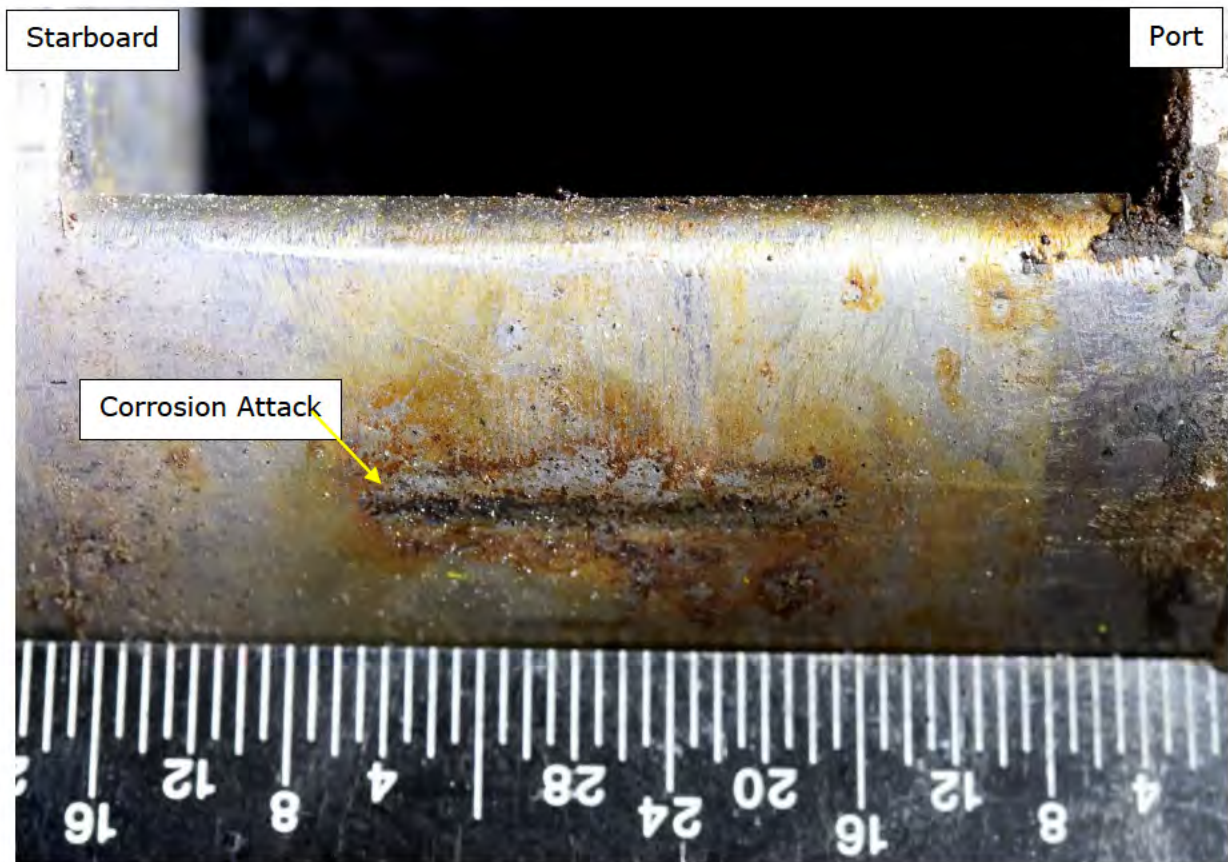
Figure 63. Photograph of the locking shaft from the Subject Aft Hook showing an area with corrosion attack on the round of the locking shaft. Ruler is in inches.

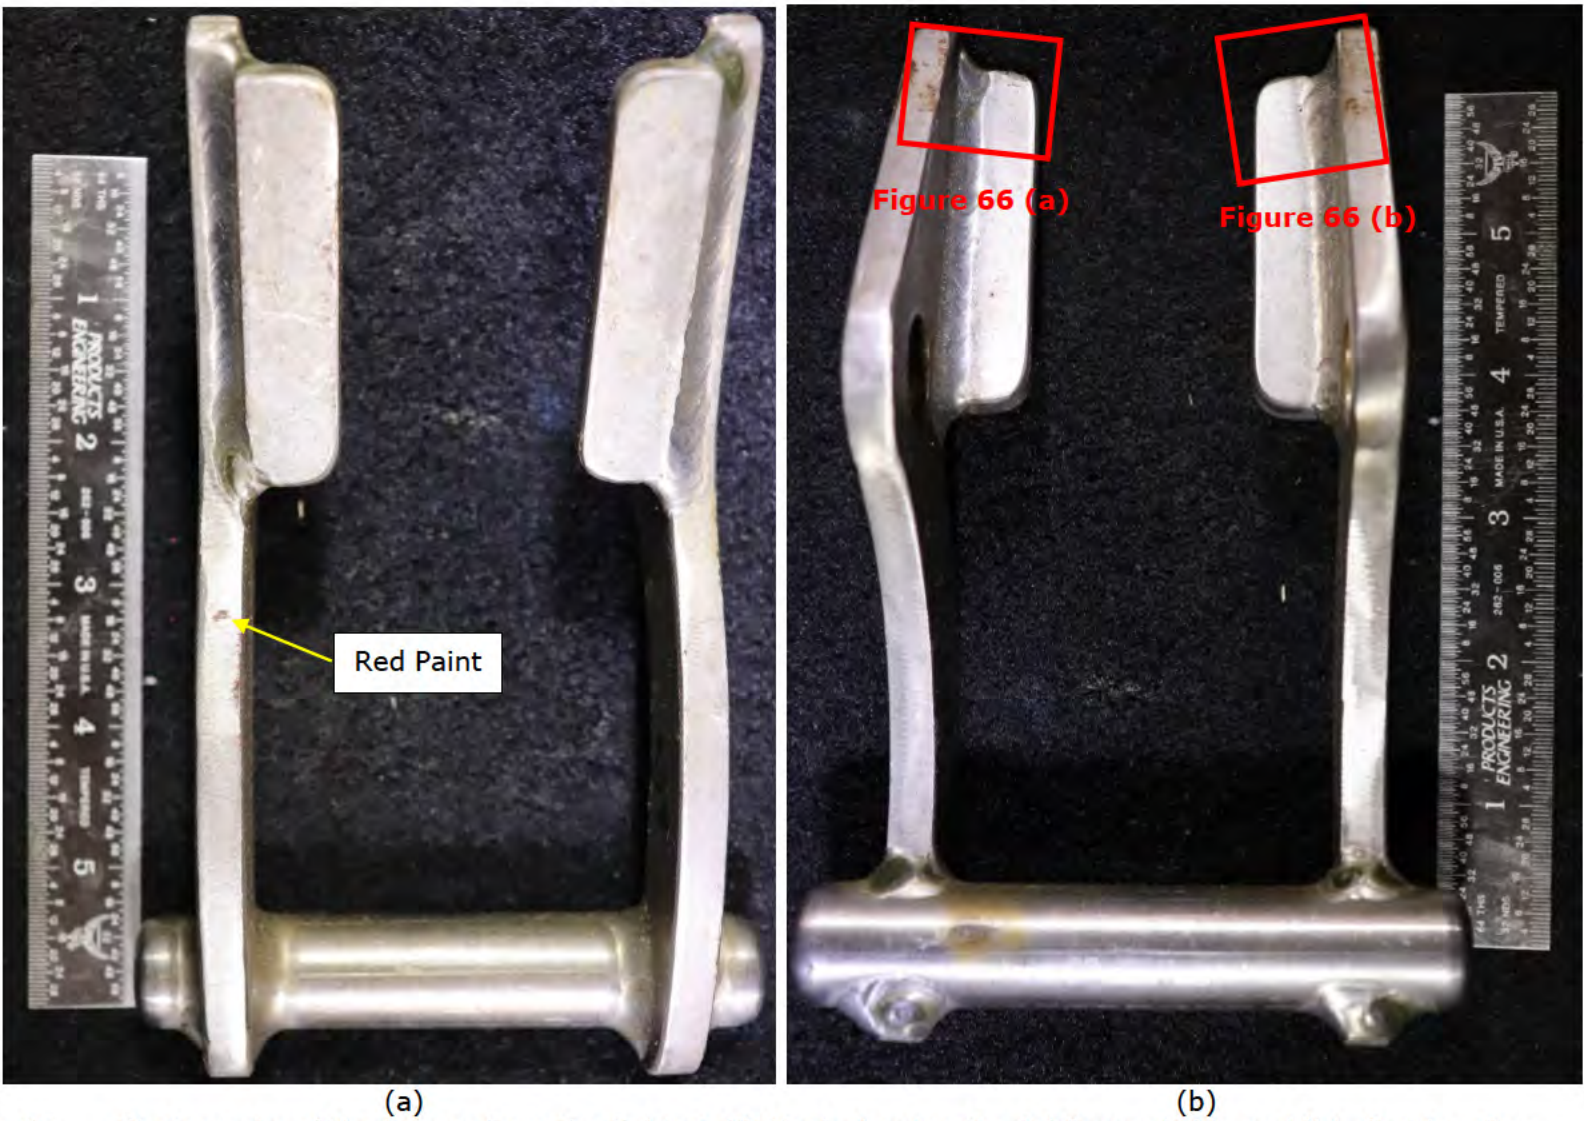
Figure 65. Photographs of the keeper from the Subject Aft Hook showing the (a) forward side and (b) aft side, after disassembly. Forward and aft refer to the orientation of the keeper relative to the lifeboat. Ruler is in inches.

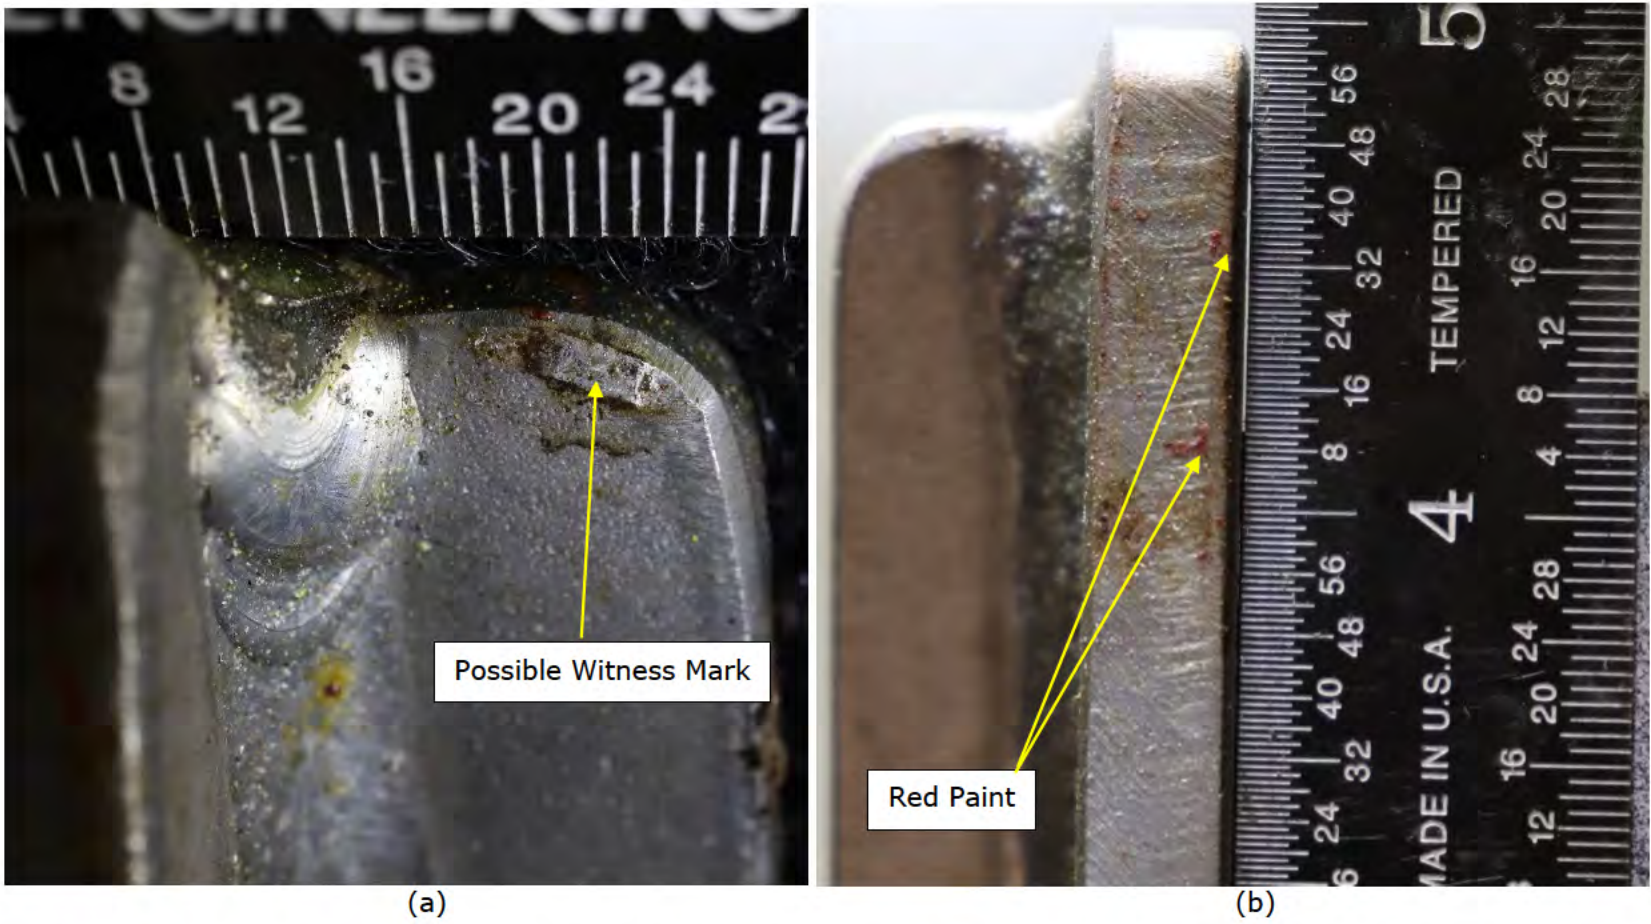
Figure 66. Photographs of the keeper from the Subject Aft Hook showing (a) a possible witness mark and (b) red paint; locations shown in Figure 65. Rulers are in inches.
