Final Report

Auger Lifeboat 6 Incident

Shell Oil Company
Houston, Texas, USA

Report No.: O-AP-FINV / BPADG (10165575)
July 9, 2020

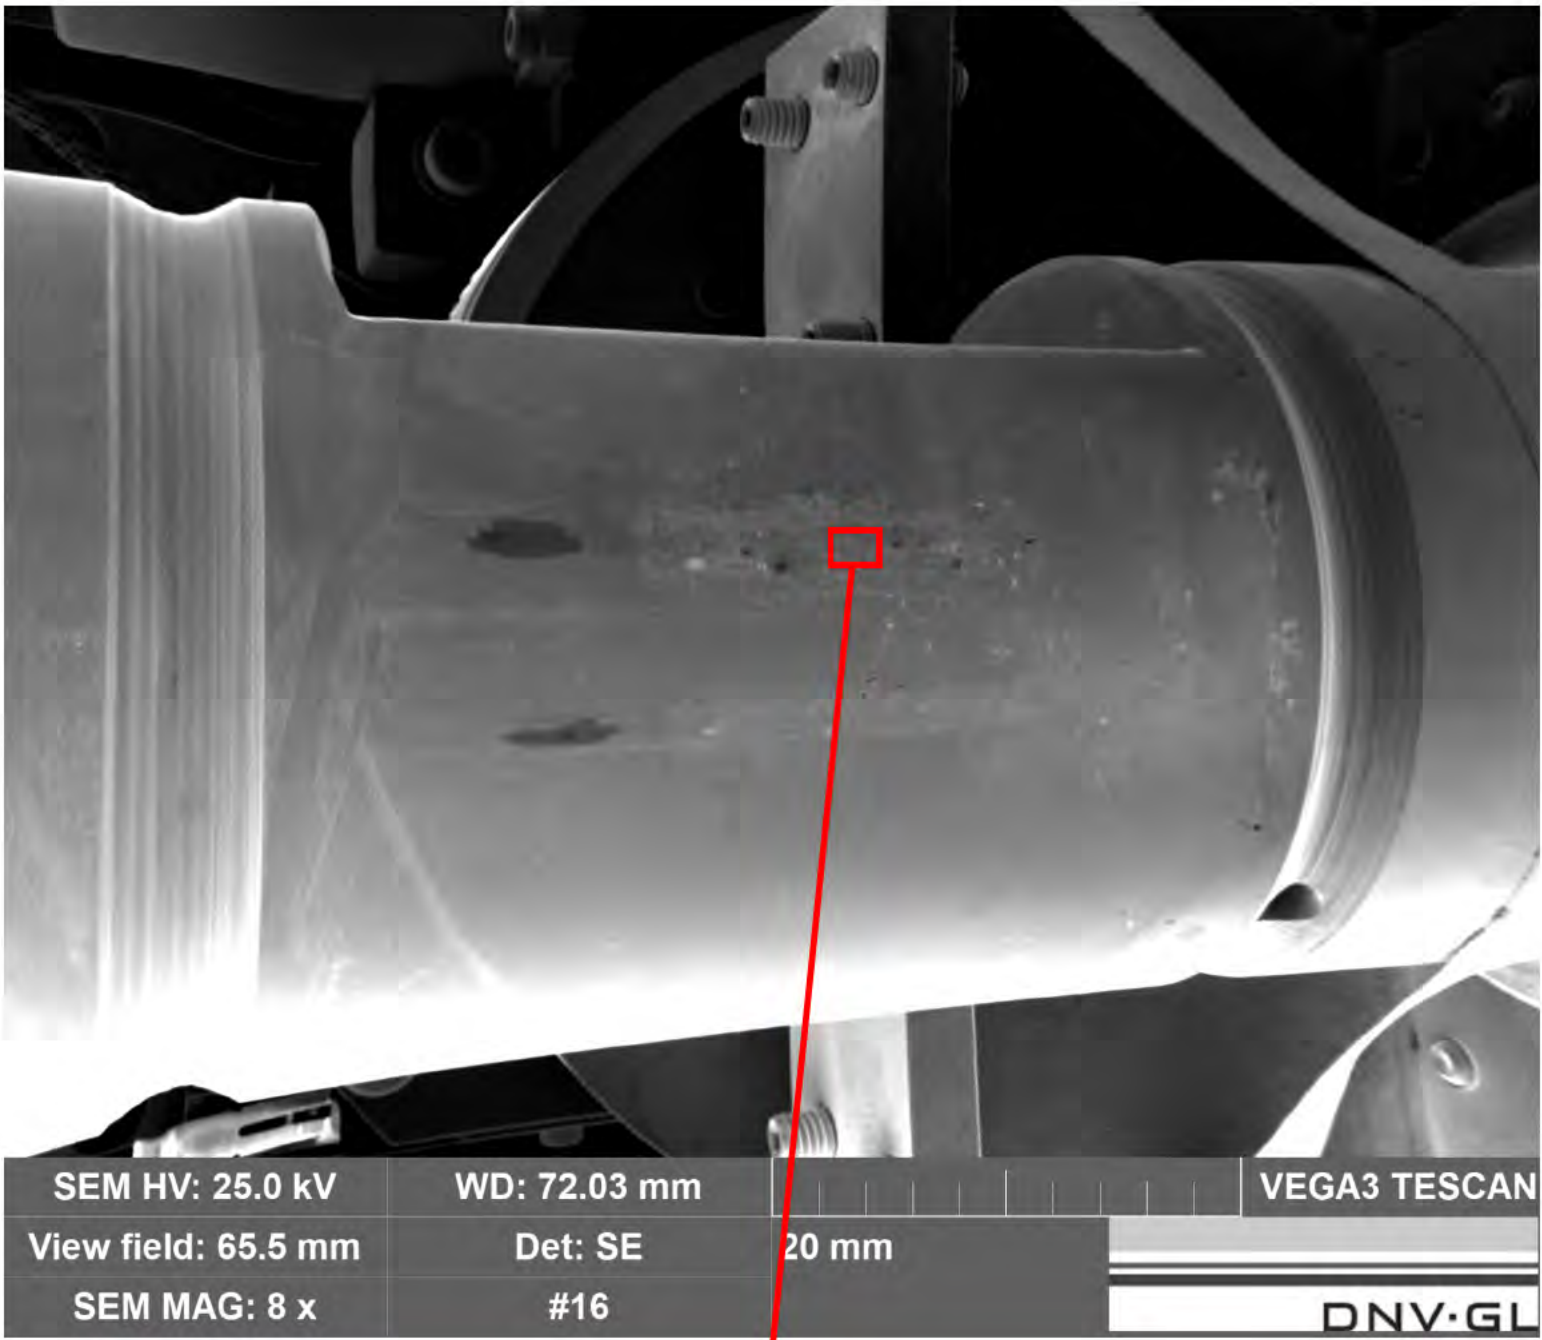
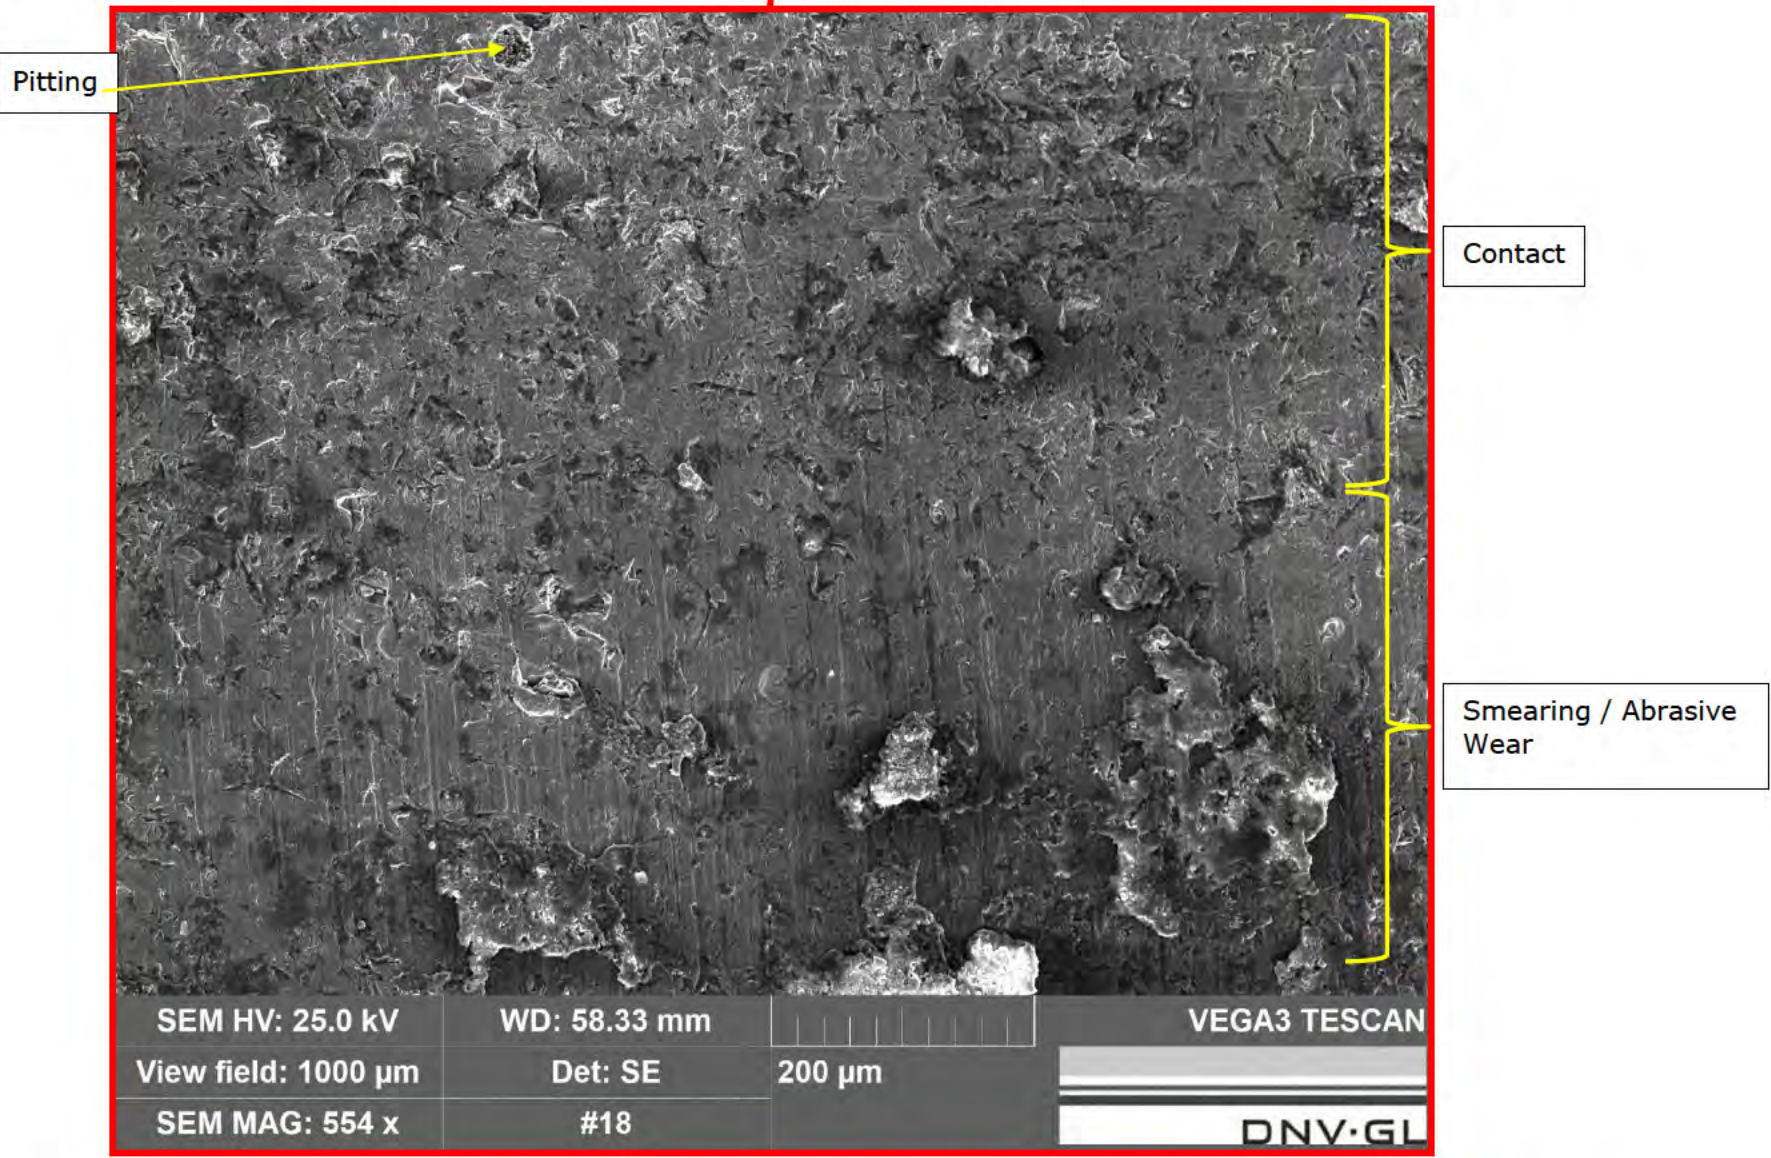
Figure 68. SEM images showing the detail for a suspected area of contact between the roller of the hook and locking shaft from the Subject Aft Hook.

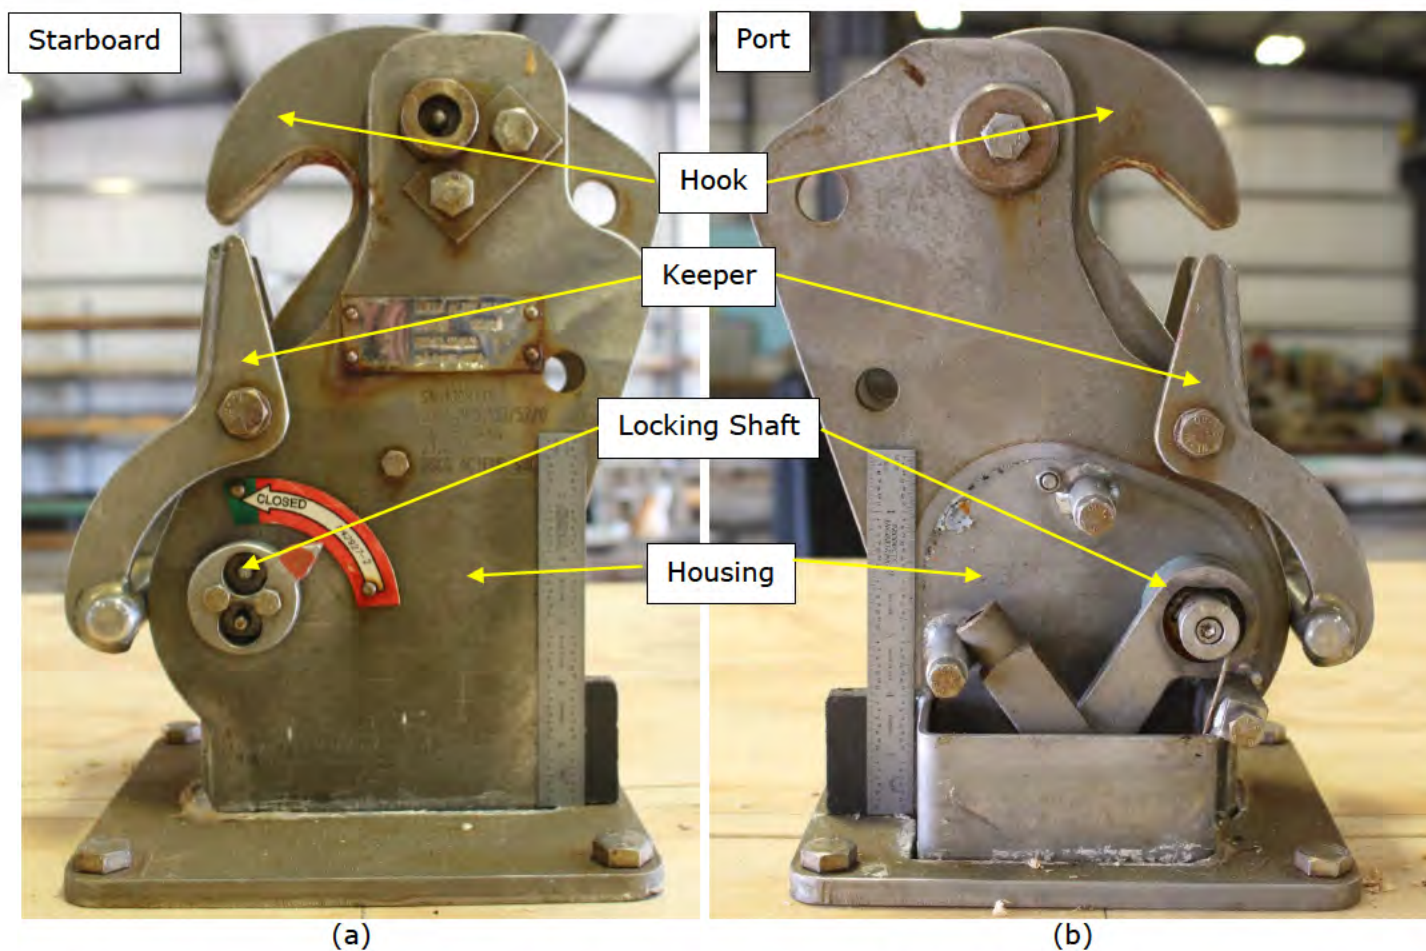
Figure 70. Photographs of the Subject Forward Hook with the locking shaft cover removed, viewed from (a) the starboard side and (b) the port side. Rulers are in inches.

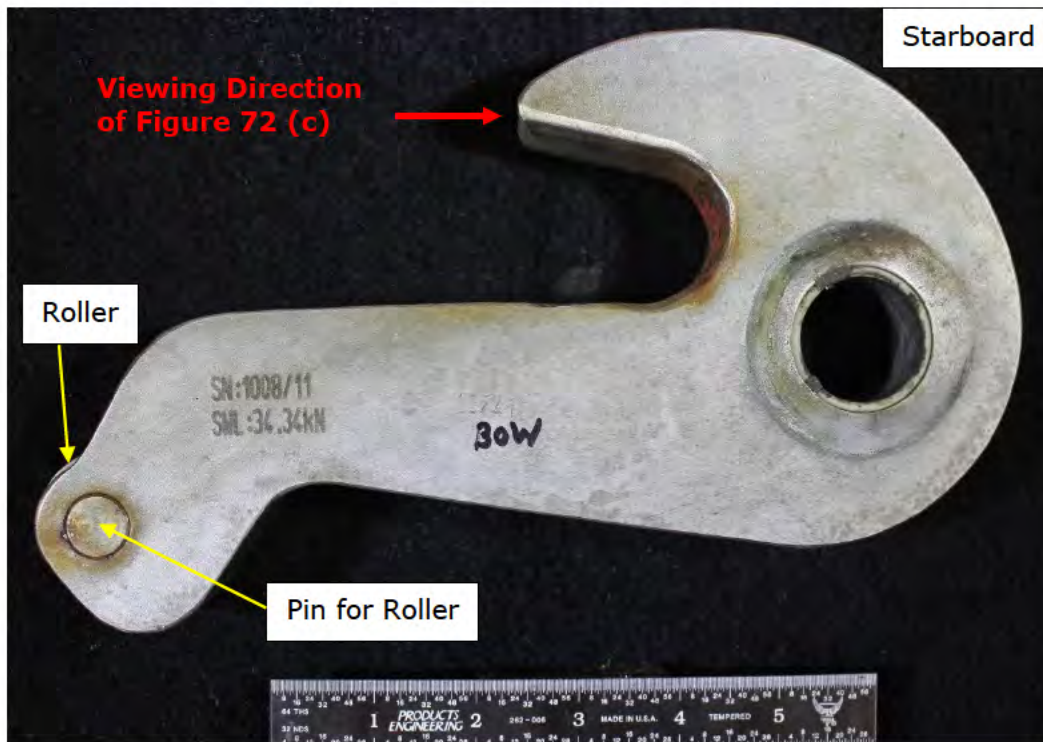
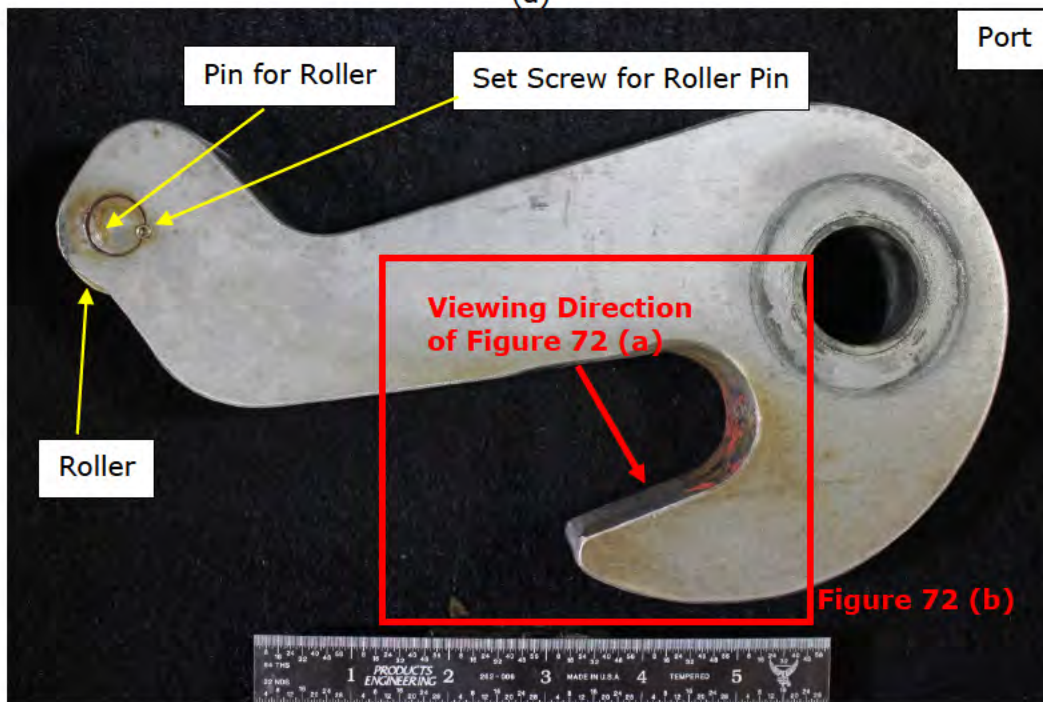
Figure 71. Photographs of the hook from the Subject Forward Hook showing the (a) starboard side and (b) port side, after disassembly. Ruler is in inches.

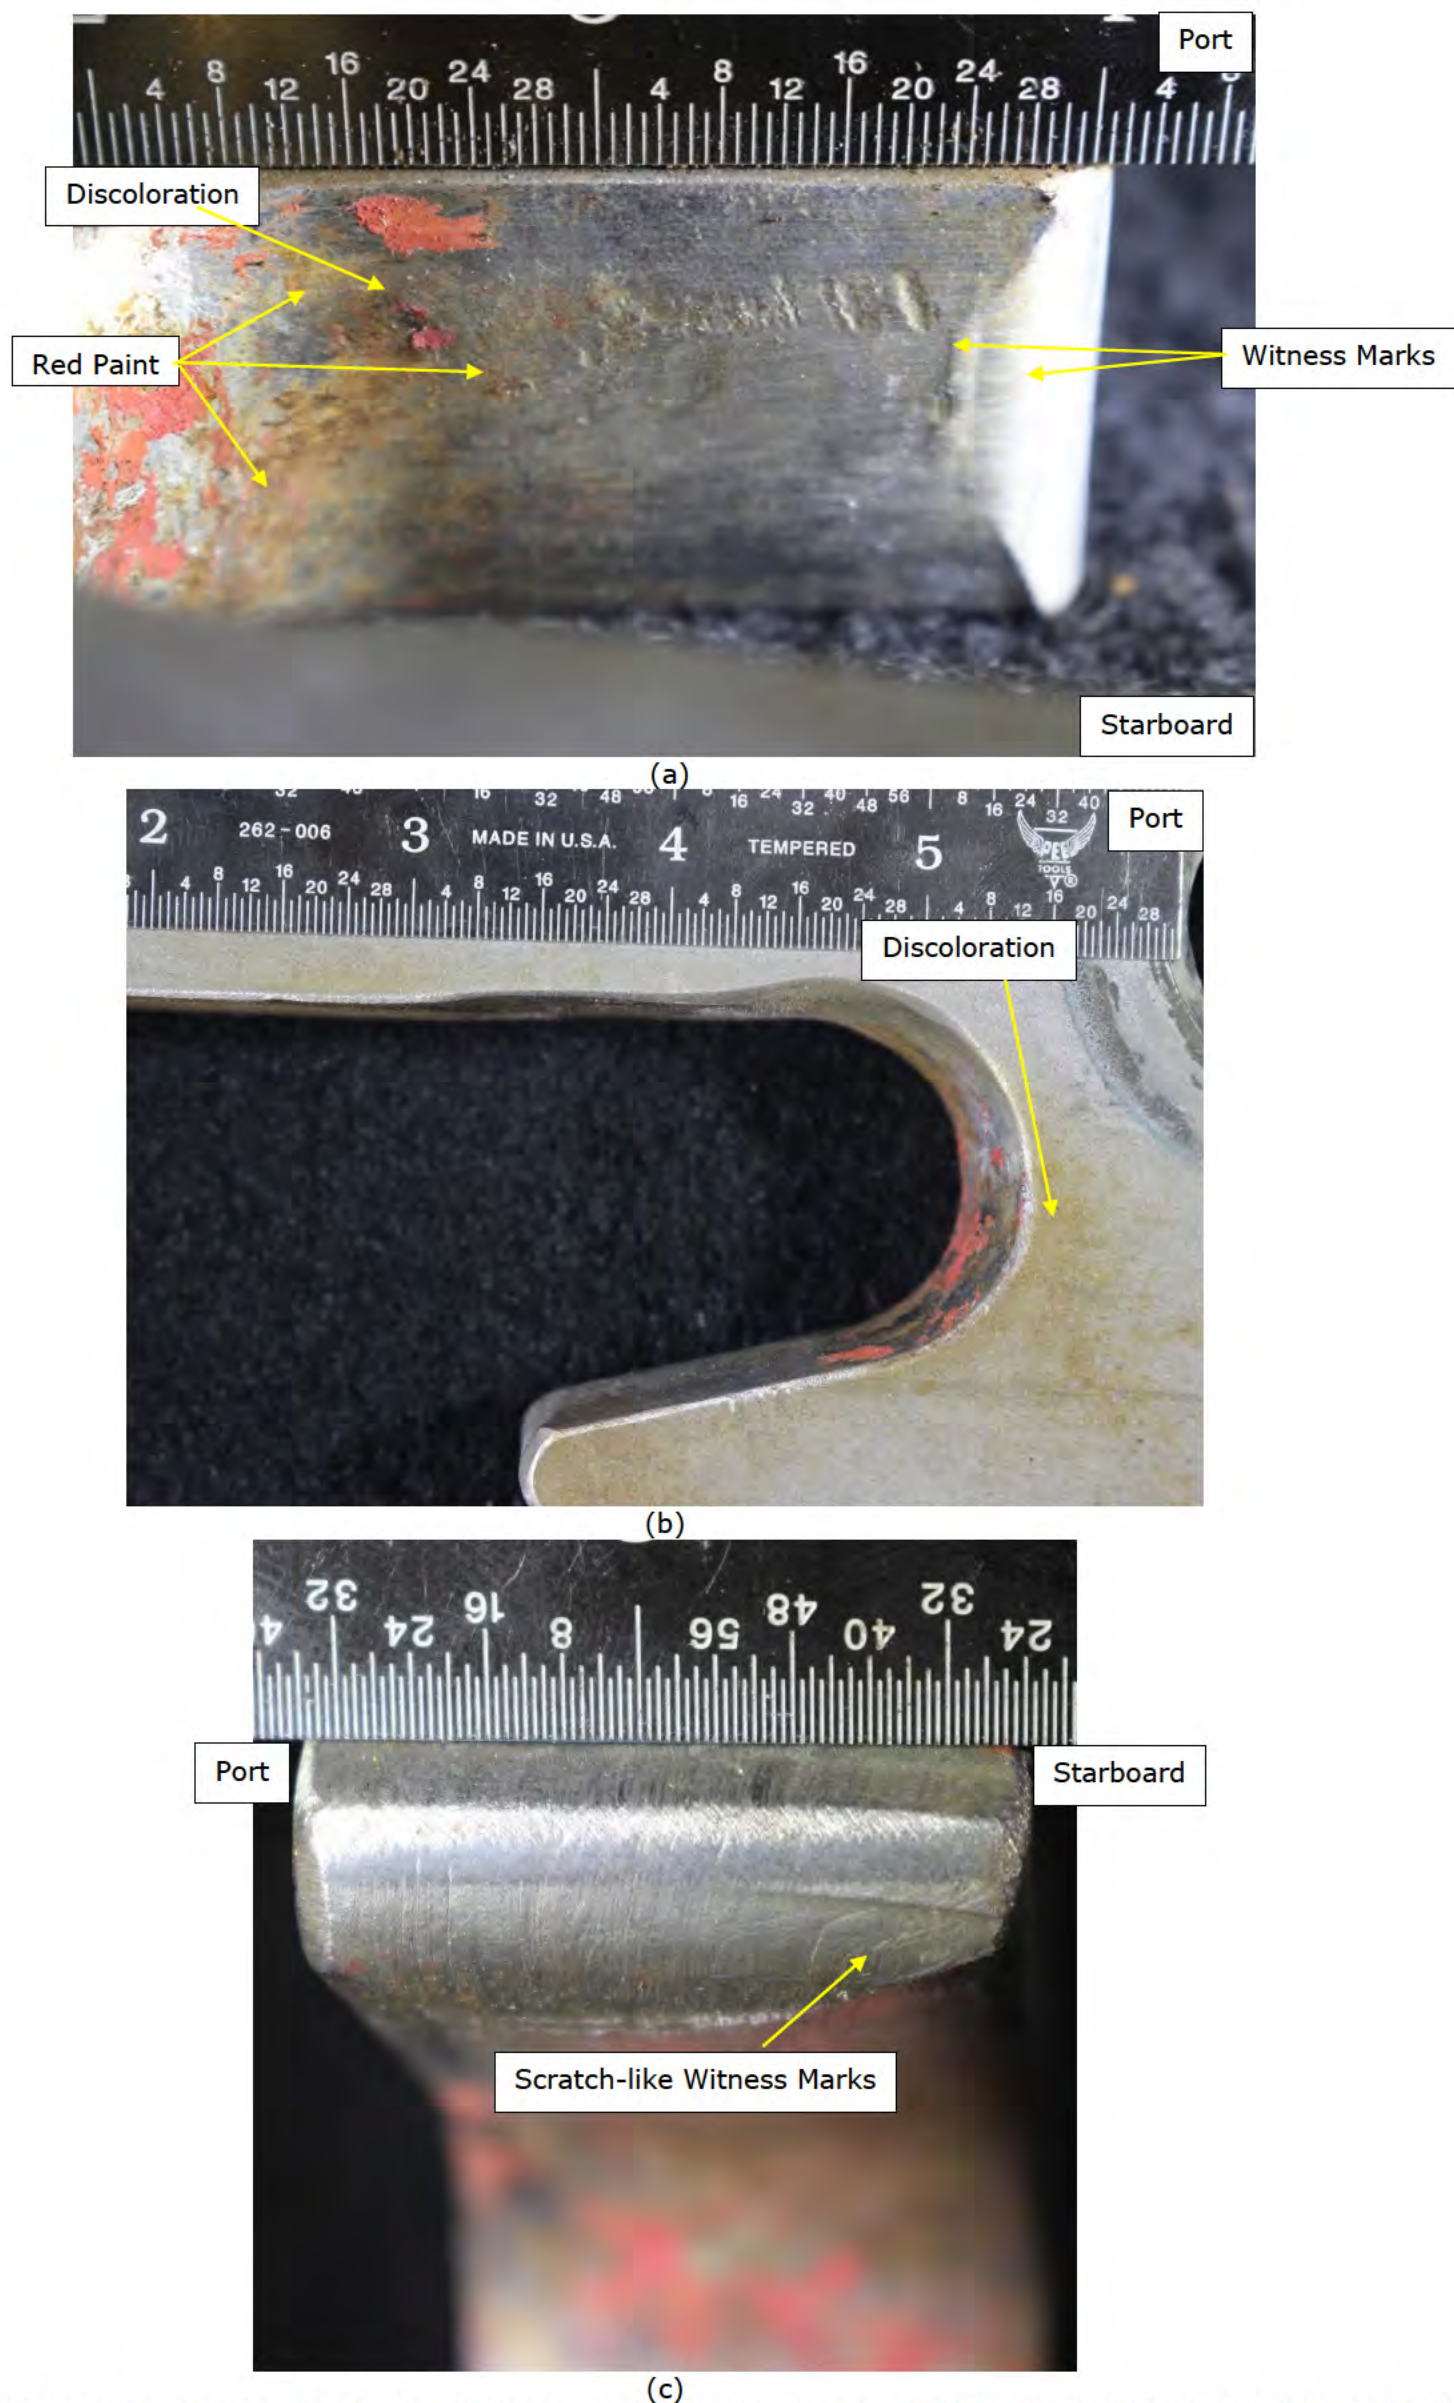
Figure 72. Photographs showing the details of witness marks identified on the Subject Forward Hook at (a) the inside bend of the hook, (b) the edge of the bend as viewed from the port side, and (c) the point of the hook; locations and viewing directions shown in Figure 58 (a) and (b). Rulers are in inches.

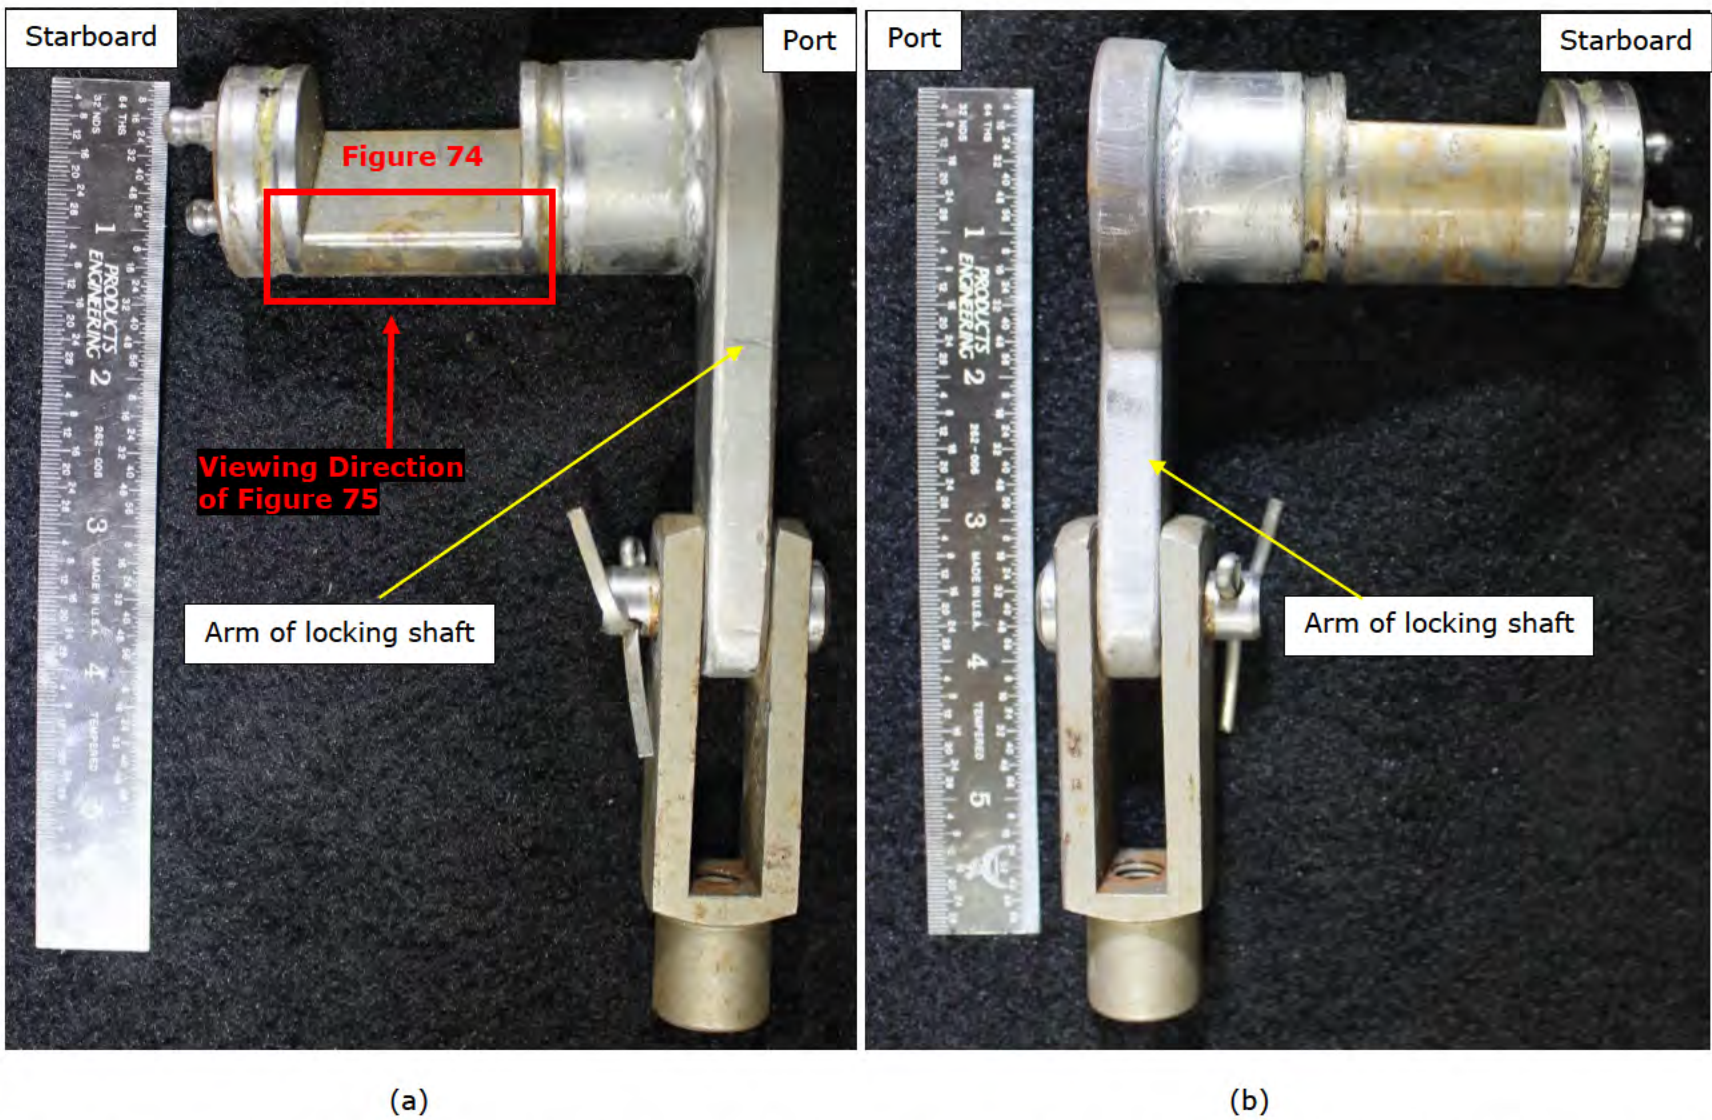
Figure 73. Photographs of the locking shaft from the Subject Forward Hook showing the (a) round side and (b) the flat, after disassembly. Rulers are in inches.

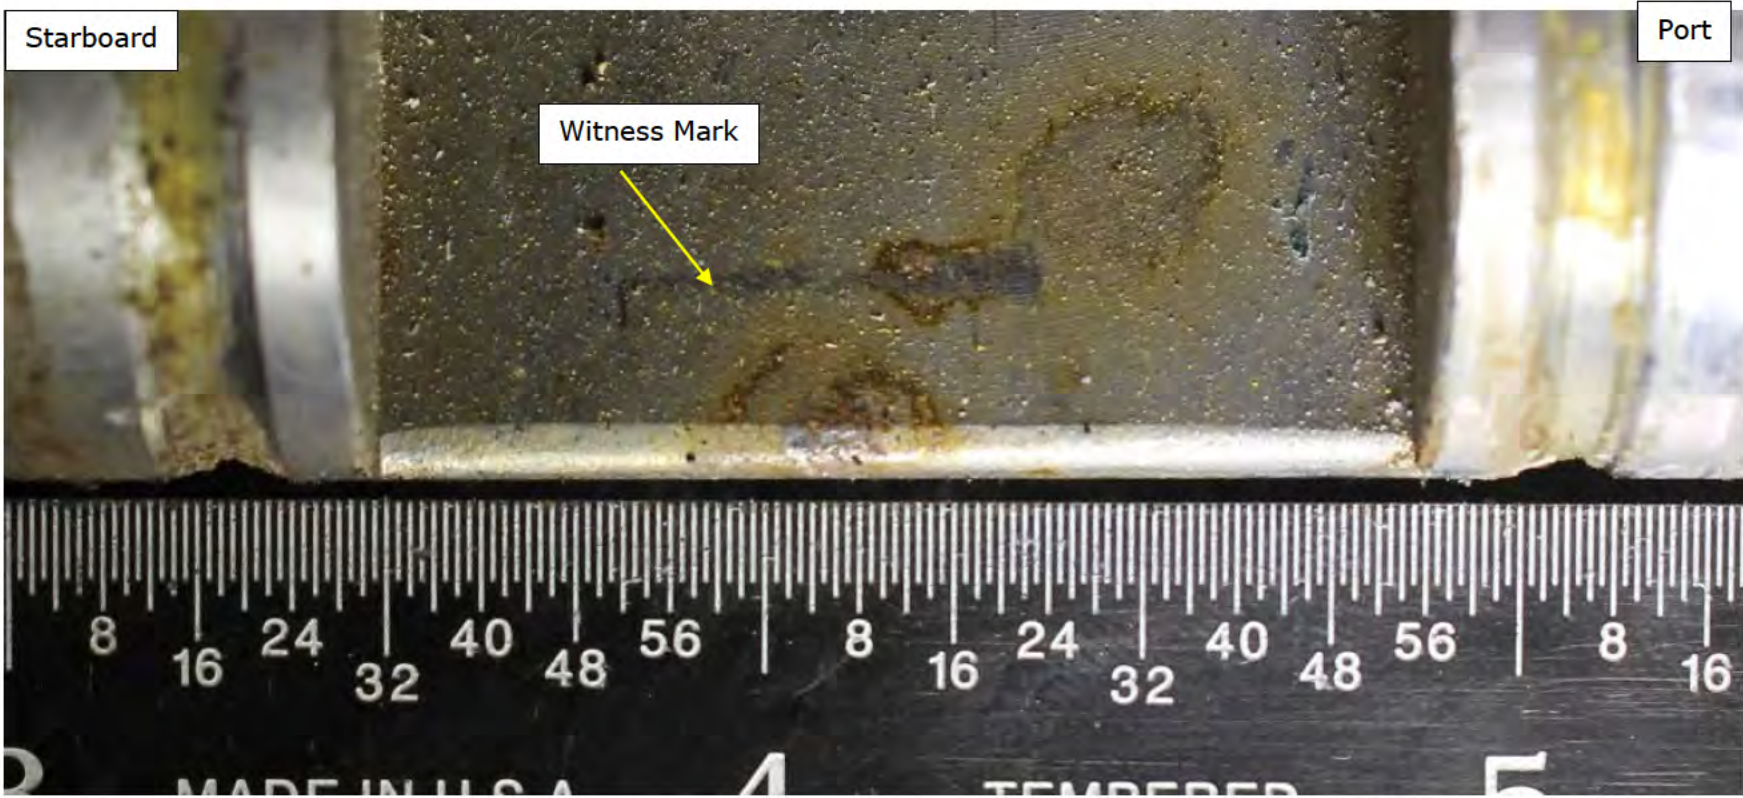
Figure 74. Photograph of the locking shaft from the Subject Forward Hook showing the edge between the round and flat of the locking shaft; area shown in Figure 73. Ruler is in inches.

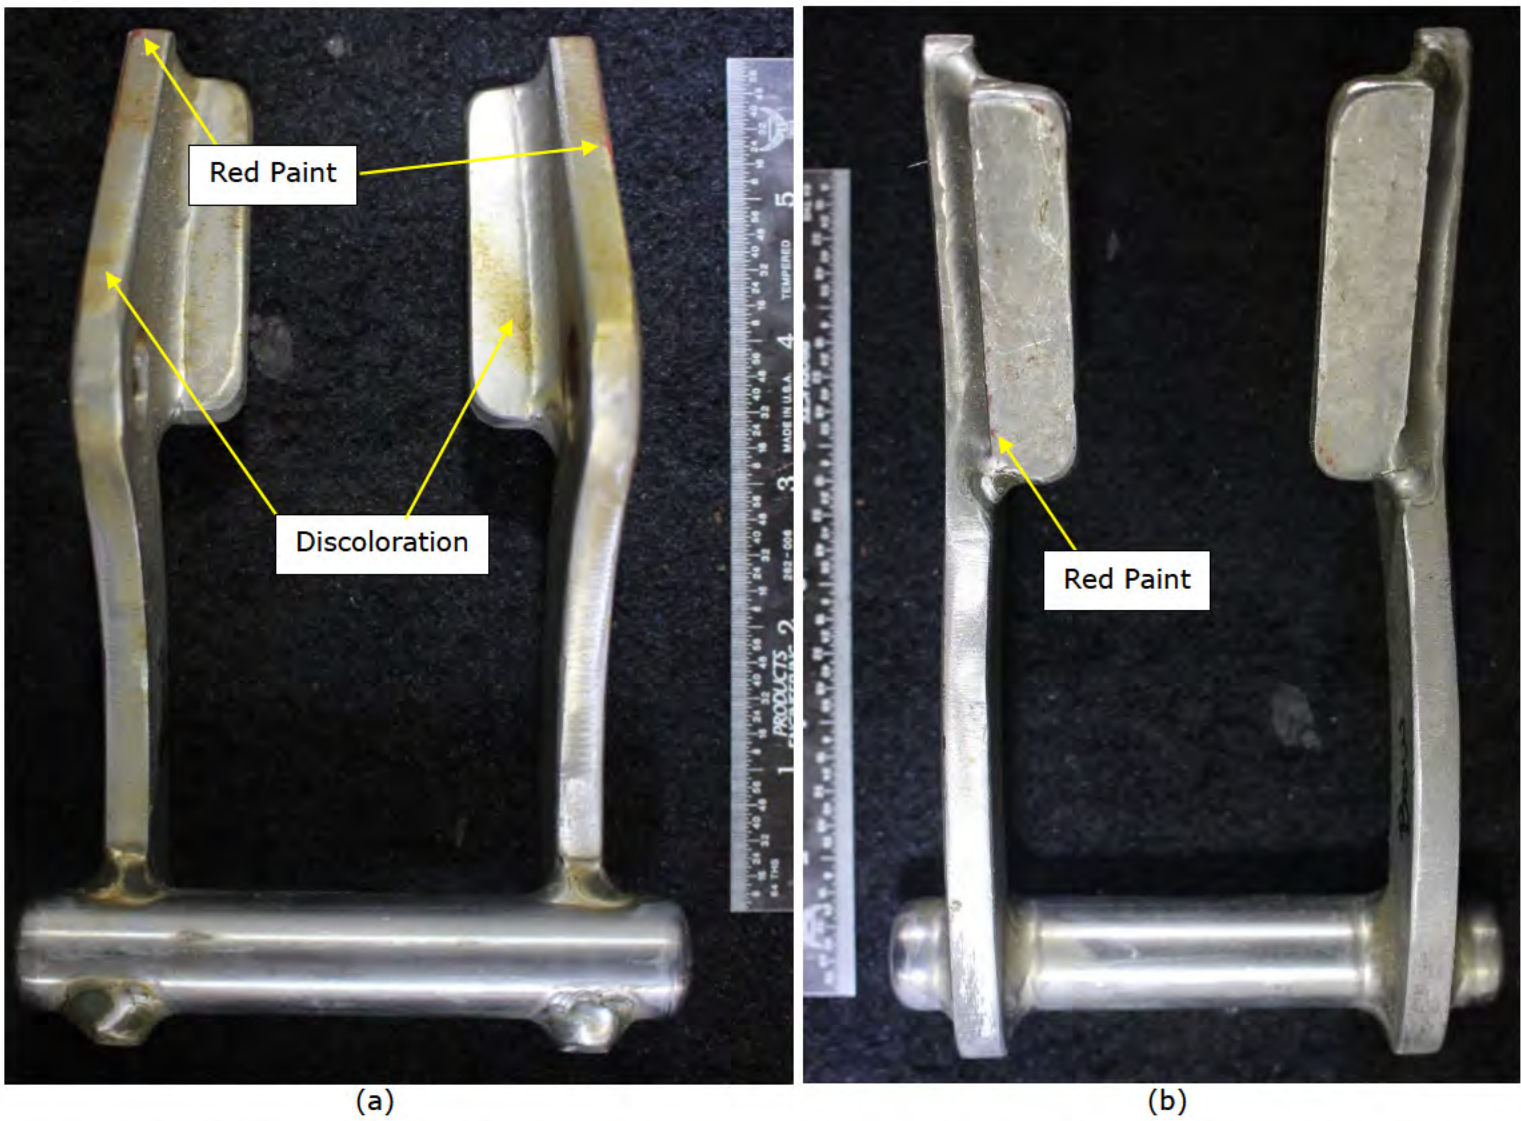
Figure 76 contains photographs of the keeper from the Subject Forward Hook showing the (a) forward side and (b) aft side, after disassembly. Red paint is visible on the forward and aft sides of the keeper, likely from transfer of the red paint from the ring. There is no evidence of witness marks in the vicinity of the red paint. There is also some discoloration on the forward side of the keeper, likely from superficial corrosion.

Figure 76. Photographs of the keeper from the Subject Forward Hook showing the (a) forward side and (b) aft side, after disassembly. Forward and aft refer to the orientation of the keeper relative to the lifeboat. Rulers are in inches.

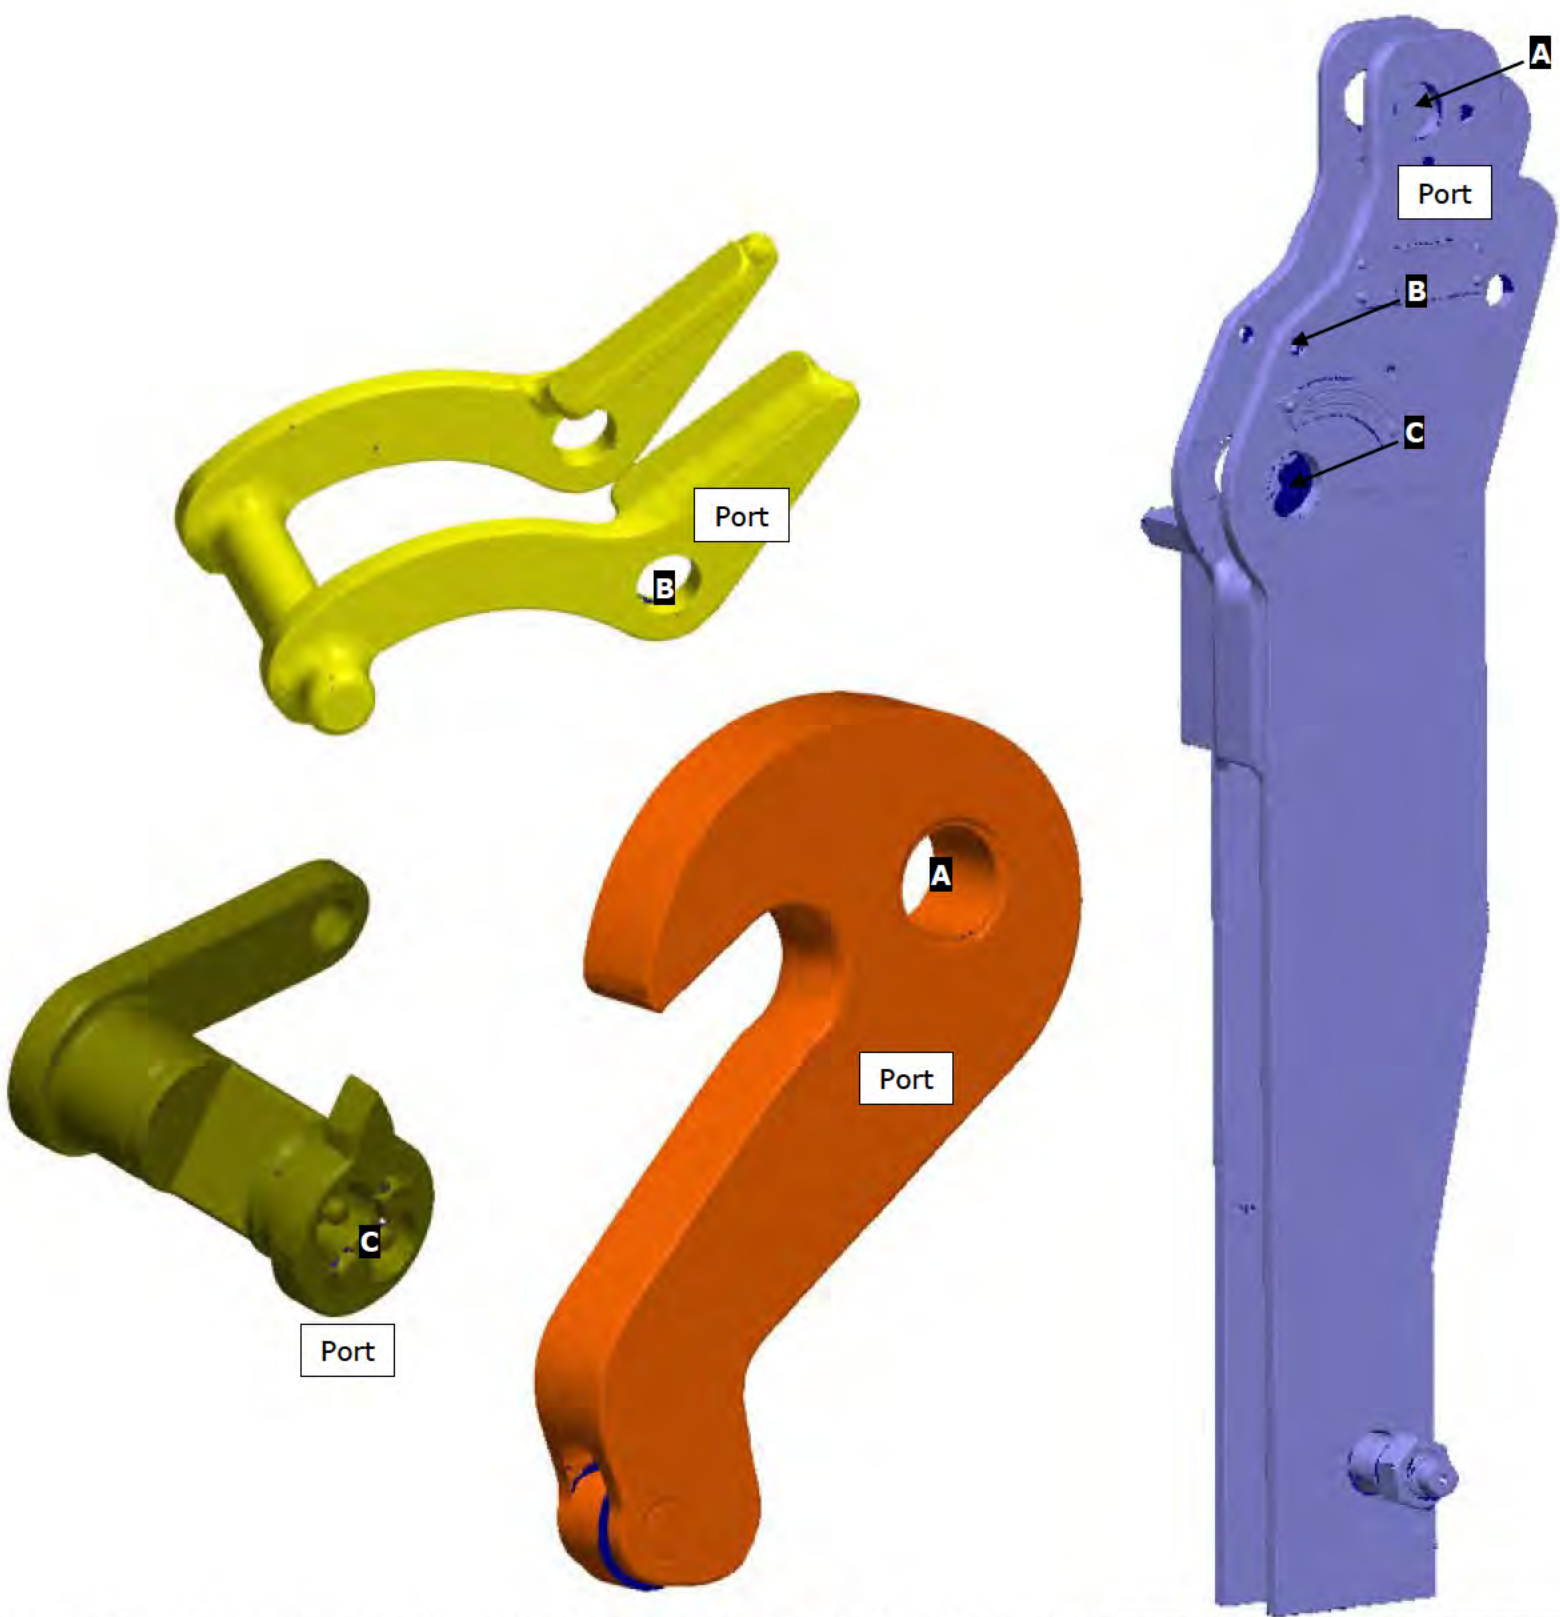
The hook, keeper, locking shaft and housing of the Subject Aft Hook were scanned using the FARO Edge after disassembly, as shown in Figure 77. The components were aligned in 3D space by using geometrical characteristics of the components. Centerline axes were fit to the centerlines of the hole in the hook (Location A in Figure 77), bolt hole of the keeper (Location B in Figure 77), and the locking shaft (Location C in Figure 77). Those centerlines were aligned to the centerlines of the respective holes in the hook housing. The result is the assembly shown in Figure 78, which can be manipulated to investigate relationships between component contact areas and component positions.

Figure 77. Laser scans of Subject Aft Hook components displayed individually. From left to right: the locking shaft (gold), the keeper (yellow), the hook (orange), and the housing (purple). The Locations A, B, and C correlate to the centerlines of the components and their respective positions in the housing.

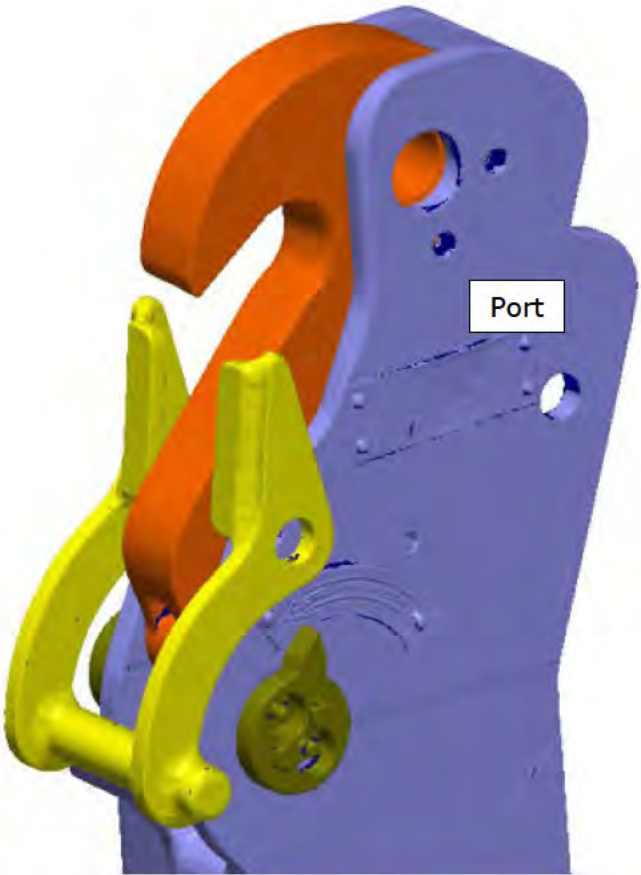
The 3D assembly shown in Figure 78 was utilized to investigate the relationship between the contact area of the locking shaft and hook for various locking shaft orientations. Figure 79 shows the assembly positioned to create contact between the arm of the locking shaft and standoff for the locking shaft cover (see Figure 52 (a)), which is the fully closed position . Both starboard and port views of the assembly as well as a wire outline cross-section extracted from the centerline of the hook are shown.

Figure 78. Laser scans of Subject Aft Hook components aligned to working positions.

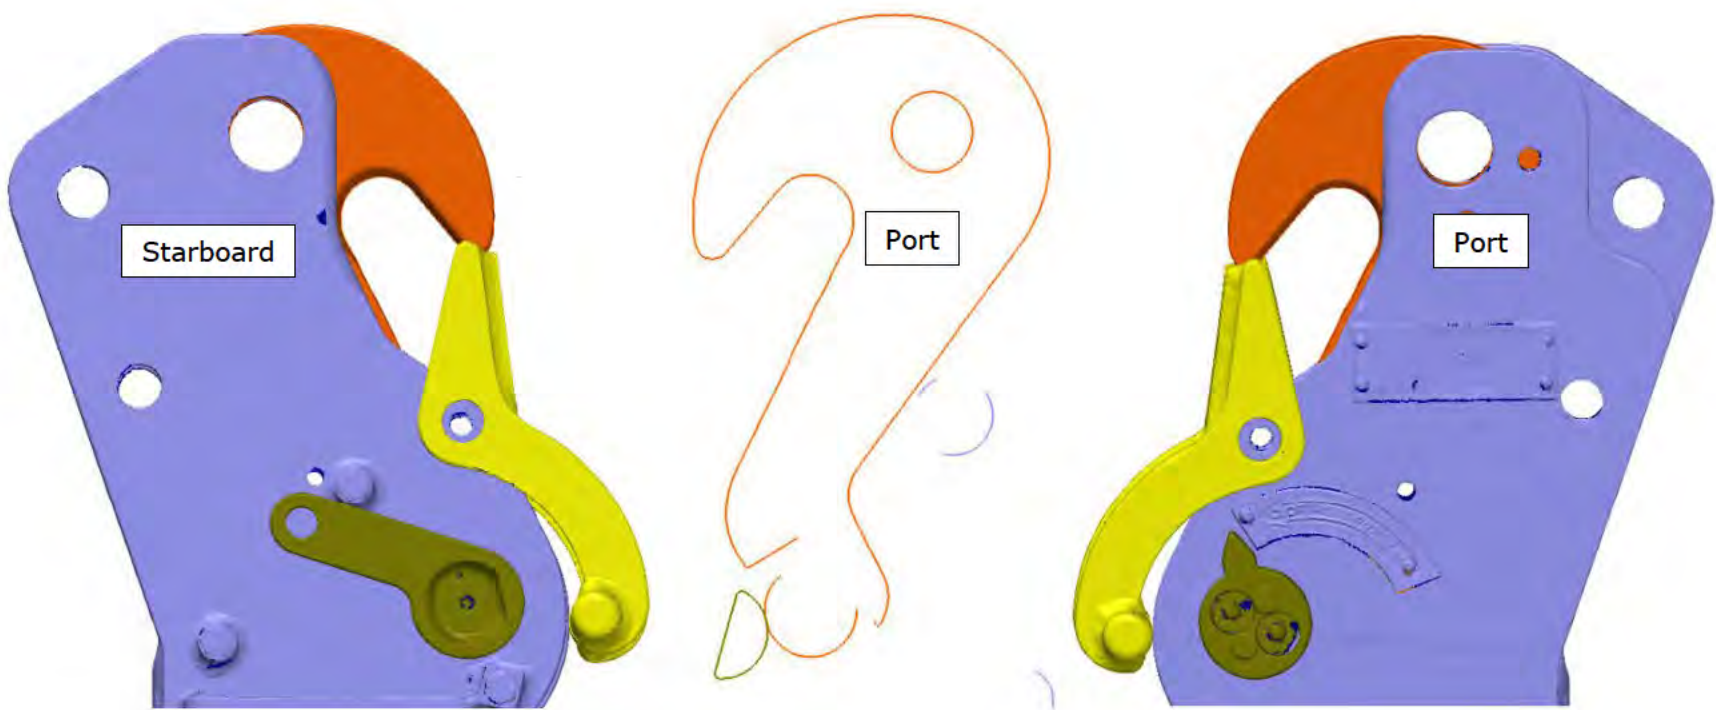
Figure 79. Laser scans of Subject Aft Hook components aligned to working positions with the locking shaft rotated into contact with the post of the hook body. An outline of the components shows the interacting locations of the hook and locking shaft.

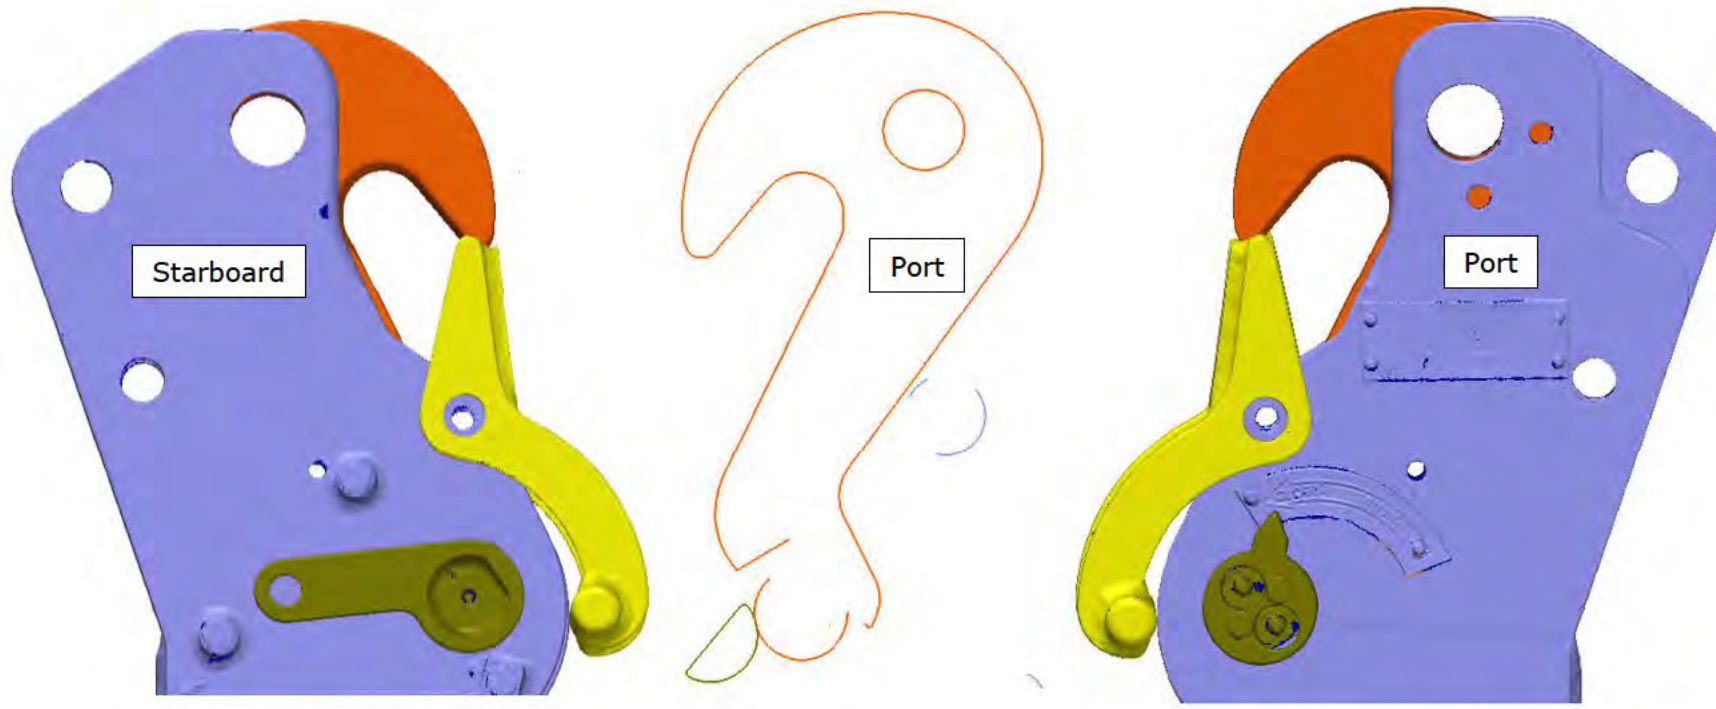
Figure 80 shows laser scans of Subject Aft Hook showing the 3D assembly aligned assuming elongation of the liner equivalent to 2.58 inches.⁵ Both starboard and port views of the assembly as well as a wire outline cross-section extracted from the centerline of the hook are shown. Figure 79 and Figure 80 highlight the effect of the rotation of the locking shaft on the contact location between the hook and locking shaft.

Figure 80. Laser scans of Subject Aft Hook showing the 3D assembly aligned assuming elongation of the liner equivalent to 2.58 inches. An outline of the components shows the interacting locations of the hook and locking shaft.
