Final Report

Auger Lifeboat 6 Incident

Shell Oil Company
Houston, Texas, USA

Report No.: O-AP-FINV / BPADG (10165575)
July 9, 2020

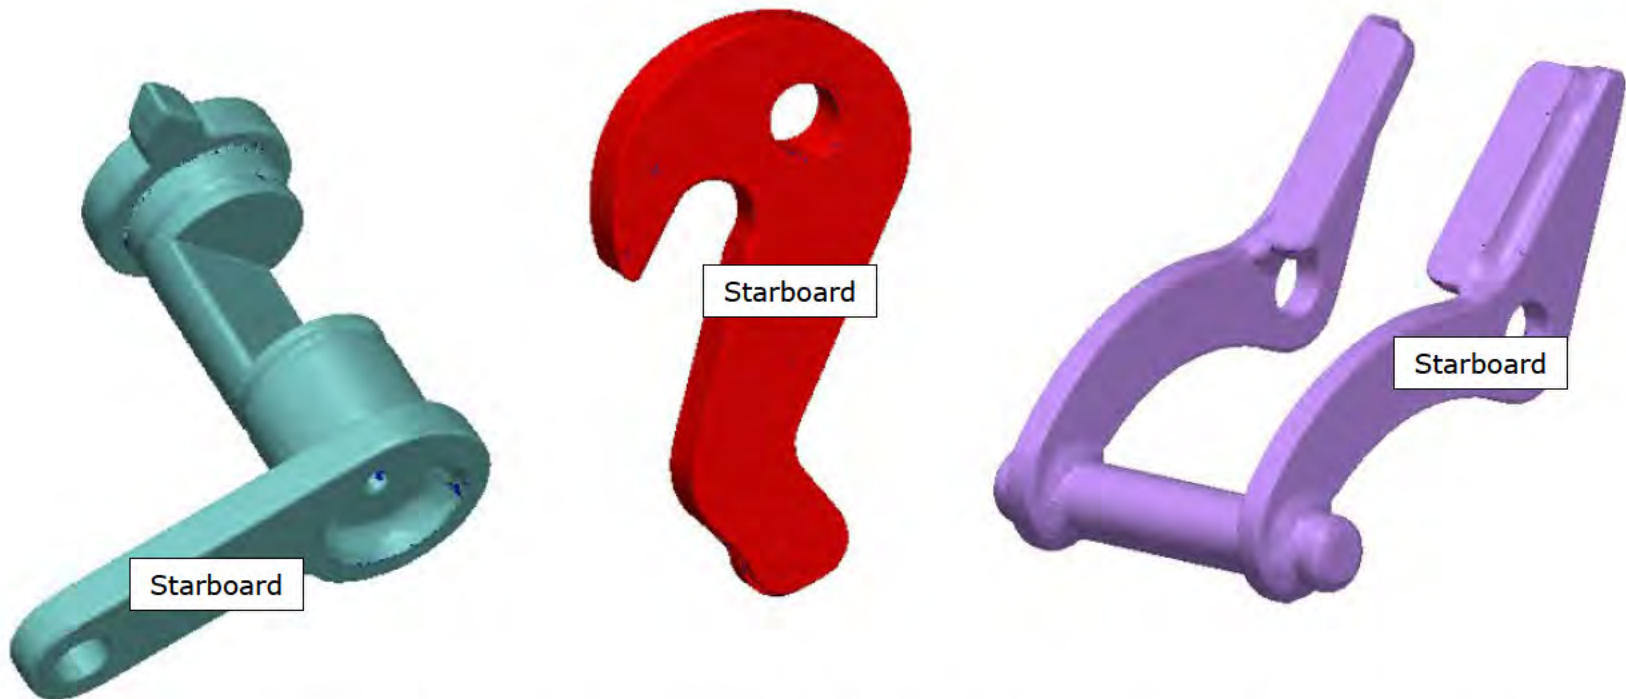
Figure 81 shows the 3D scans of the Subject Forward Hook, locking shaft, keeper, and hook. These items were documented using laser scanning for comparison to the Subject Aft Hook components. No significant differences were noted.

Figure 81. Laser scans of Subject Forward Hook components. From left to right: the locking shaft (teal), the hook (red), and the keeper (light purple).

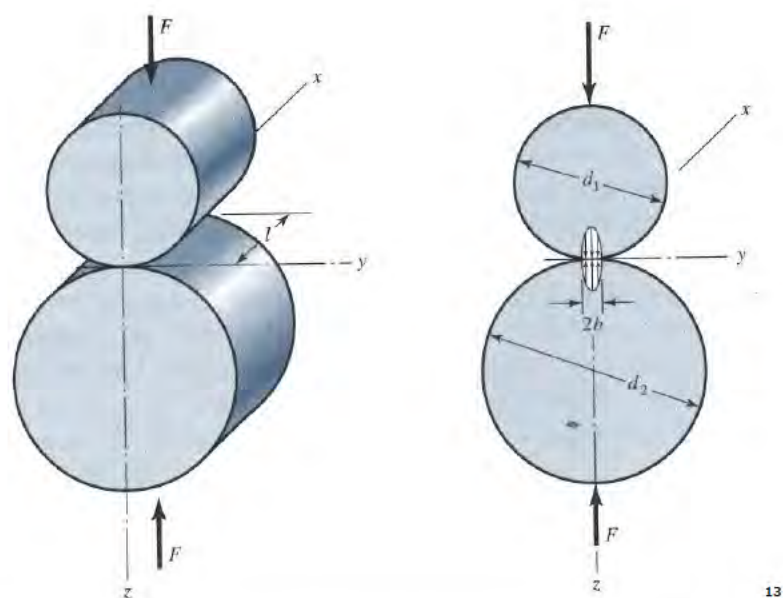
Stresses due to contact of cylindrical components can have large magnitudes and are compressive in nature. The stress fields in the material tend to be very shallow leading to surface damage. Figure 82 illustrates the interaction of the components and the elliptical stress distribution with width $2b^6$ as well as lists the quantities used in this analysis. Figure 83 illustrates the major diameter of the locking shaft, edge diameter of the locking shaft⁷, and diameter of the hook roller using the laser scan data of the Subject Aft Hook components. The analysis was performed assuming the locking shaft was in contact with the major diameter of the hook roller and again assuming the locking shaft was in contact with the edge diameter of the locking shaft near the transition to the flat portion of the locking shaft.

Figure 82. Two right circular cylinders held in contact by forces F uniformly distributed along length l (Left). Elliptical contact stress distribution across contact area $2b$ (Right). Table of variables used in associated calculations (Bottom).

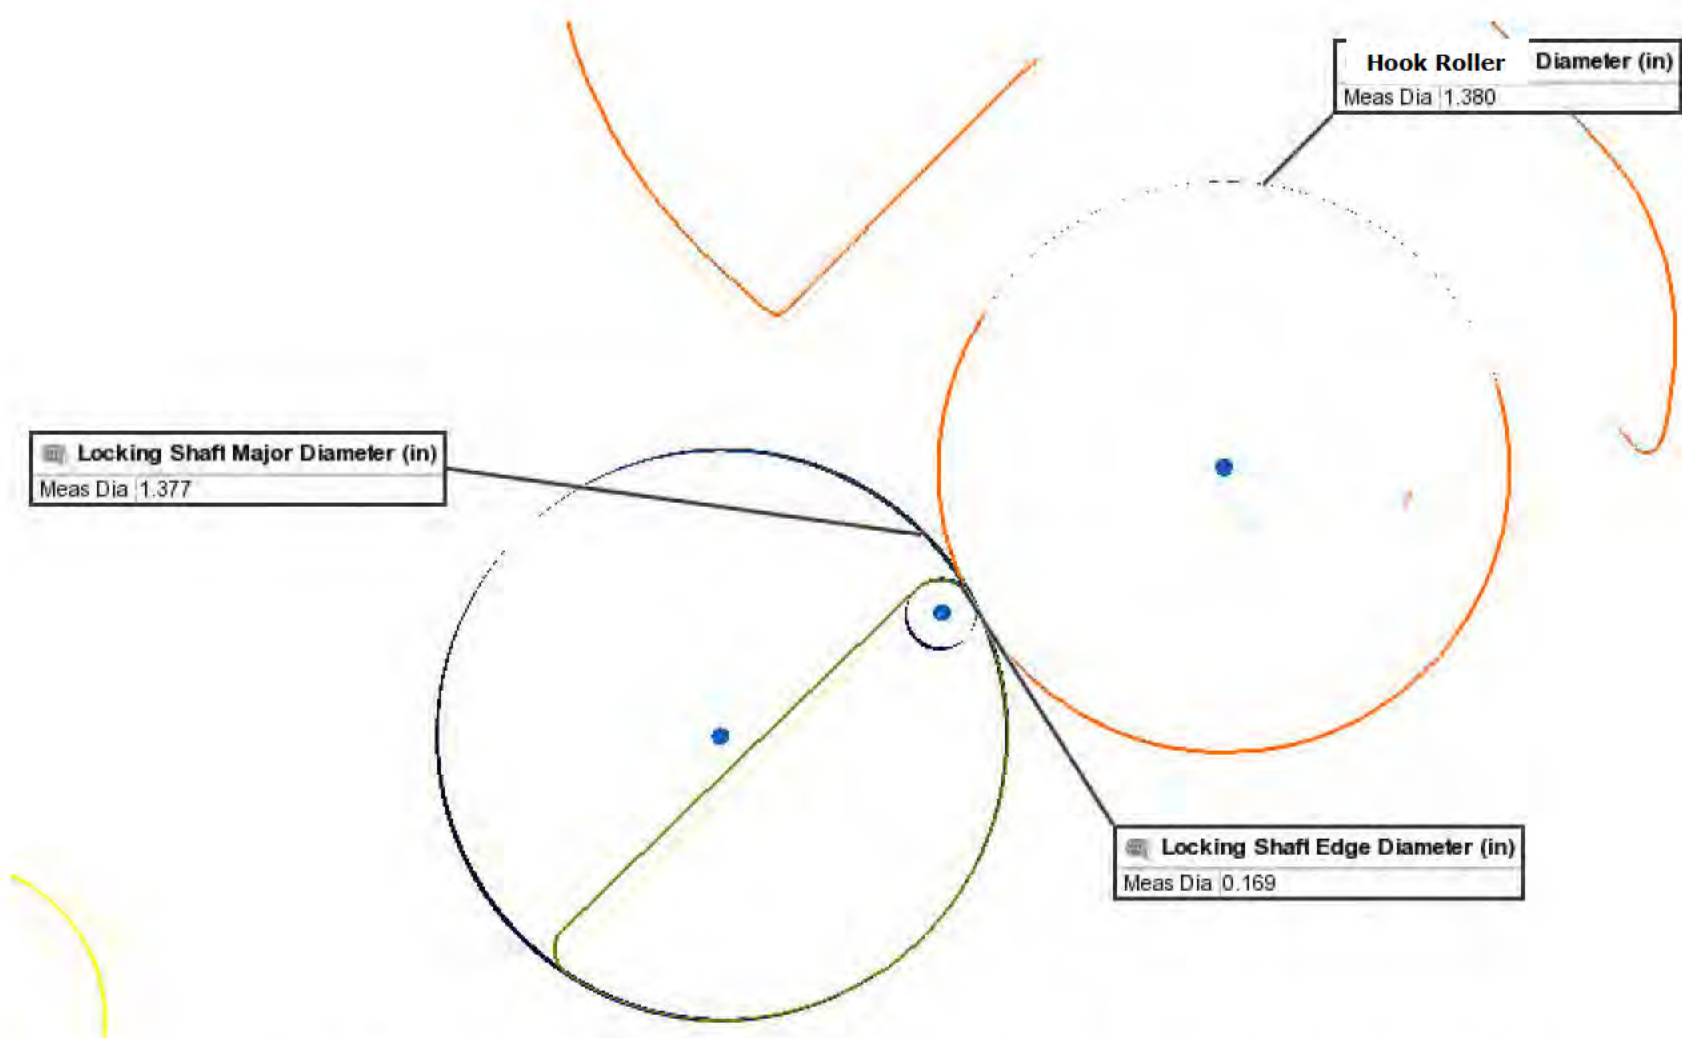
between the hook roller and locking shaft is 2.14 times larger when contacting the major diameter versus the edge diameter. The larger contact area created between the hook roller and major diameter of the locking shaft corresponds to a lower maximum pressure (stress) since the loading remains constant for both cases. Figure 84 illustrates the local compressive stress in the locking shaft and hook roller material with depth into the material. The largest stress manifests on the surface of the components and decreases below an assumed yield strength of 80.0 ksi at an approximate depth of 0.06 inches. The magnitude of the stress is likely an overestimation as the equation relies on only the elastic modulus and does not include plastic characteristics of the materials. It does however serve as a way to compare the stresses and contact areas that would result due to the different positions of the locking shaft.

Figure 83. Locking shaft major diameter, locking shaft edge diameter and hook roller diameter illustrated by fitting nominal cylinders to the Subject Aft Locking Shaft (green) and Subject Aft Hook (Orange).

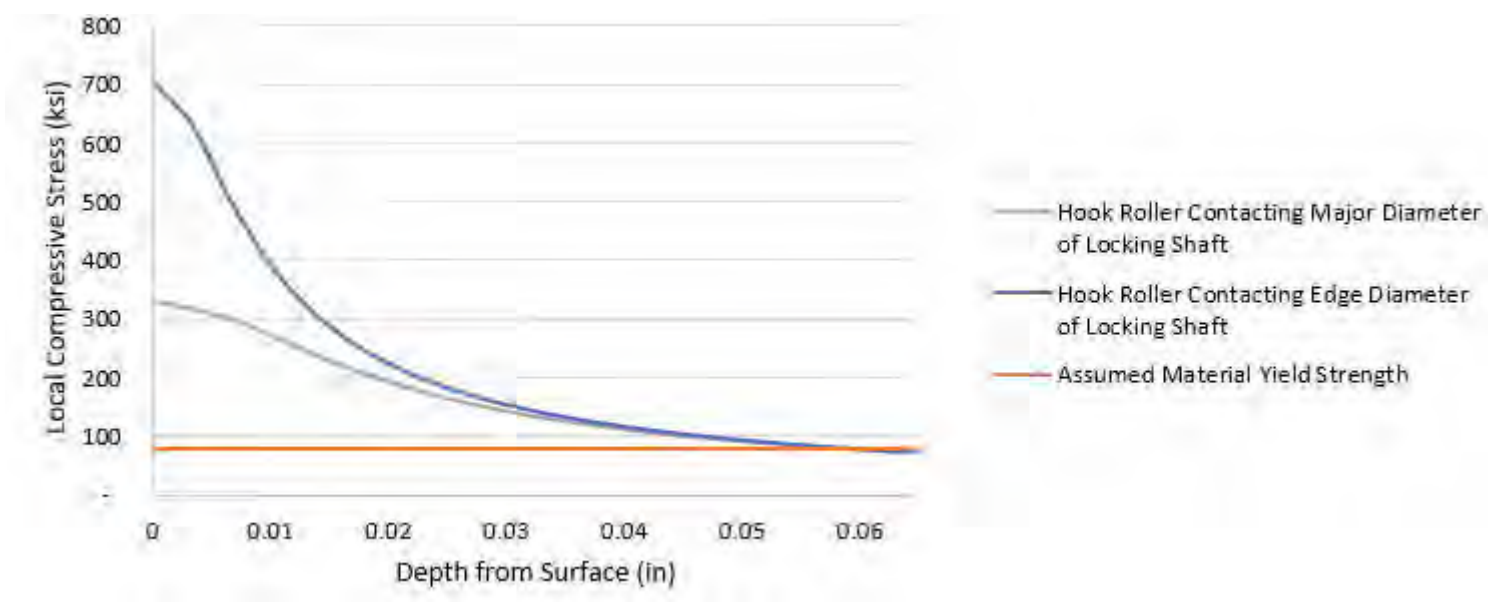
Figure 84. Local Compressive Stress vs. Depth into Material from Contact Surface.

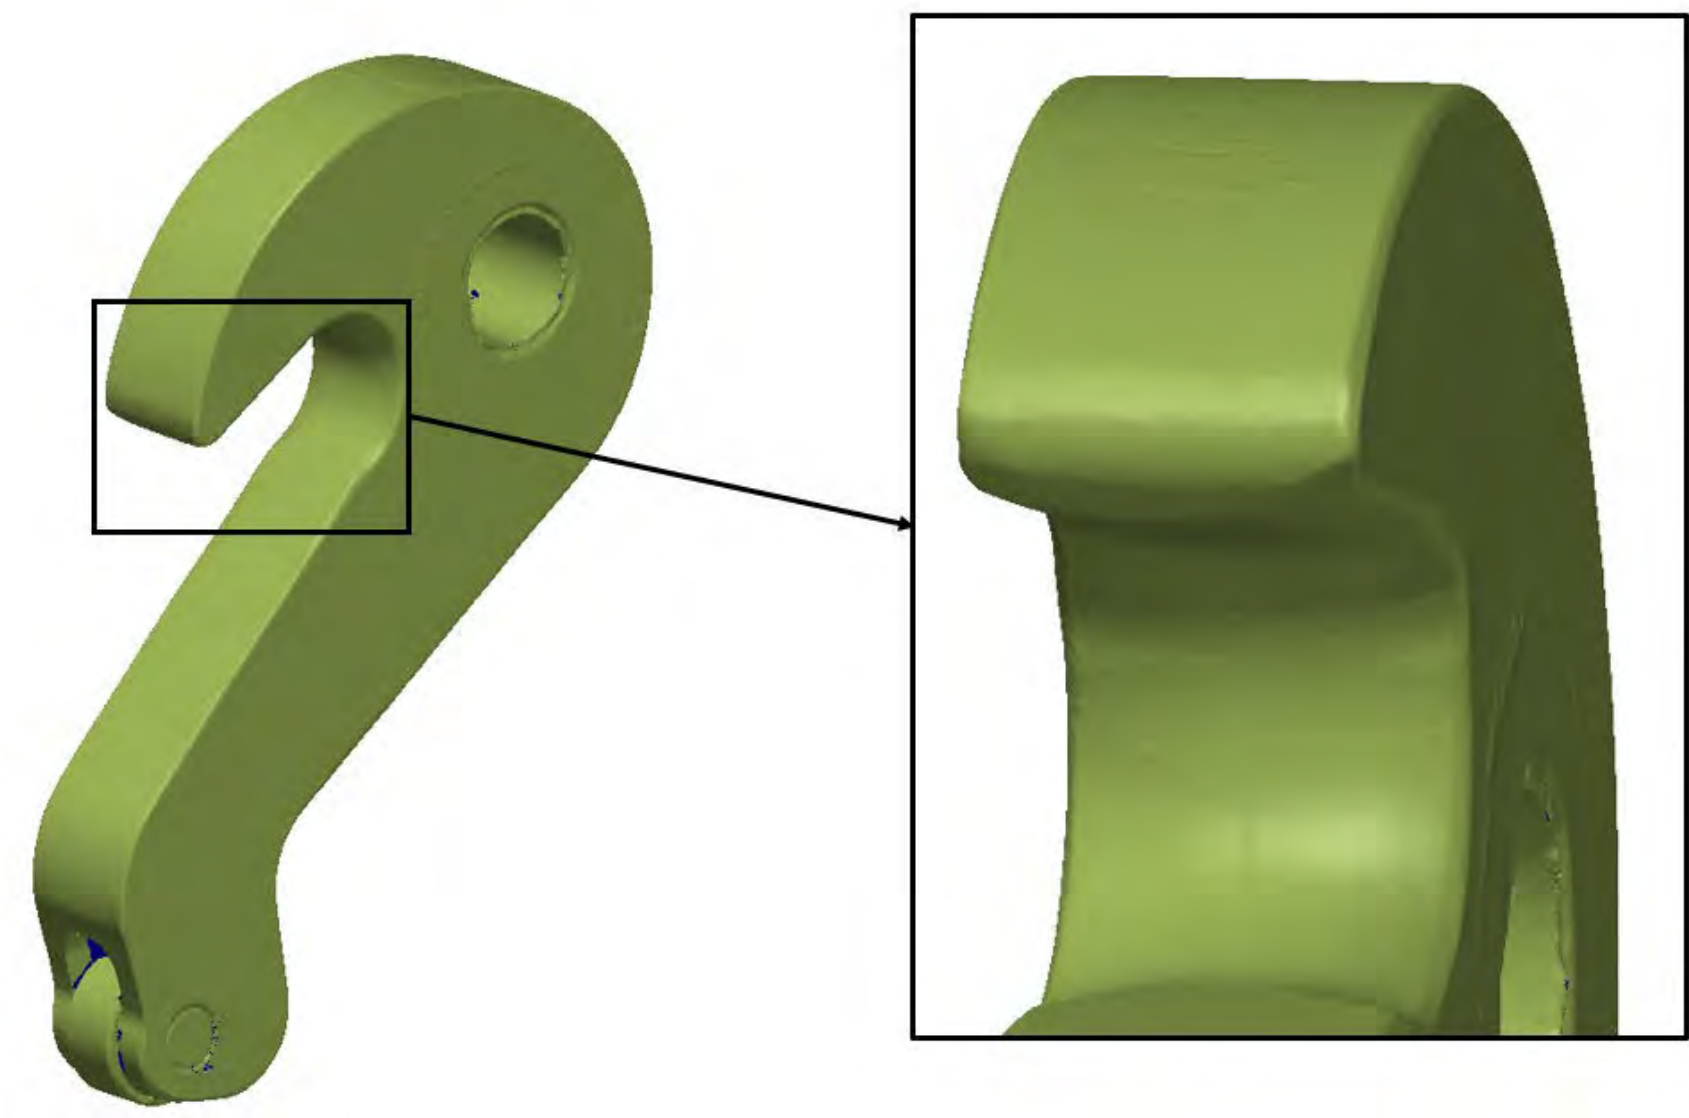
Figure 85 contains laser scans of the Exemplar Hook with a close-up image of the hook tip. The laser scanning was performed to document the as-received condition of the Exemplar Hook. Load testing using the Exemplar Hook was performed to understand the damage accumulation at the hook point when the ring and the hook point were in contact (i.e. improper installation of the ring into the hook). The load testing is discussed in Section 3.3.4.4. The laser scan data of the Exemplar Hook and Subject Hook were compared to ensure the Exemplar Hook was suitable for testing. The dimensions between the two hooks are similar with some subtle differences at the hook point. This is likely because the point is reportedly hand-ground as a final manufacturing step, per Palfinger, thus differences would be anticipated at this location.

Figure 85. Laser scans of Exemplar Hook with a close-up image of the hook tip.

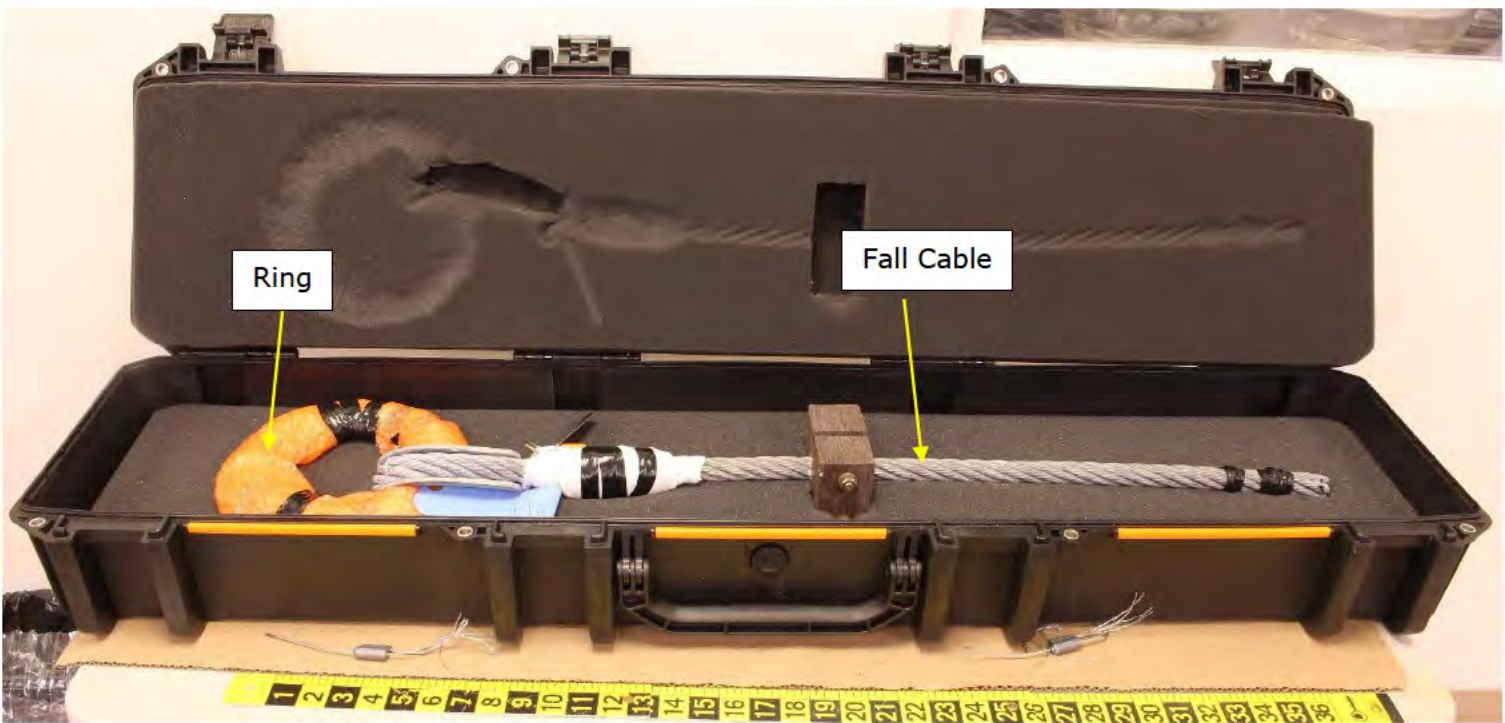
Figure 86 is a photograph of the Subject Aft Ring and a section of the Subject Aft Fall Cable as received at DNV GL. The ring was wrapped in white cloth covered with orange bubble wrap and fixed in place with black electrical tape. The ferrule of the eye splice was also covered in white cloth held in place with black electrical tape. The entirety of the assembly was placed in a case for transport.

Figure 86. Photograph of the Subject Aft Ring and a section of the Subject Aft Fall Cable as received at DNV GL. Ruler is in inches.

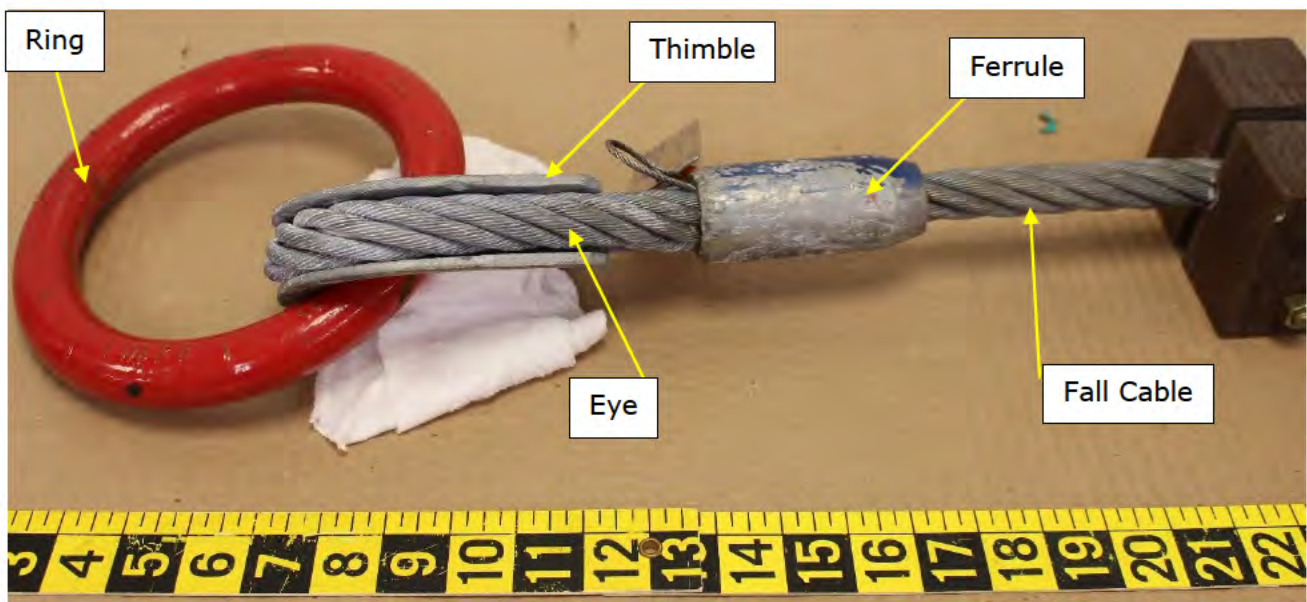
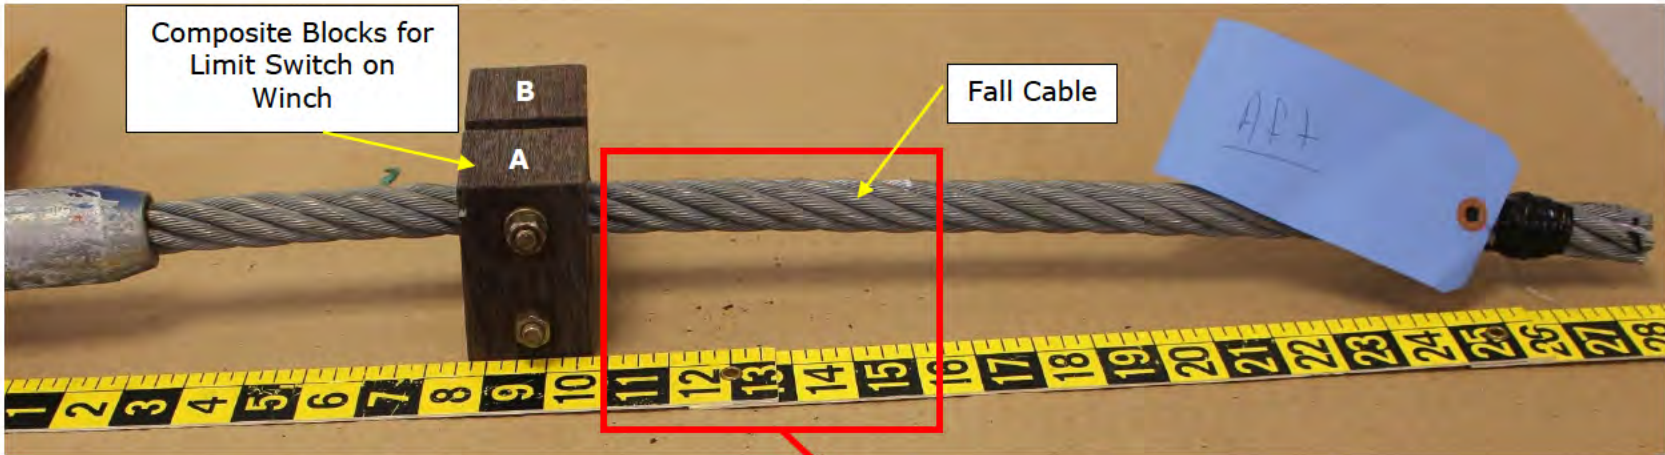
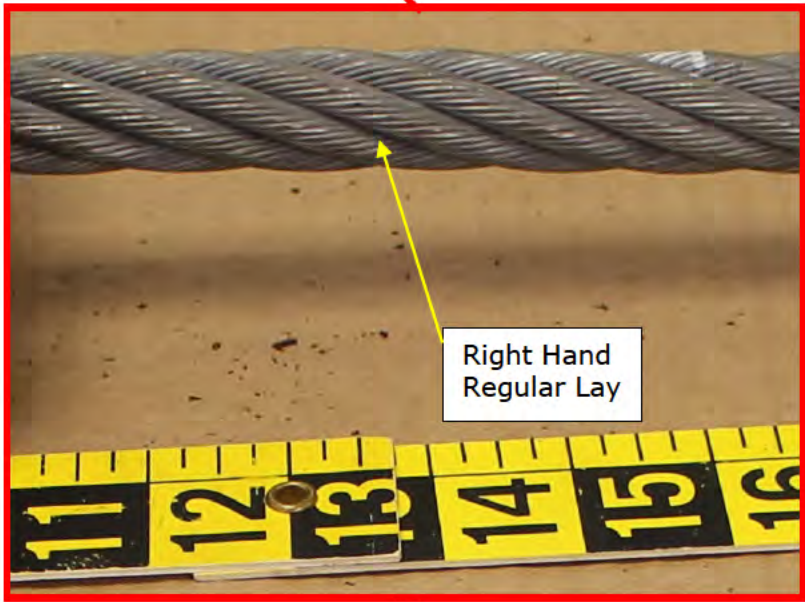
Figure 87. Photographs of (a) the Subject Aft Ring and (b) the section of the Subject Aft Fall Cable after removal from shipping container. Rulers are in inches.

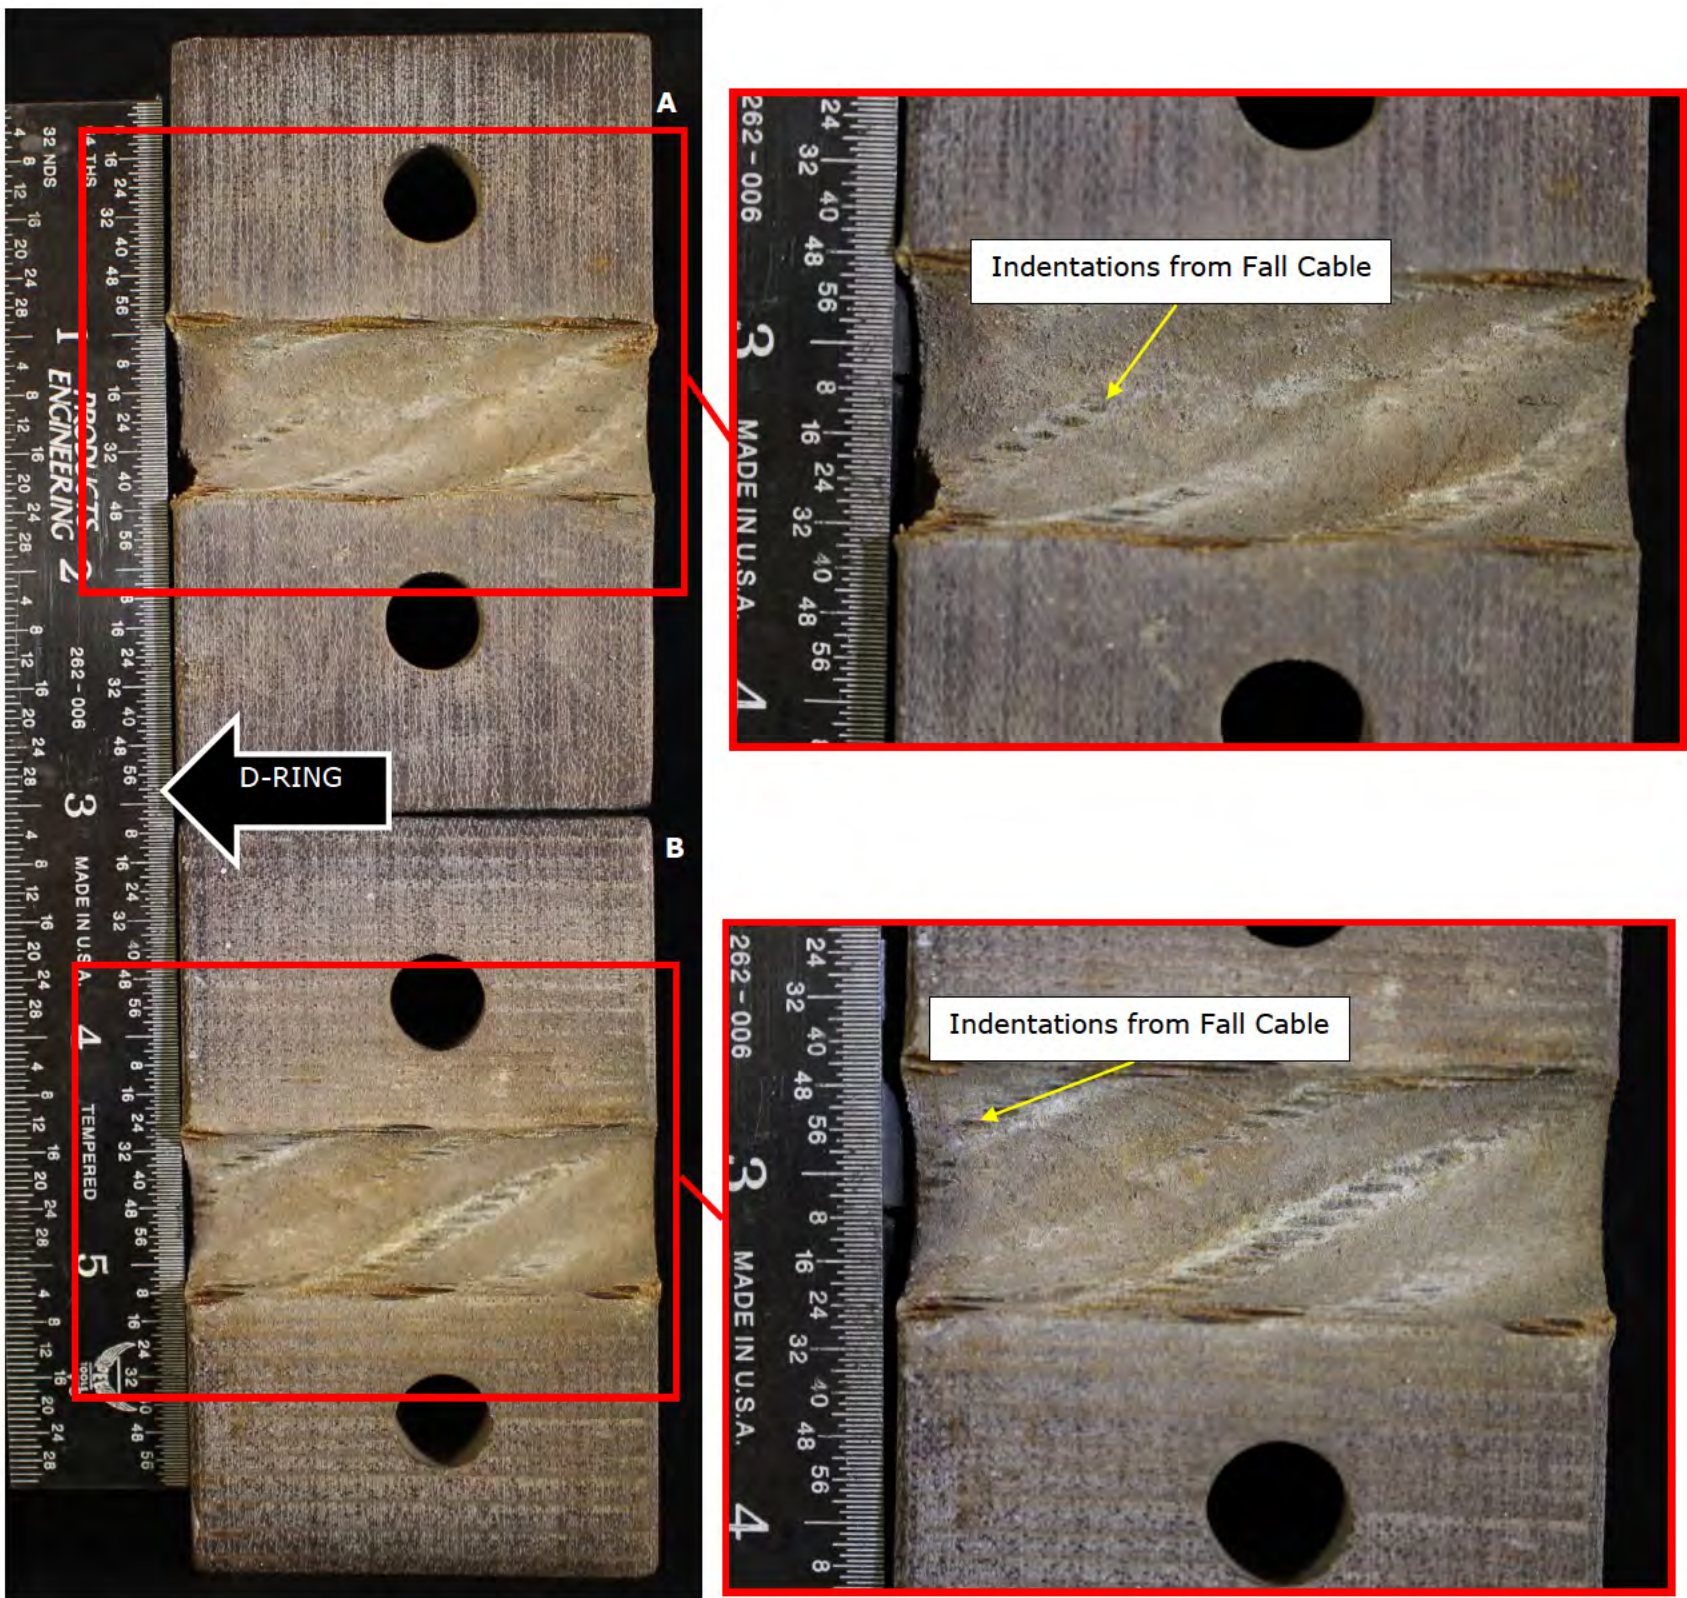
Figure 88. Photographs of composite block after removal from the section of the Subject Aft Fall Cable. The direction toward the Subject Aft Ring is shown. Rulers are in inches.

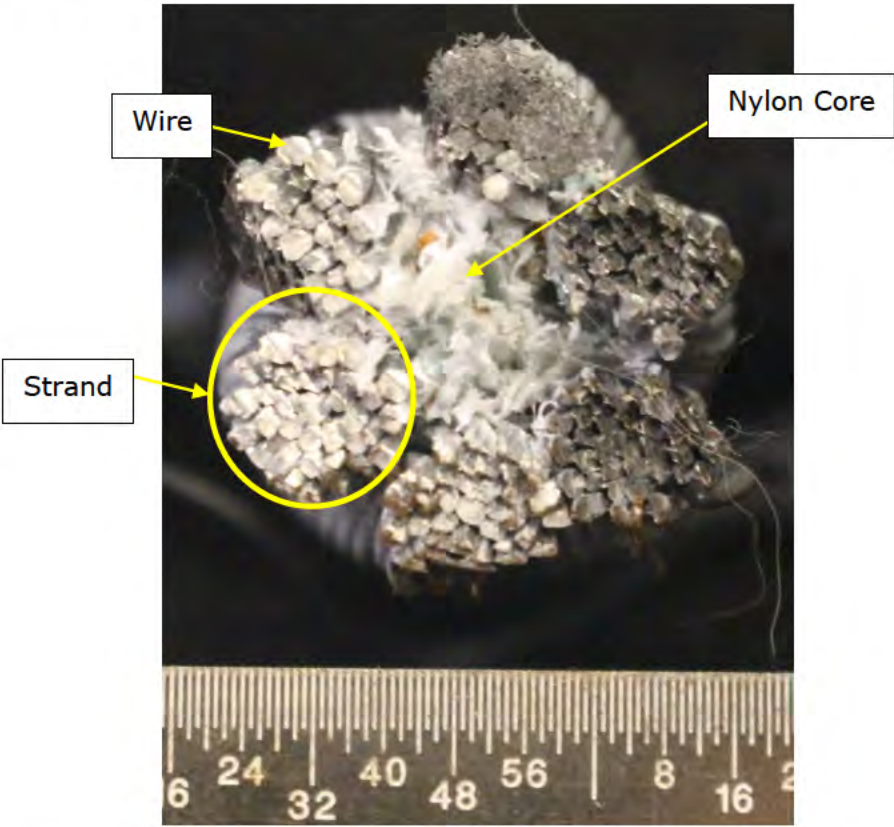
Figure 89 is a photograph of the cross-section of the Subject Aft Fall Cable. The wire rope is comprised of six strands of bundled metallic wires and a center core of nylon. There is no evidence of significant necking or failed wires along the length inspected.

Figure 89. Photograph showing the cross-section of the Subject Aft Fall Cable. Ruler is in inches.

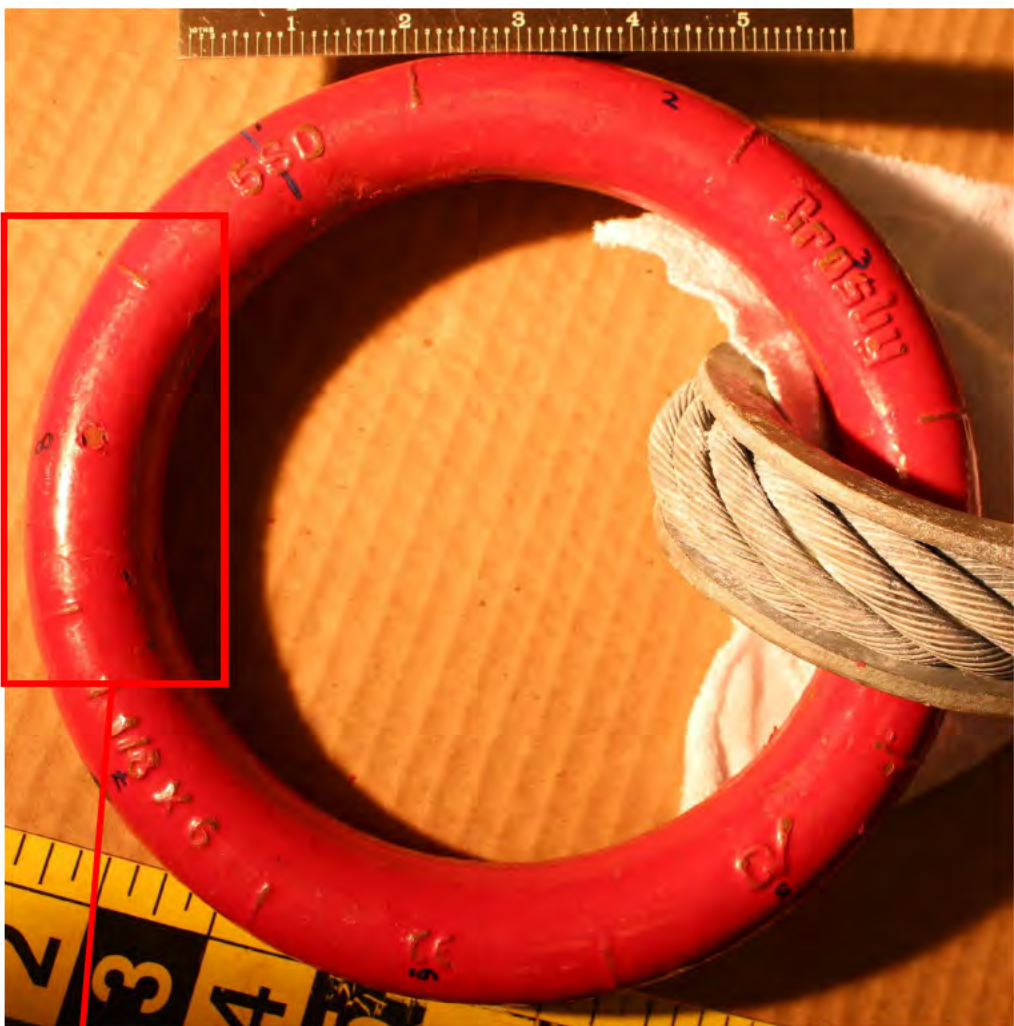
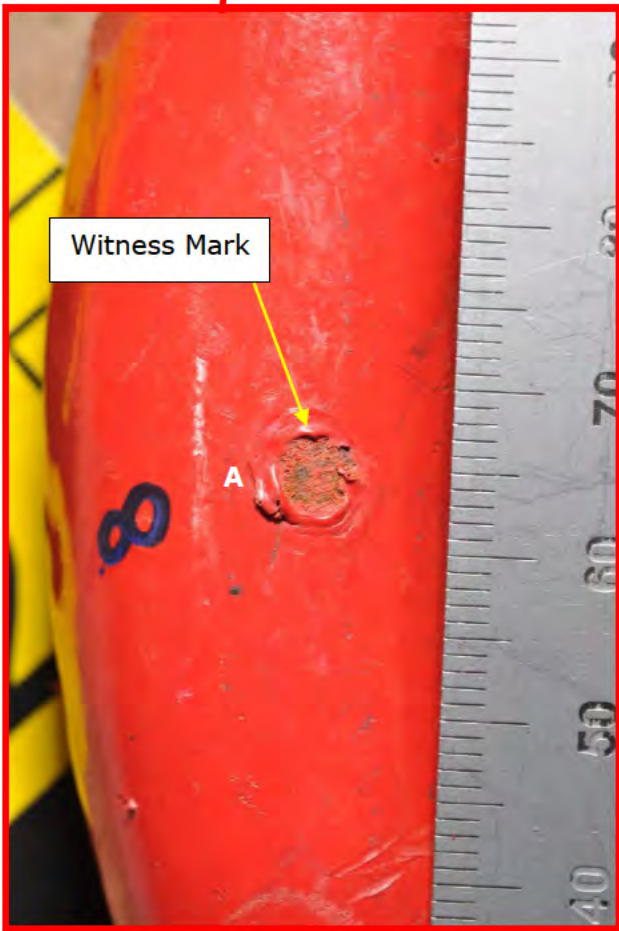
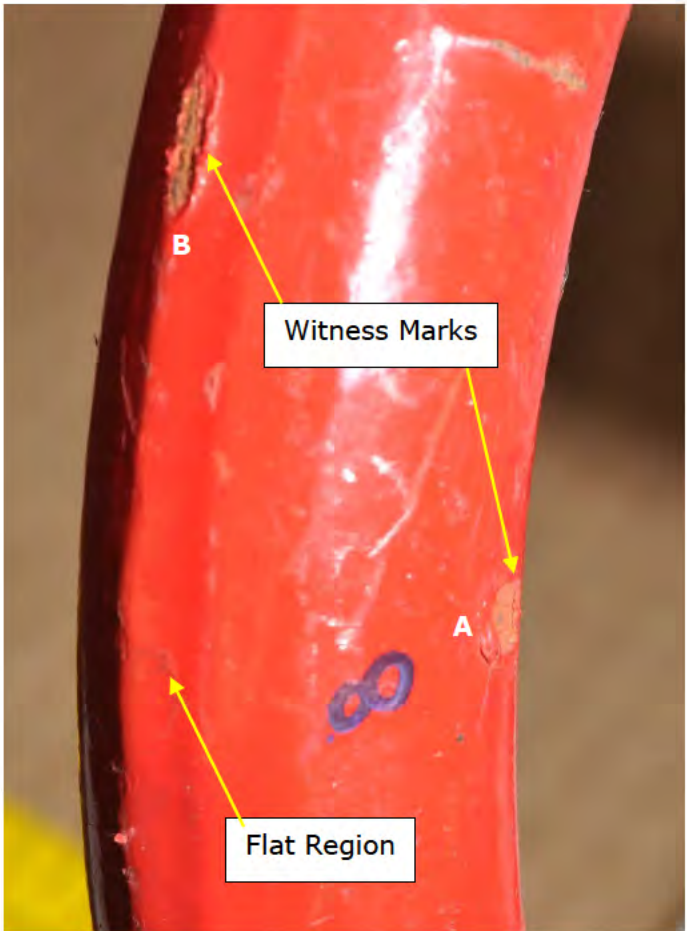
Figure 90. Photographs showing the Subject Aft Ring and locations where witness marks were identified. Ruler in top image is in inches and the ruler in the bottom image is in mm.

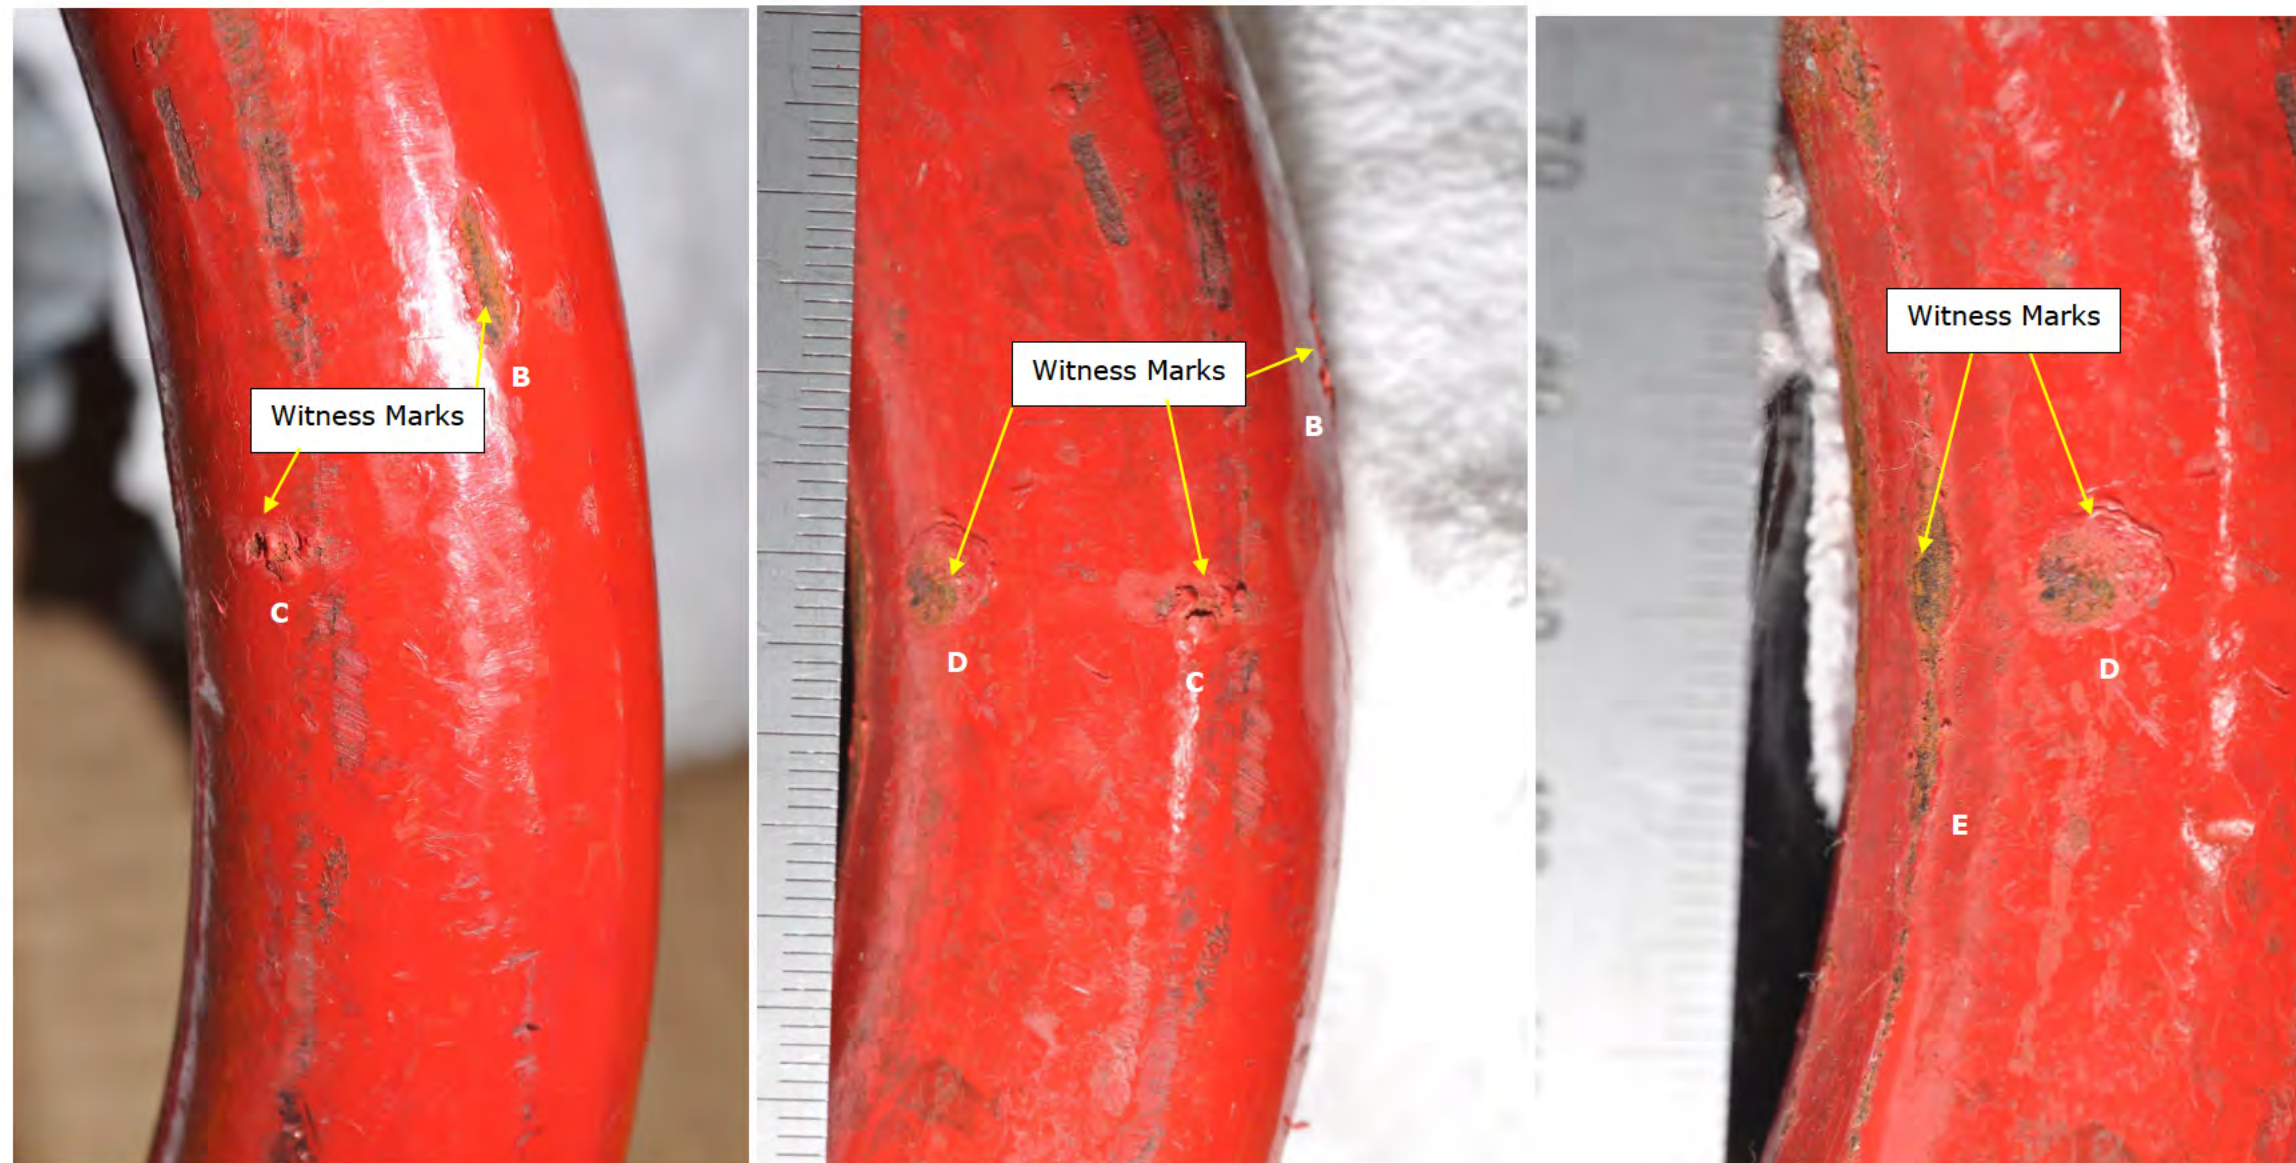
Figure 91. Photographs showing additional witness marks on the Subject Aft Ring; the location of witness mark "B" is shown in Figure 90. Ruler is in mm.

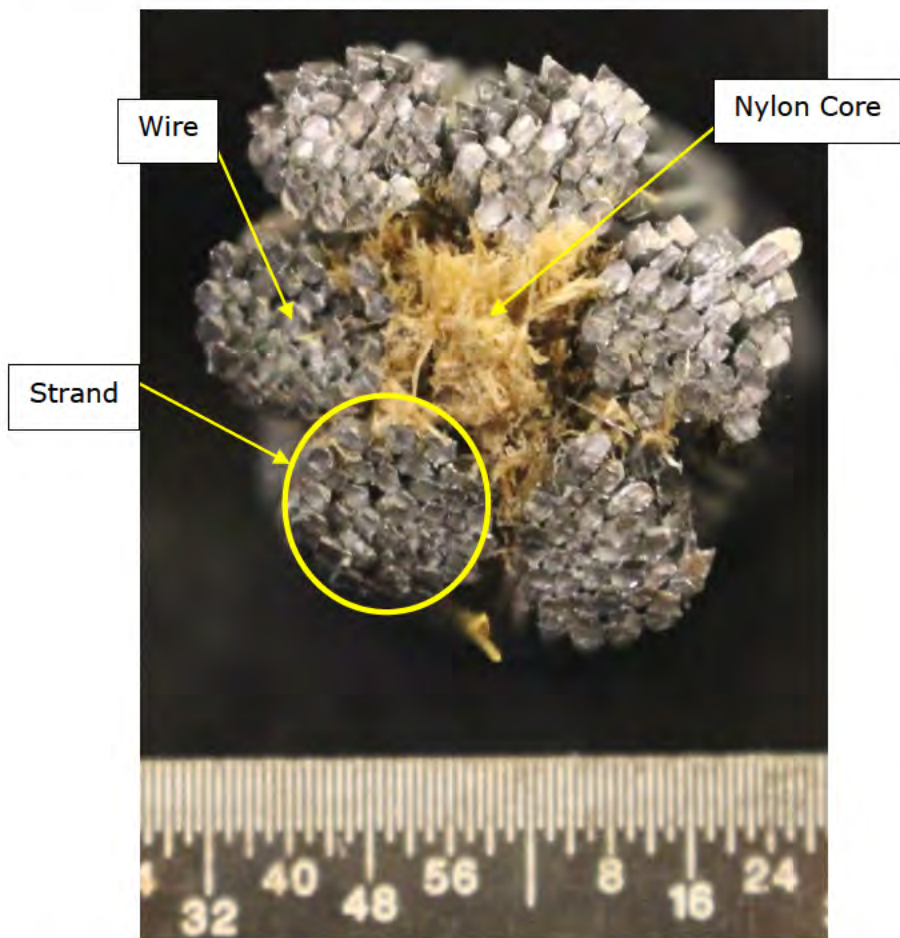
Figure 95. Photograph showing the cross-section of the Subject Forward Fall Cable. Ruler is in inches.

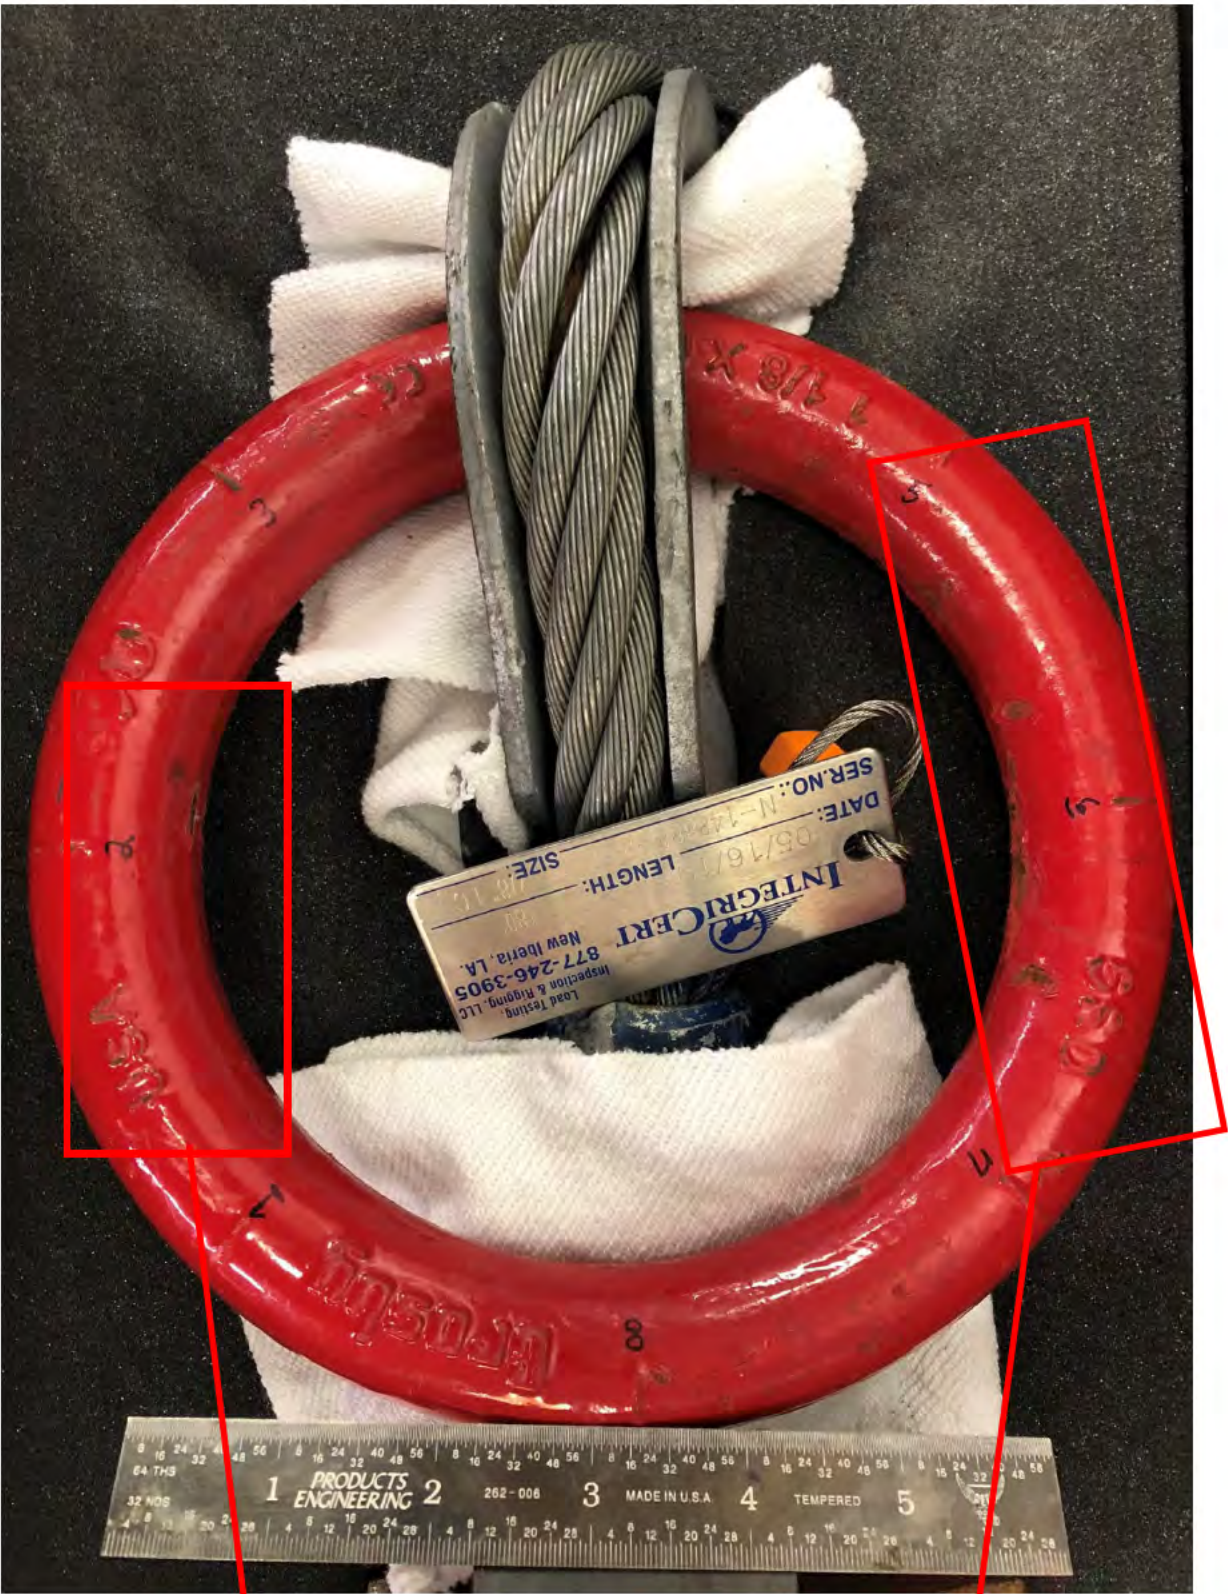
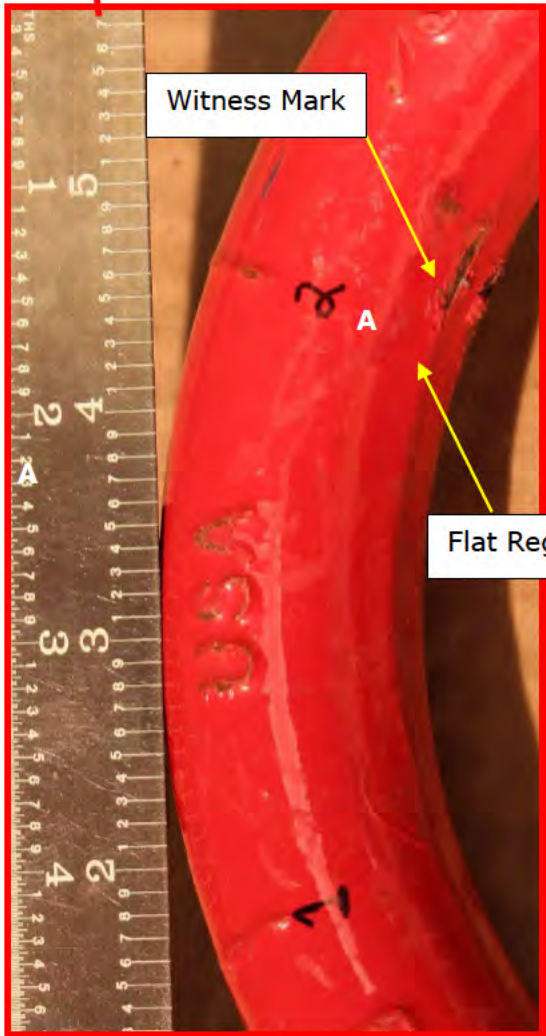
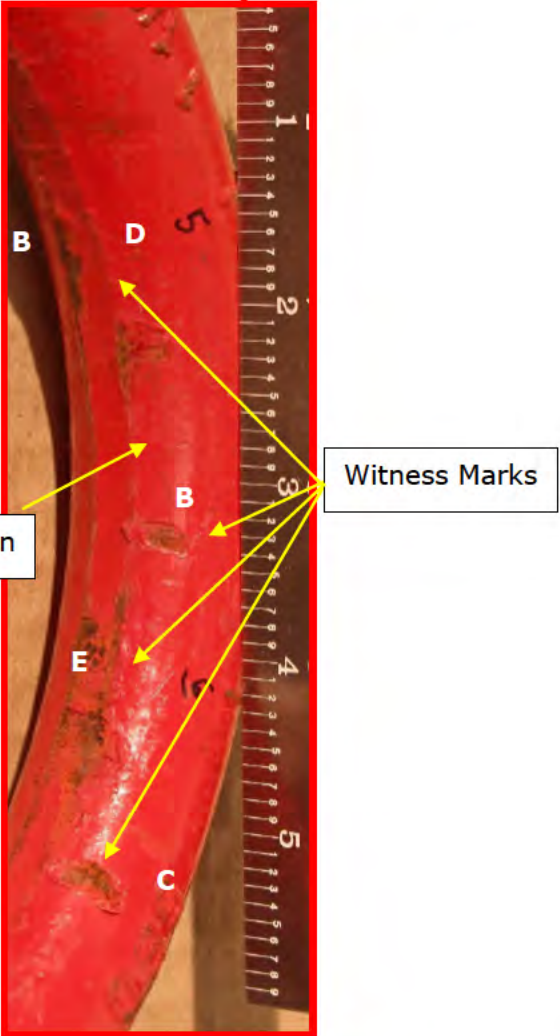
Figure 96. Photographs showing the Subject Forward Ring and locations where witness marks were identified. Rulers are in inches.
