Final Report

Auger Lifeboat 6 Incident

Shell Oil Company
Houston, Texas, USA

Report No.: O-AP-FINV / BPADG (10165575)
July 9, 2020

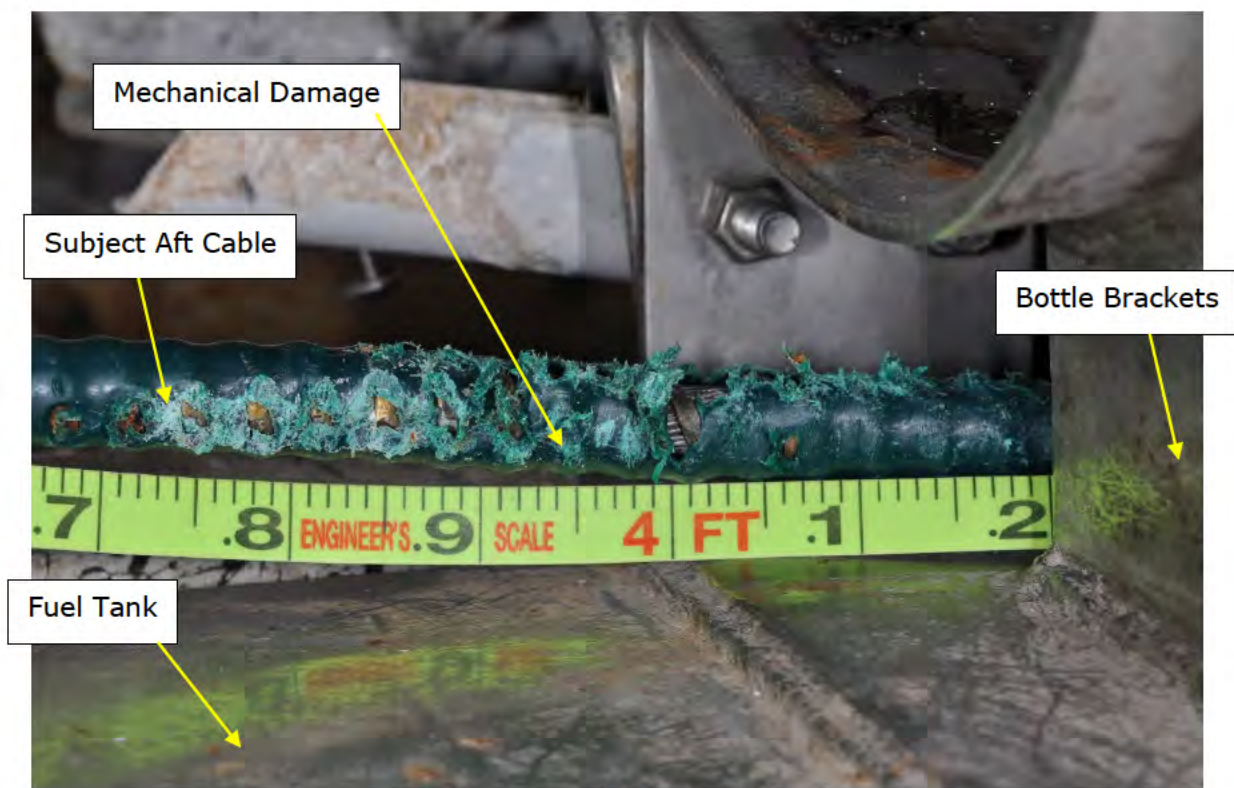
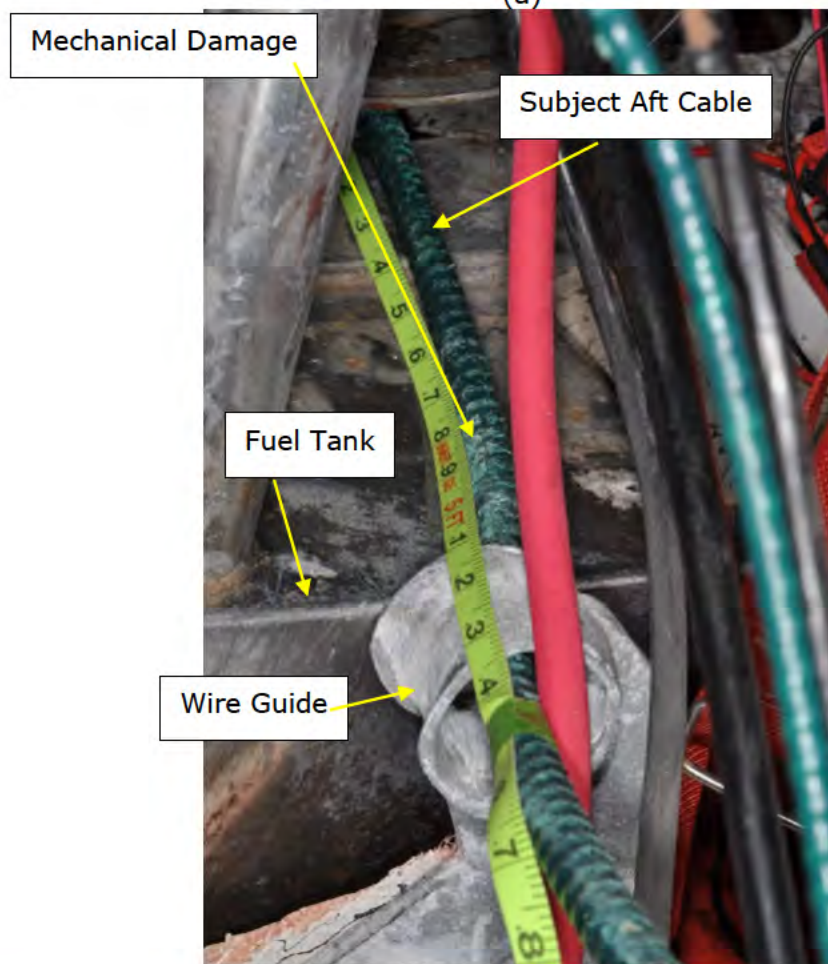
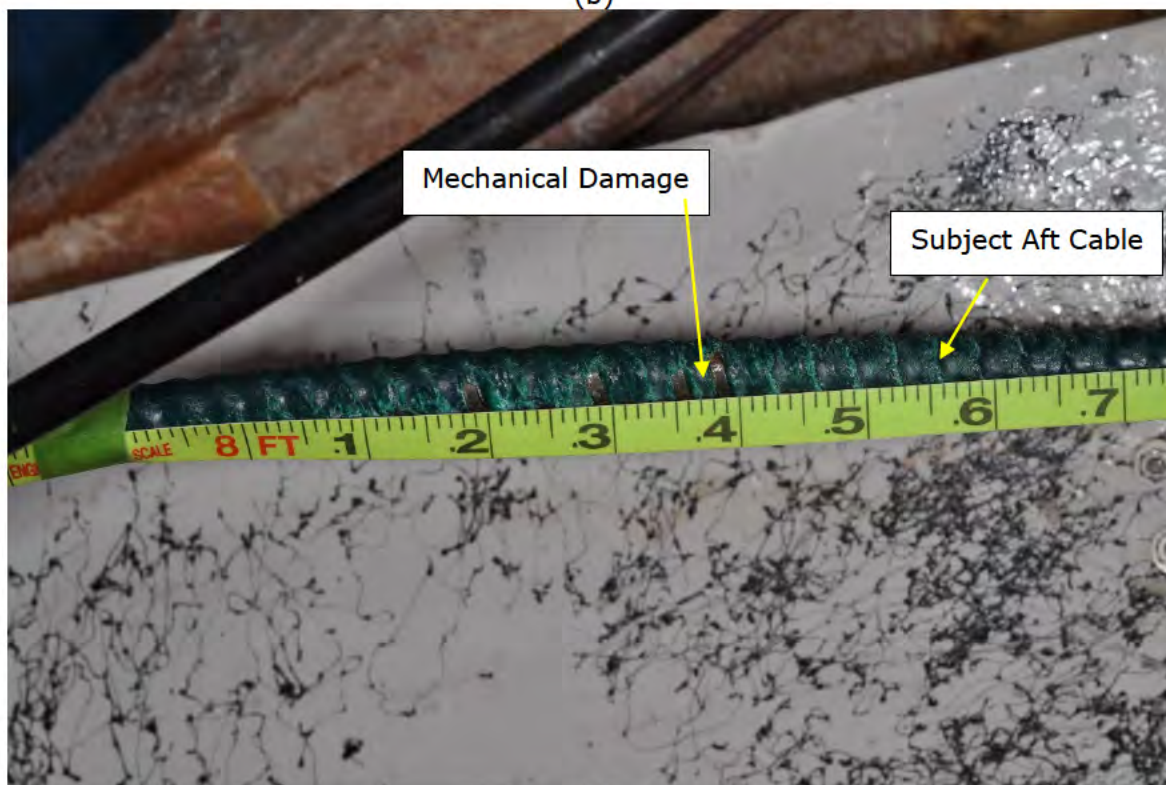
Figure 103. Photographs showing mechanical damage to the cover of the Subject Aft Cable (a) 3.70 feet to 4.10 feet, (b) 4.70 feet to 5.70 feet, and (c) 8.10 feet to 8.60 feet from the conduit cap at the Subject Release Unit. These photographs were taken by DNV GL during a site visit to Harvey Terminal on July 31, 2019. Tape measures are in feet.

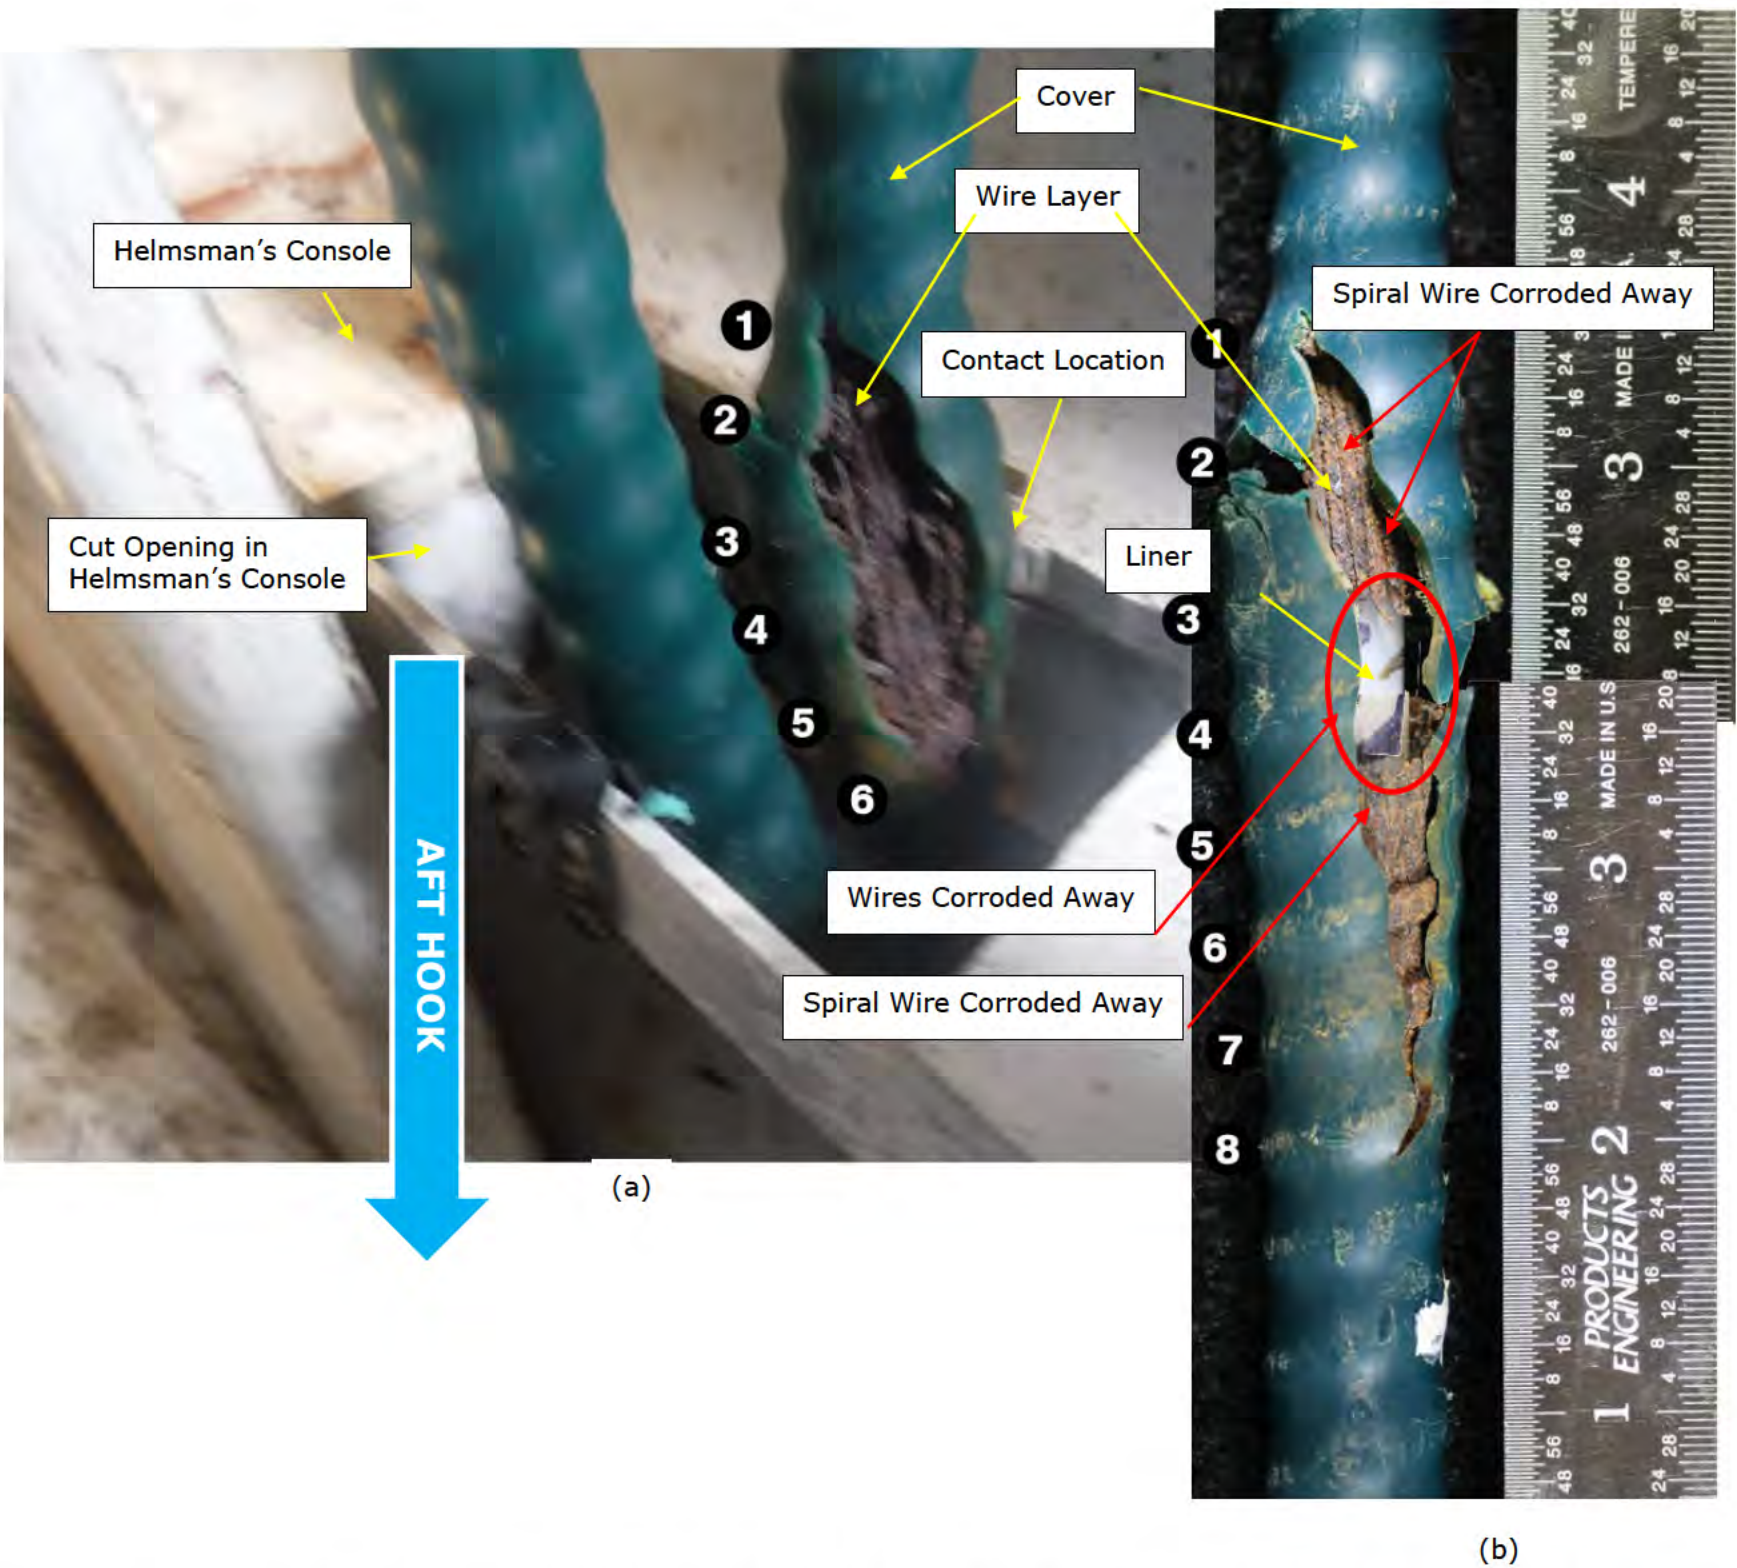
Figure 107. Photograph and montage of photographs of the Subject Aft Cable (a) taken in the field on June 6, 2019 by Palfinger and (b) taken in the laboratory by DNV GL, respectively. For the montage, the fracture surfaces of the cover were matched to generate an image similar to the photograph shown in Figure 107 (a). The numbers in Figure 107 (a) and (b) are corresponding locations along the length the control cable. The direction of the Subject Aft Hook is noted with the blue arrow. Ruler is in inches.

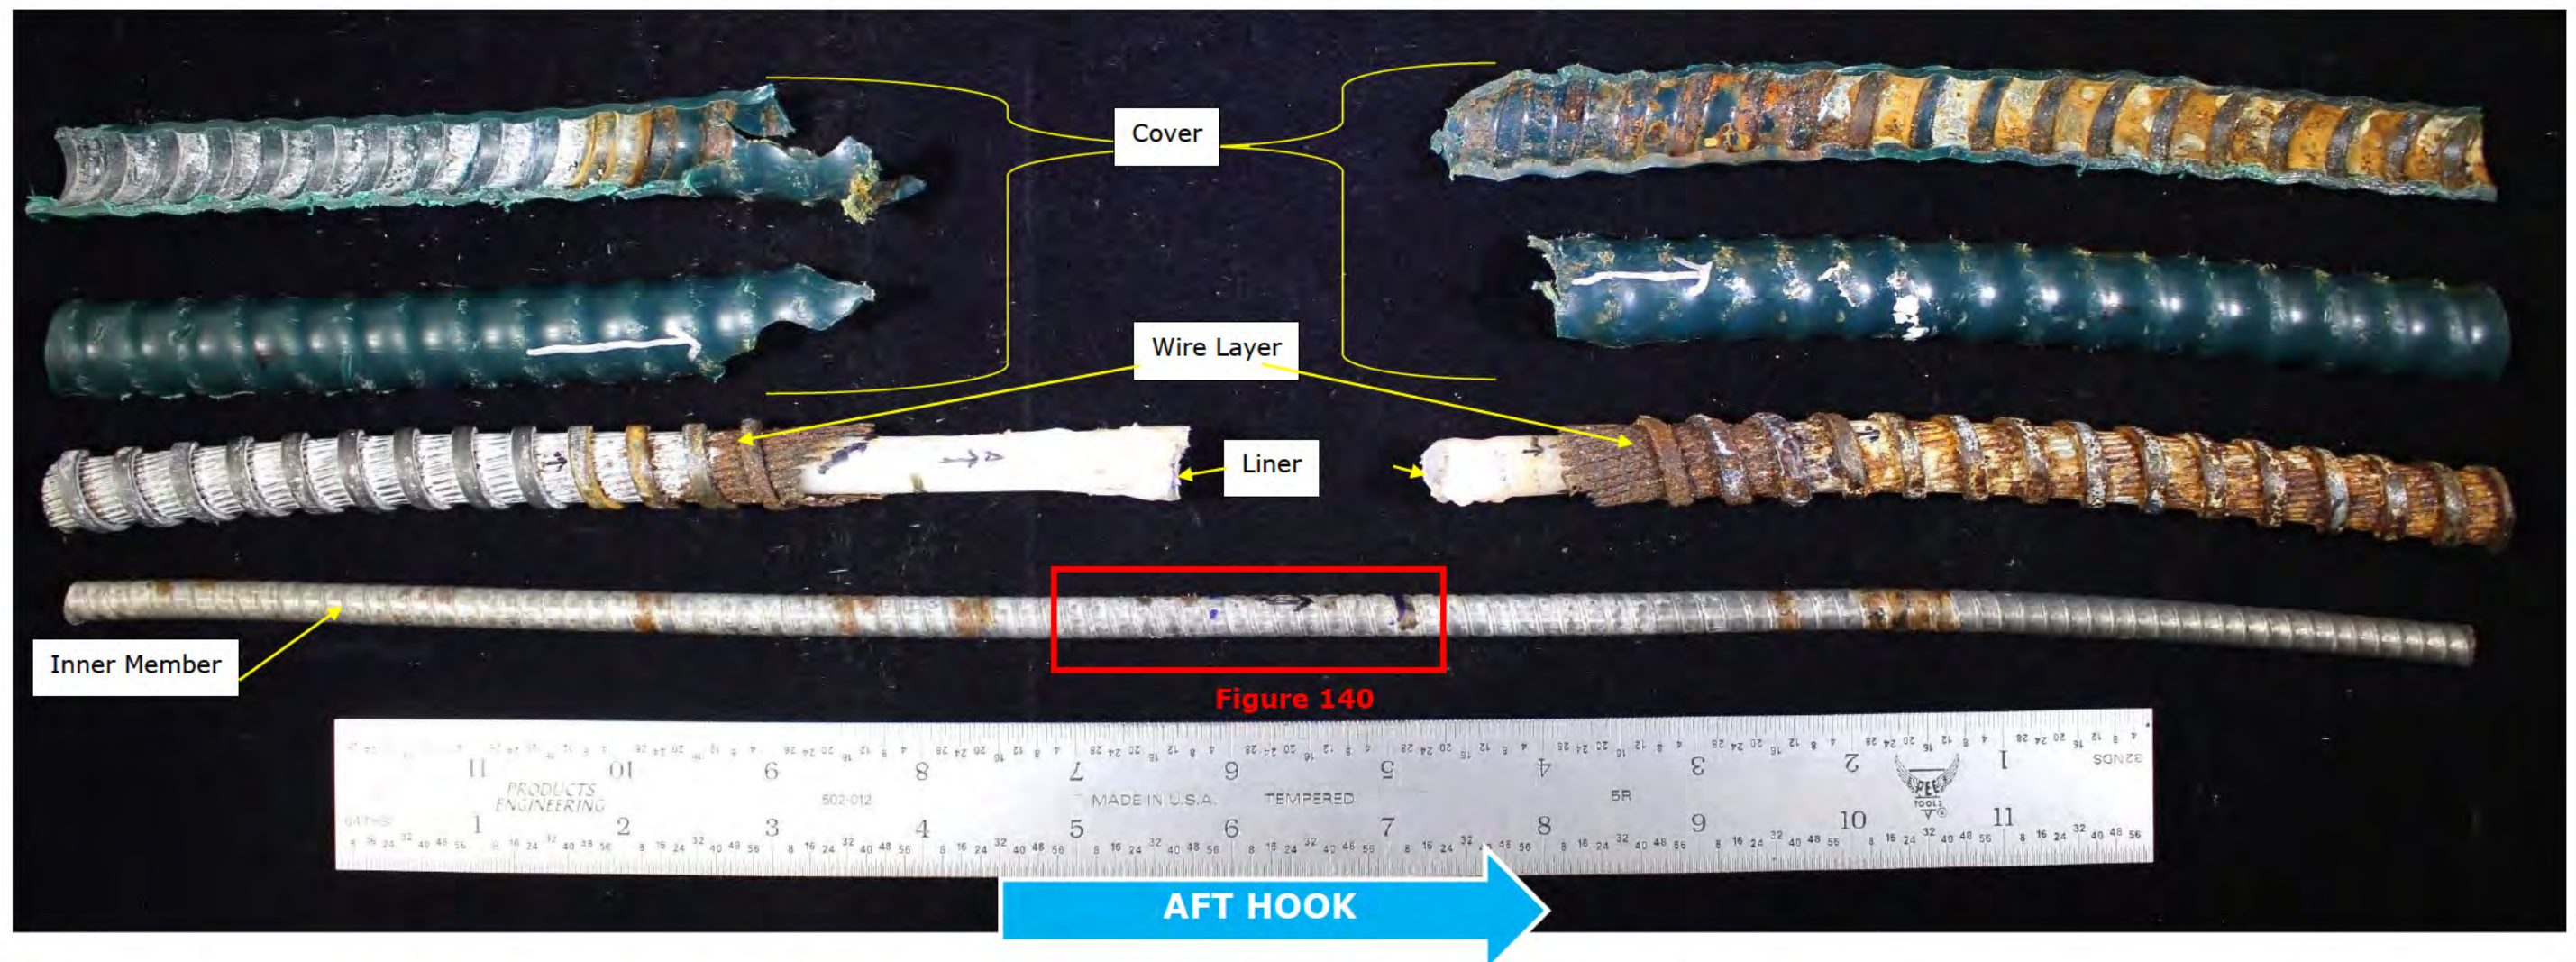
Figure 108. Photograph of the Subject Aft Cable showing the layers of the control cable after dissection near the location of failure. The direction of the Subject Aft Hook is noted with the blue arrow. Ruler is in inches.

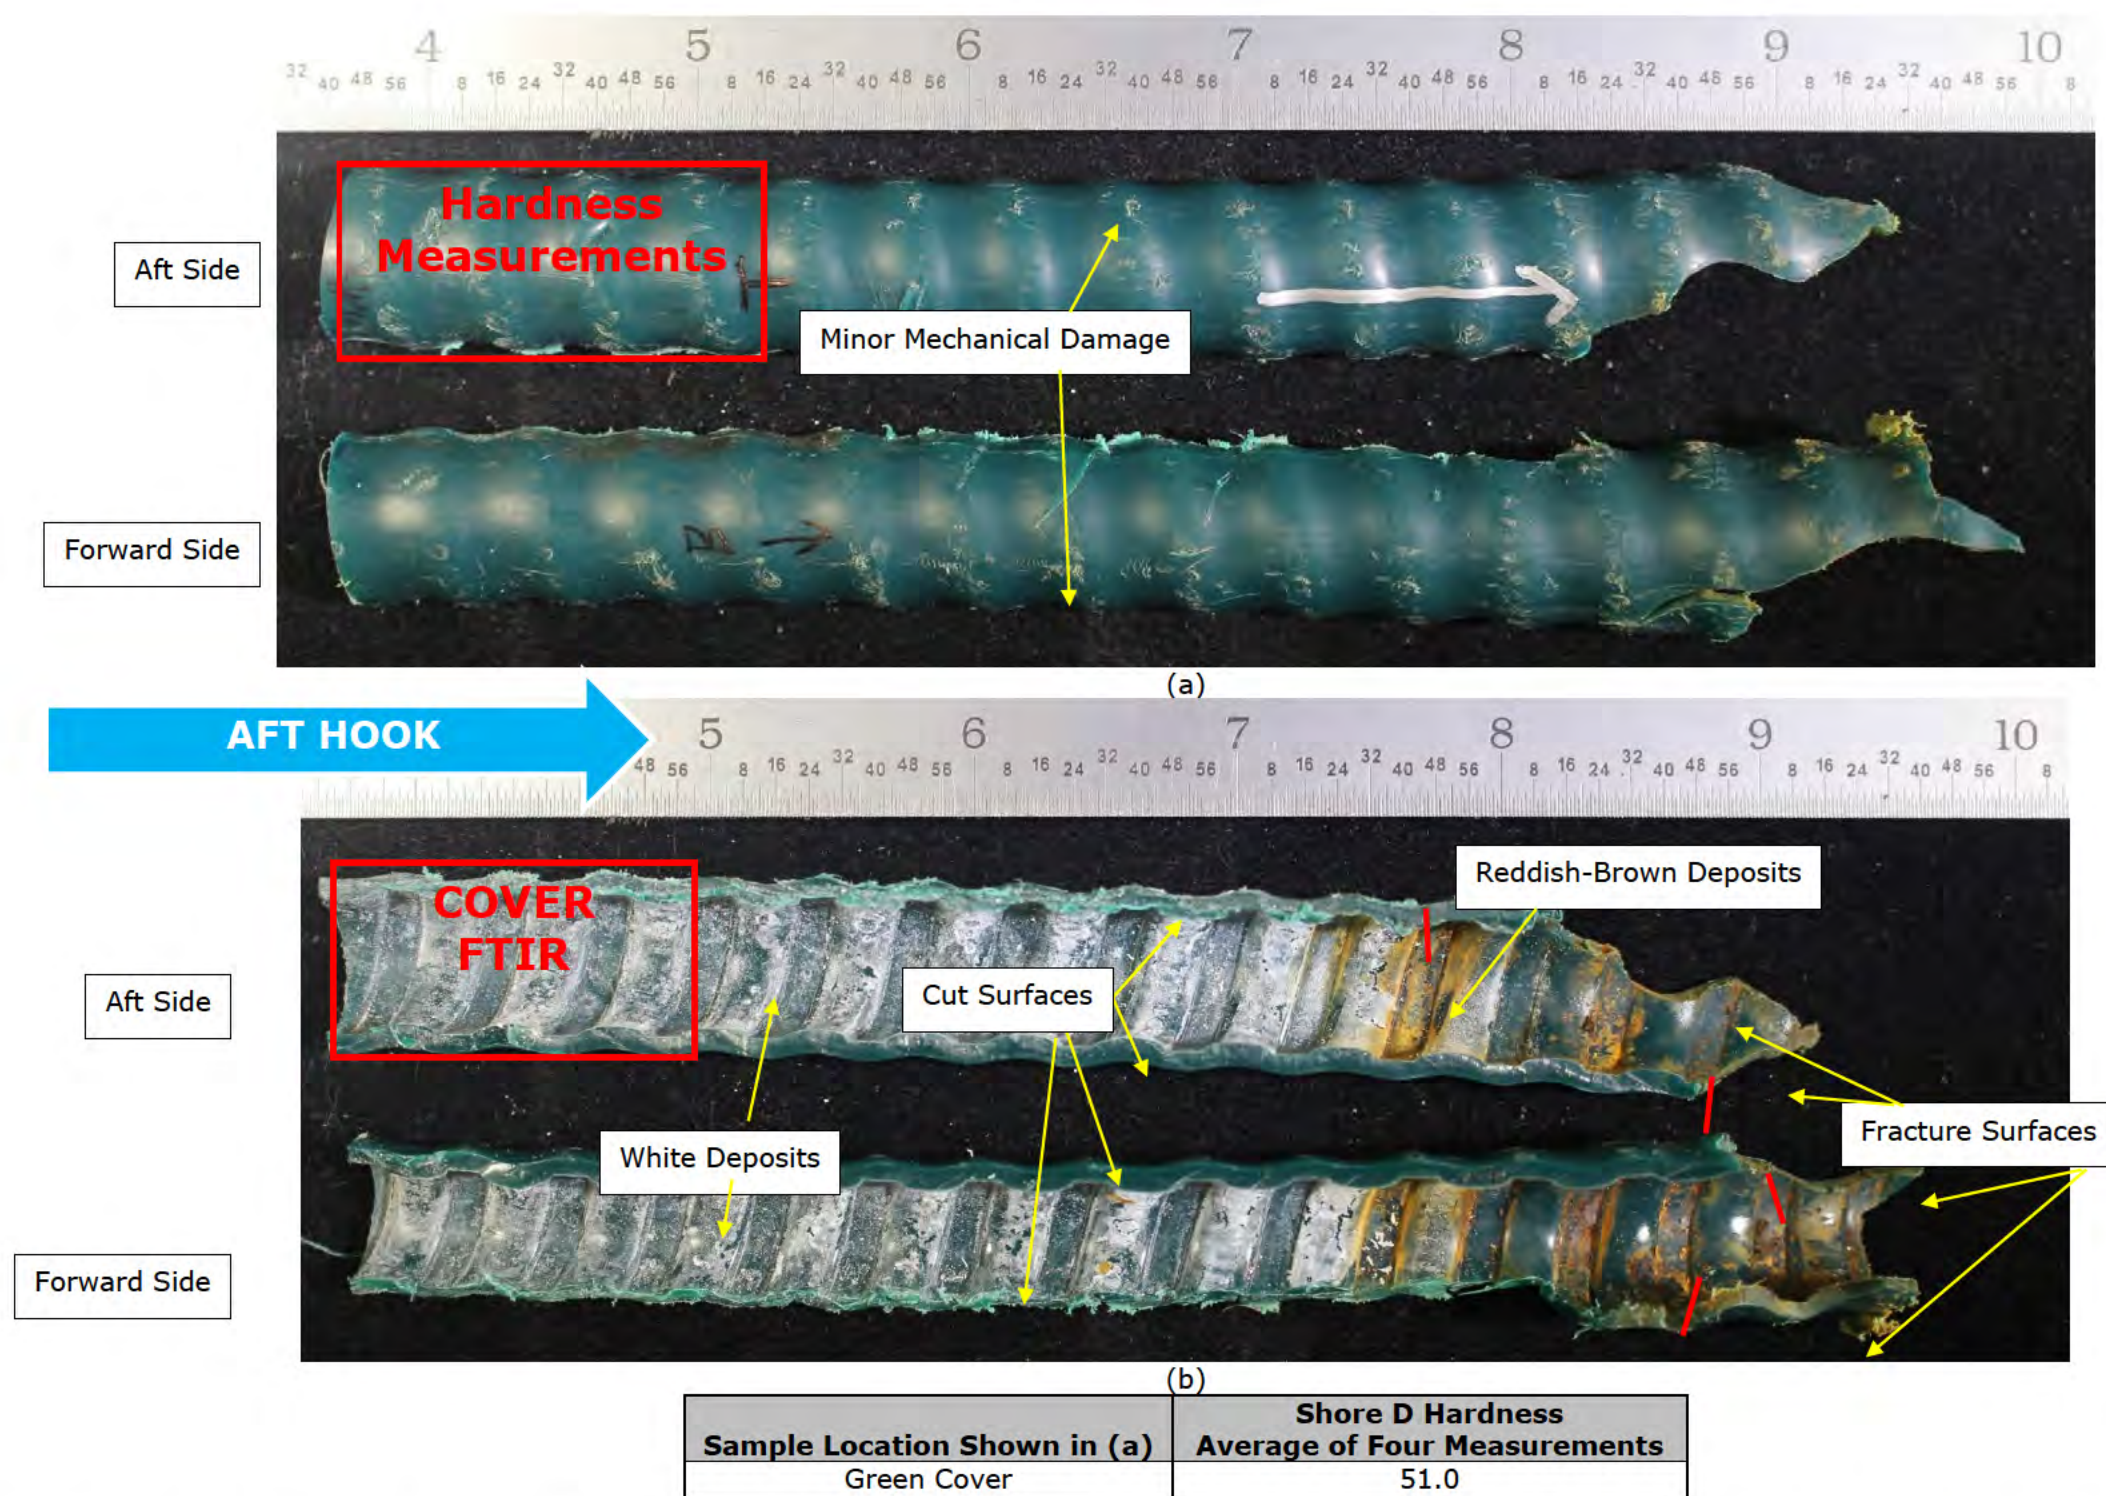
Figure 109. Photographs of the cover from the Subject Release Unit side of the failure in the Subject Aft Cable after dissection showing the (a) external surface and (b) internal surface; samples shown in Figure 108. Forward and aft refer to the orientation of the cover relative to the lifeboat. The direction of the Subject Aft Hook is noted with the blue arrow. Results of hardness measurements shown in table. Ruler is in inches.

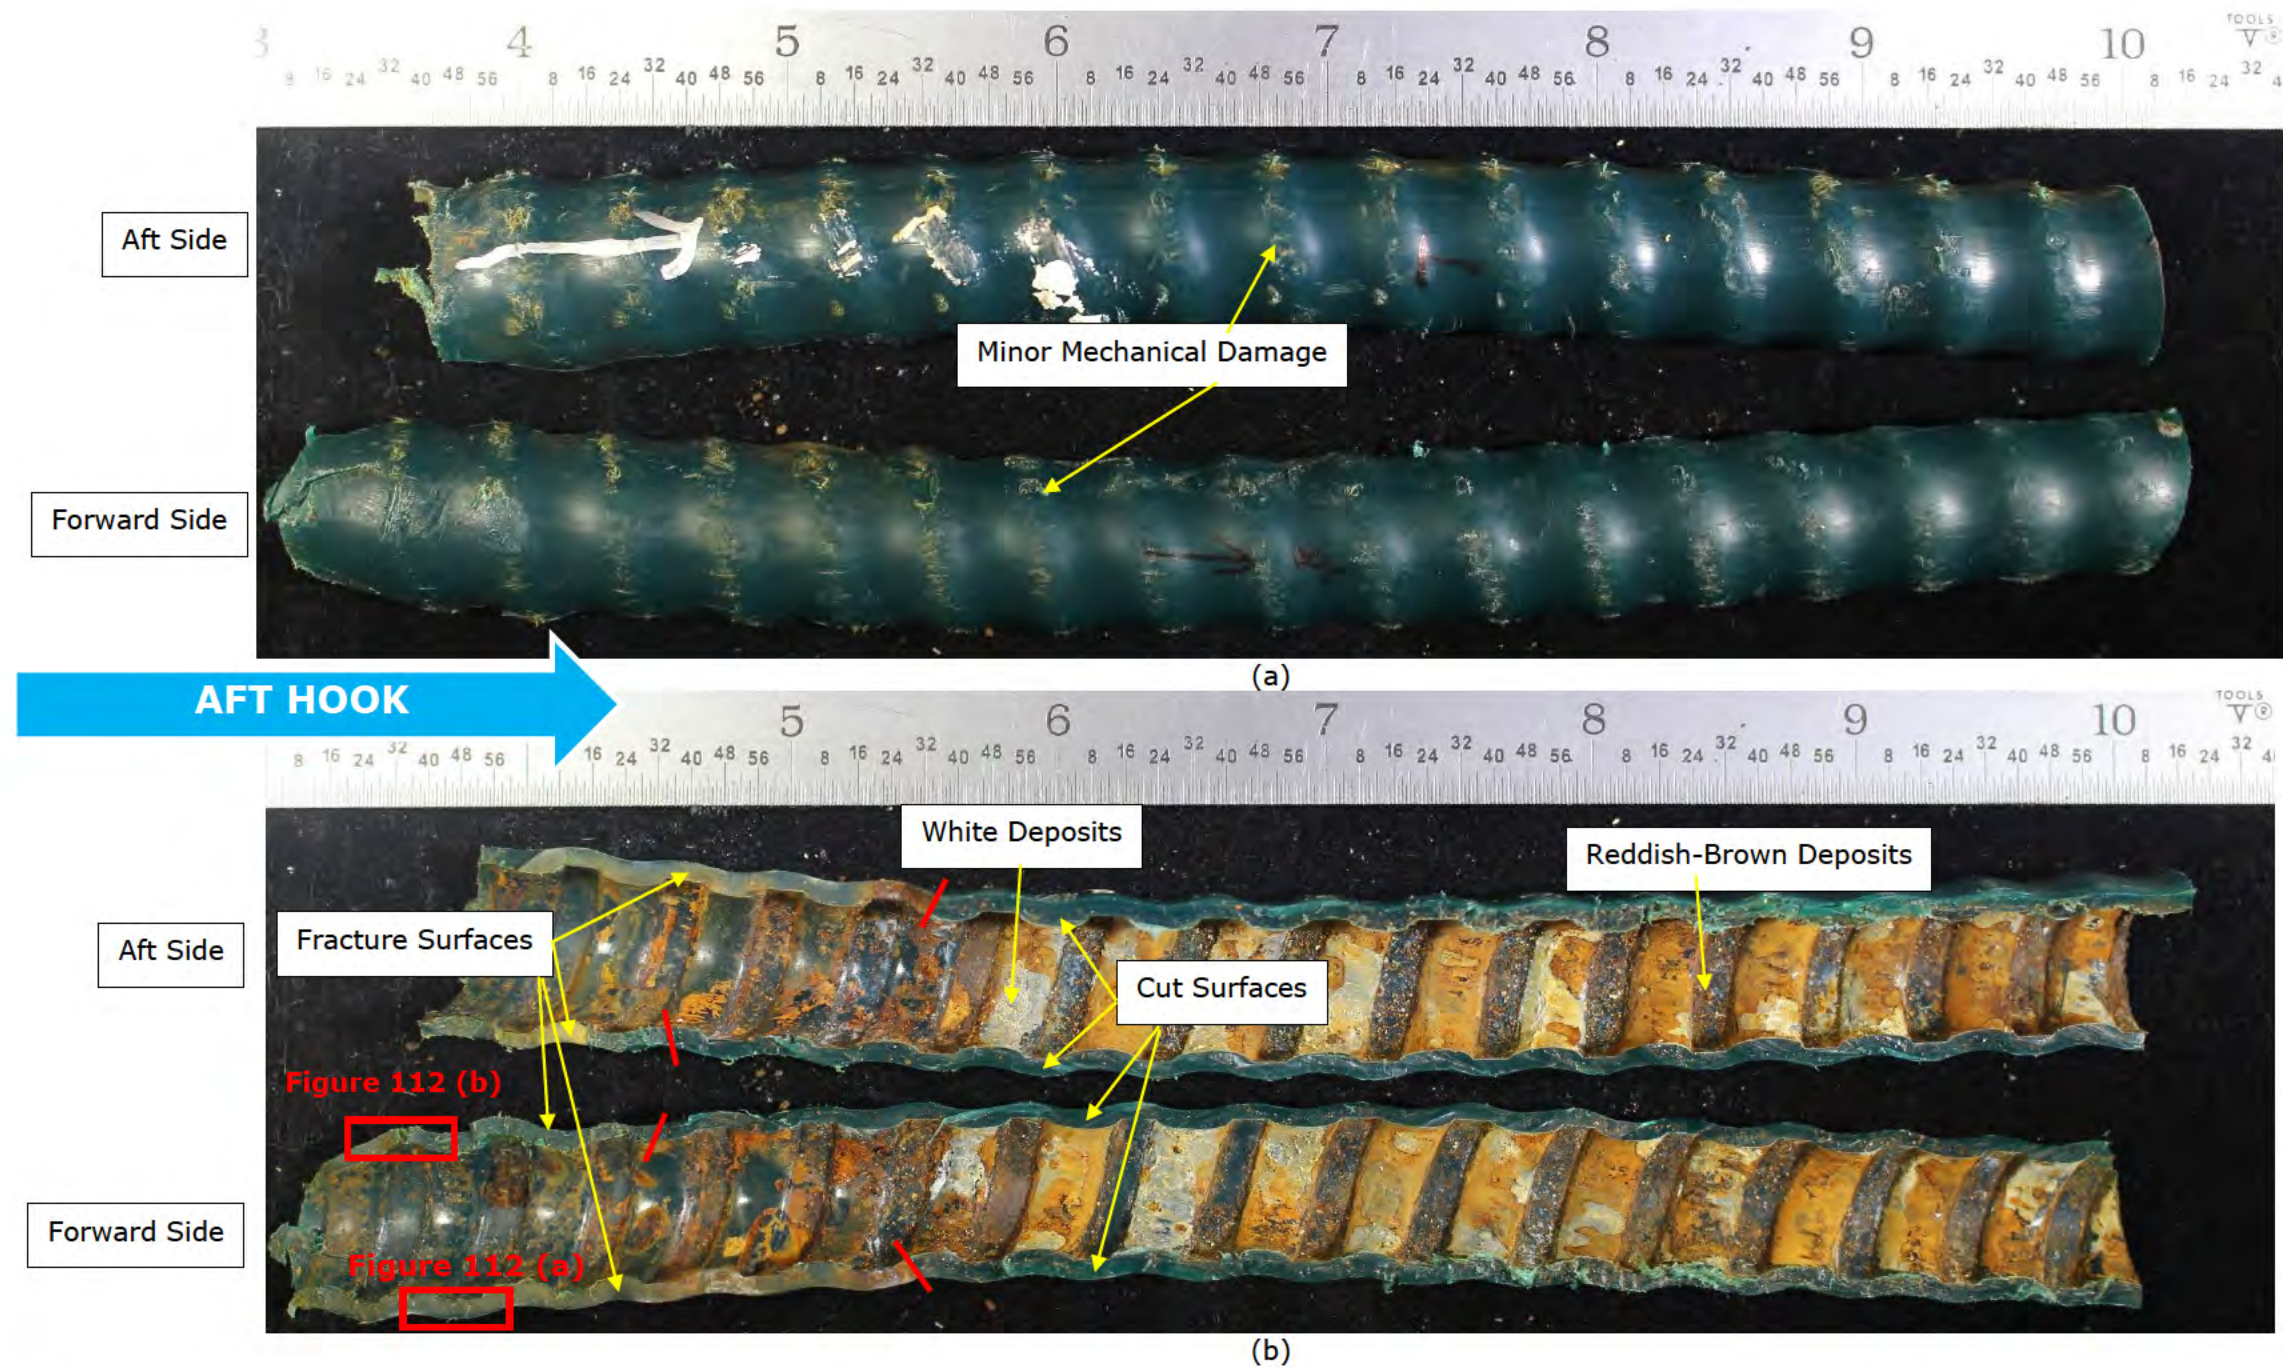
Figure 110. Photographs of the cover from the Subject Aft Hook side of the failure in the Subject Aft Cable after dissection showing the (a) external surface and (b) internal surface; samples shown in Figure 108. Forward and aft refer to the orientation of the cover relative to the lifeboat. The direction of the Subject Aft Hook is noted with the blue arrow. Ruler is in inches.

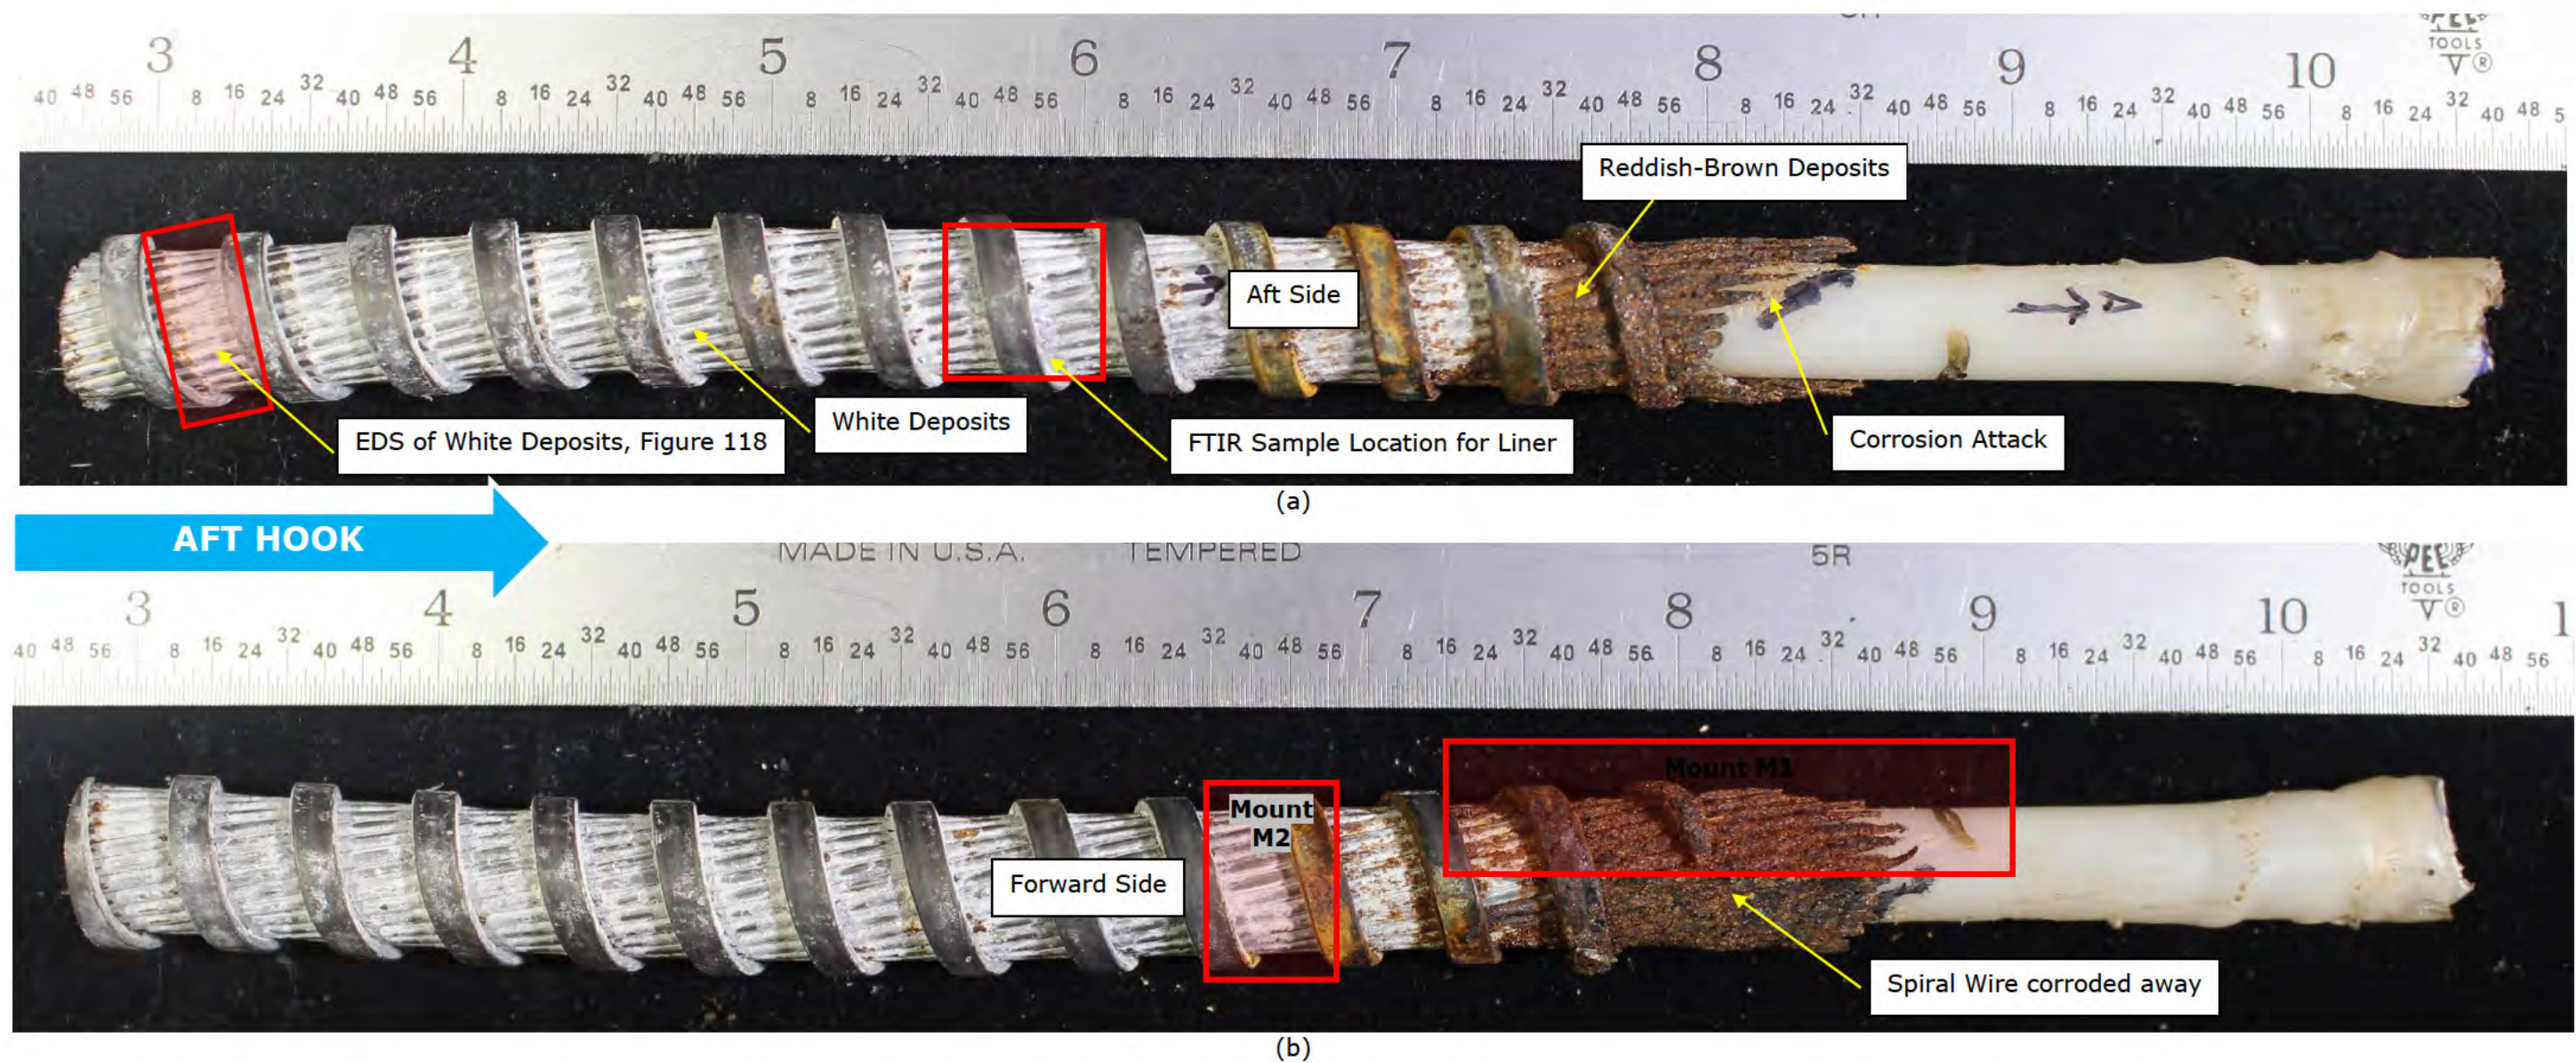
Figure 114. Photographs of the wire layer from the Subject Release Unit side of the failure in the Subject Aft Cable after dissection showing the (a) aft side and (b) forward side; samples shown in Figure 108. Forward and aft refer to the orientation of the keeper relative to the lifeboat. The direction of the Subject Aft Hook is noted with the blue arrow. Rulers are in inches.

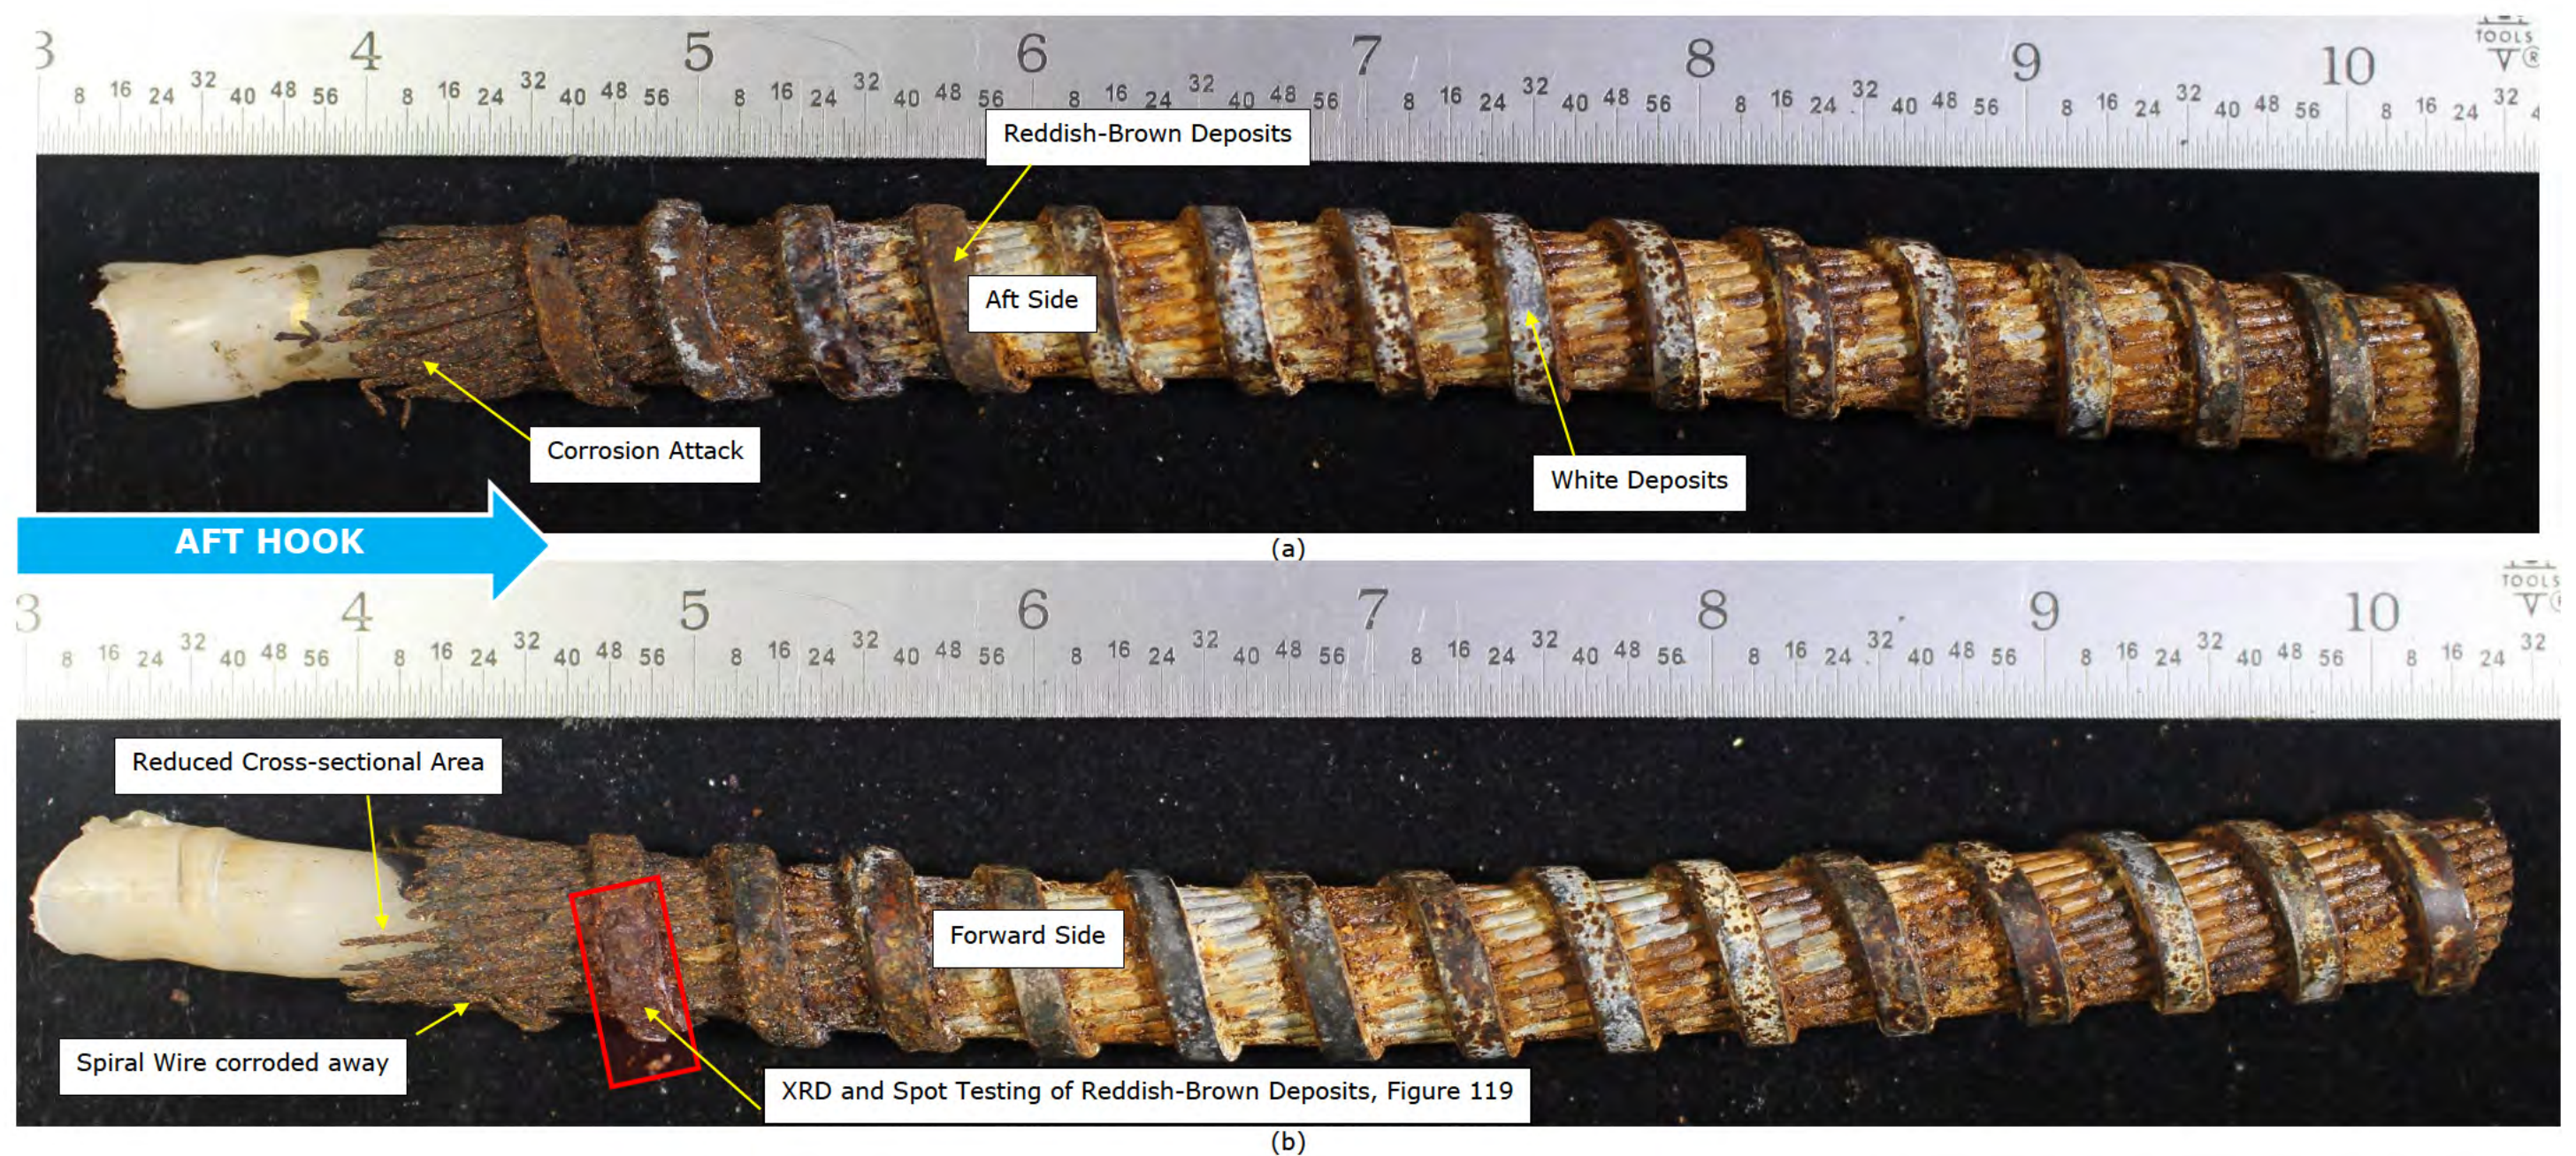
| Deposits | Sulfides | Carbonates |
| Reddish-Brown from Wire Layer | N | N |

Figure 115. Photographs of the wire layer from the Subject Aft Hook side of the failure in the Subject Aft Cable after dissection showing the (a) aft side and (b) forward side; samples shown in Figure 108. The direction of the Subject Aft Hook is noted with the blue arrow. Forward and aft refer to the orientation of the keeper relative to the lifeboat. Rulers are in inches.

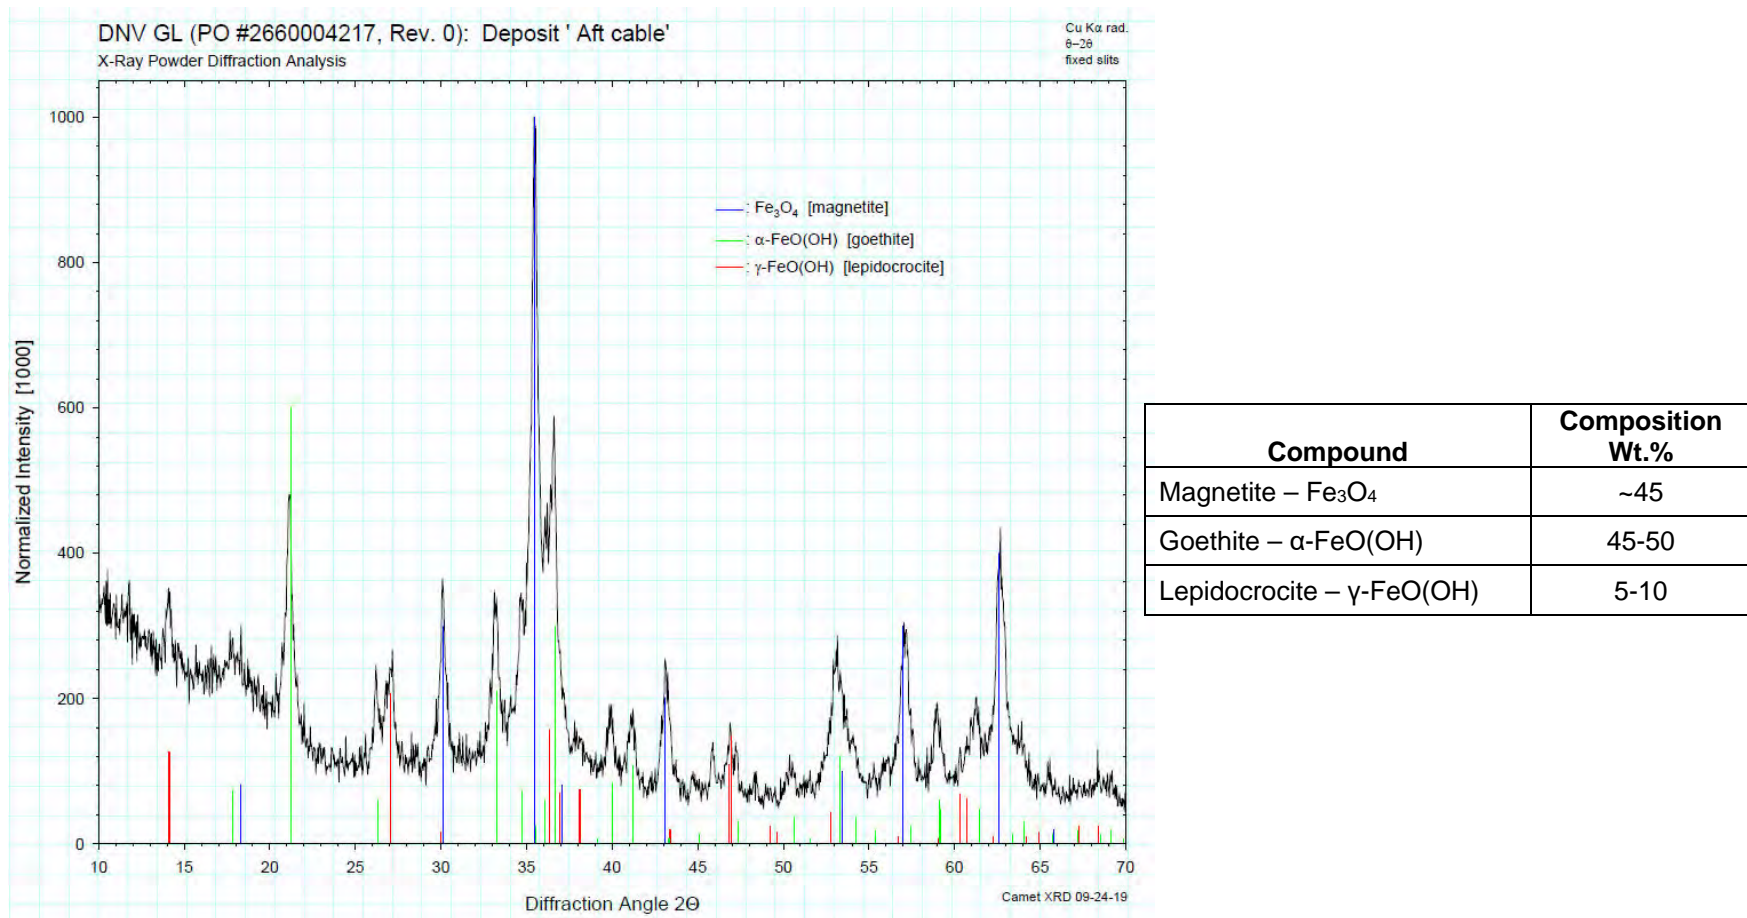
Figure 119. Spectrum and table summarizing the results of an XRD analysis performed on reddish-brown deposits that were removed from the wire layer of Subject Aft Cable near the failure; location shown in Figure 115.
