Final Report

Auger Lifeboat 6 Incident

Shell Oil Company
Houston, Texas, USA

Report No.: O-AP-FINV / BPADG (10165575)
July 9, 2020

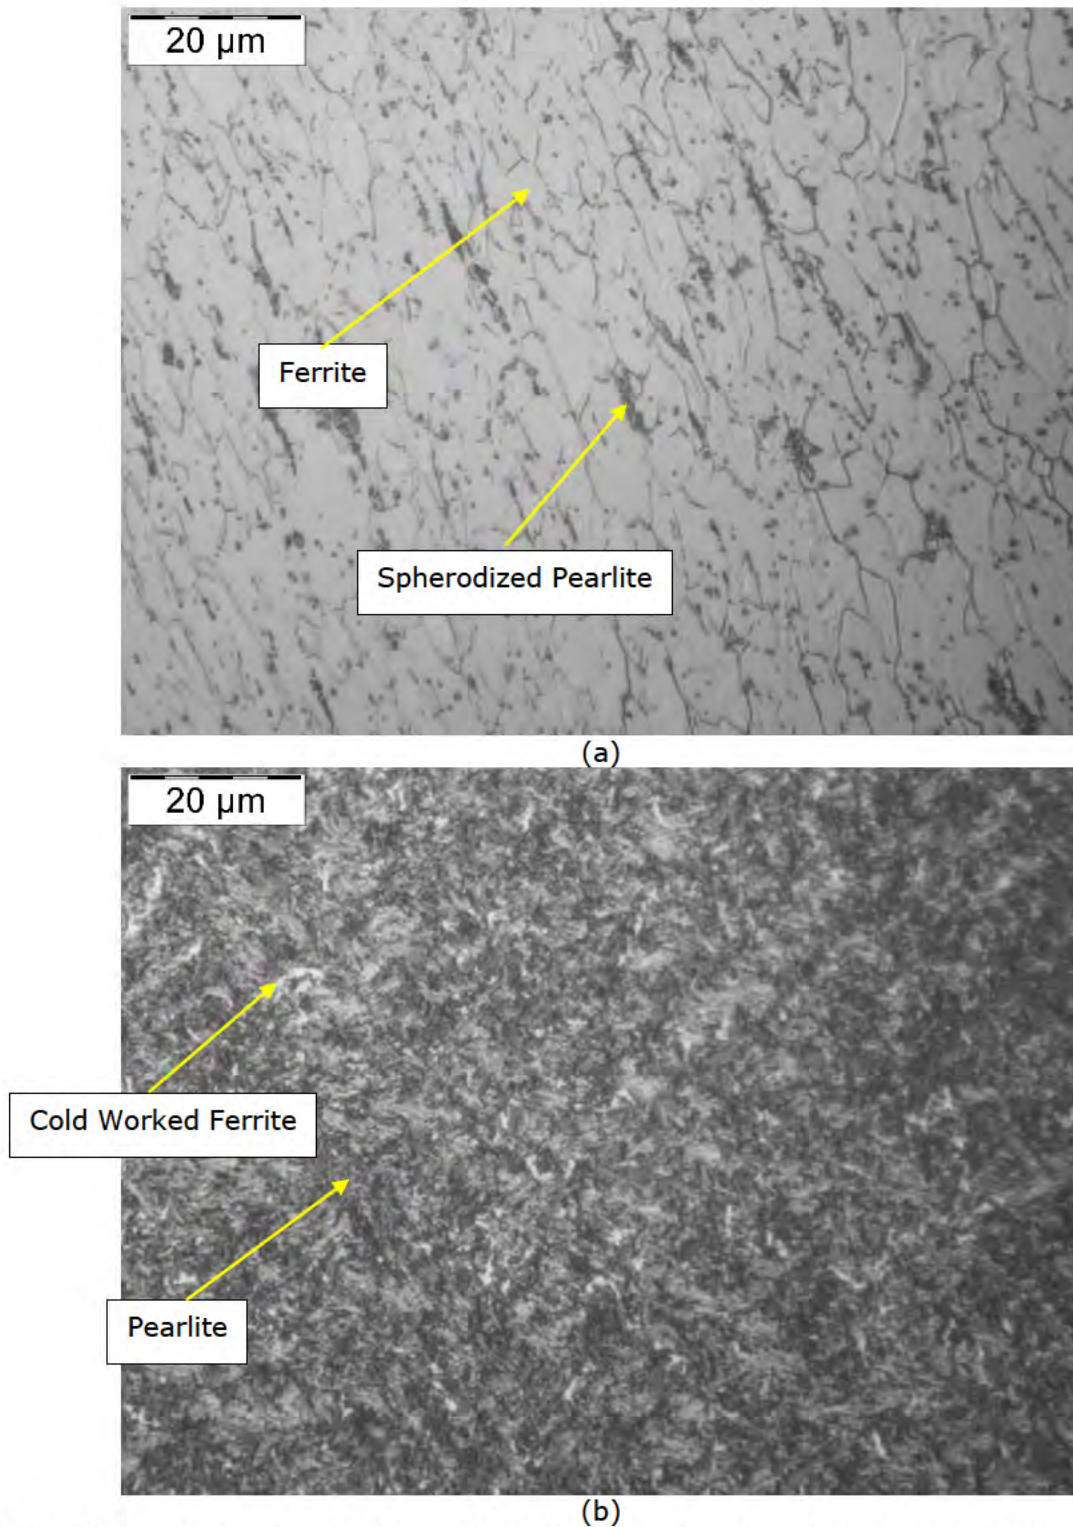
Figure 123. Photomicrographs of Mount M2 showing the microstructure of the (a) binder wire and (b) strand wires from the wire layer of the Subject Aft Cable in the transverse orientation; locations shown in Figure 122.

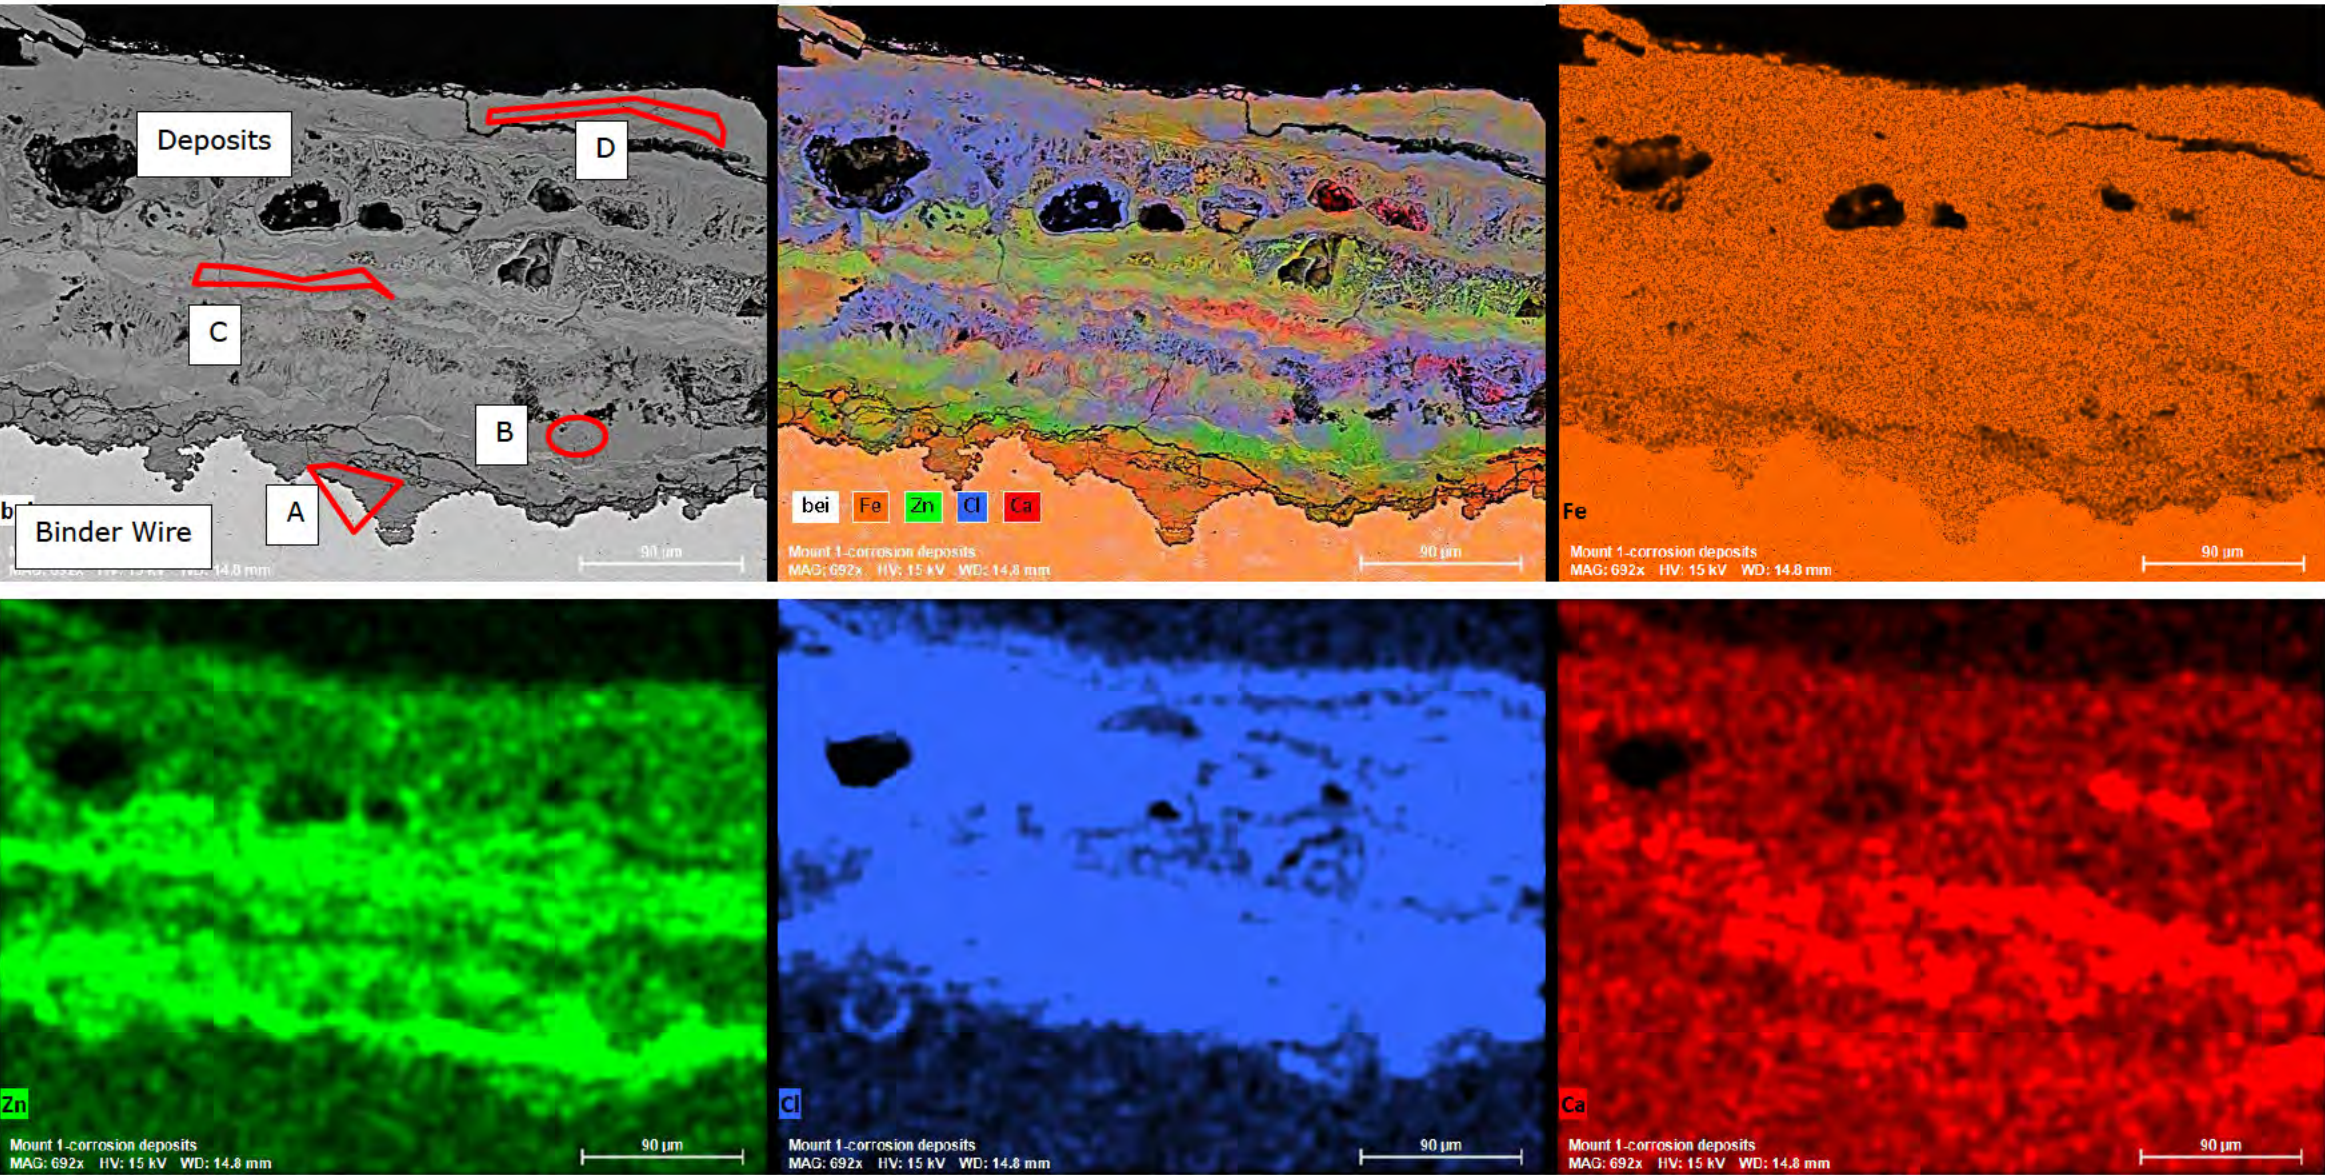
Figure 124 and Figure 125 contain SEM images, SEM-EDS elemental maps, and EDS results of the deposits found within Mount M1 (binder wire); see Figure 120 for locations. The SEM-EDS elemental map in Figure 124 shows that there is a relatively uniform distribution of Cl through the thickness of the deposit and that the Zn is present as layers through the deposit. Some Ca is present near the metal -deposit interface. The deposits of the binder wire have high amounts of Fe and O at the metal interface (Location A), which are likely present in the form of an iron oxide. There are higher concentrations of Zn at Locations B, C, and D that are remnants from the galvanized layer. Relatively low to trace concentrations of Na, magnesium (Mg), aluminum (Al), Si, S, Cl, Ca, Cr, manganese (Mn), and copper (Cu) were also detected. The Cl is likely present in the form of chlorides and the remaining elements were likely from the environment and / or impurities from the galvanizing process.

Figure 124. SEM images, SEM-EDS elemental maps, and EDS results of deposits present on the binder wire from the Subject Aft Cable showing the distribution of iron (Fe), zinc (Zn), chlorine (Cl), and calcium (Ca); area of Mount M1 shown in Figure 120 (rotated 90°).

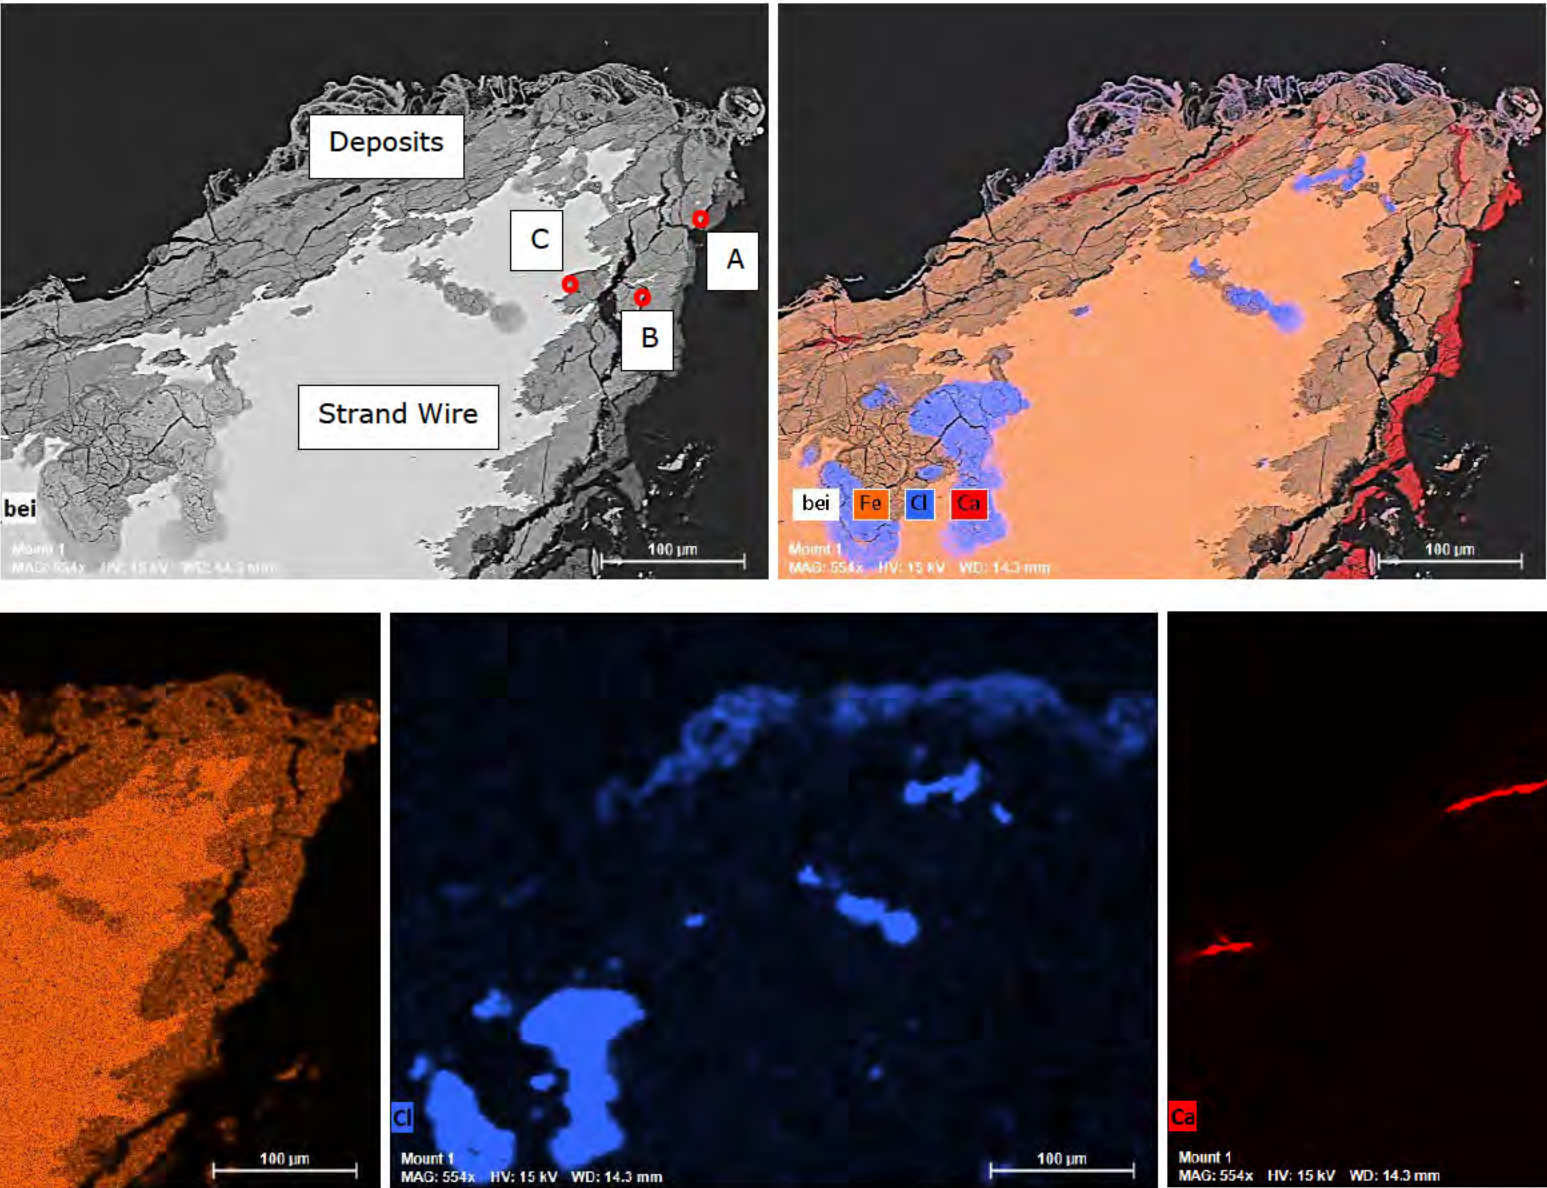
The SEM-EDS elemental map in Figure 125 (strand wire) shows that there are high concentrations of Cl at pits near the metal and deposit interface. Some Ca is also detected within a deposit layer and on the outer edge of the deposits. The deposits of the wire have high amounts of Fe and O at the metal interface (Locations B and C), which are likely present in the form of an iron oxide. Calcium and oxygen are present in high amounts at Location A, which is typically consistent with carbonates; however, none were detected during spot testing. As such, it is most likely these elements are from the environment.

Figure 125. SEM images, SEM-EDS elemental maps, and EDS results of deposits present on the strand wire from the Subject Aft Cable showing the distribution of iron (Fe), chlorine (Cl), and calcium (Ca); area of Mount M1 shown in Figure 120 (rotated 90°).

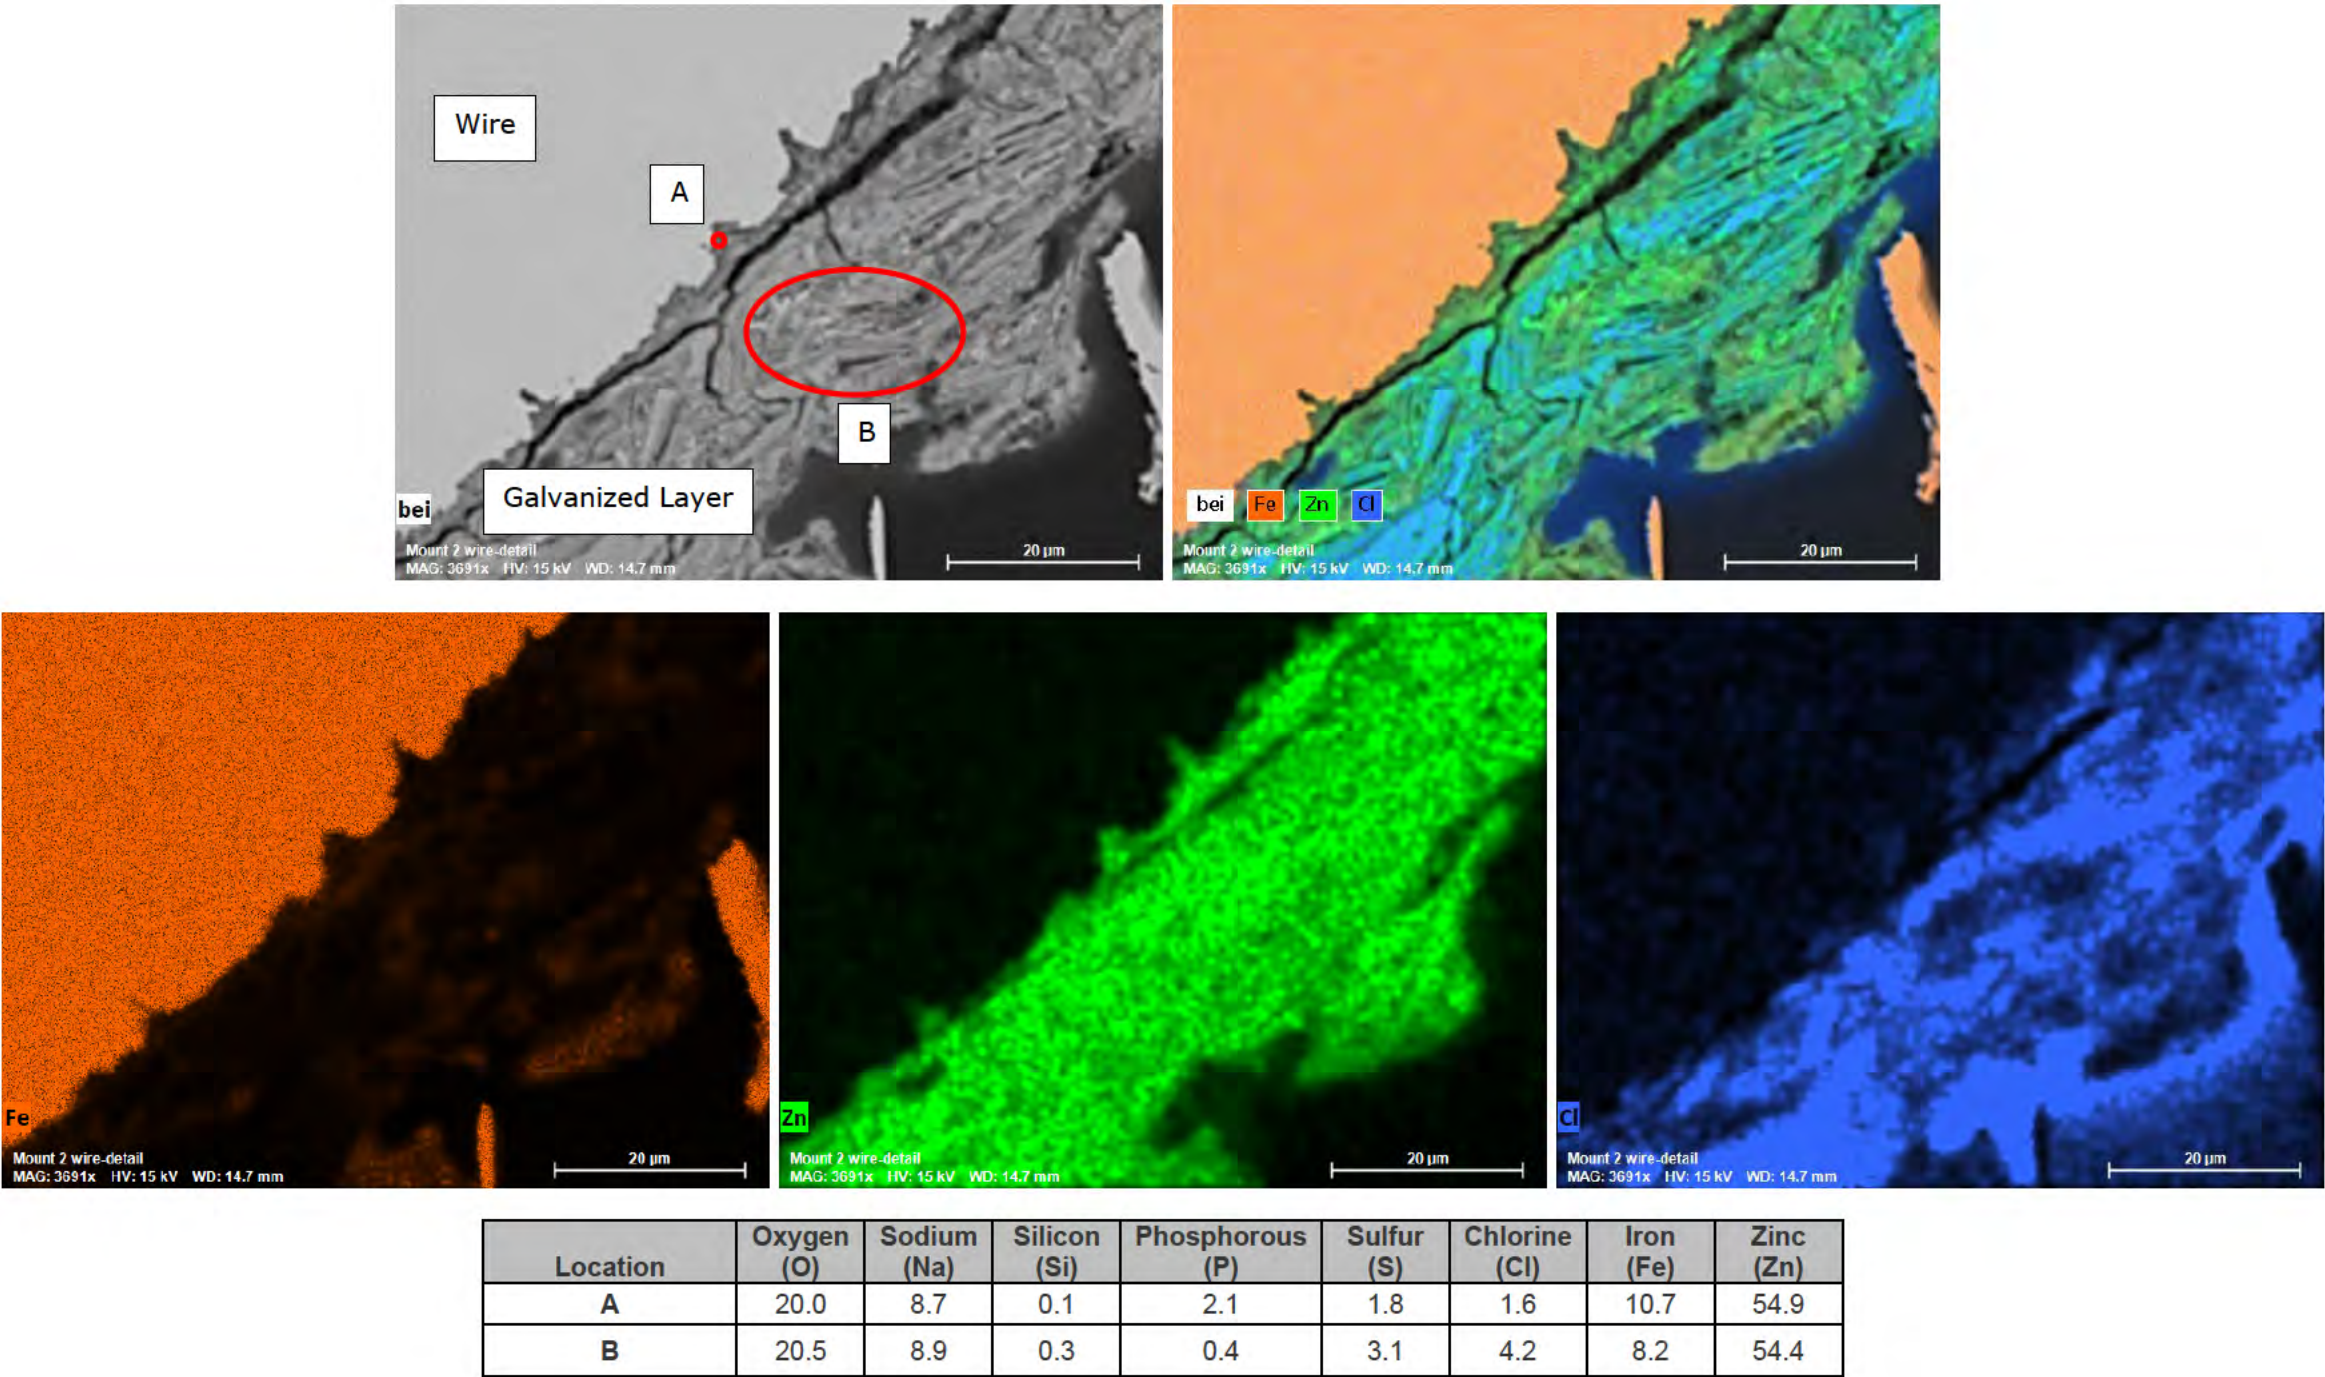
The SEM-EDS elemental map in Figure 126 (binder wire) shows that there are high concentrations of Zn and Cl in the galvanized layer. The galvanized layer of the wire has high amounts of Zn, Fe, and O at the metal interface (Locations A and B), which are likely present in the form of a zinc oxide and / or an iron oxide. There is also a high concentration of Na in the galvanized layer. The Fe concentration is slightly higher at the metal / galvanized layer interface. Relatively low to trace concentrations of Si, S, and Cl were also detected at both locations. The Cl is likely present in the form of chlorides and the remaining elements were likely from the environment and / or impurities from the galvanizing process.

Figure 126. SEM images and SEM-EDS elemental maps of deposits present on the binder wire from the Subject Aft Cable showing the distribution of iron (Fe), zinc (Zn), and chlorine (Cl); area of Mount M2 shown in Figure 122 (rotated 90° counter clockwise).

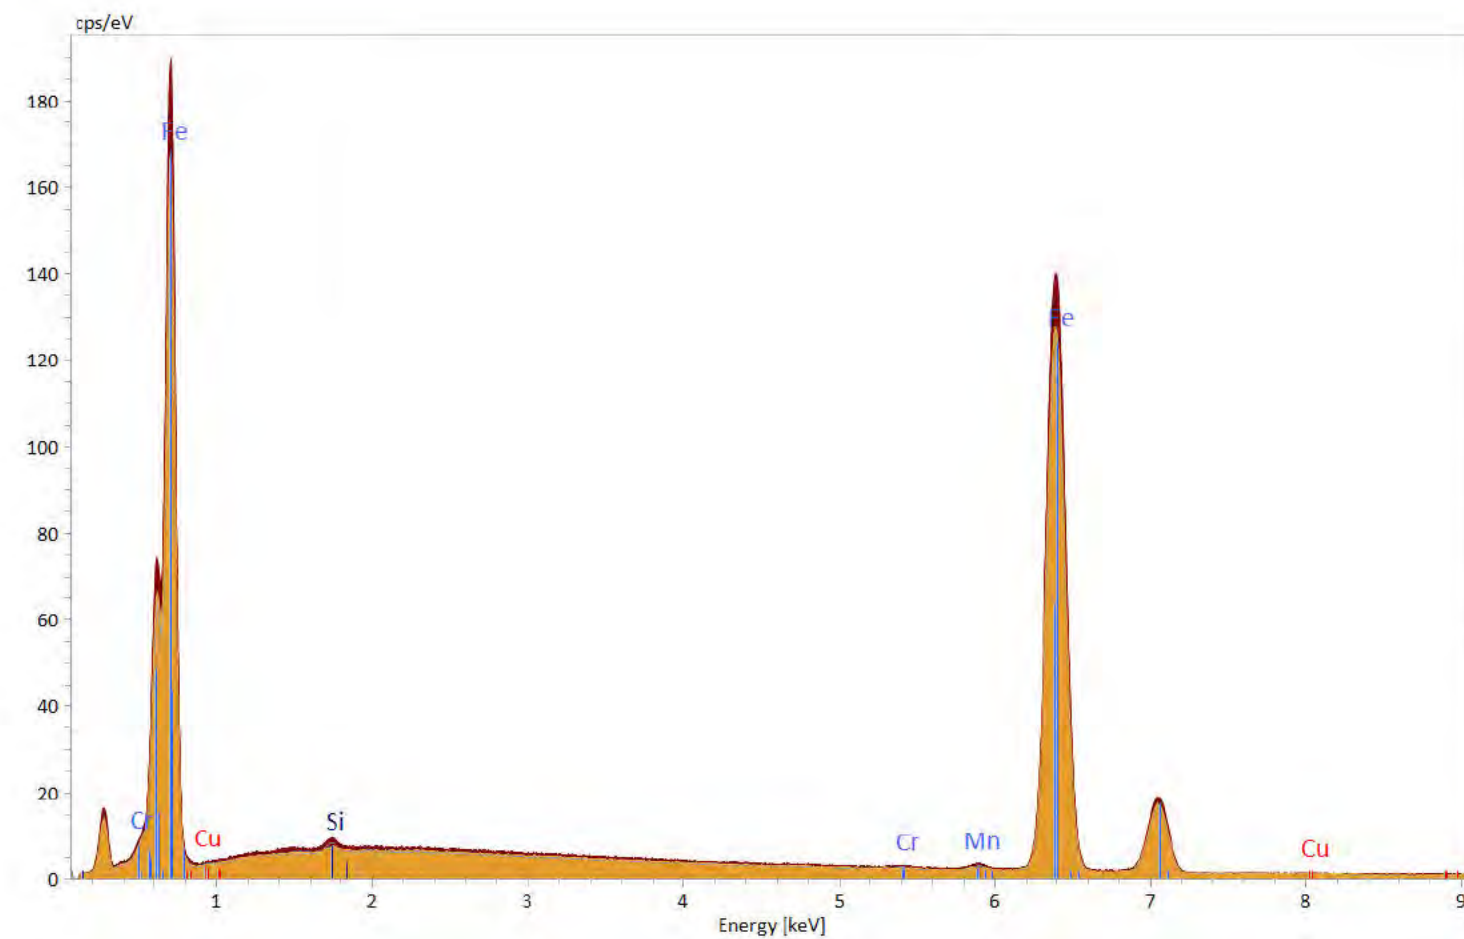
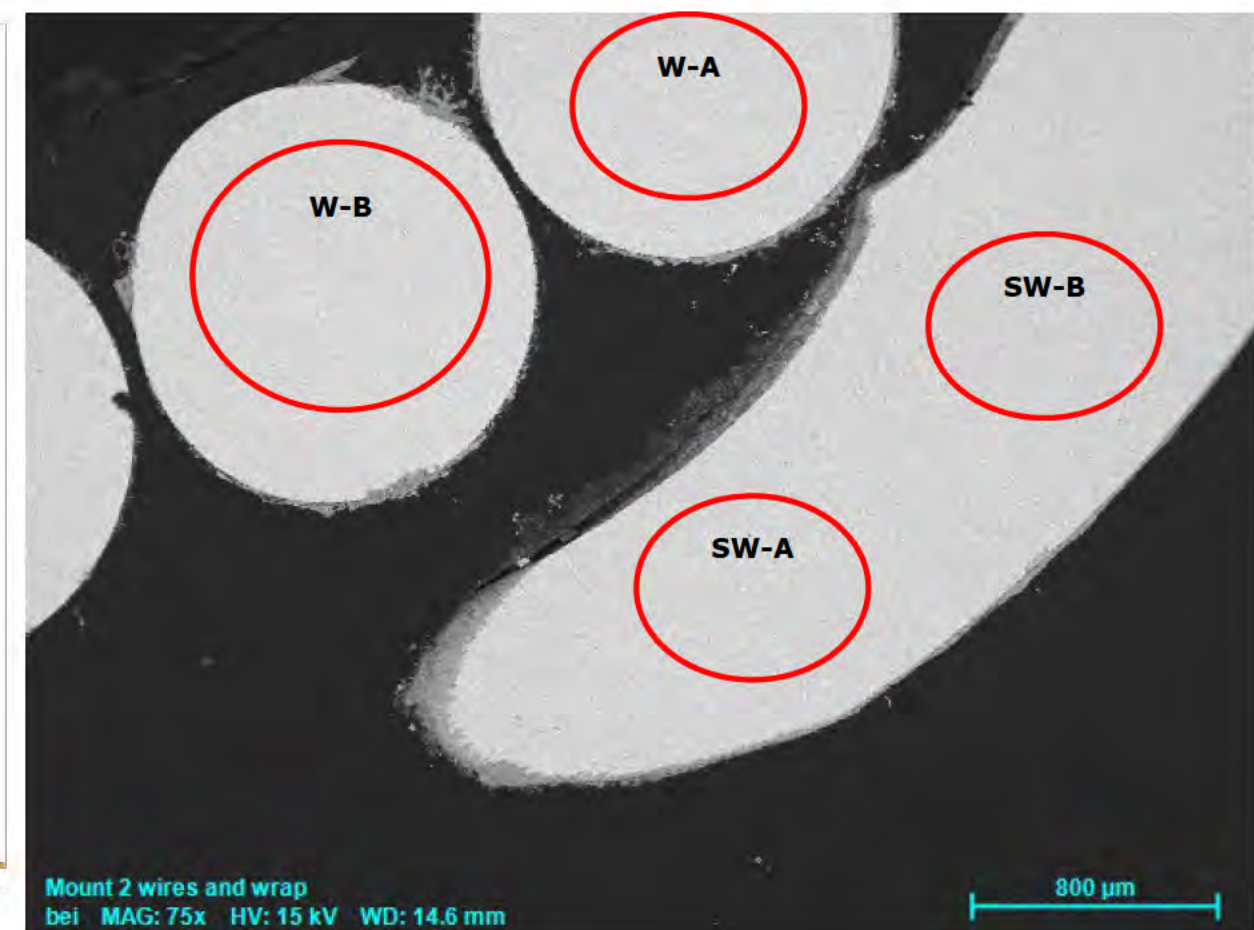
Figure 127. EDS Spectra, SEM image, and EDS results for wire and binder wire from the Subject Aft Cable; area shown in Figure 122 (rotated 90°).

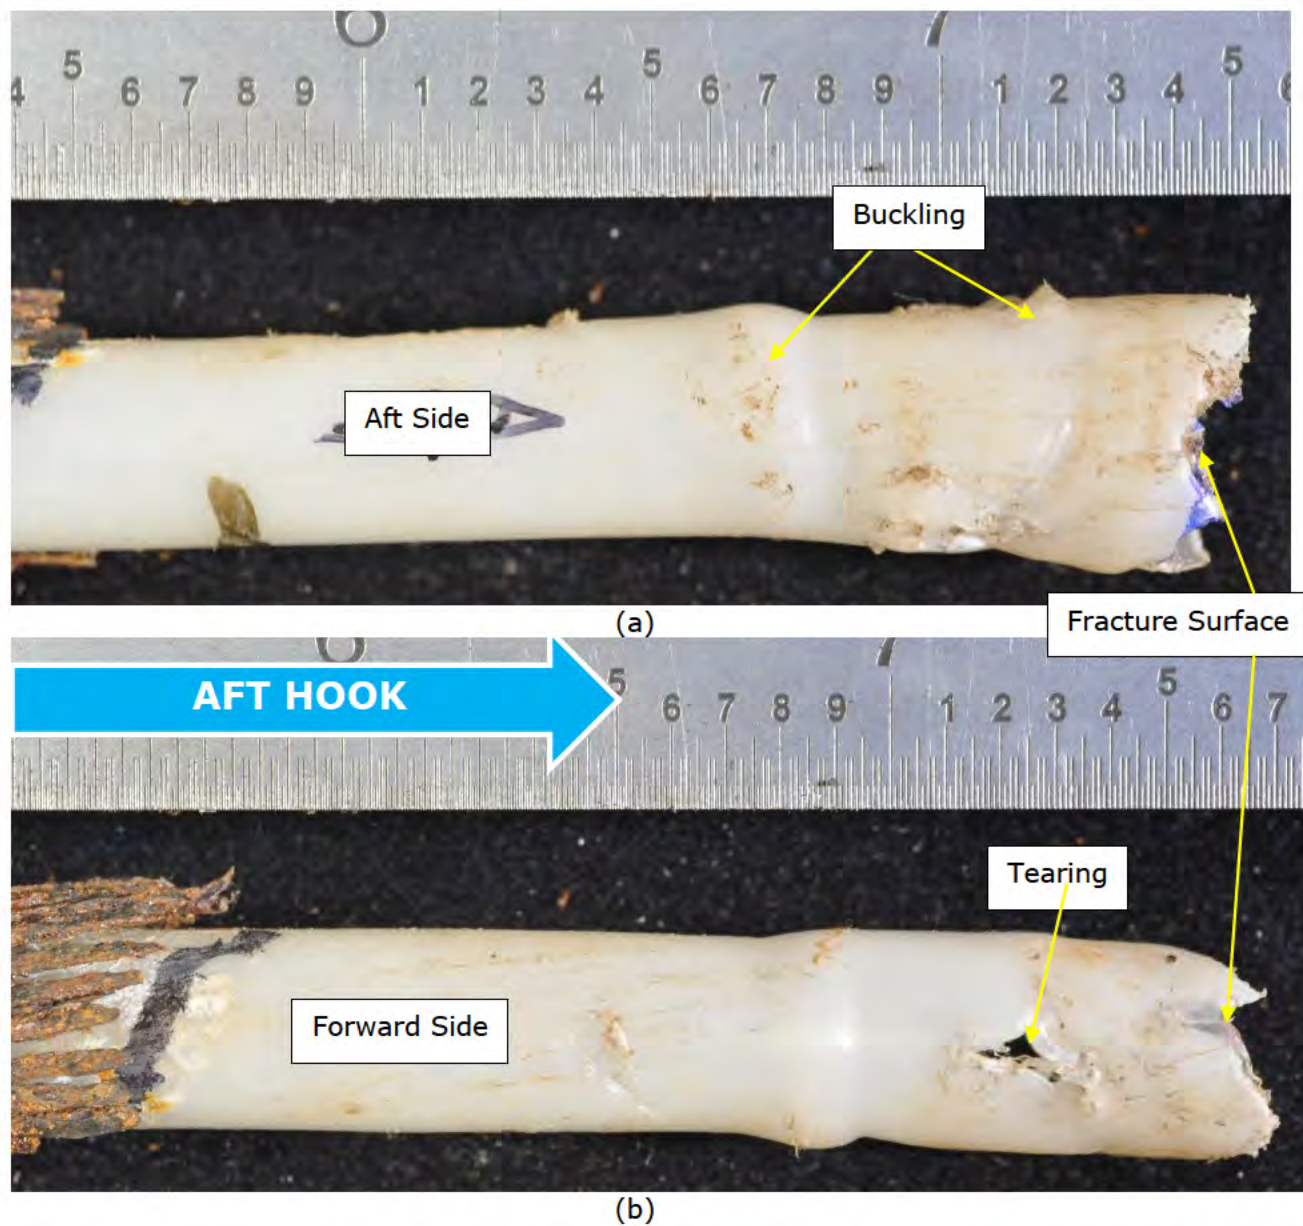
Figure 128. Photographs of the one failed liner from the Subject Release Unit side after dissection showing the (a) aft side and (b) forward side; samples shown in Figure 108. The mating half of the failed liner is shown in Figure 129. Forward and aft refer to the orientation of the keeper relative to the lifeboat. The direction of the Subject Aft Hook is noted with the blue arrow. Rulers are in inches.

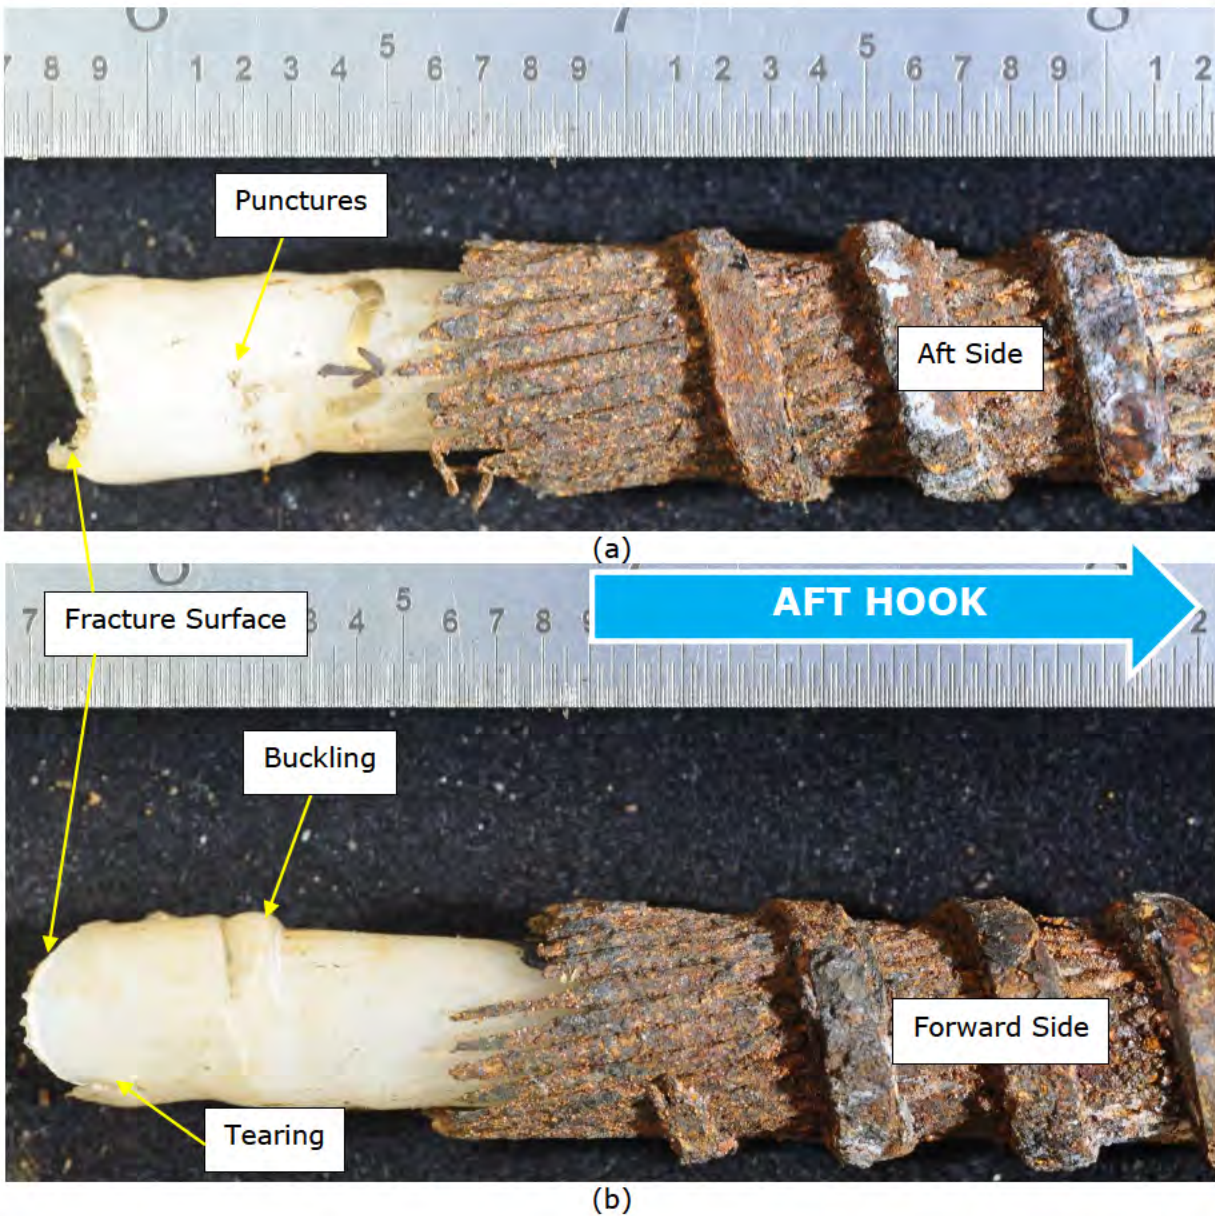
Figure 129. Photographs of the failed liner from the Subject Aft Hook side after dissection showing the (a) aft side and (b) forward side; samples shown in Figure 108. The mating half of the failed liner is shown in Figure 128. Forward and aft refer to the orientation of the keeper relative to the lifeboat. The direction of the Subject Aft Hook is noted with the blue arrow. Rulers are in inches.

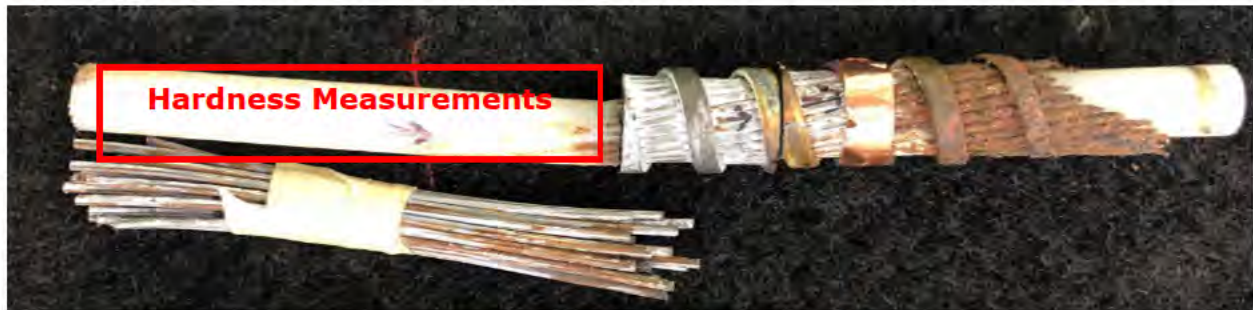
Figure 130. Photograph showing the liner from the Subject Release Unit side after removing the wire layer; sample shown in Figure 108. The direction of the Subject Aft Hook is noted with the blue arrow. The results of the hardness testing of the white liner layer are shown in the table.

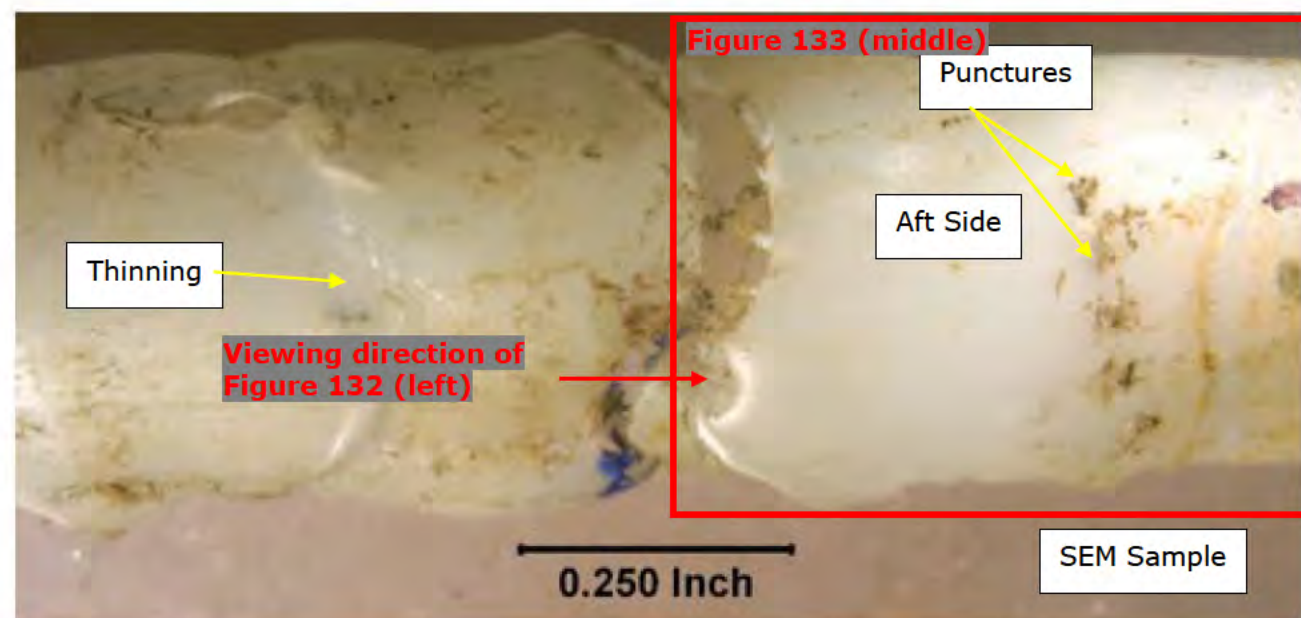
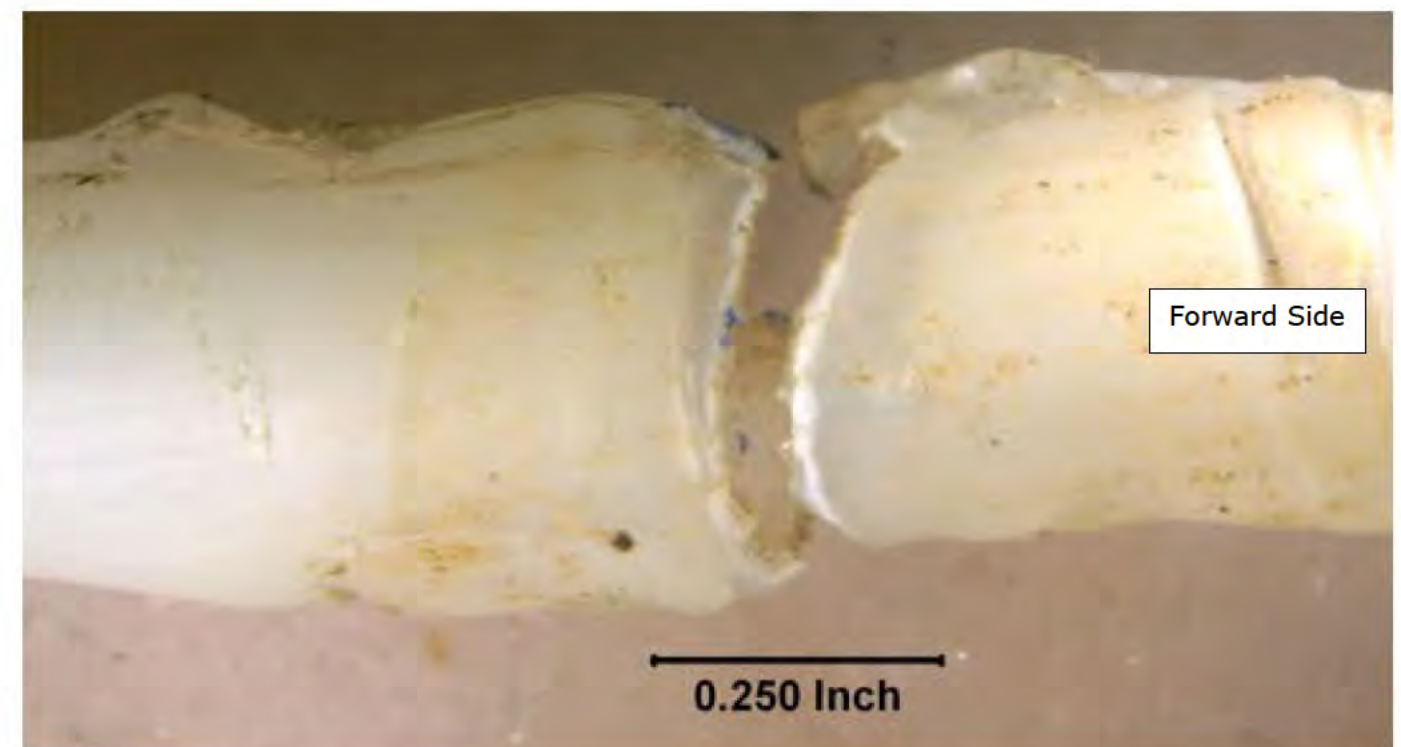
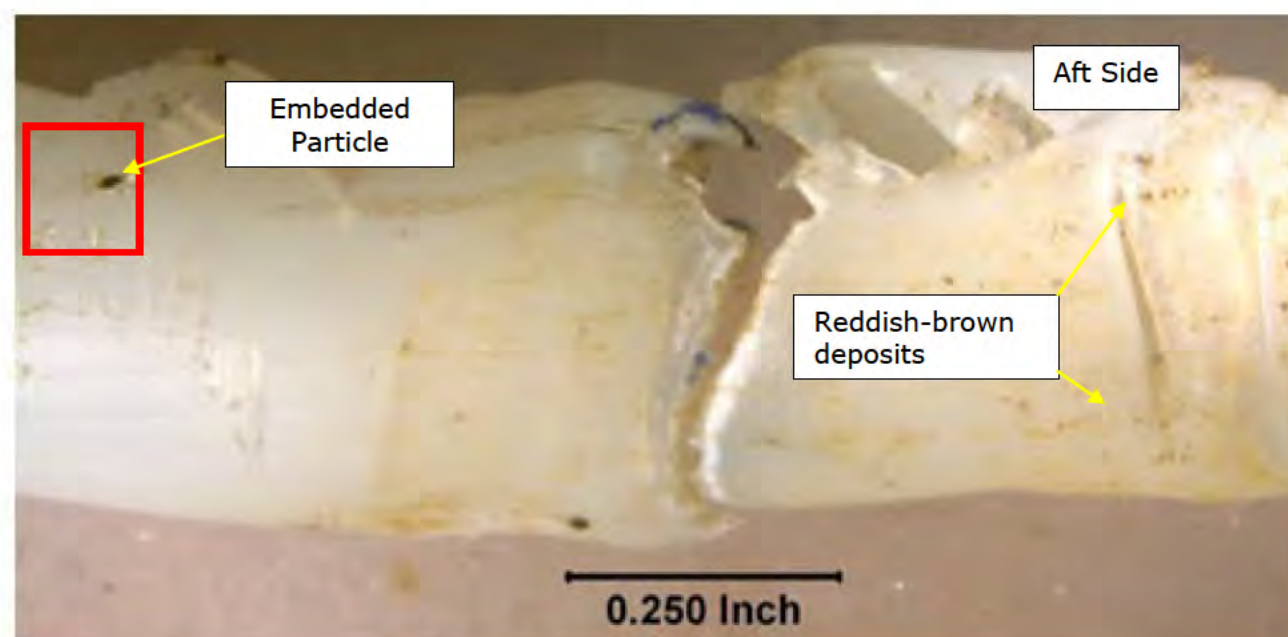
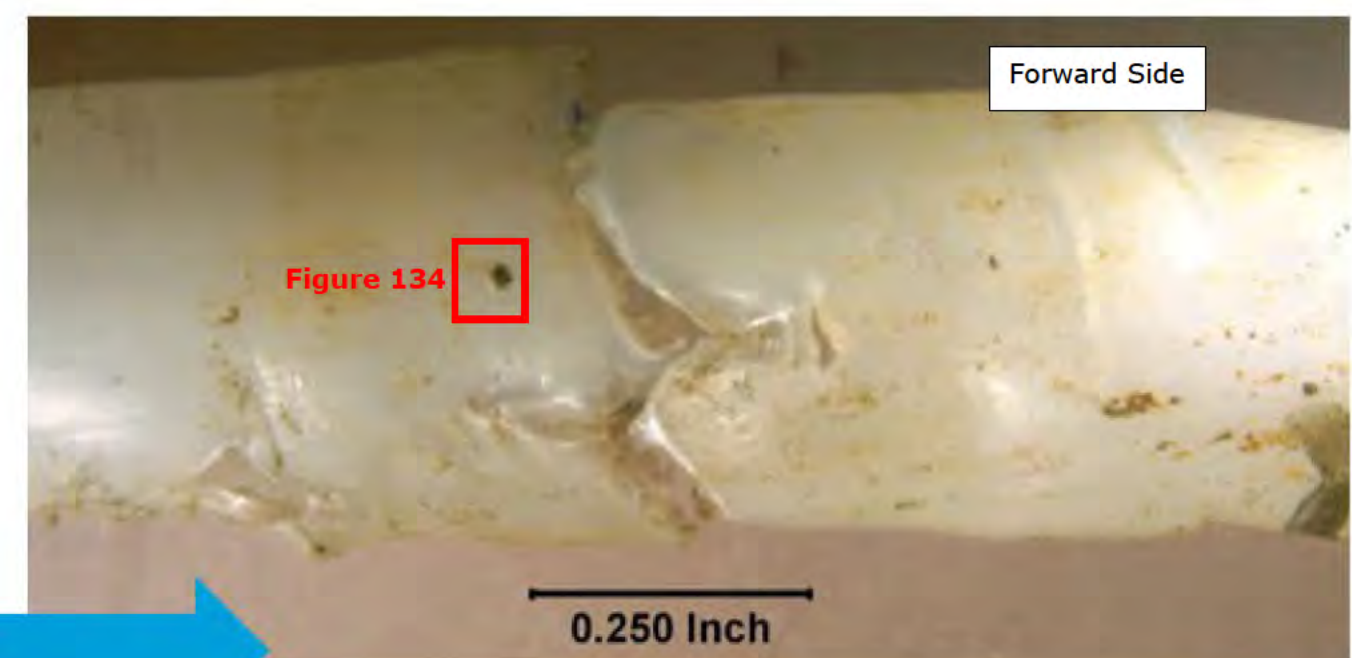
Figure 131. Light photomicrographs of the liner from the Subject Aft Cable showing the failure. The direction of the Subject Aft Hook is noted with the blue arrow.

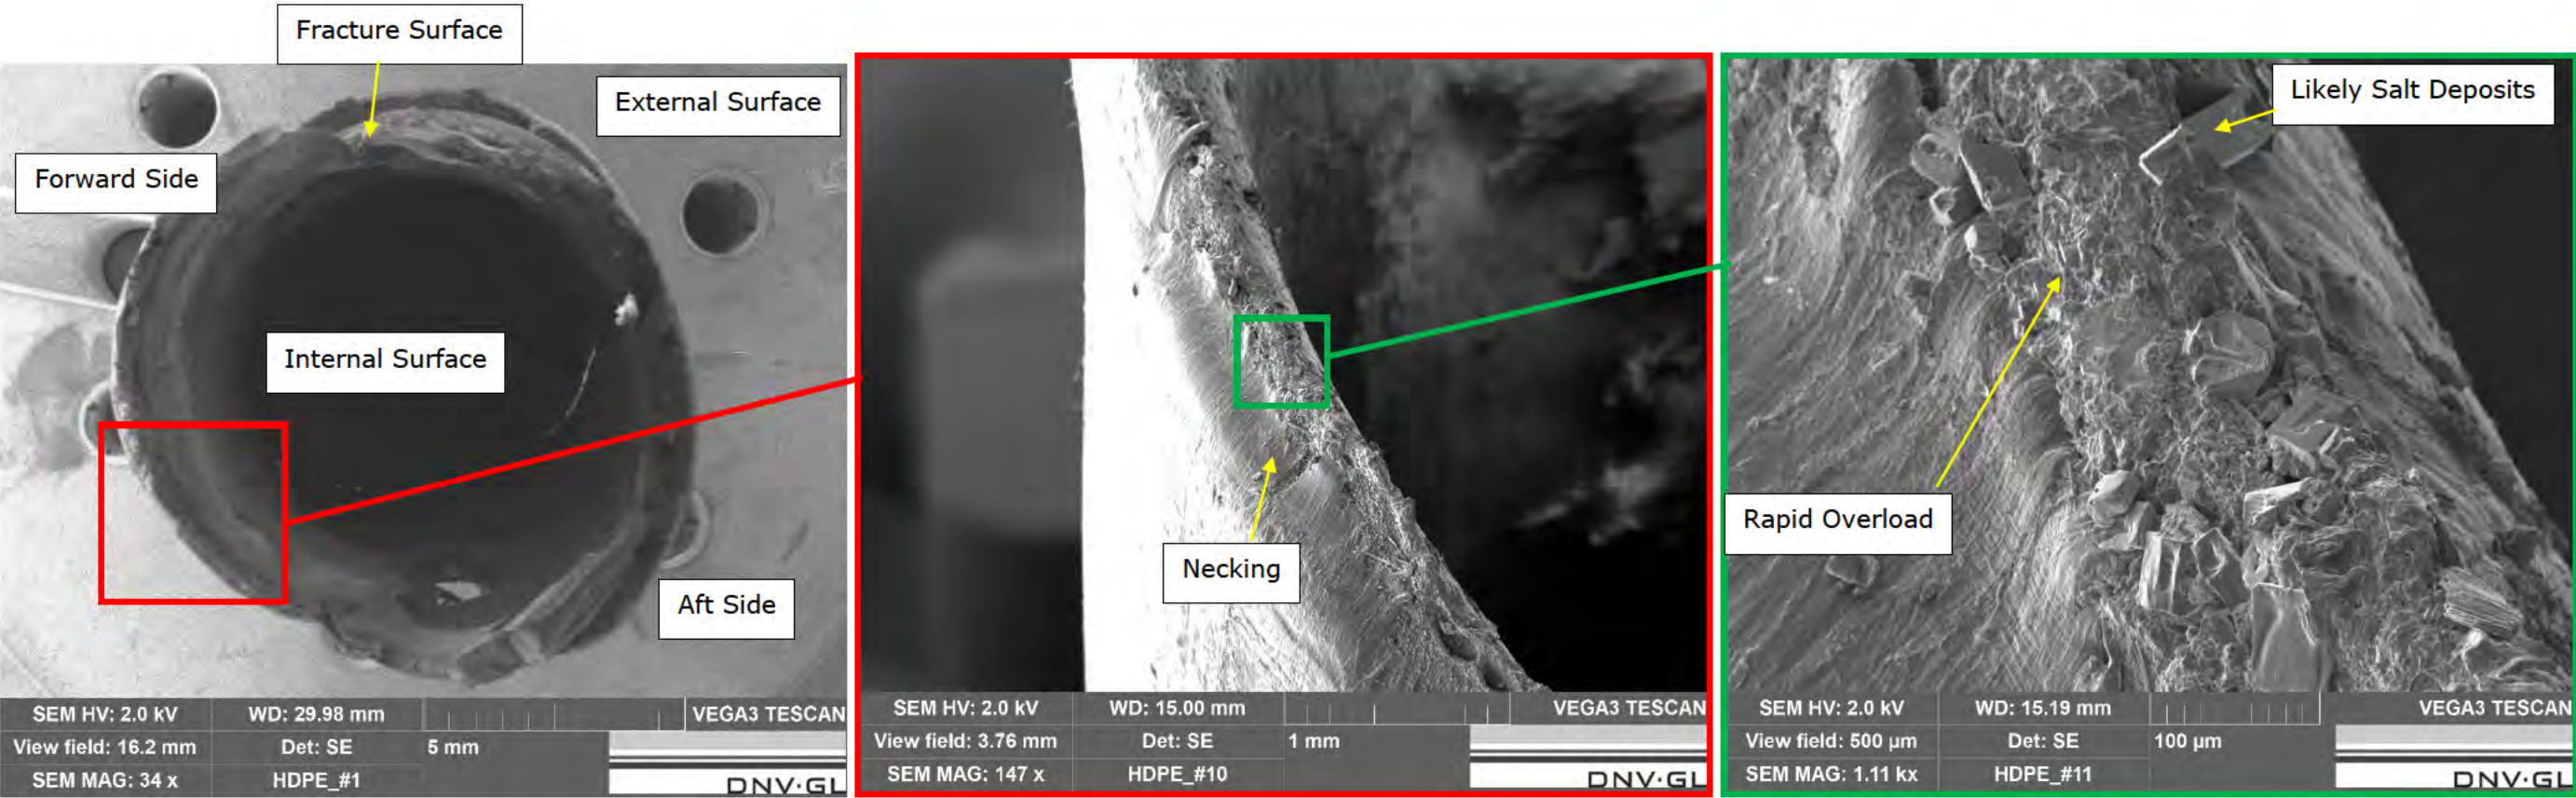
Figure 132. SEM images of the liner from the Subject Aft Hook side of the Subject Aft Cable showing the fracture surface; sample location is shown in Figure 131.
