Final Report

Auger Lifeboat 6 Incident

Shell Oil Company
Houston, Texas, USA

Report No.: O-AP-FINV / BPADG (10165575)
July 9, 2020

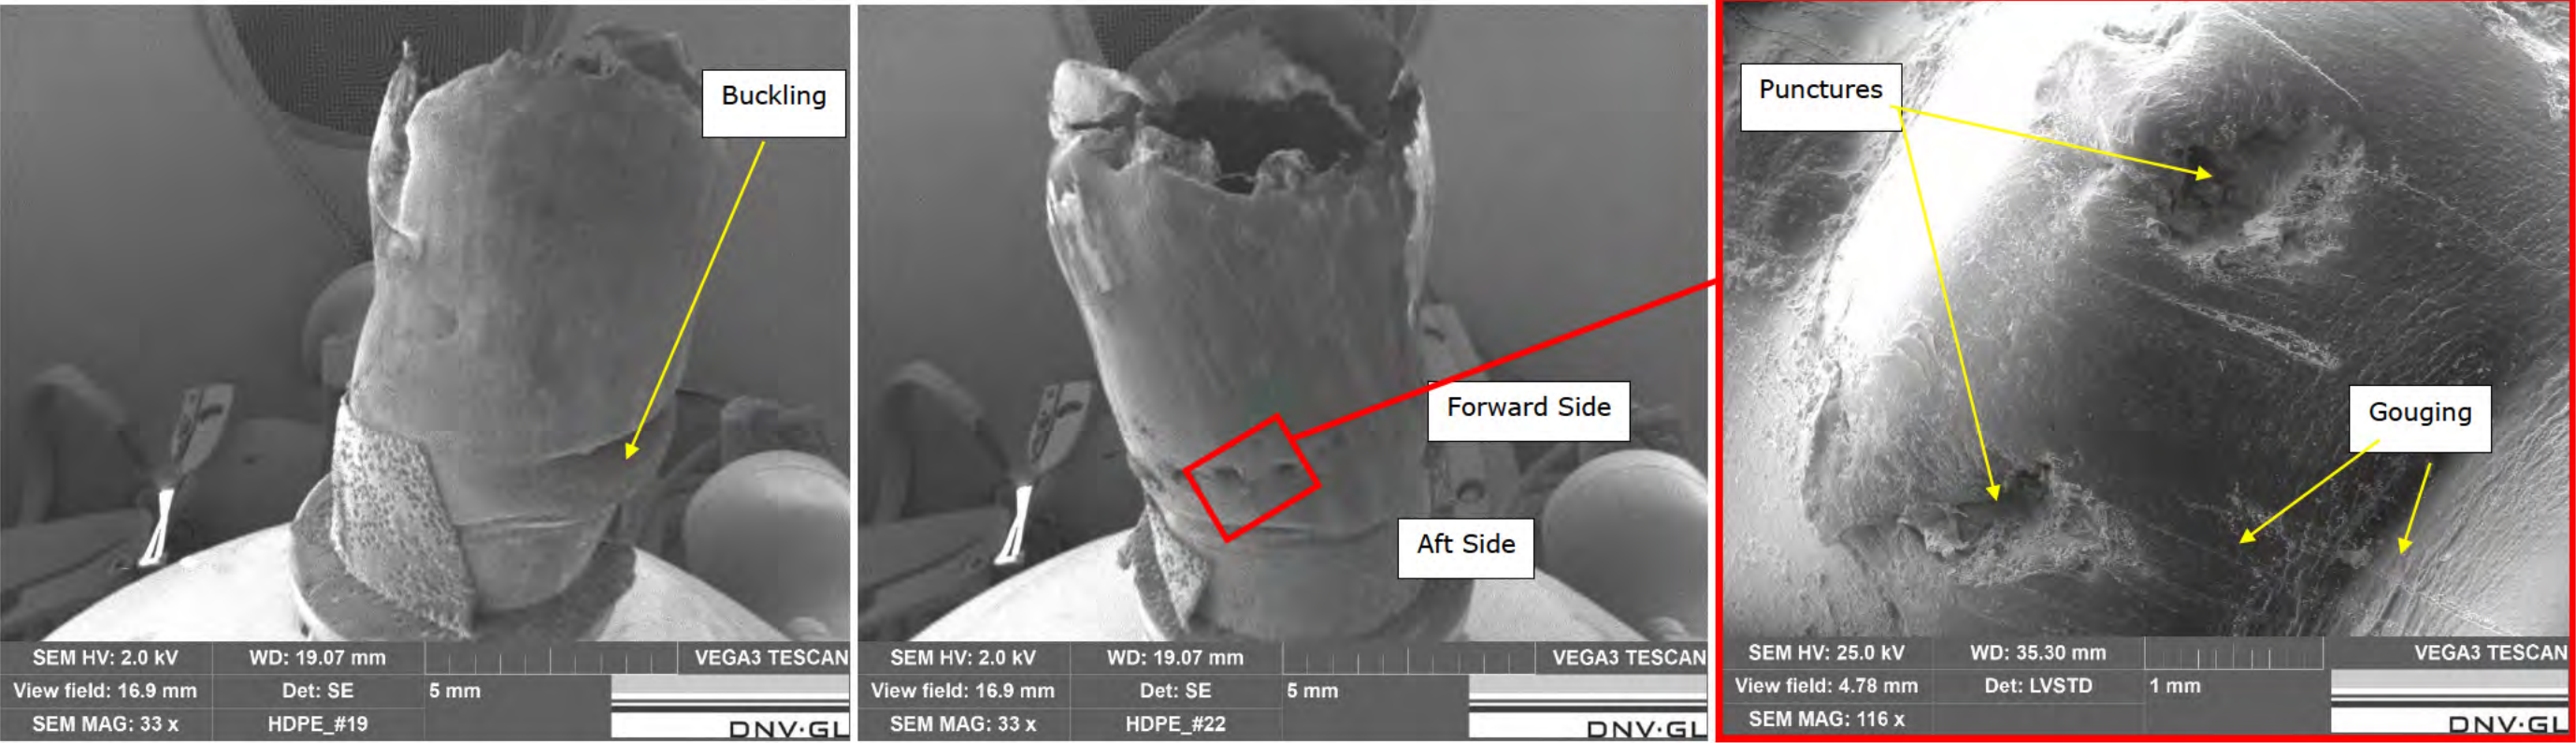
Figure 133. SEM images of the liner from the Subject Aft Hook side of the Subject Aft Cable showing the external surface; sample location is shown in Figure 131.

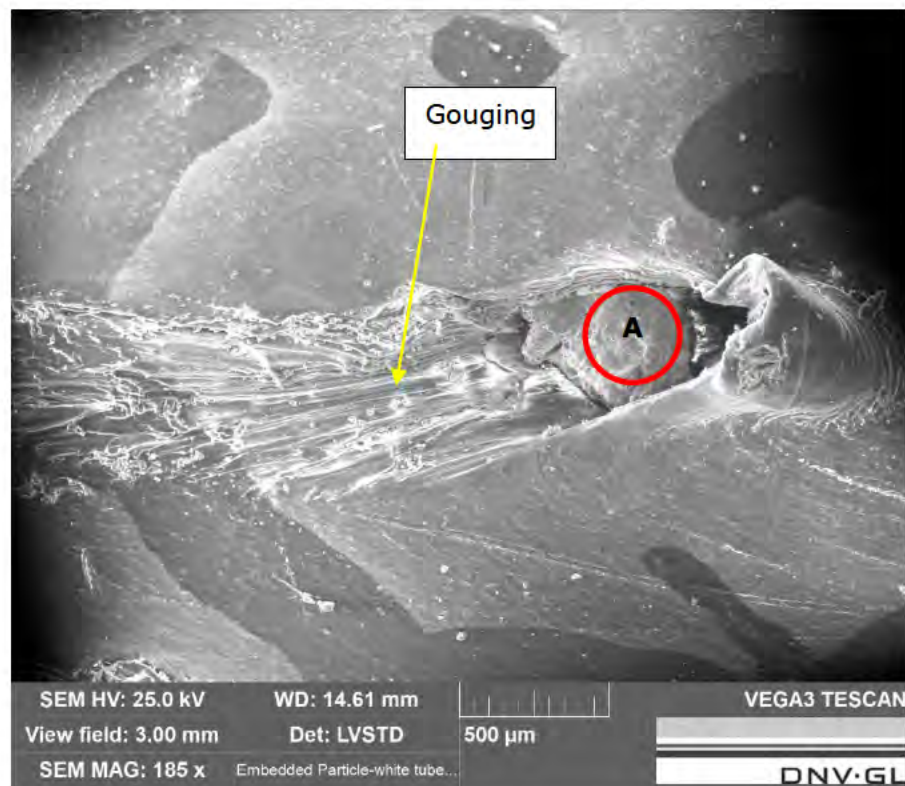
Figure 134 contains an SEM image and EDS results for an embedded particle in the external surface of the liner of the Subject Aft Cable; location is shown in Figure 131. Some gouging

Figure 134. SEM image and EDS Results of the embedded particle in the external surface of the liner of the Subject Aft Cable; location is shown in Figure 131.

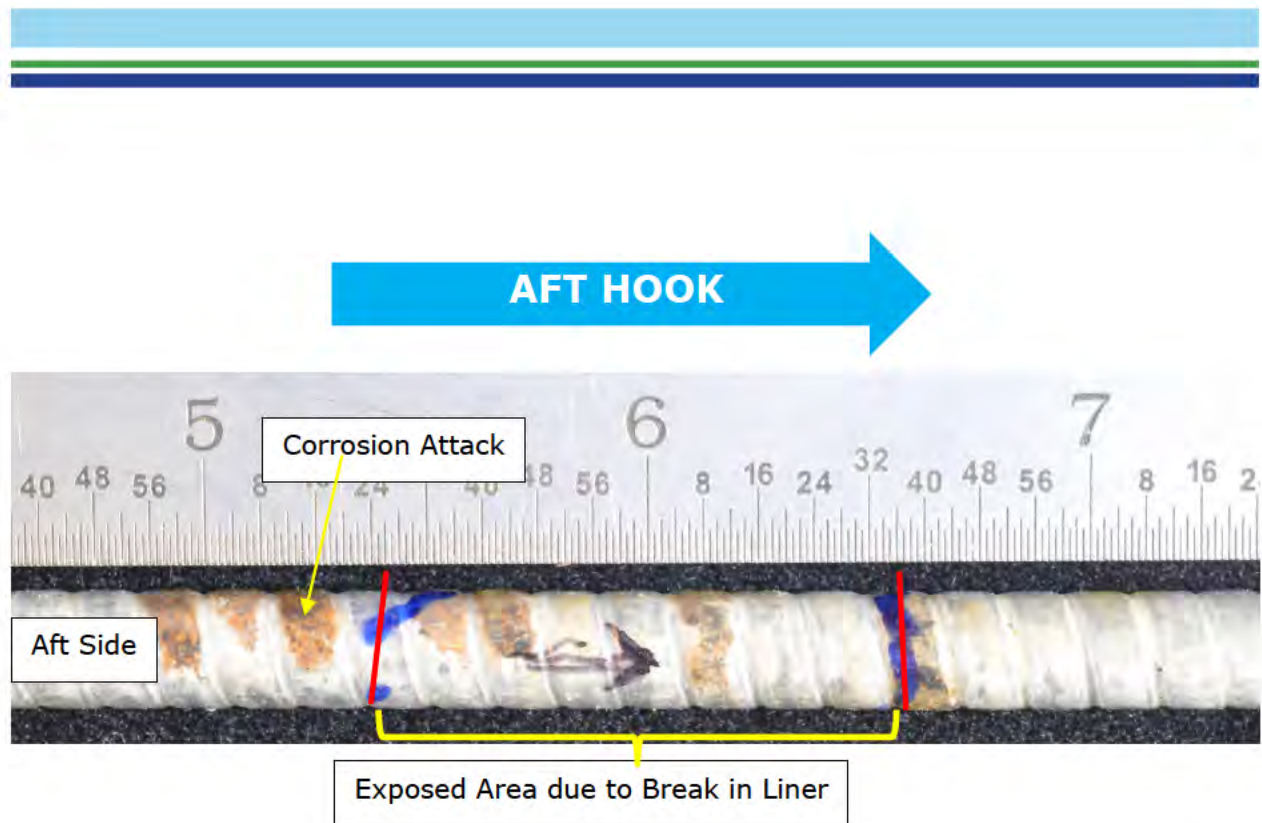
Figure 140. Photograph of the inner member from the Subject Aft Cable after dissection showing the aft side; samples shown in Figure 108. Aft refers to the orientation of the keeper relative to the lifeboat. The direction of the Subject Aft Hook is noted with the blue arrow. Ruler is in inches.

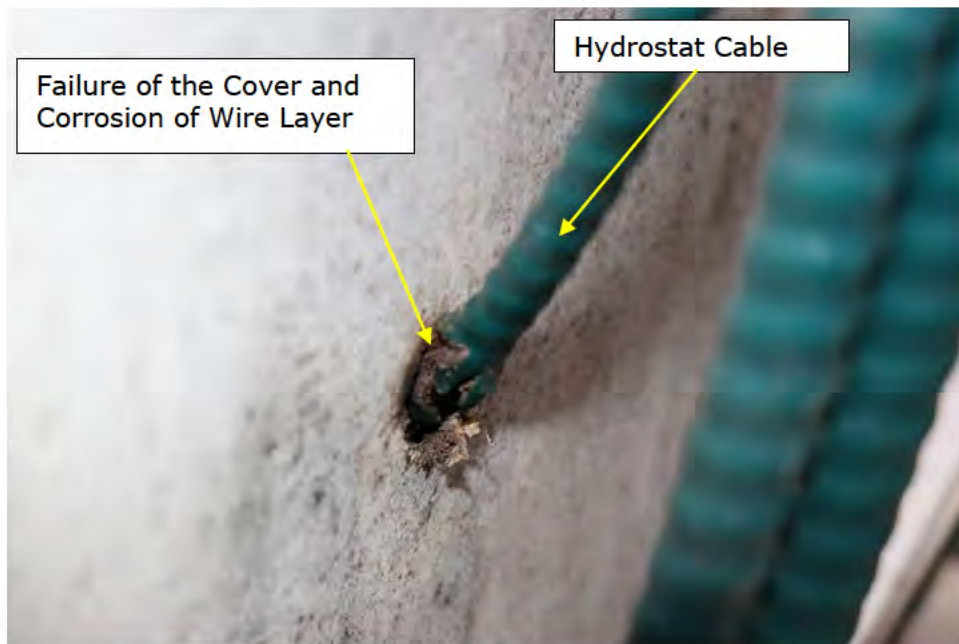
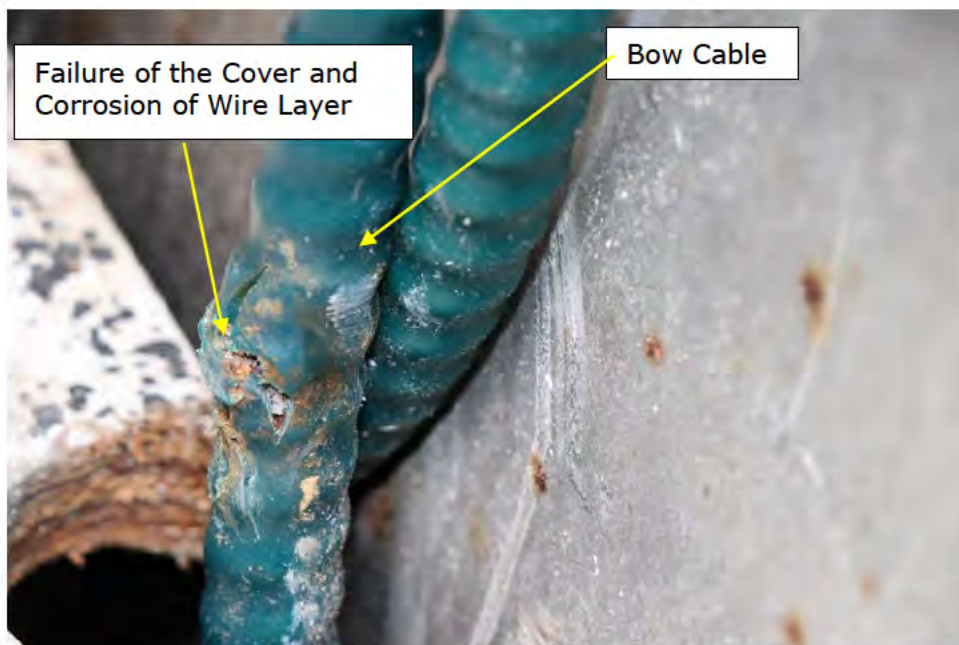
Figure 142. Photographs of the (a) hydrostat cable from Lifeboat 7 and (b) the forward control cable from Lifeboat 8 showing evidence of degradation. Photographs were provided by SOI.

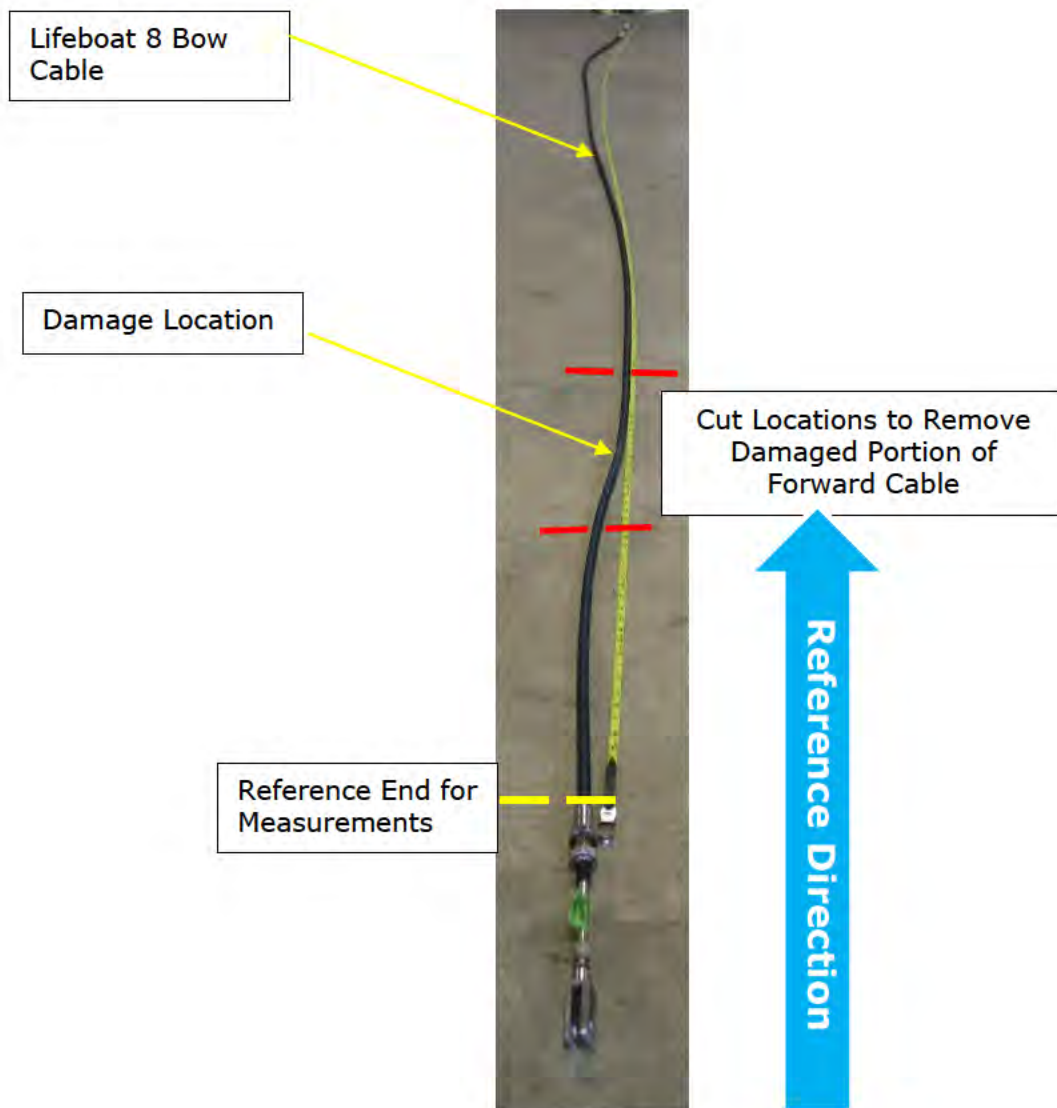
Figure 146 is a photograph of the forward control cable from Lifeboat 8 after removing the wrappings. The damage location of the cable is noted in the image. Measurements were performed using the reference end located at the shoulder of the conduit cap, which is noted in the photograph.

Figure 146. Photograph of the forward control cable from Lifeboat 8 after removing the wrappings. Measuring tape is in feet.

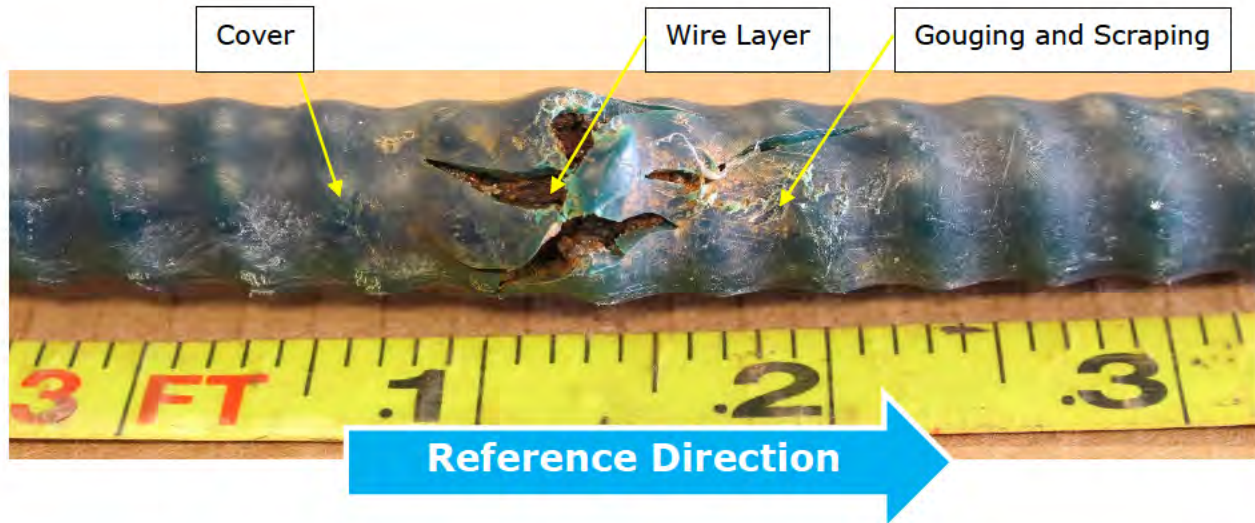
Figure 147 contains a photograph of the forward control cable from Lifeboat 8 showing the assumed top orientation. The external surface of the cover exhibits evidence of gouging and scraping associated with the installation and / or removal of the cable through a penetration in plywood. The cracking in the cover is located between 3.07 feet and 3.21 feet from the shoulder of the conduit cap. The cracking is both axially and circumferentially oriented; however, the cracking is not continuous around the circumference of the cable and only present at the top orientation. Severe corrosion attack to the wire layer is visible in Figure 147; however, the liner is not exposed.

Figure 147. Photograph of the forward control cable from Lifeboat 8 showing damage at the assumed top orientation. Measuring tape is in feet.

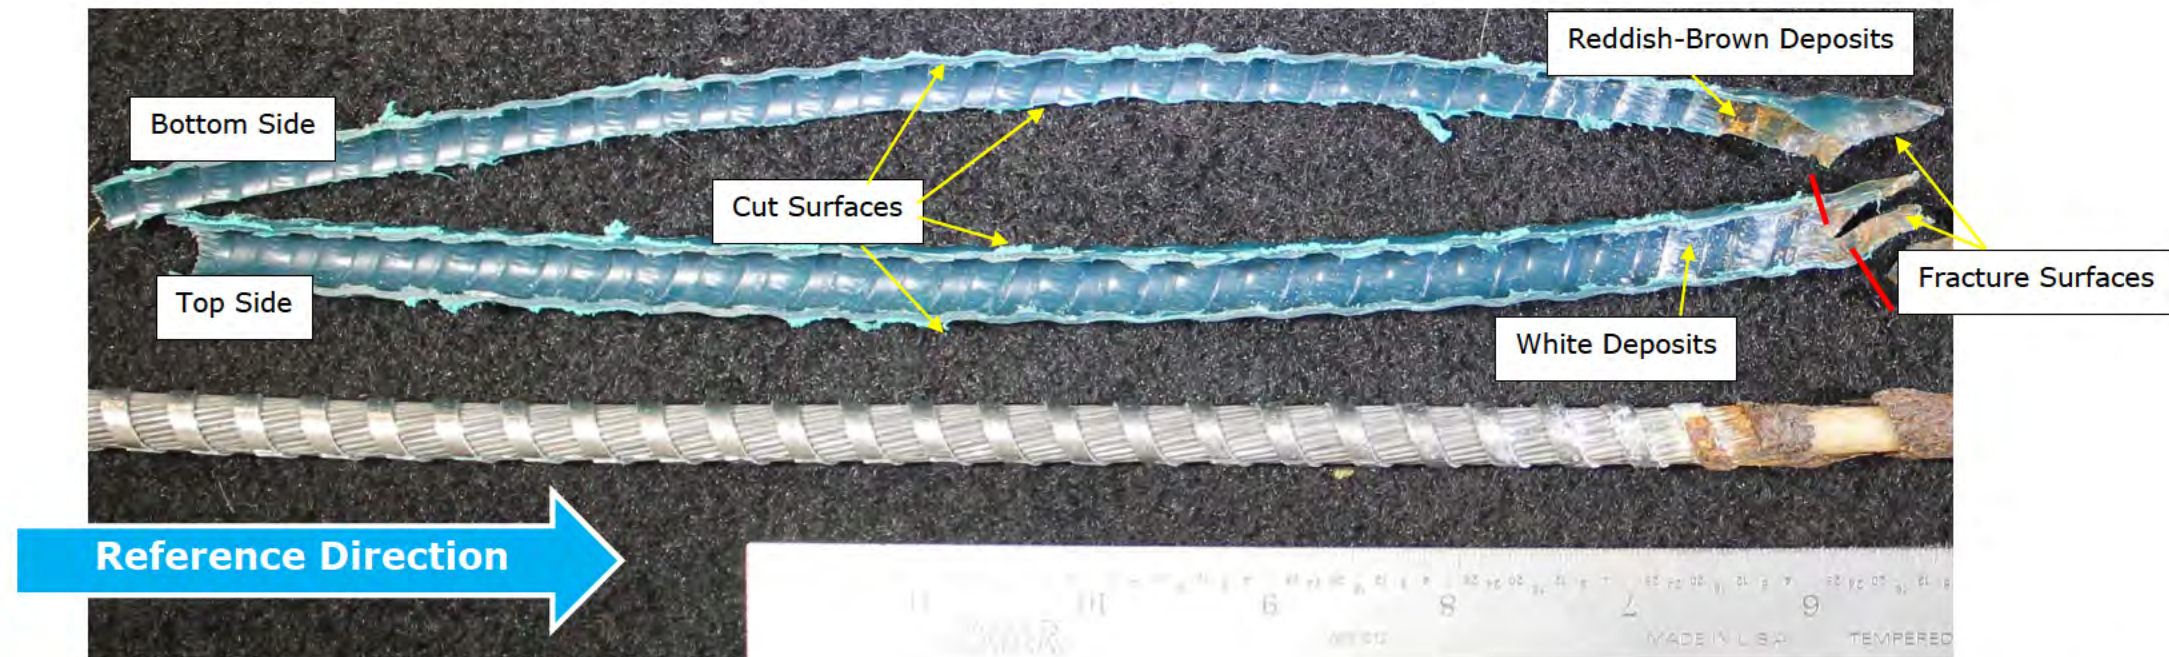
Figure 150 and Figure 151 contain photographs of the cover from the Lifeboat 7 hydrostat cable at the damage location after dissection showing the internal surfaces; sample location shown in Figure 144. The internal surfaces have white and reddish-brown deposits. The white deposits are likely zinc oxides, which suggests that the wire layer was galvanized. The reddish-brown deposits are consistent with an iron oxide and are due to the corrosion of the wire layer. The fracture surfaces of the cover are noted in the figures and are discussed in more detail below. The external surfaces have minor mechanical damage at the high spots in the cover (not shown in the images). These high spots correlate to the binder wire from the wire layer.

Figure 150. Photographs of the half the cover from the Lifeboat 7 hydrostat cable after dissection showing the internal surface near the damaged location; samples shown in Figure 148. The reference direction is noted with the blue arrow. Rulers are in inches.

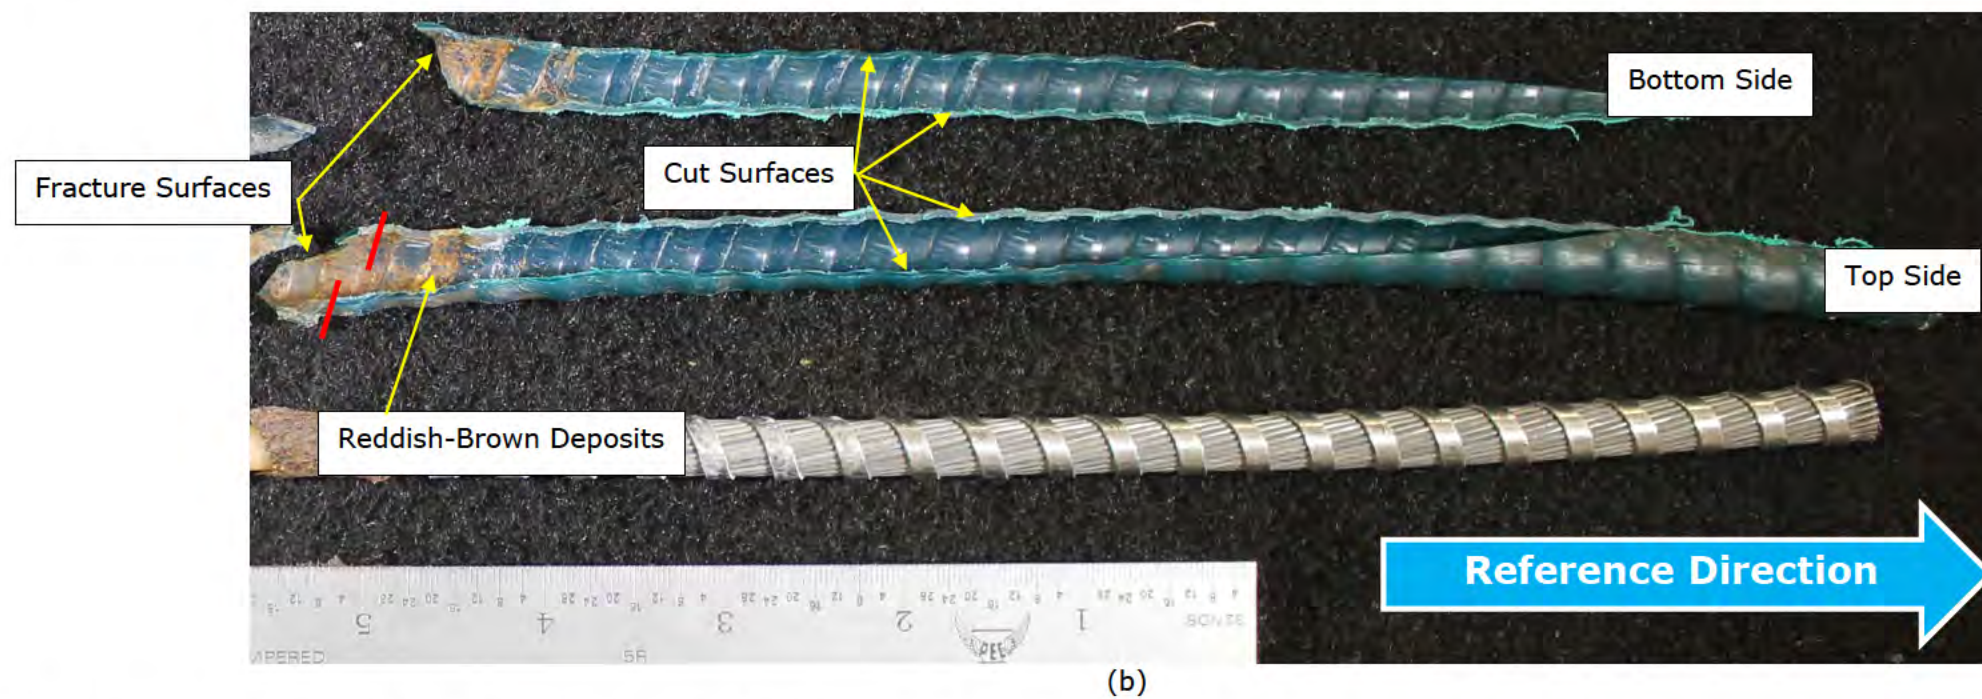
Figure 151. Photographs of the cover from the Lifeboat 7 hydrostat cable after dissection showing the internal surface near the damaged location; samples shown in Figure 148. The reference direction is noted with the blue arrow. Rulers are in inches.

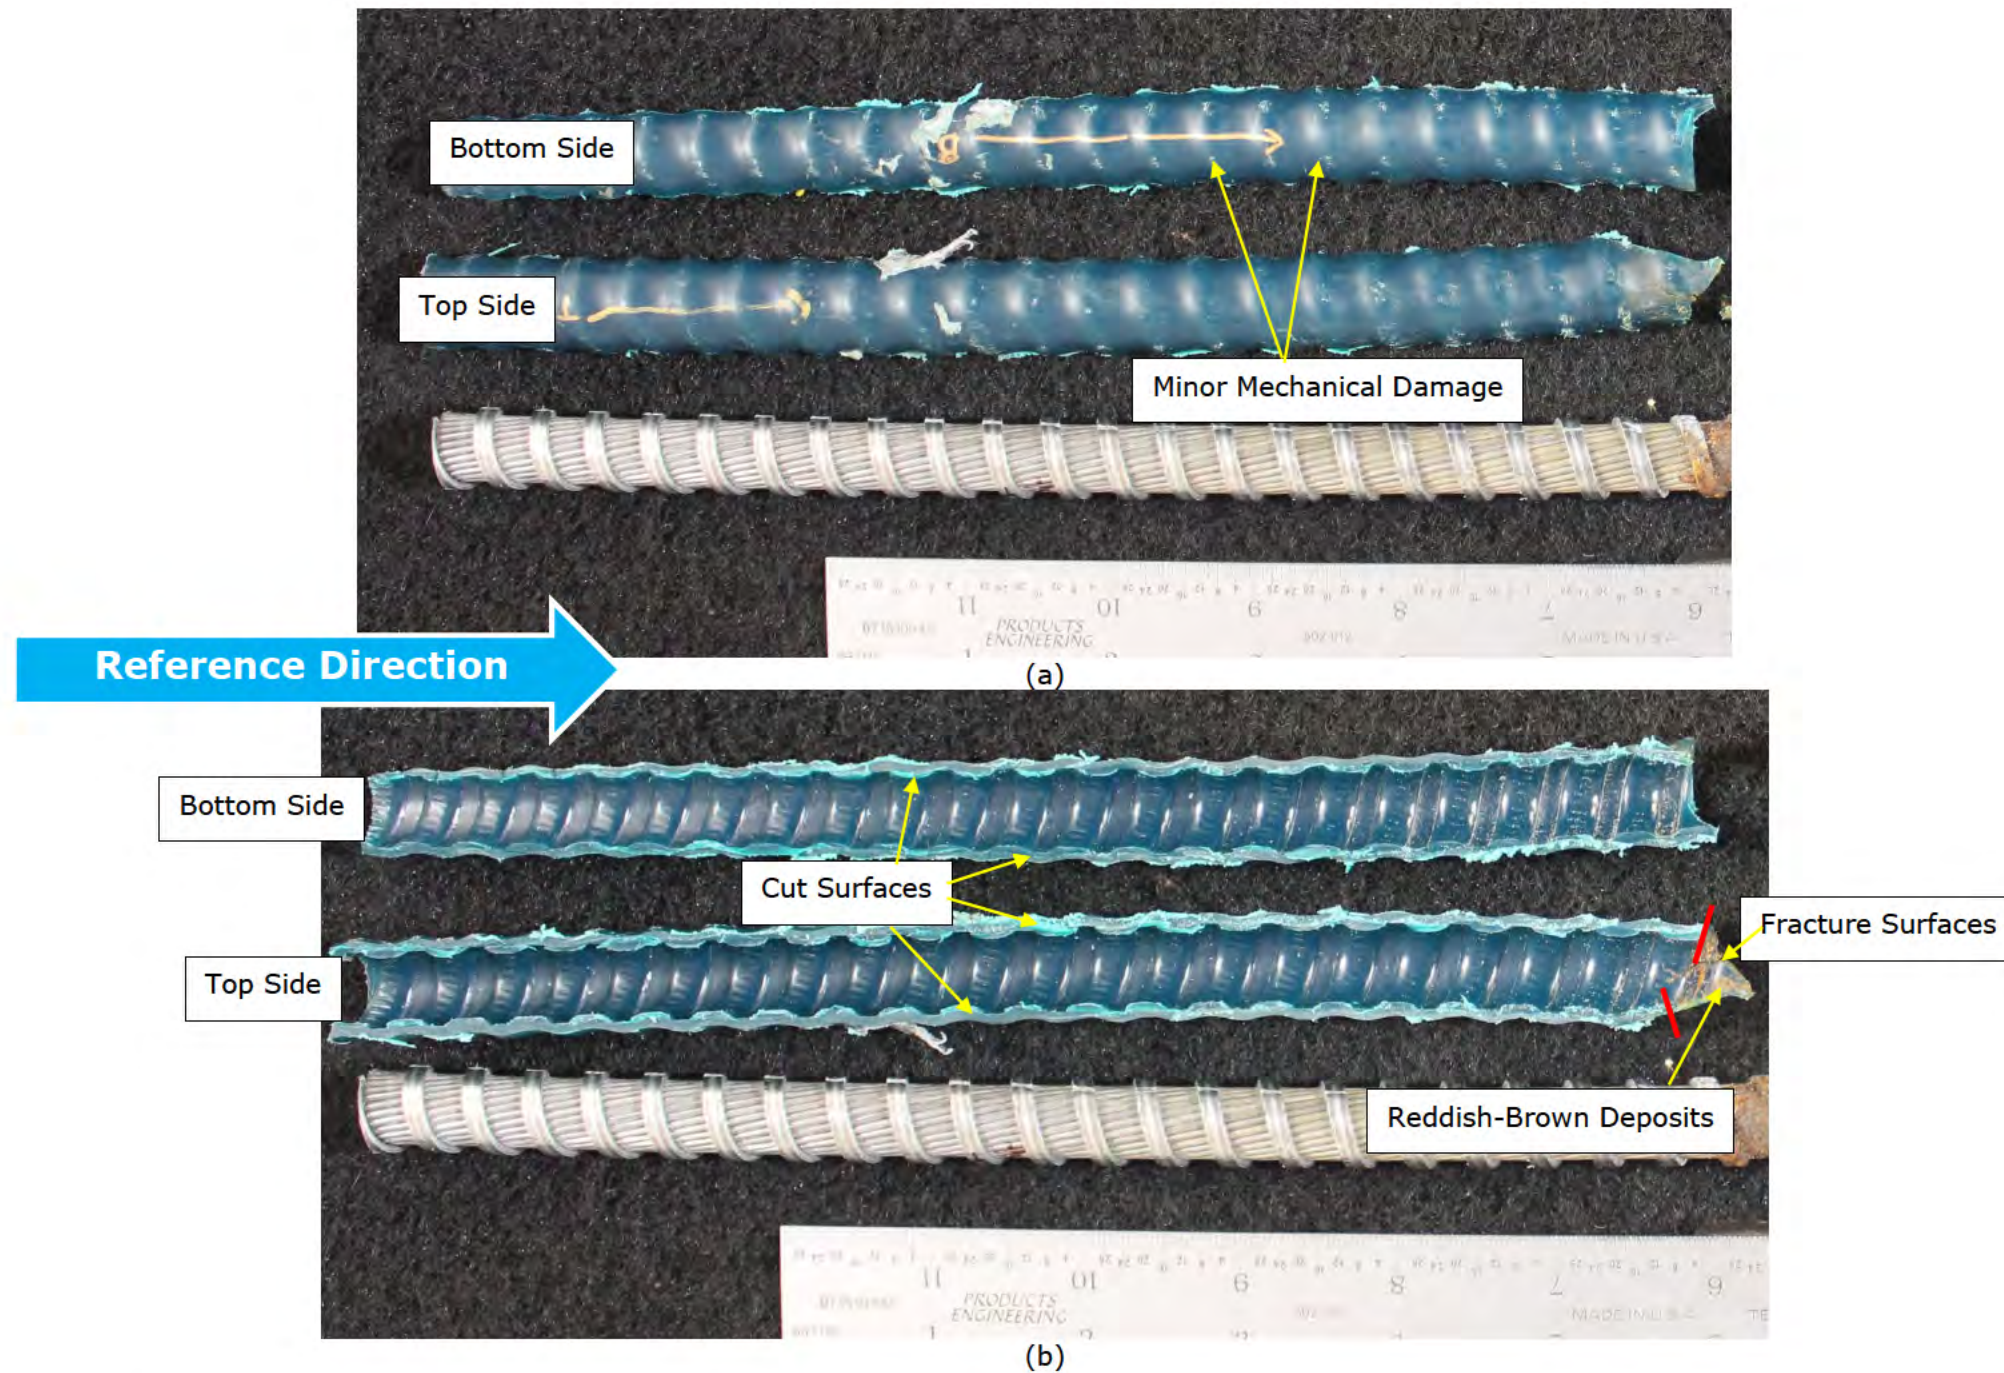
Figure 152 and Figure 153 contain photographs of the cover from the Lifeboat 8 forward control cable at the damage location after dissection showing the (a) external surfaces and (b) internal surfaces; sample location shown in Figure 149 (top). The appearance of the cover from Lifeboat 8 was similar to the cables from Lifeboat 6 and Lifeboat 7.

Figure 152. Photographs of the cover from the Lifeboat 8 forward control cable after dissection showing the (a) external surface and (b) internal surface near the damaged location; samples shown in Figure 149 (top). The reference direction is noted with the blue arrow. Rulers are in inches.

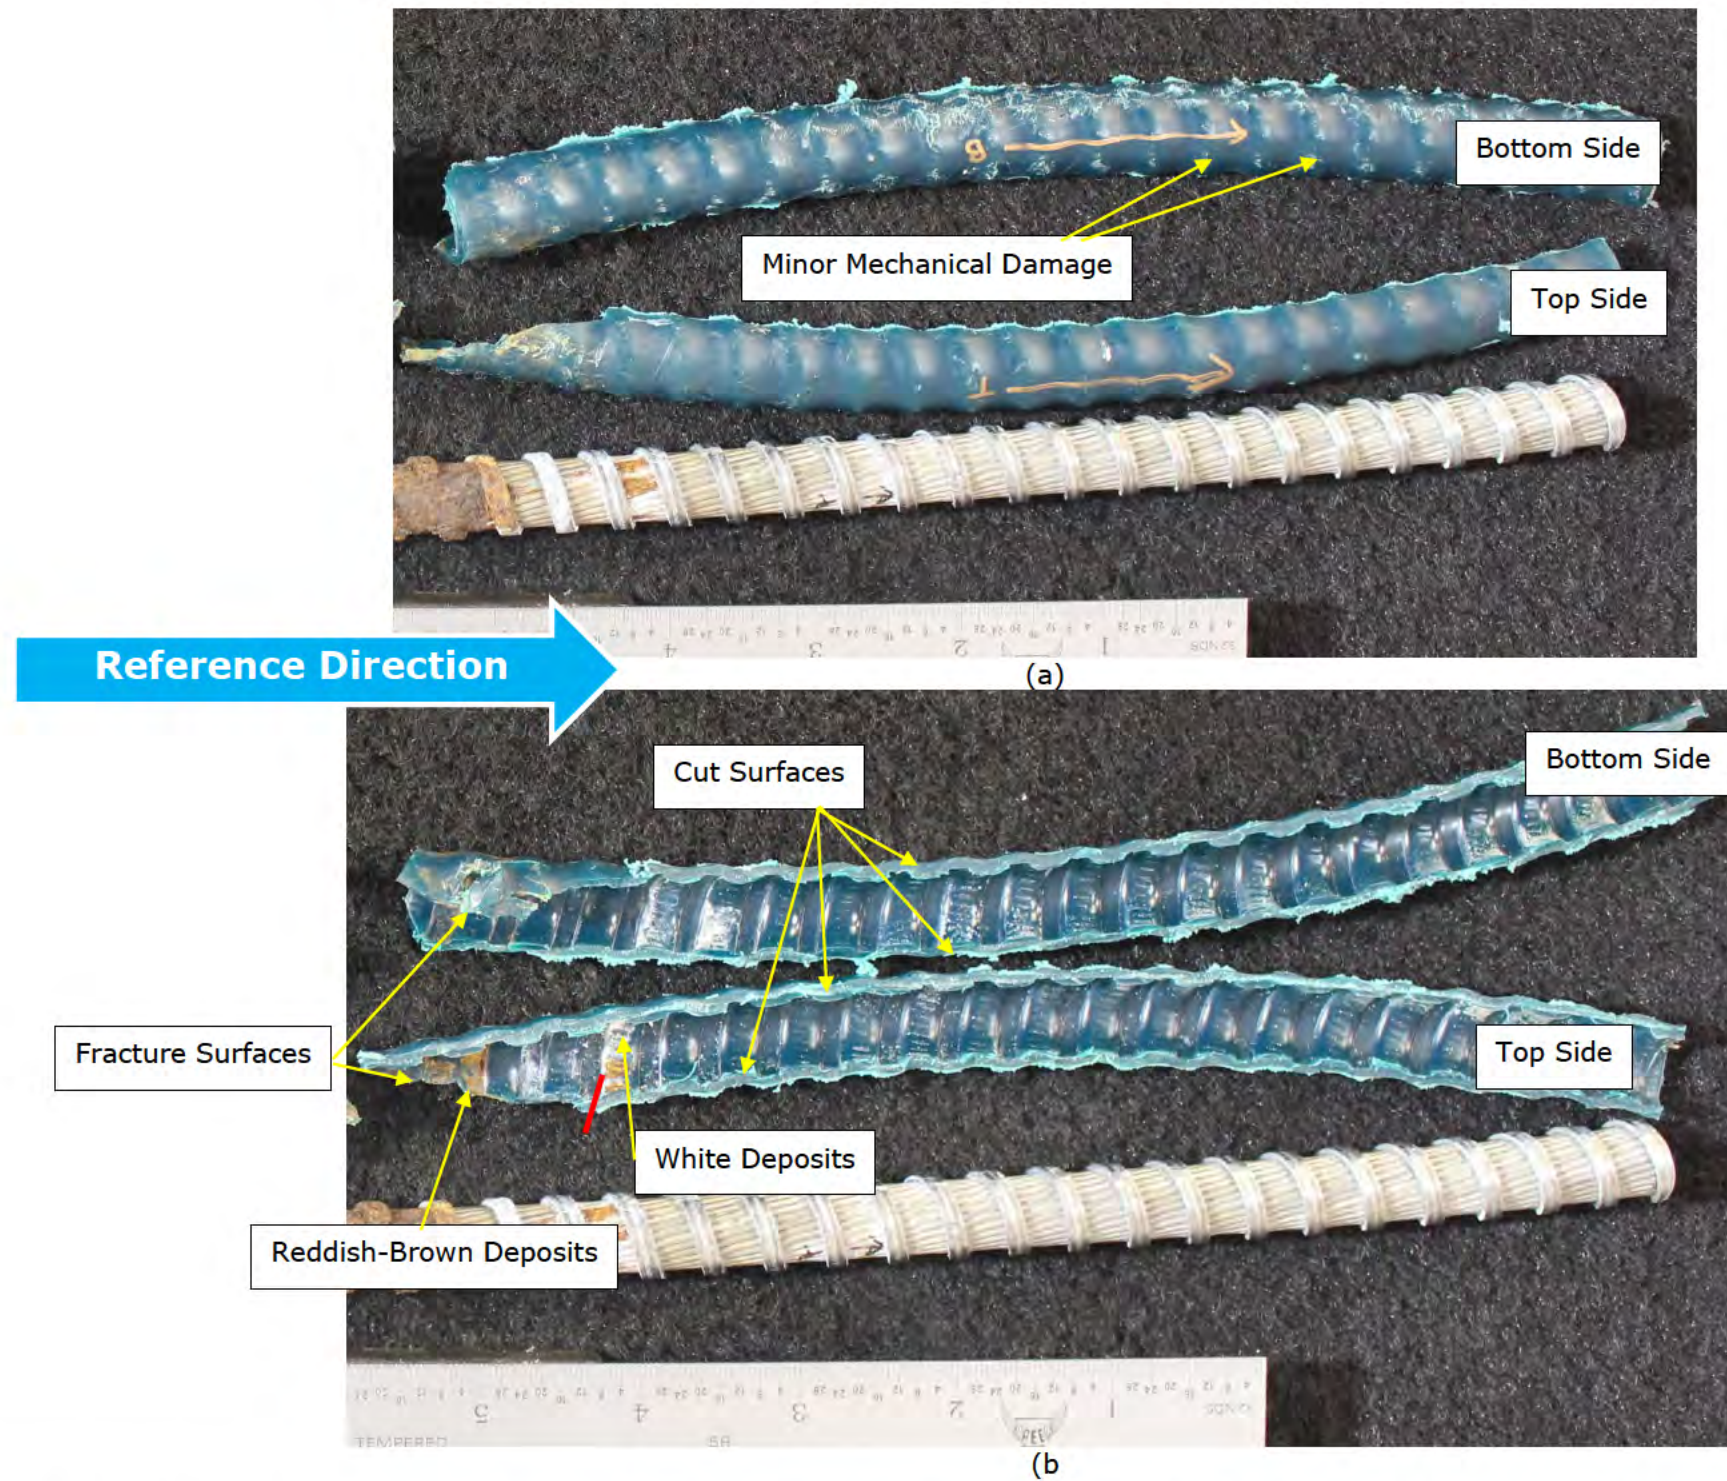
Figure 153. Photographs of the cover from the Lifeboat 8 forward control cable after dissection showing the (a) external surface and (b) internal surface near the damaged location; samples shown in Figure 149 (top). The reference direction is noted with the blue arrow. Rulers are in inches.

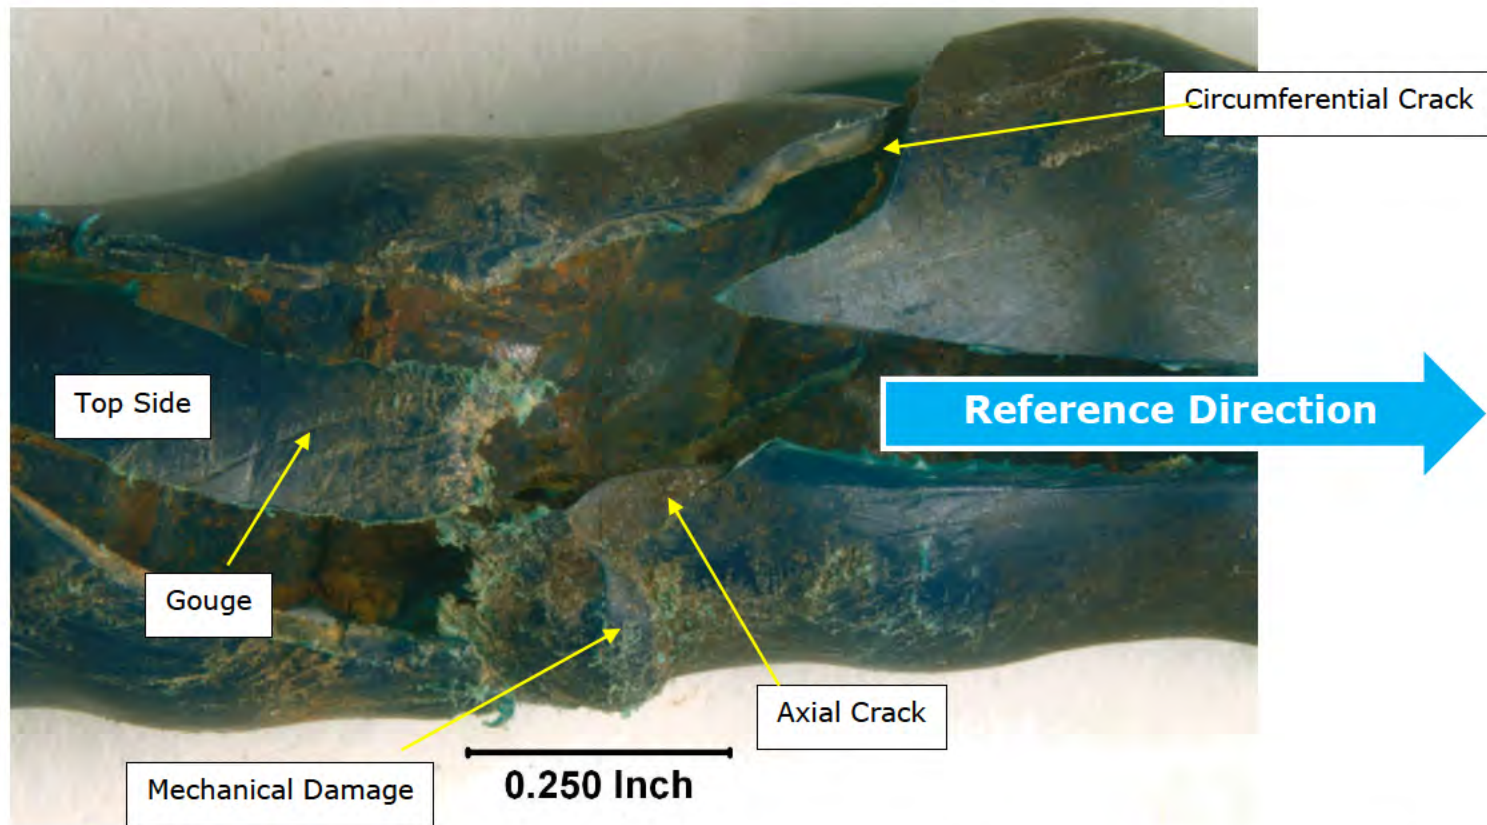
Figure 154 and Figure 155 contain light photomicrographs of the Lifeboat 7 hydrostat cable and Lifeboat 8 forward control cable, respectively, after matching the fractures surfaces. The fracture surface paths are both axial and circumferential in nature. Some mechanical damage and gouging are visible on the external surface where the cable is compromised. This damage corresponds to the location of contact with the plywood where the cables in Lifeboat 7 and Lifeboat 8 (see Figure 142) were routed. Mechanical damage in the form of impact and / or gouging was likely the primary cause(s) of failure of the cover layers of Lifeboat 7 and Lifeboat 8. With the cover layer compromised, water could ingress leading to the corrosion of the wire layer. As with the Subject Aft Cable, the cracking of the cover layer likely propagated by fatigue due to the voluminous corrosion product from the corrosion of the wire layer, which is similar to the appearance of the cover from the Subject Aft Cable of Lifeboat 6.

Figure 154. Light photomicrographs of the cover from the Lifeboat 7 hydrostat cable after matching the fractures surfaces. The reference direction is noted with the blue arrow.

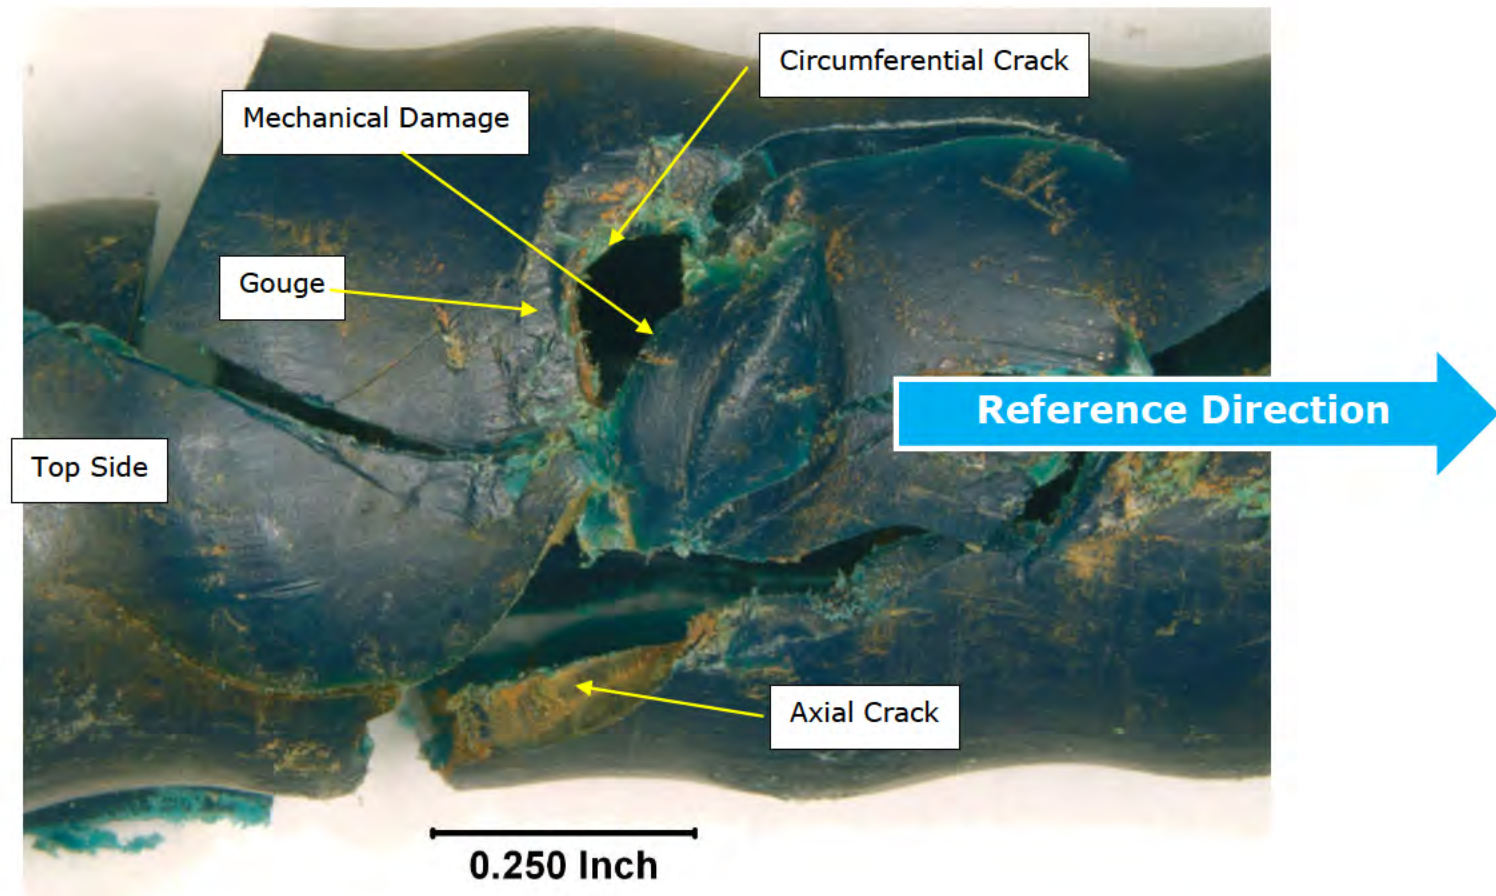
Figure 155. Light photomicrographs of the cover from the Lifeboat 8 forward control cable after matching the fractures surfaces. The reference direction is noted with the blue arrow.

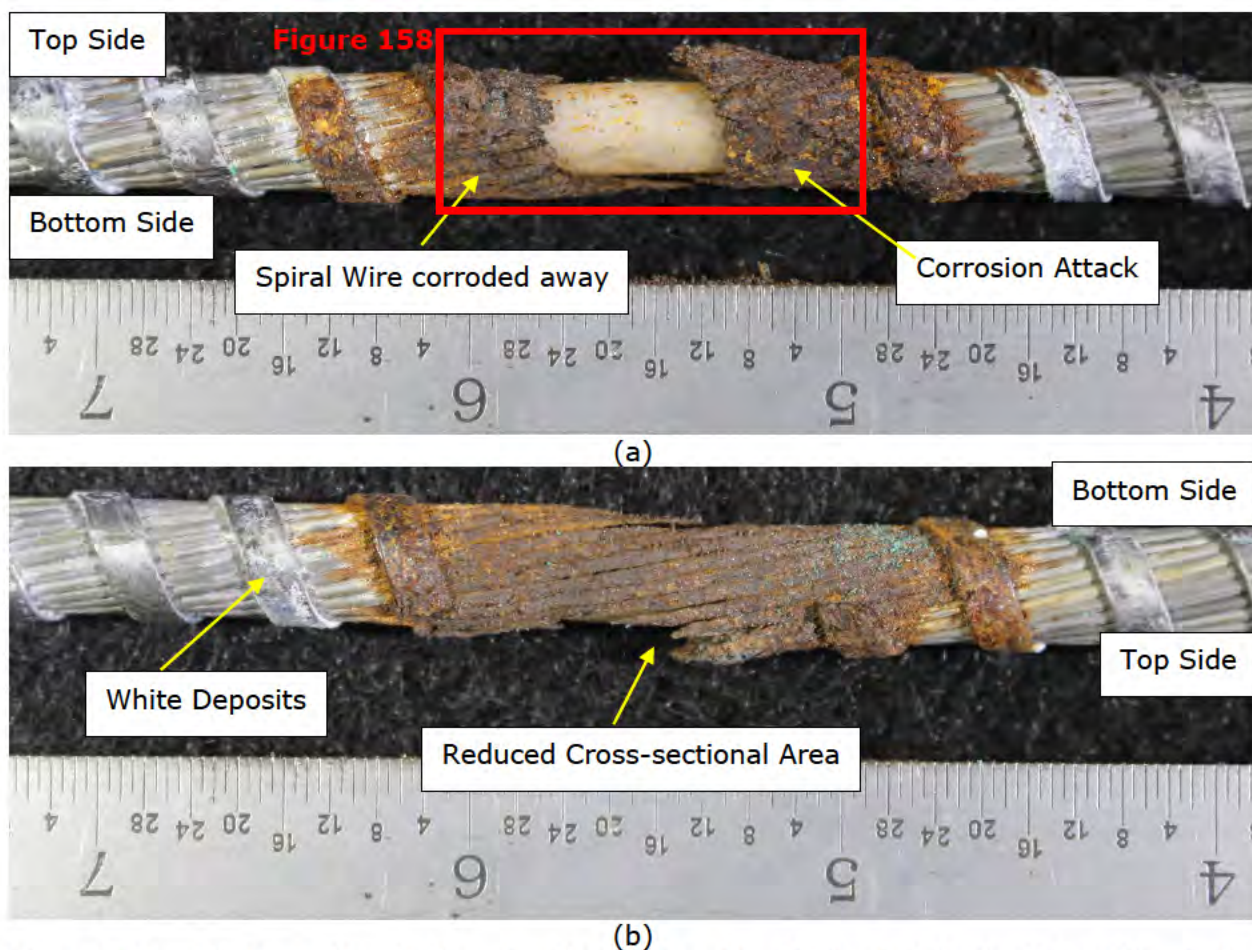
Figure 156 and Figure 157 contain photographs of the wire layers from the Lifeboat 7 hydrostat cable and Lifeboat 8 forward control cable, respectively, showing the corrosion damage; samples shown in Figure 144 and Figure 146, respectively. The corrosion attack to the Lifeboat 7 hydrostat cable is less severe than the Subject Aft Cable from Lifeboat 6, but more severe than the Lifeboat 8 forward control cable. Both cables show white deposits and reddish-brown deposits near the failure location. The reddish-brown deposits are consistent with an iron oxide and are due to the corrosion of the wire layer. The white deposits are likely zinc oxides, which suggests that the wire layer was galvanized. The strand wires in hydrostat cable of Lifeboat 7 have a reduced cross-sectional area from corrosion attack. The binder wire has been corroded away at both locations.

Figure 156. Photographs of the wire layer from the Lifeboat 7 hydrostat cable at the damaged location showing the (a) side exposing the liner and (b) the side with some wires intact; sample location shown in Figure 148 (top). The reference direction is noted with the blue arrow. Rulers are in inches.

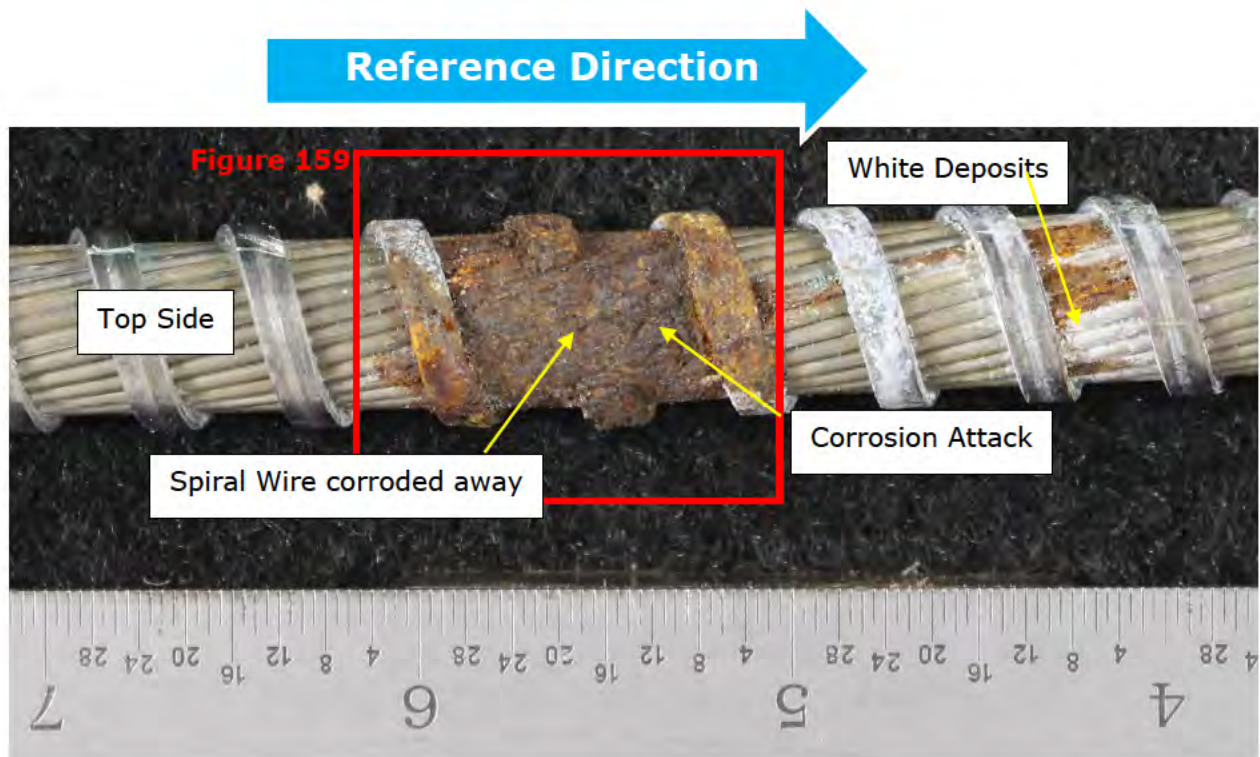
Figure 157. Photograph of the wire layer from the Lifeboat 8 forward control cable at the damaged location showing the corrosion attack to the wire layer; sample location shown in Figure 149. The reference direction is noted with the blue arrow. Ruler is in inches.
