Final Report

Auger Lifeboat 6 Incident

Shell Oil Company
Houston, Texas, USA

Report No.: O-AP-FINV / BPADG (10165575)
July 9, 2020

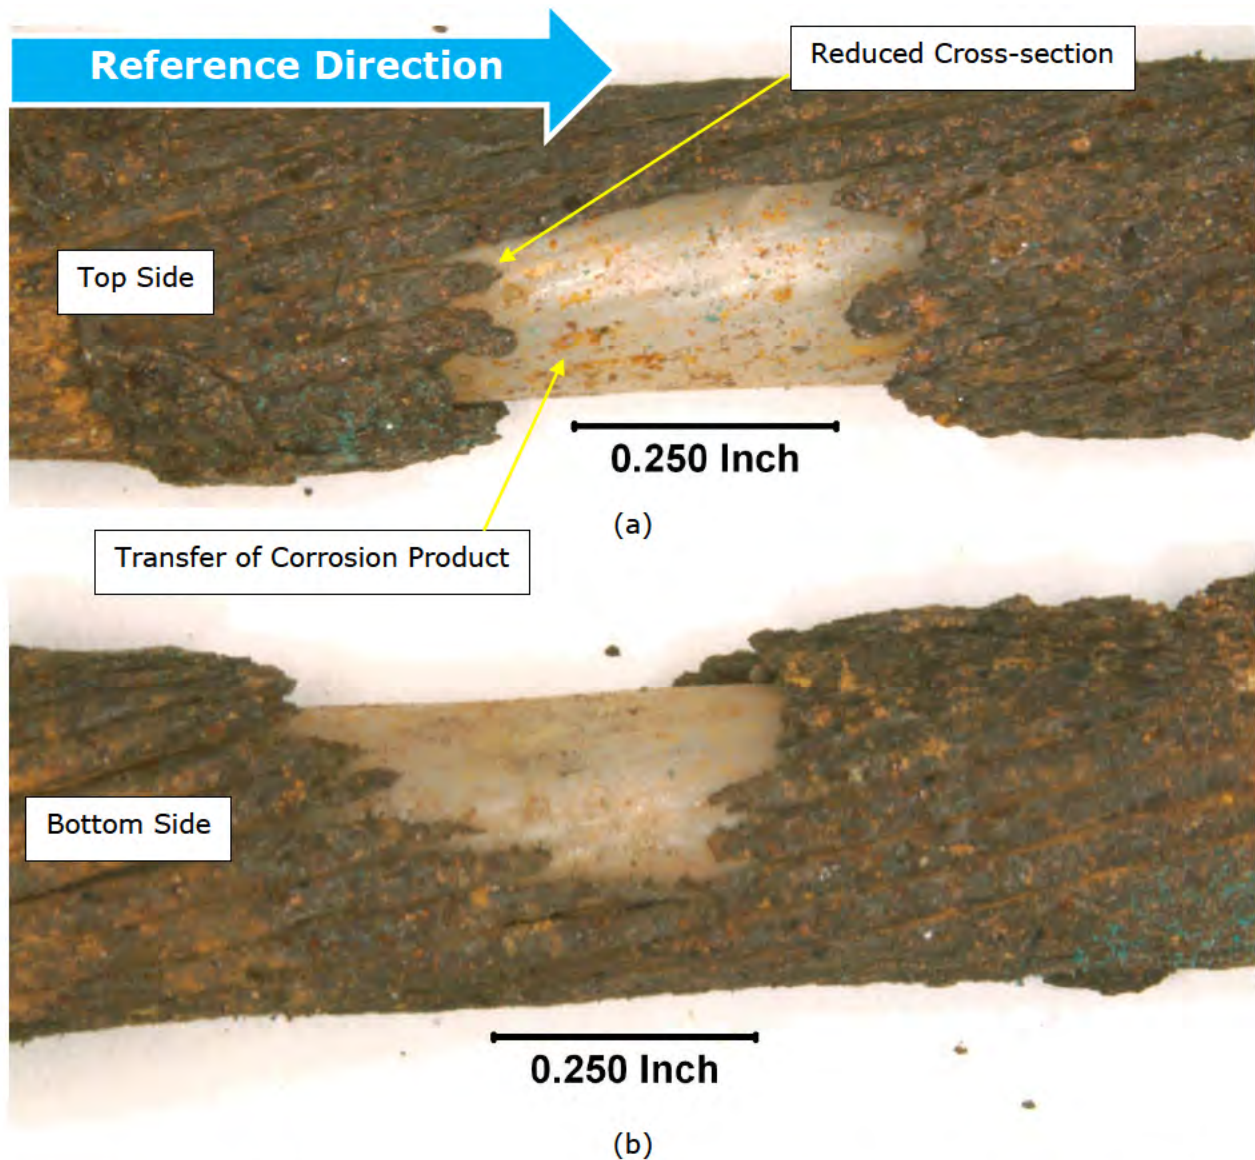
Figure 158 and Figure 159 contains light photomicrographs of the wire layer from the Lifeboat 7 hydrostat cable and Lifeboat 8 forward control cable, respectively, showing the detail of the corrosion at the damage location. The reduced cross-section area for the wires from the wire layer of Lifeboat 7 hydrostat cable is more evident. Some transfer of the corrosion product of wire layer to the liner is evident in Figure 158. Pitting in the area of most severe corrosion is evident for the wire layer from the Lifeboat 8 forward control cable. This area is coincident with the area where the spiral cable would have been. It is worth noting that the corrosion damage accumulation on the wire layer from forward control cable of Lifeboat 8 was less severe the wire layer from the hydrostat cable of Lifeboat 7. The bottom side of Lifeboat 8 forward control cable did not show significant corrosion attack.

Figure 158. Light photomicrographs showing the (a) top and (b) bottom of the wire layer from the Lifeboat 7 hydrostat cable showing the corrosion damage; location shown in Figure 156. The reference direction is noted with the blue arrow.

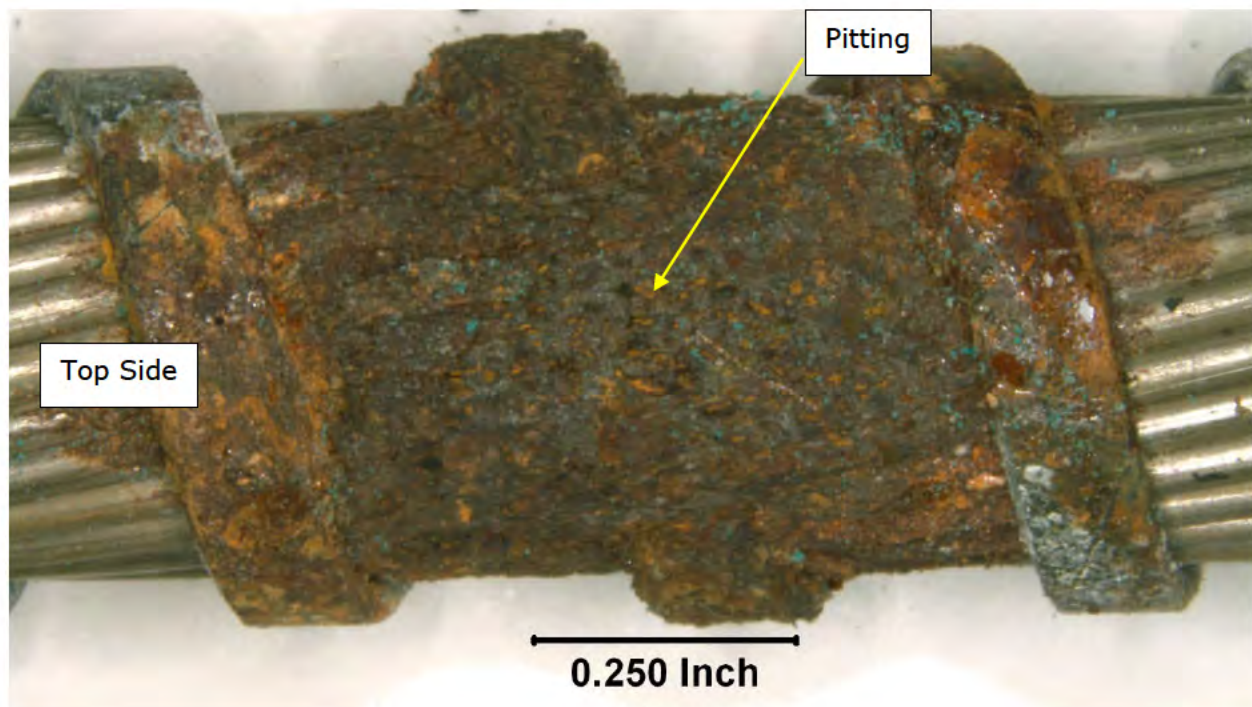
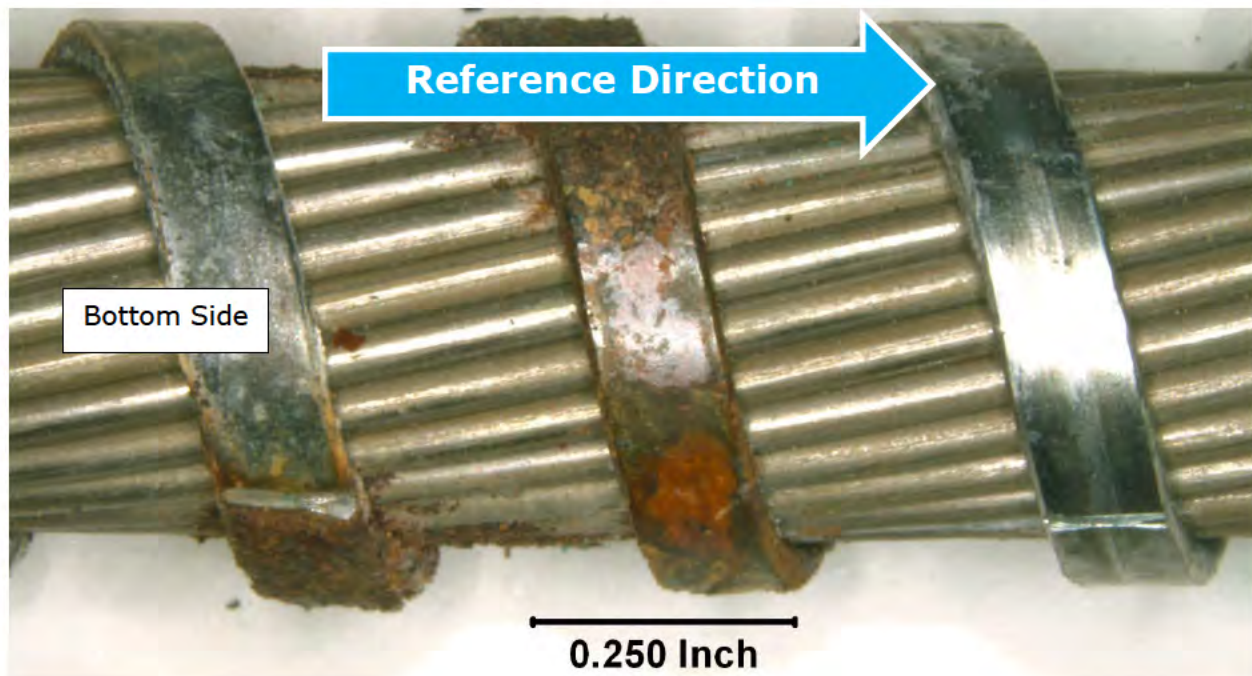
Figure 159. Light photomicrographs showing the (a) top and (b) bottom of the wire layer from the Lifeboat 8 forward control cable showing the corrosion damage; location shown in Figure 157. The reference direction is noted with the blue arrow.

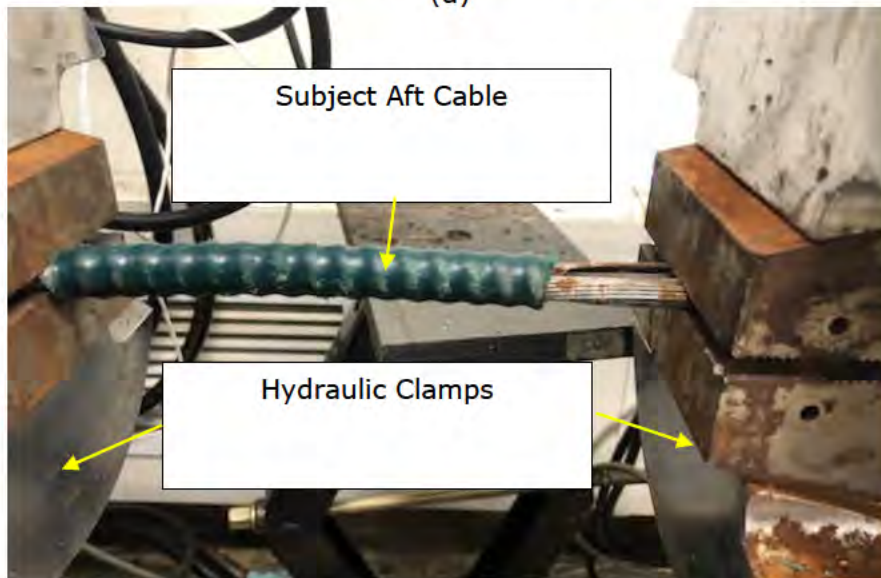
Figure 161. Photographs showing the Subject Aft Cable in the hydraulic clamps (a) before and (b) after mechanical testing as well as a table summarizing the results of the mechanical testing of the Subject Aft Cable and Exemplar Cable.

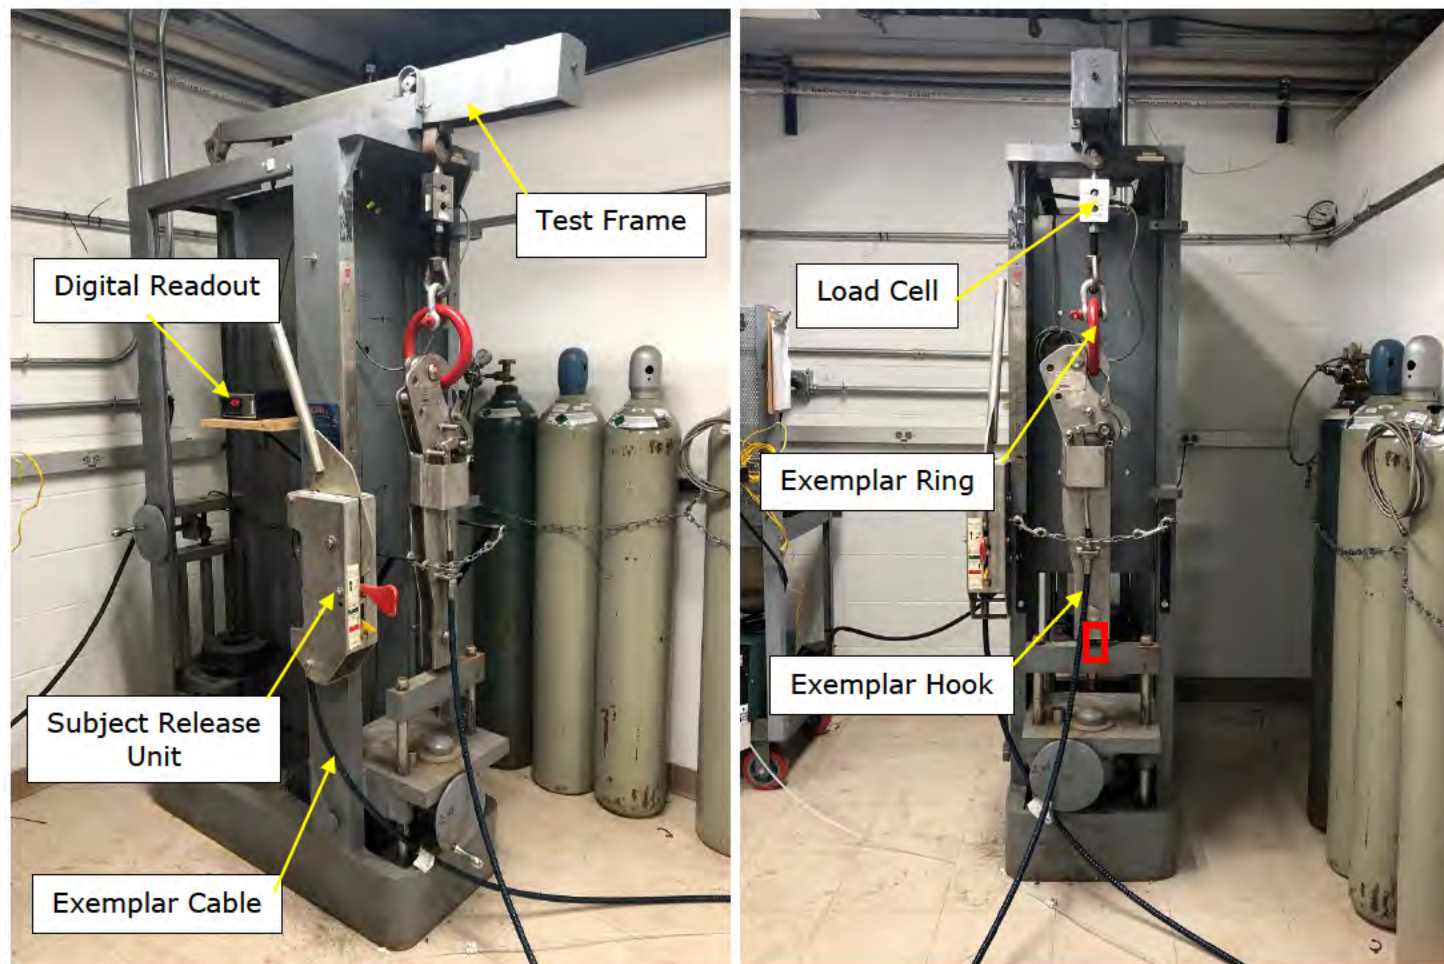
Figure 162. Photographs showing the test rig for the load testing with the Exemplar Cable, Exemplar Hook, Exemplar Ring, and Subject Release Unit.

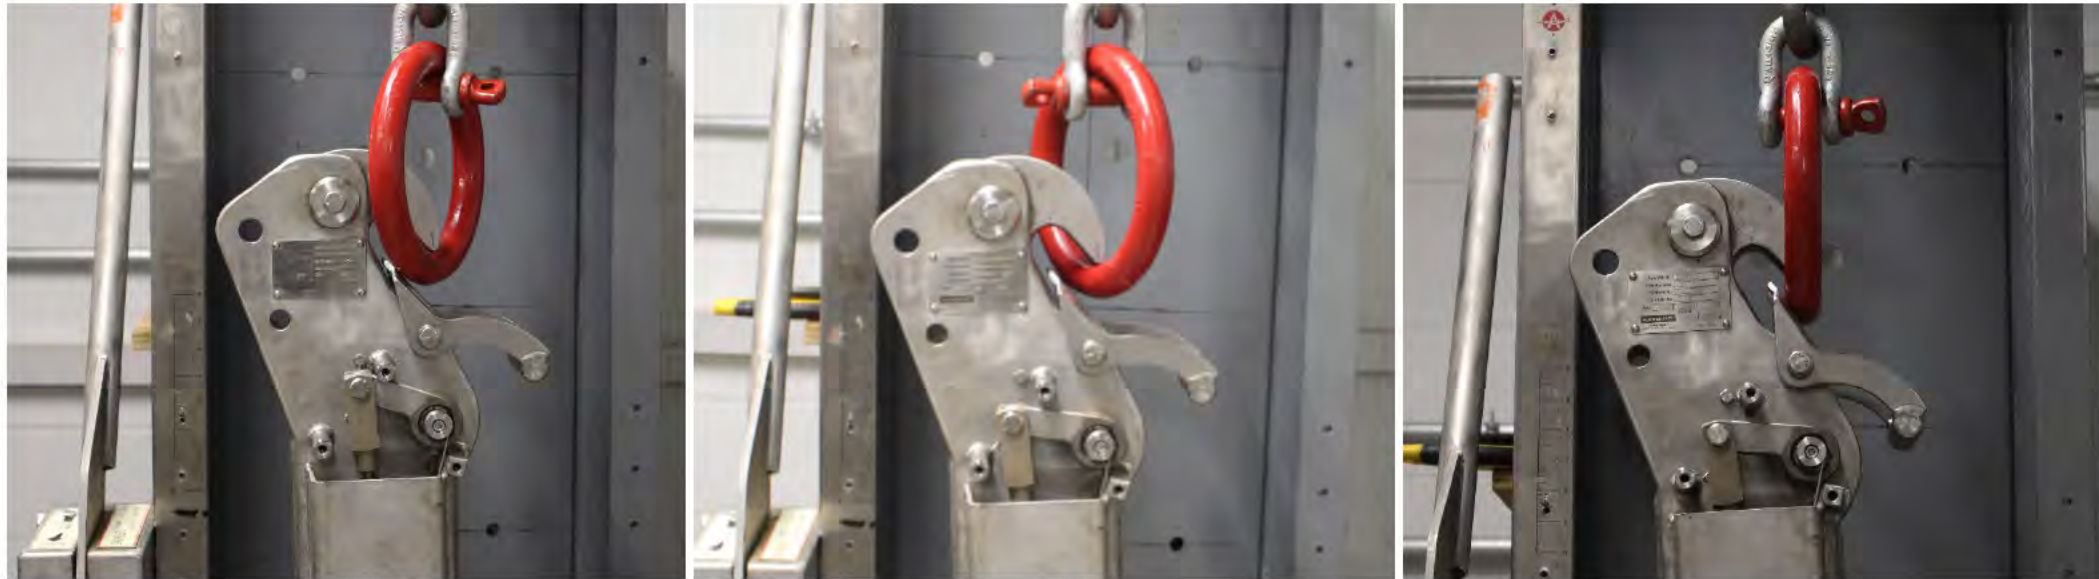
Figure 163. Photographs showing (a) Scenario 1, (b) Scenario 2, and (c) Scenario 3 of the ring resting on the point of the Exemplar Hook and a table summarizing the results of the load testing. In Scenario 1 and 2, the ring did not move, but in Scenario 3 the ring slipped off the hook point.

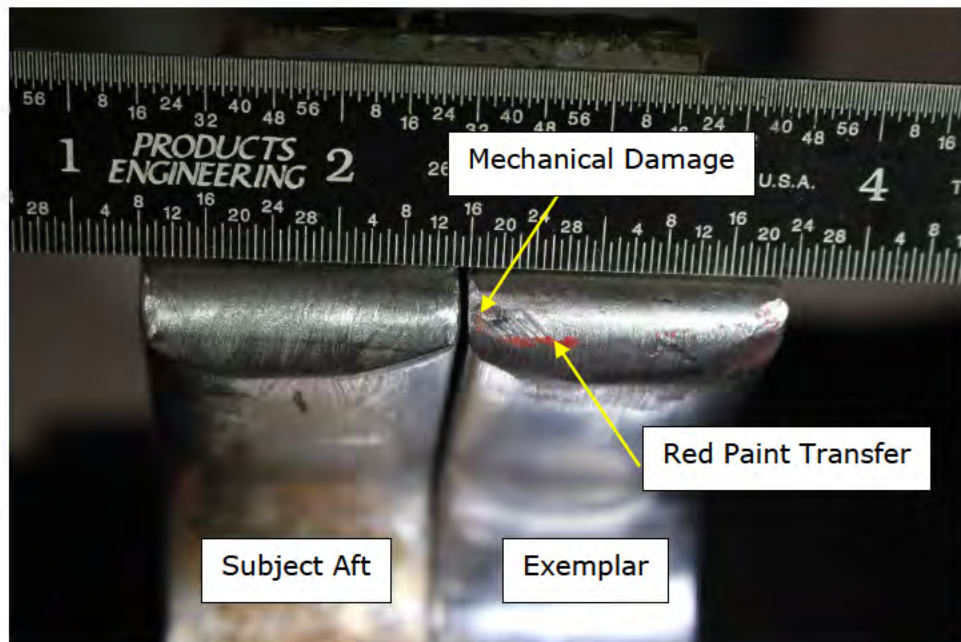
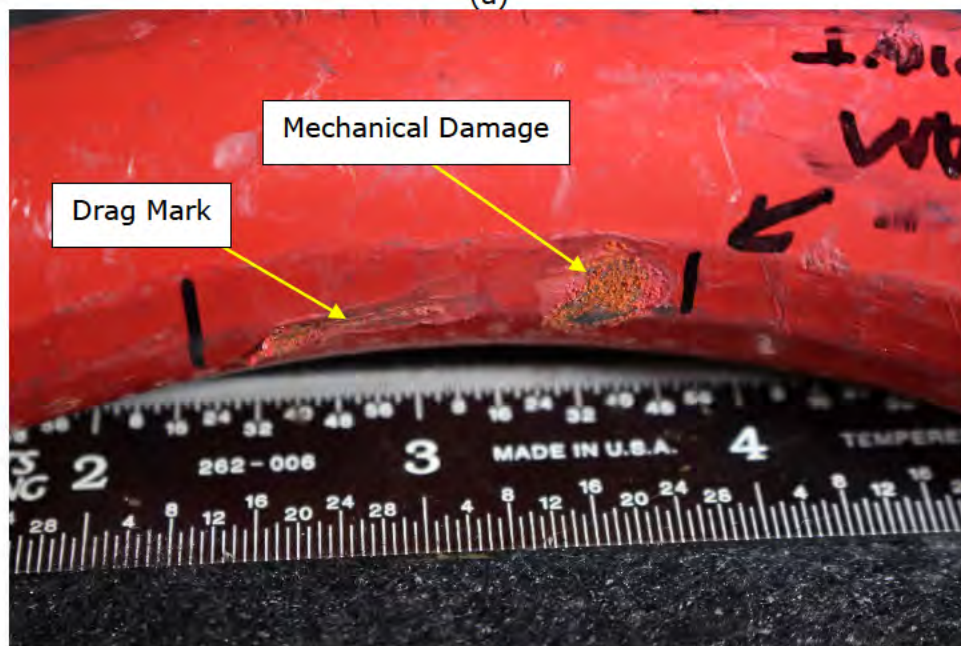
Figure 164. Photographs showing (a) the point of the Exemplar Hook compared to the Subject Aft Hook and (b) the mechanical damage to the ring after testing Scenario 1. Rulers are in inches.

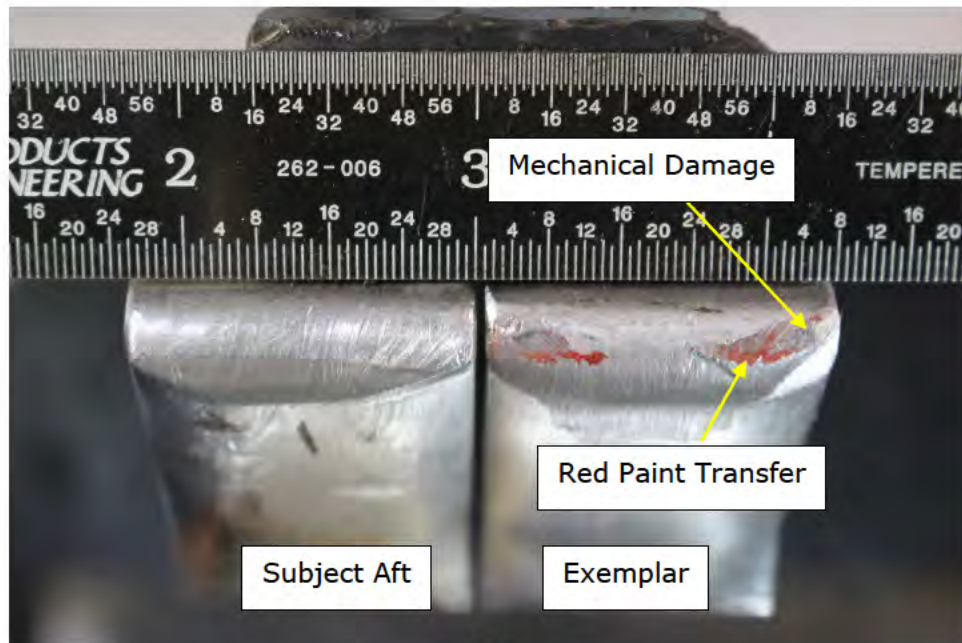
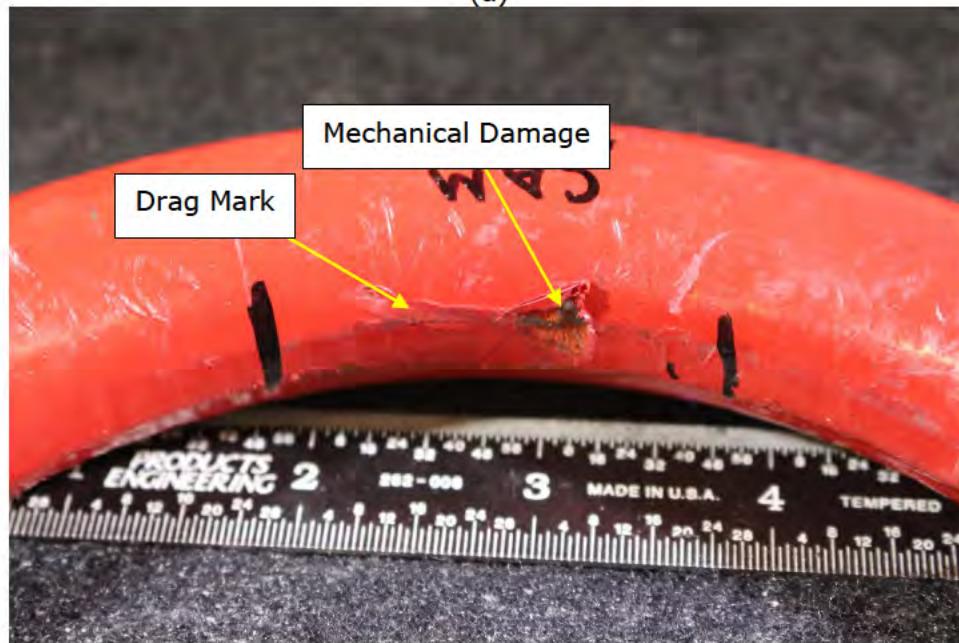
Figure 165. Photographs showing (a) the point of the Exemplar Hook compared to the Subject Aft Hook and (b) the mechanical damage to the ring after testing Scenario 2. Rulers are in inches.

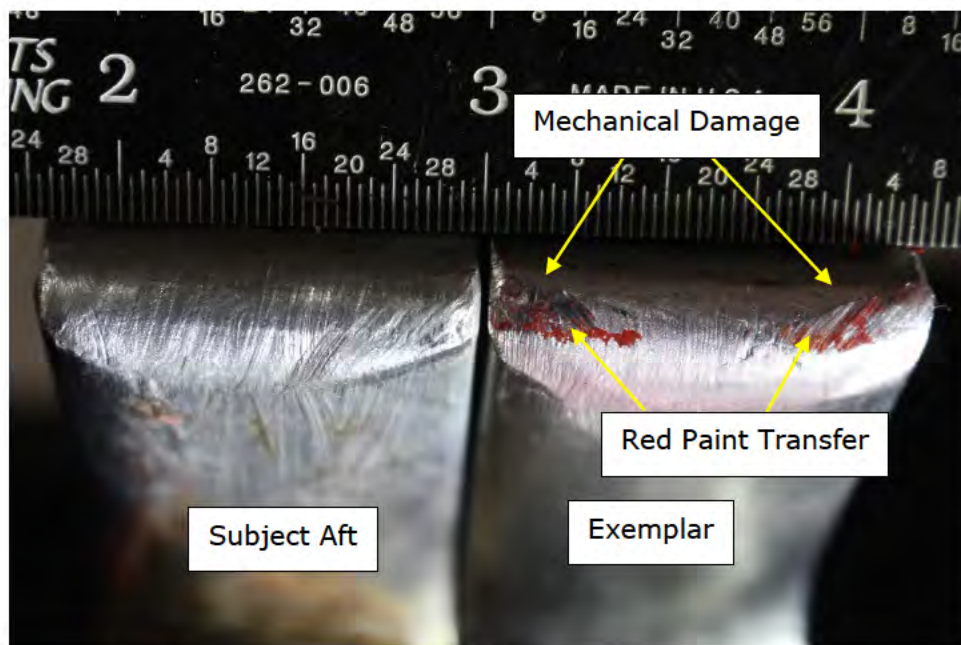
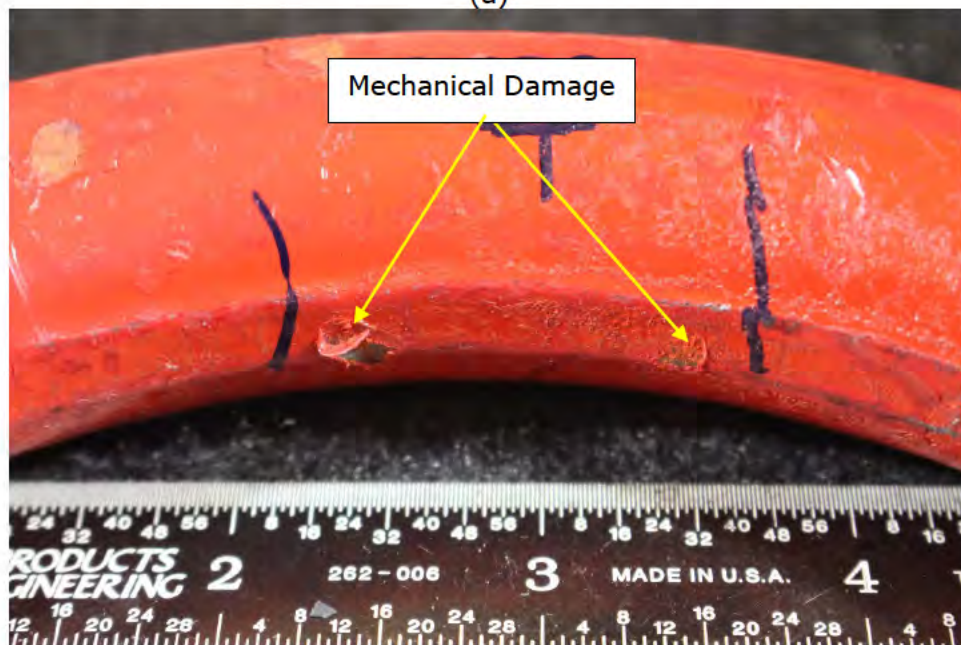
Figure 166. Photographs showing (a) the point of the Exemplar Hook compared to the Subject Aft Hook and (b) the mechanical damage to the ring after testing Scenario 3. Rulers are in inches.

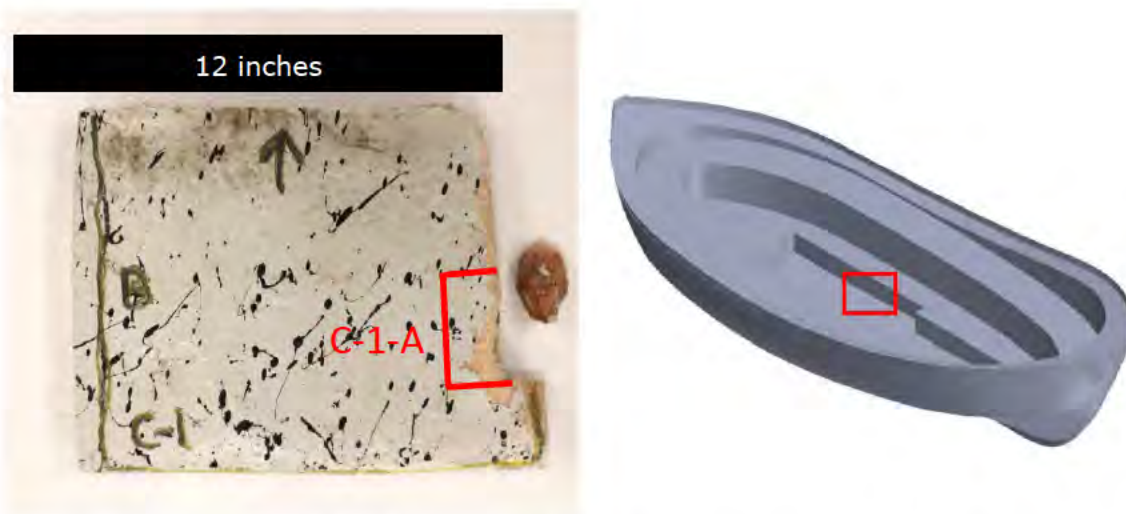
Figure 168. Photograph of Sample C-1 and schematic showing the location where the sample was removed from the inner hull. Sample C-1 was located near the engine mount. The location of the sample examined in the SEM, Sample C-1-A, is shown. Ruler is in inches.

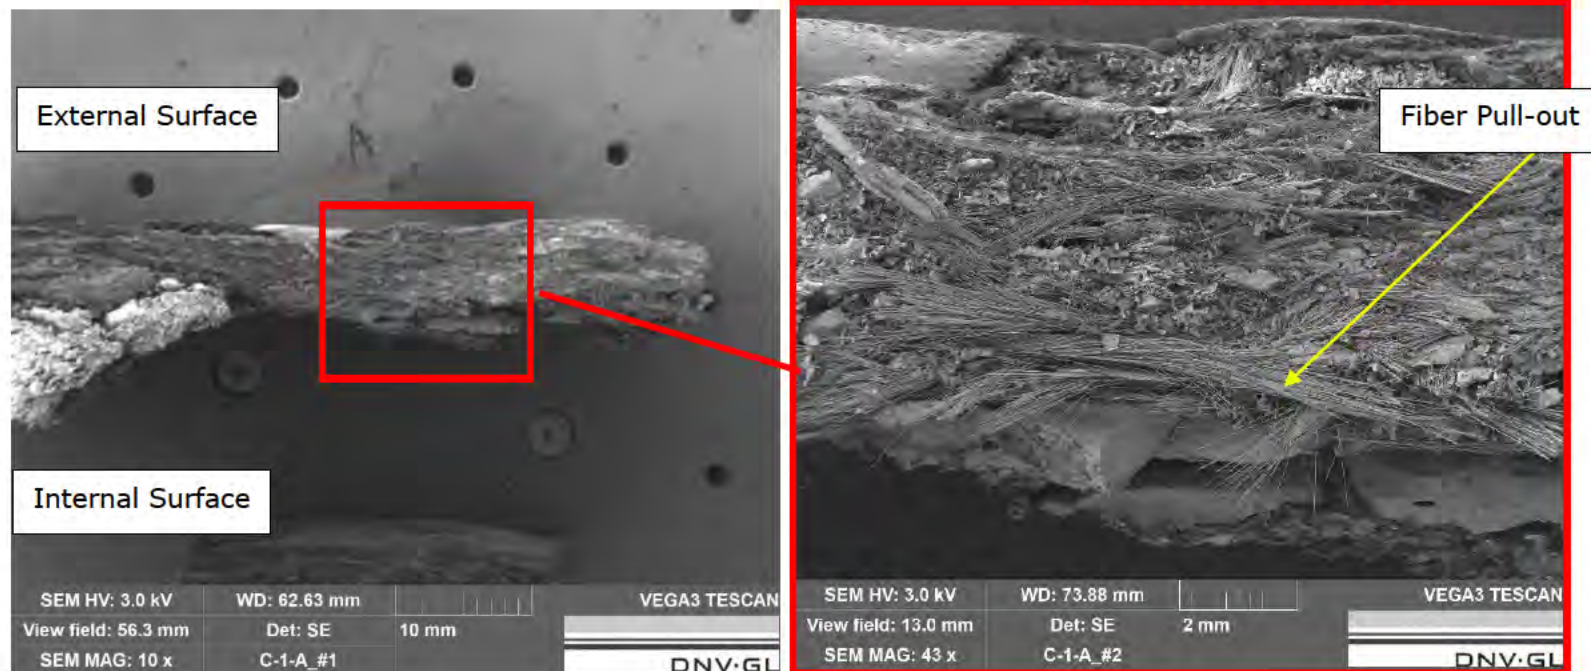
Figure 169. SEM images of Sample C-1-A and schematic showing the fracture surface at a low magnification. Fiber pull-out from the resin matrix is visible near the internal surface. Sample location is shown in Figure 168.

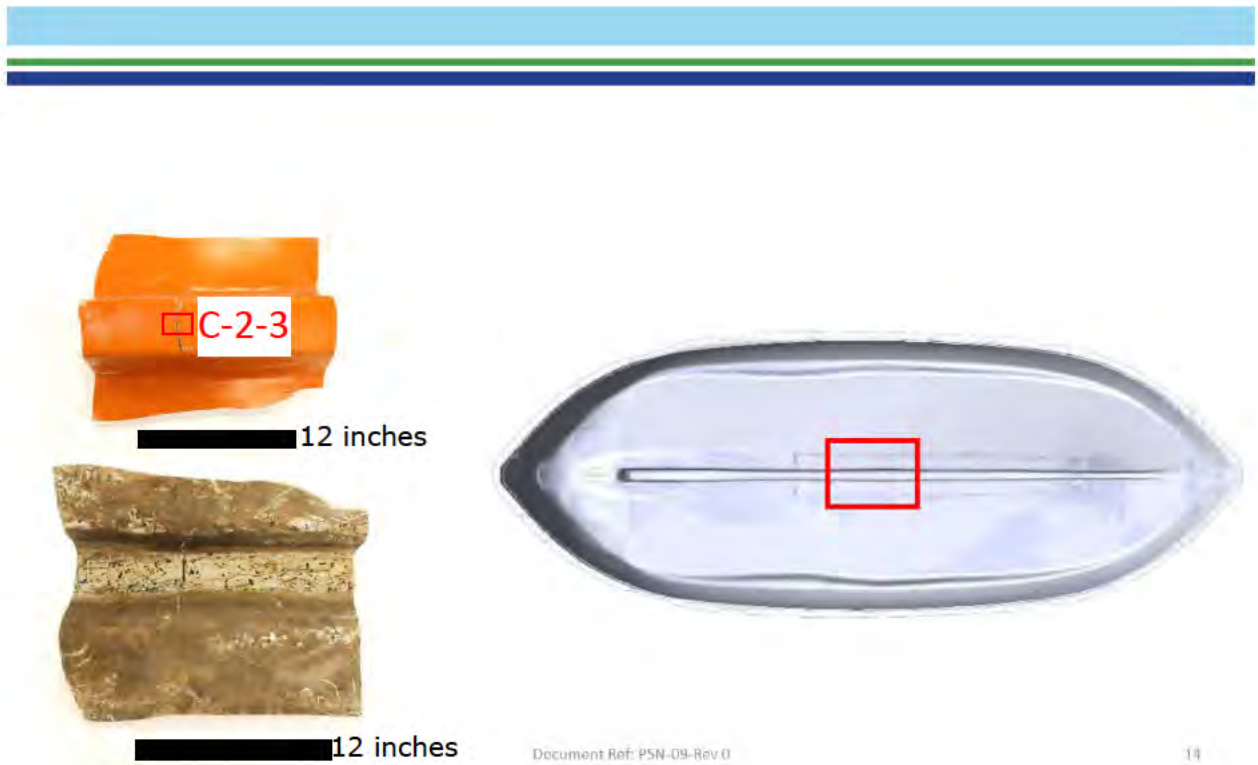
Figure 171. Photographs of Sample C-2 and schematic showing the location where the sample was removed from the inner hull. Sample C-2 was located near a crack in the keel. The location of the sample examined in the SEM, Sample C-2-3, is shown.

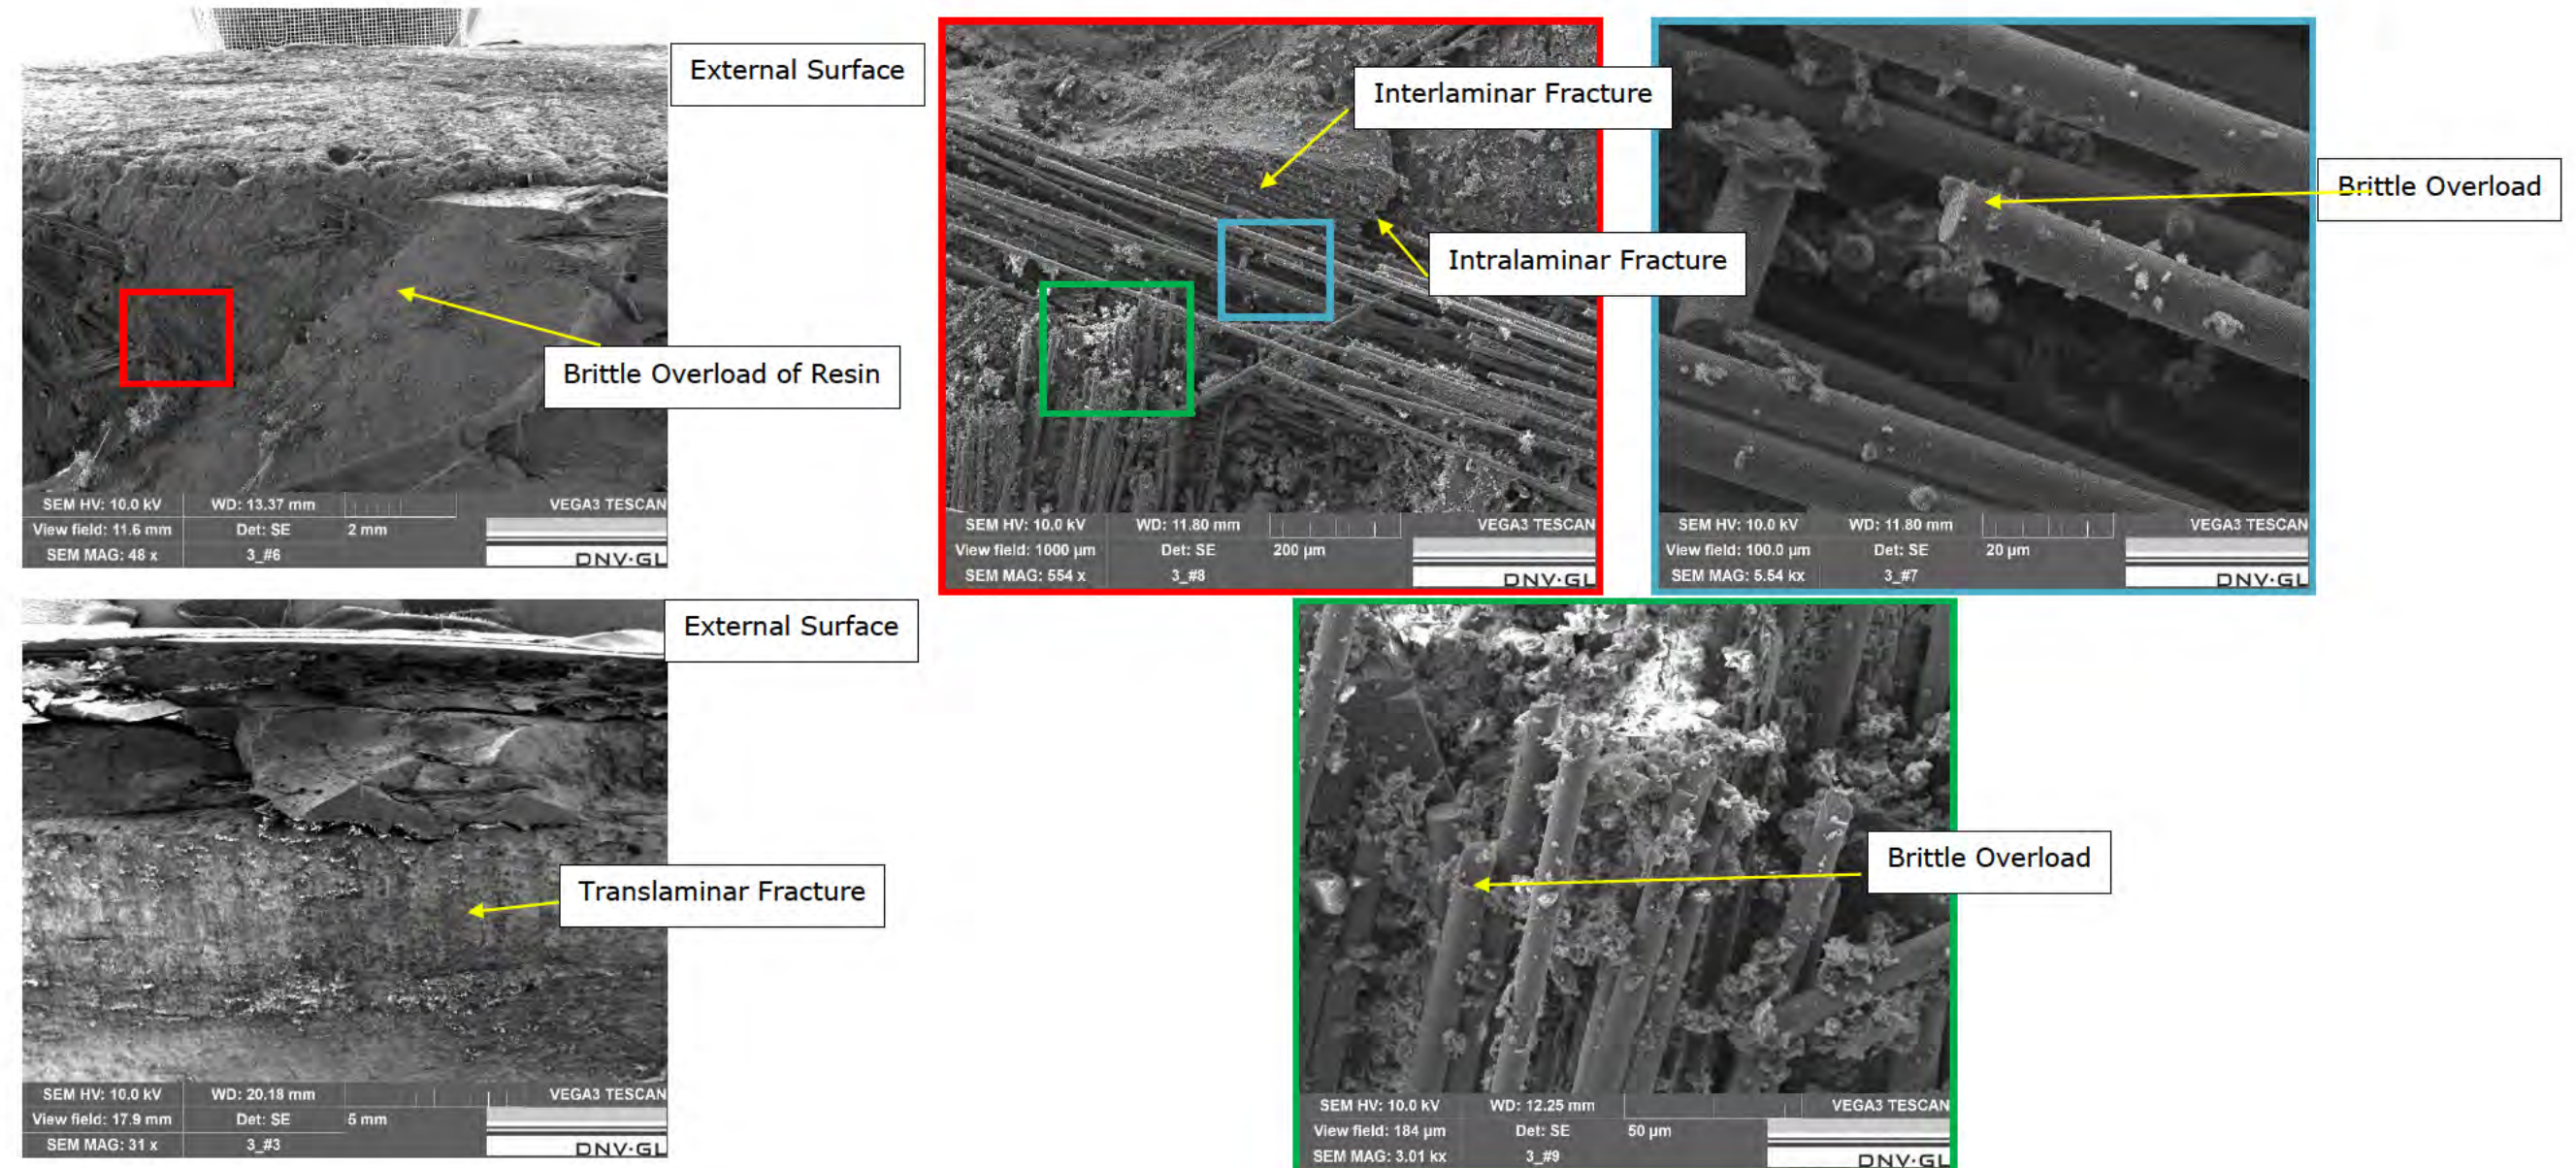
Figure 172. SEM images of Sample C-2-3 showing notable fractures of glass fibers.

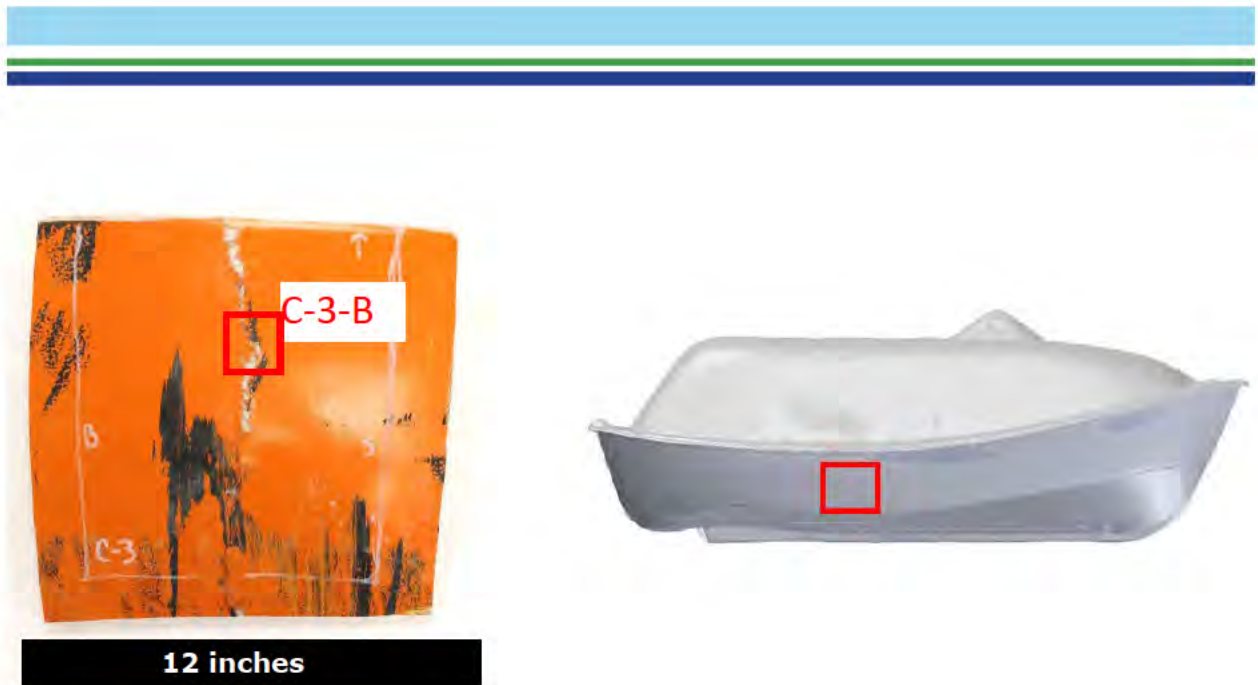
Figure 173. Photograph of Sample C-3 and schematic showing the location where the sample was removed from the outer hull. Sample C-3 was located 11.4 feet from the aft of Lifeboat 6. The location of the sample examined in the SEM, Sample C-3-B, is shown. Ruler are in inches.

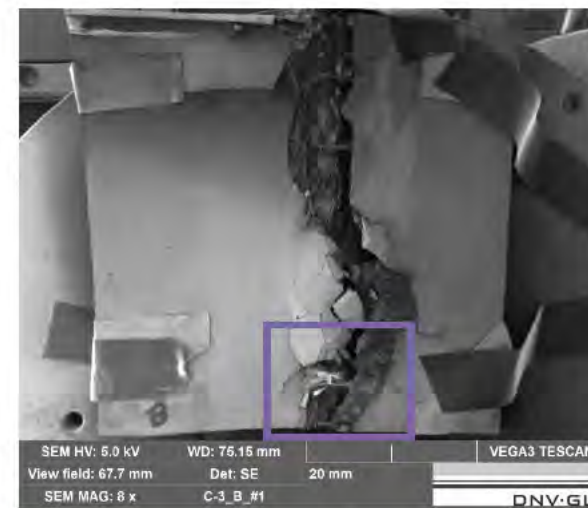
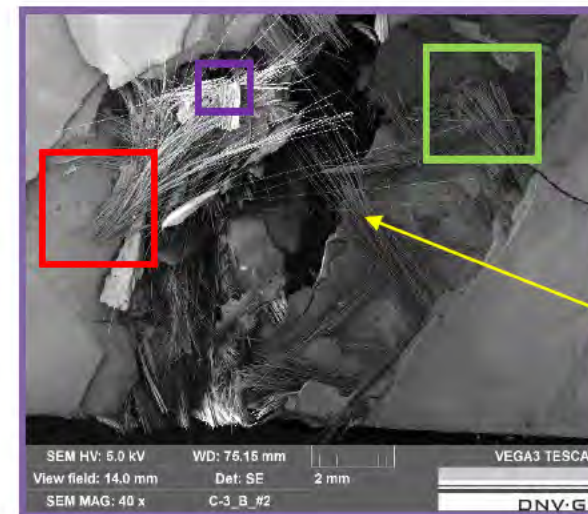
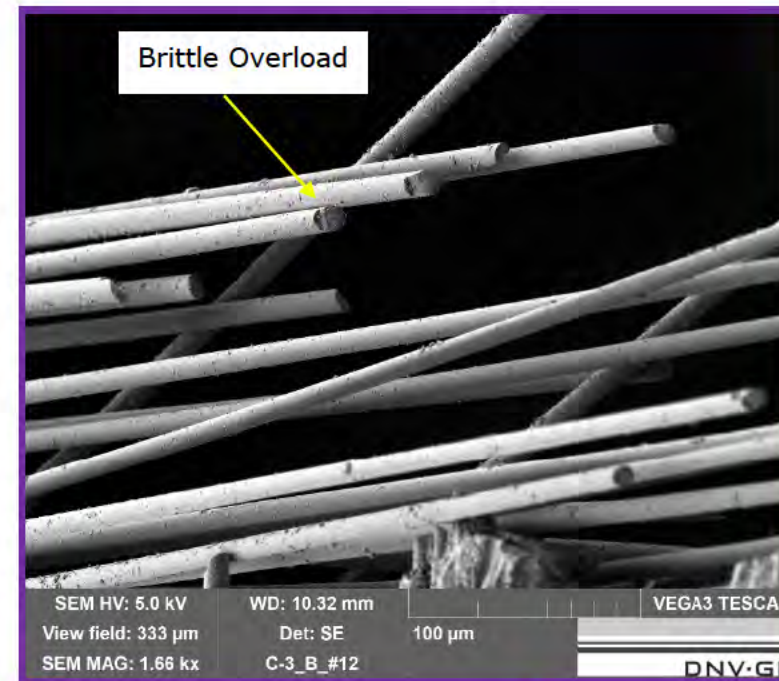
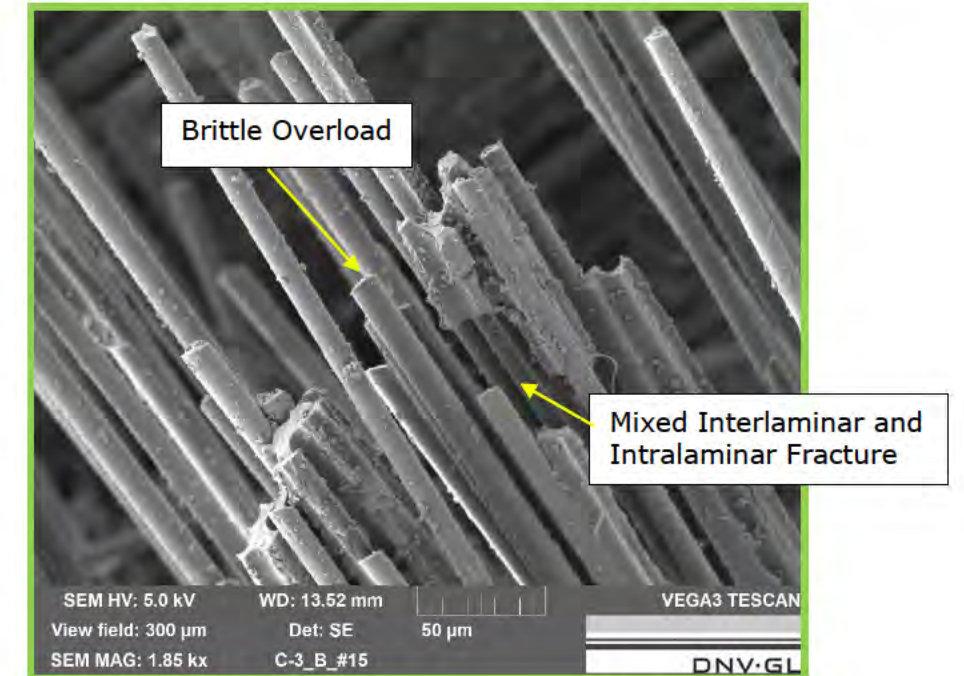
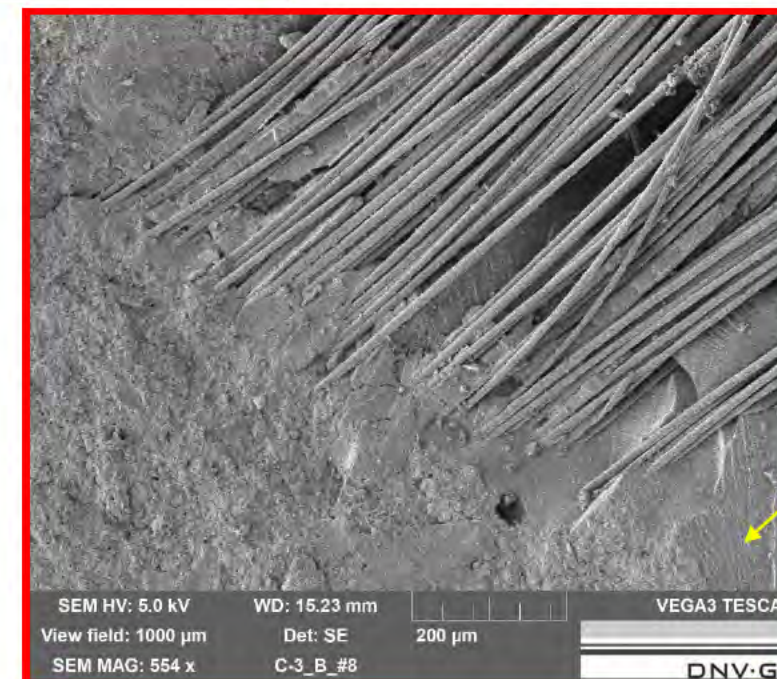
Fiber pull-out

Brittle Overload

Mixed Interlaminar and Intralaminar Fracture

Brittle Overload of Resin

Figure 174. SEM images of Sample C-3-B showing notable fractures of glass fibers.

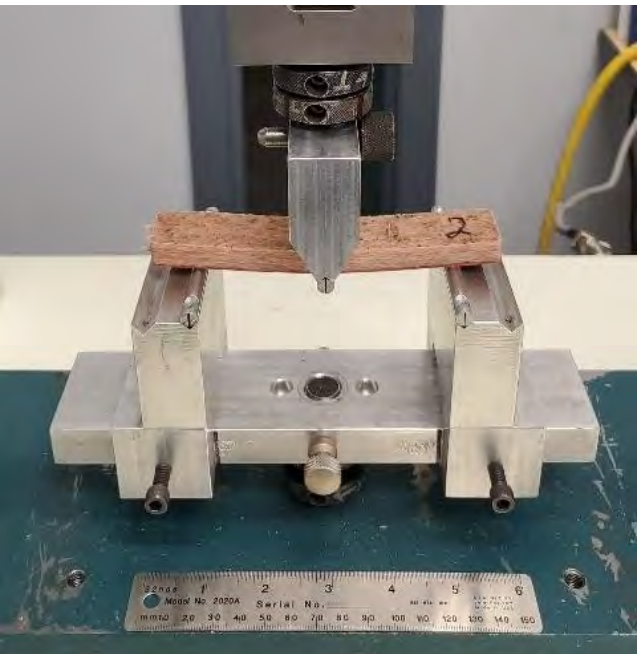
In addition, flexural testing was carried out on coupons removed from two orientations (0° and 90°) to confirm isotropy. Isotropy signifies that the material properties of the fiberglass are not directionally dependent, and a single material property can be applied. The results of this testing also are shown in Figure 176, and show isotropic properties at the 0° and 90° orientations of the specimens.

Figure 176. Photograph of the flexural testing setup on universal testing machine and tables of results for flexural testing of panels extracted from the locations shown in Figure 43.

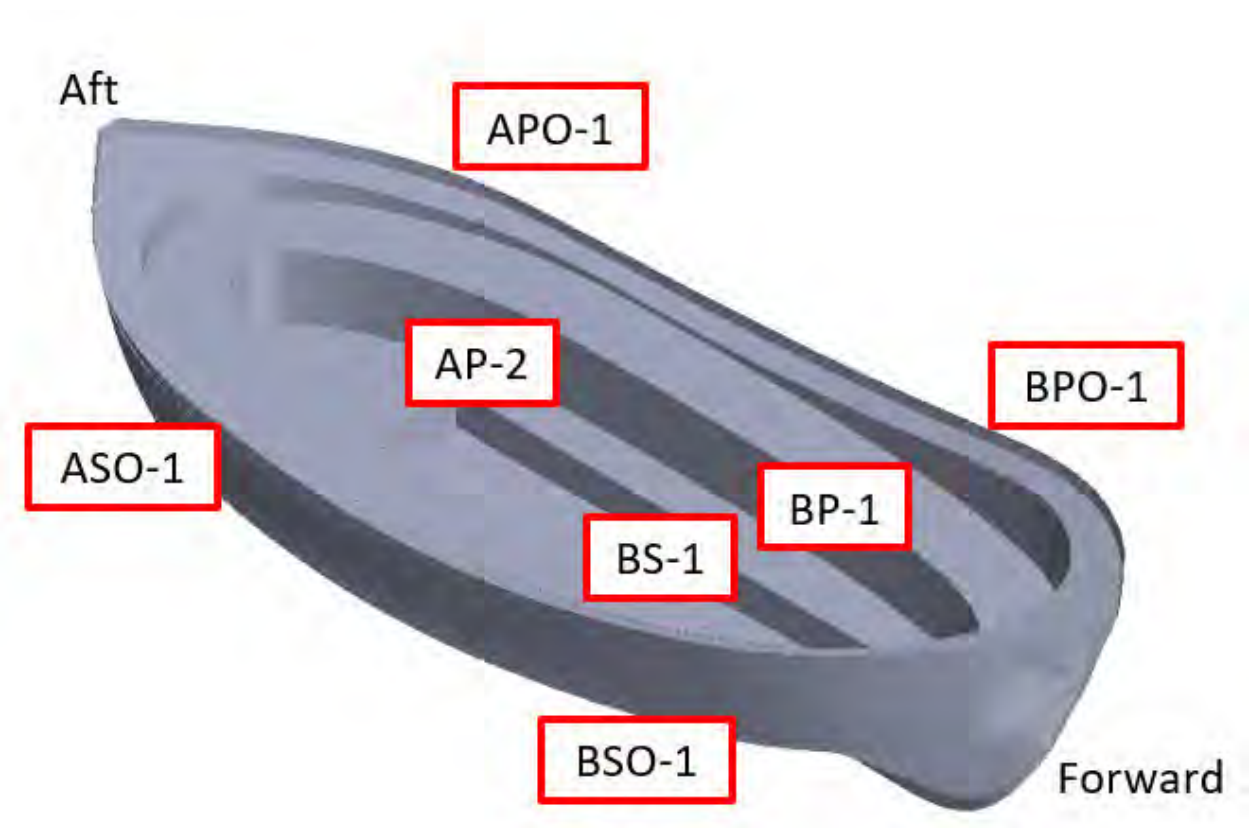
In addition to flexural testing, a glass fiber content analysis was performed at five locations within each panel to determine the average percentage of glass fiber within each panel. As stated previously, the glass fiber within the composite matrix provides the majority of the material's strength. The tests were carried out in accordance with ASTM D5630 – 13 Standard Test Method for Ash Content in Plastics. The results are shown in Figure 177 and indicate that the interior panels (AP-2 and BS-1, i.e. non-structural) have a lower glass-fiber content than the exterior panels (i.e. structural). This correlates with the findings of the flexural testing performed that indicated that the interior panels had lower strength.

Figure 177. Photograph showing the sample locations and a table summarizing the results of glass fiber content analysis via ash testing.

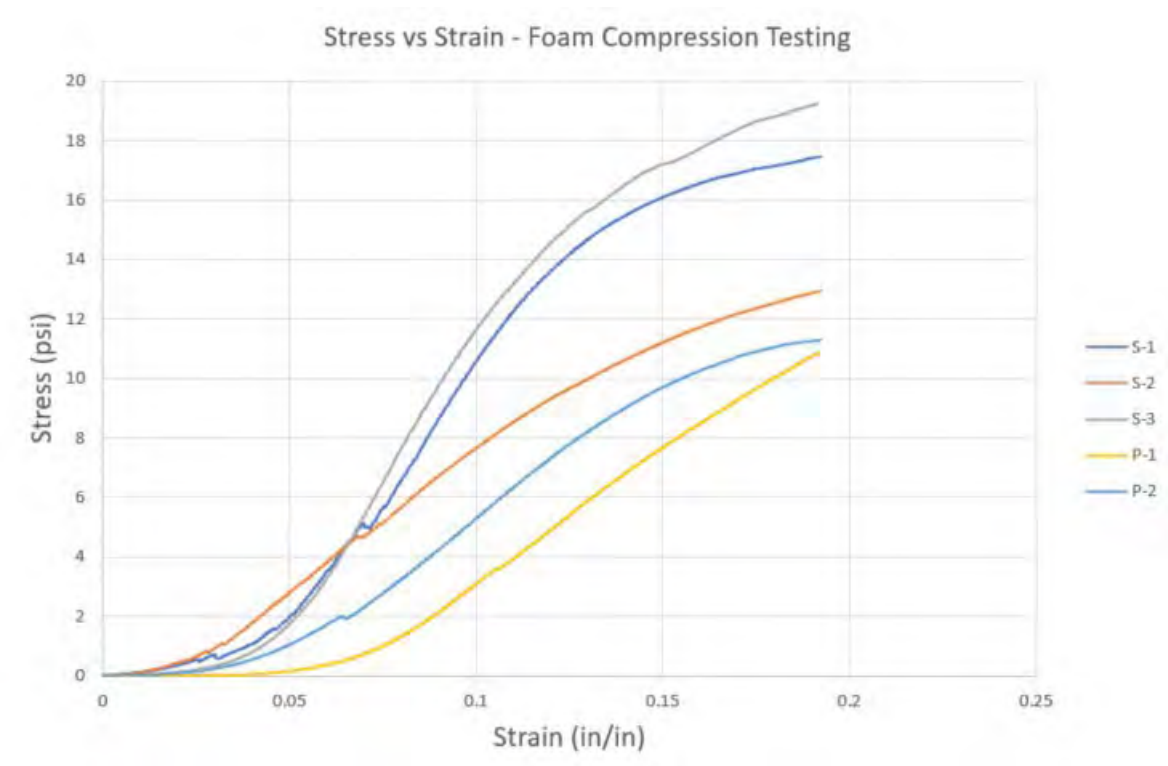
Compression testing was performed on the inner foam to obtain material properties to be applied to the Finite Element Model. The foam samples were removed from the interior of the vessel from under the fiberglass panels BP-1 and BS-1, which are shown in Figure 43. The testing was carried out in accordance with ASTM D3574 – 17 Standard Test Methods for Flexible Cellular Materials—Slab, Bonded, and Molded Urethane Foams. The foam samples were extracted from one port location and one starboard location. An average compression modulus was calculated from testing the two locations and the results were applied to the Finite Element model. The resulting Stress-Strain curve is shown in Figure 178. Samples with "S" refer to starboard and were removed from under location BS-1 and the samples with "P" refer to port and were removed from under location BP-1.

Figure 178. Schematic showing the stress-strain curves generated through compression testing foam from the Lifeboat. Samples with “S” refer to starboard and were removed from under location BS-1 and the samples with “P” refer to port and were removed from under location BP-1; locations of BS-1 and BP-1 are shown in Figure 43.
