Final Report

Auger Lifeboat 6 Incident

Shell Oil Company
Houston, Texas, USA

Report No.: O-AP-FINV / BPADG (10165575)
July 9, 2020

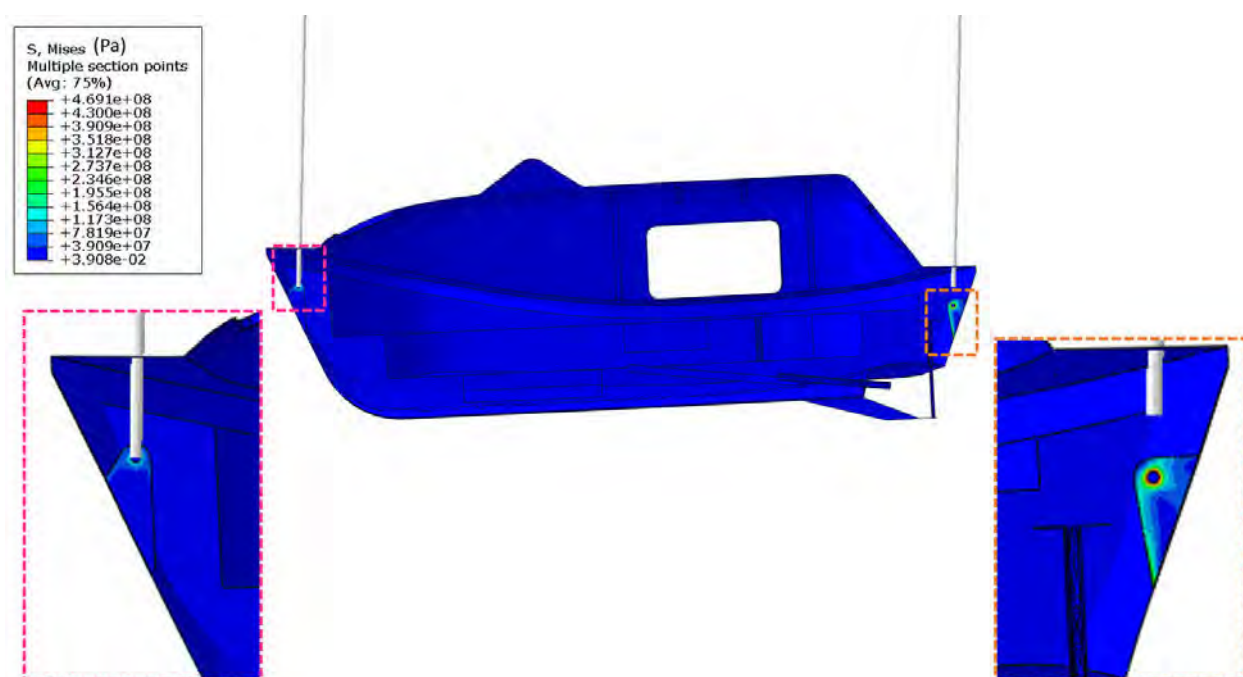
For the model with the aft bumper modeled as rubber, the lifeboat was lifted into the bumper approximately 3.1 inches before the model was unable to achieve a converged solution. For the model with the rigid bumper, the lifeboat was raised approximately 1.08 inches into the bumper before the break stress of the fiberglass was achieved. If it is assumed that the point at which the bumper model fails to converge is the point at which the rubber material ceases to absorb any additional elasticity (i.e. begins to behave as a rigid bumper). One could then approximate the total travel up into the bumper by summing the maximum vertical displacement between the bumper model and the rigid bumper model. Considering this and the model results, the total vertical displacement into the aft bumper would have been approximately 4.18 inches before the break stress of the fiberglass near the bumper was achieved. Stress contours for the lifeboat with only gravity and engine weight loading applied are shown in Figure 182 while stress contours of the lifeboat raised approximately 3.1 inches into the aft bumper are shown in Figure 183 – Figure 184 for various lifeboat components.

With the lifeboat raised approximately 3.1 inches into the aft bumper, the maximum stress at the aft lift shoe was 869 MPa (126 ksi), which exceeds the SMYS of the aft shoes. Note that no yielding was noted at the aft shoes during visual examination. The extreme deformation and strain contours of the aft bumper are shown in Figure 185. Minimal lateral deflection in the starboard direction was noted in the model in the vicinity of the engine cradle. A contour plot showing the lateral deflection is shown in Figure 186, with negative values indicating a deflection towards the starboard side and positive values indicating

Figure 183. Von Mises Stress Contour of lifeboat in Step 2 with gravity and engine weight and raised ~3.1 inches into the aft davit bumper.

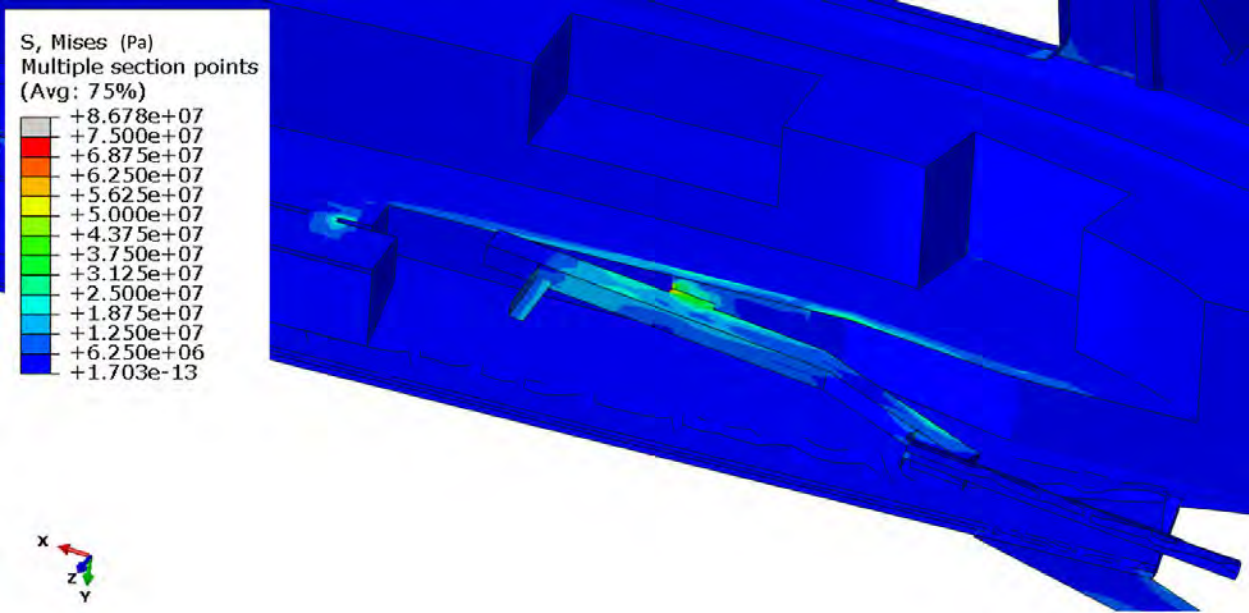
Figure 184. Von Mises Stress Contour of lifeboat in Step 2 with gravity and engine weight and raised ~3.1 inches into the aft davit bumper.

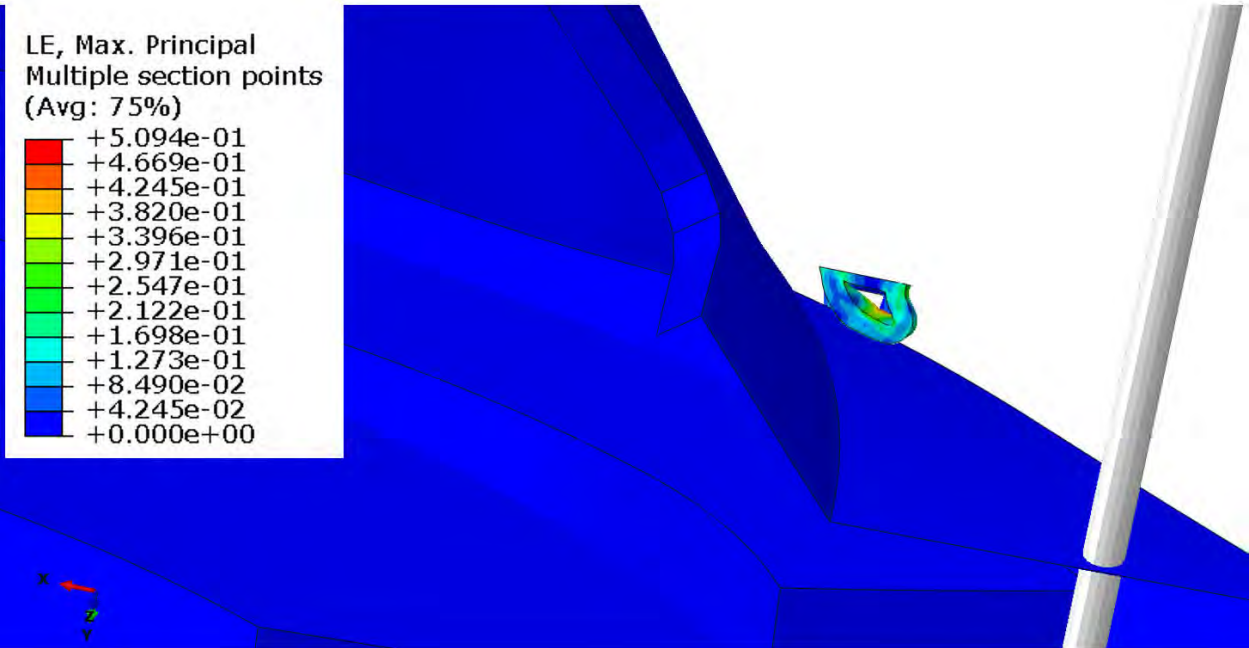
Figure 185. Strain Contours of aft bumper with lifeboat raised ~3.1 inches into the aft davit bumper.

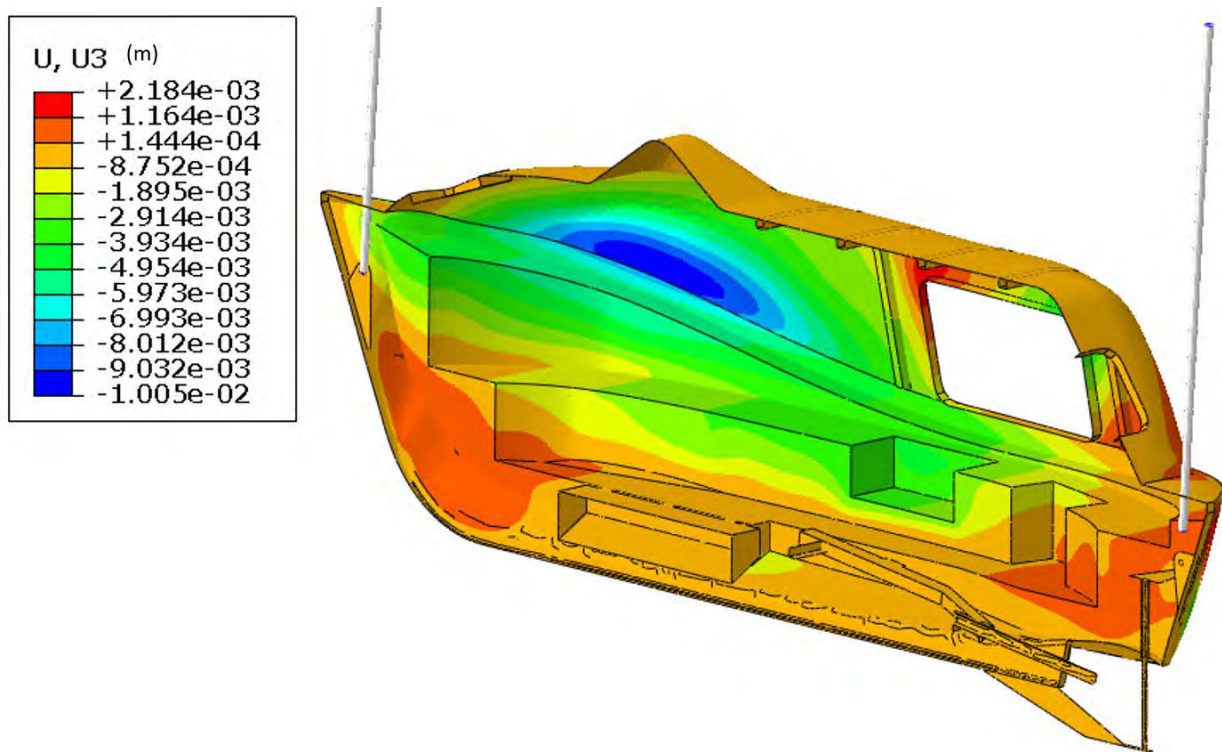
Figure 186. Lateral deflection (port/starboard) of lifeboat raised ~3.1 inches into the aft davit bumper.

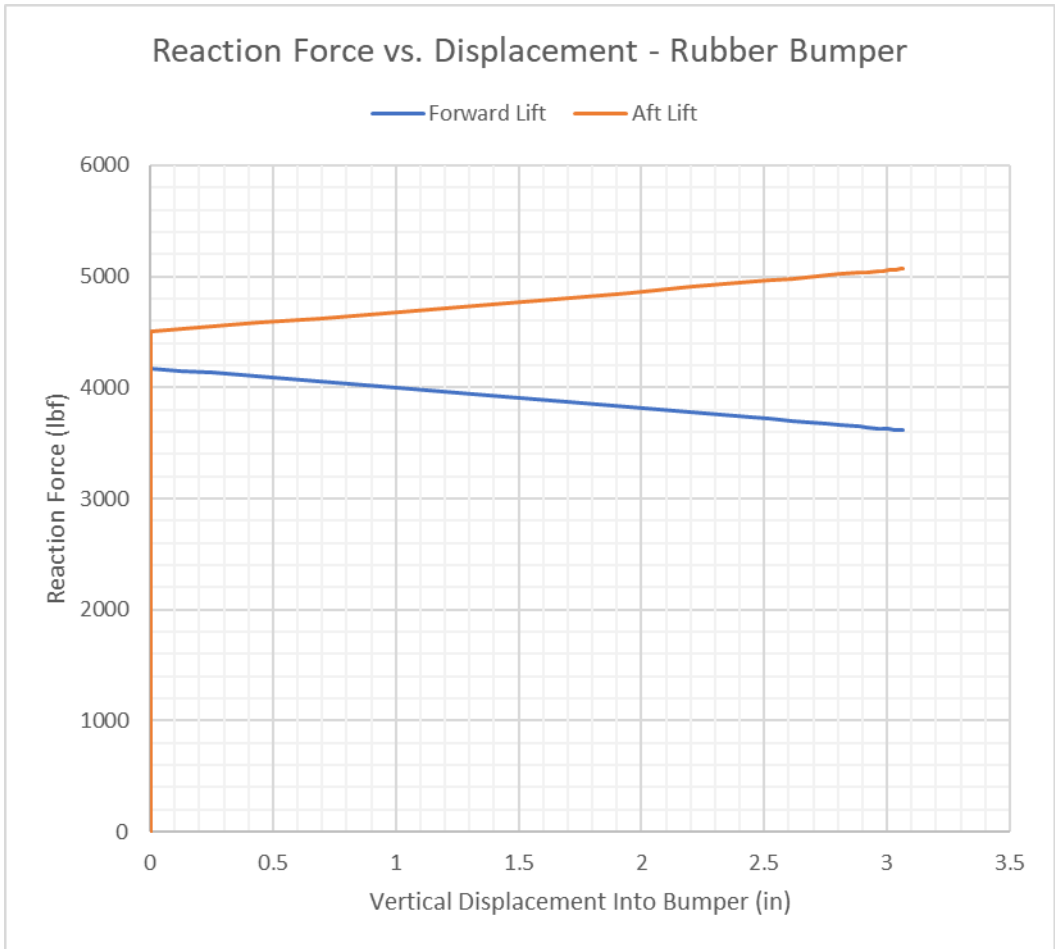
Considerable forces were observed at the aft lift shoe as the boat was raised into the aft bumper. These forces were significantly greater in the rigid bumper case than in the bumper case. A plot of the reaction forces at the forward and aft lift shoes as a function of vertical displacement is shown in Figure 187 and Figure 188 considering a rubber and rigid bumper, respectively.

Figure 187. Reaction forces at forward and aft lifting shoes throughout the assessment as a function of vertical displacement considering a bumper.

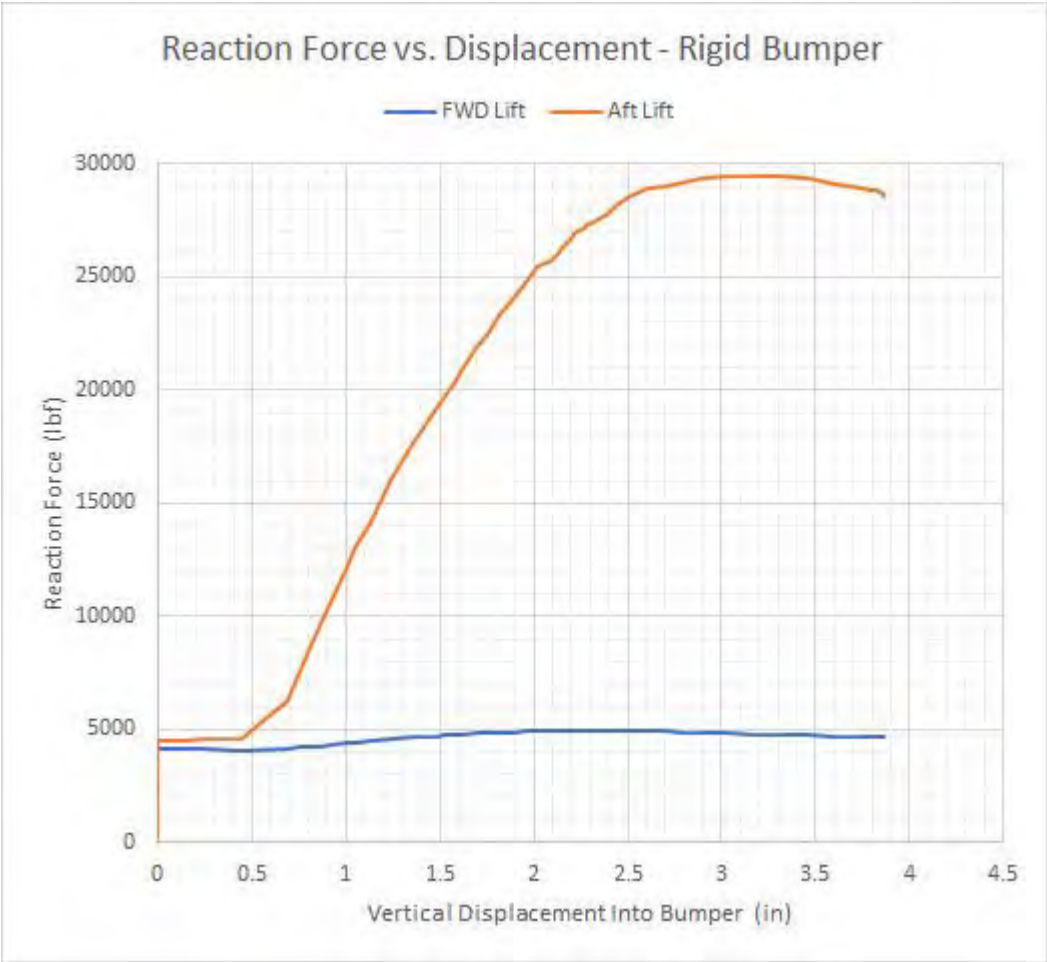
Figure 188. Reaction forces at forward and aft lifting shoes throughout the assessment as a function of vertical displacement considering a rigid bumper.

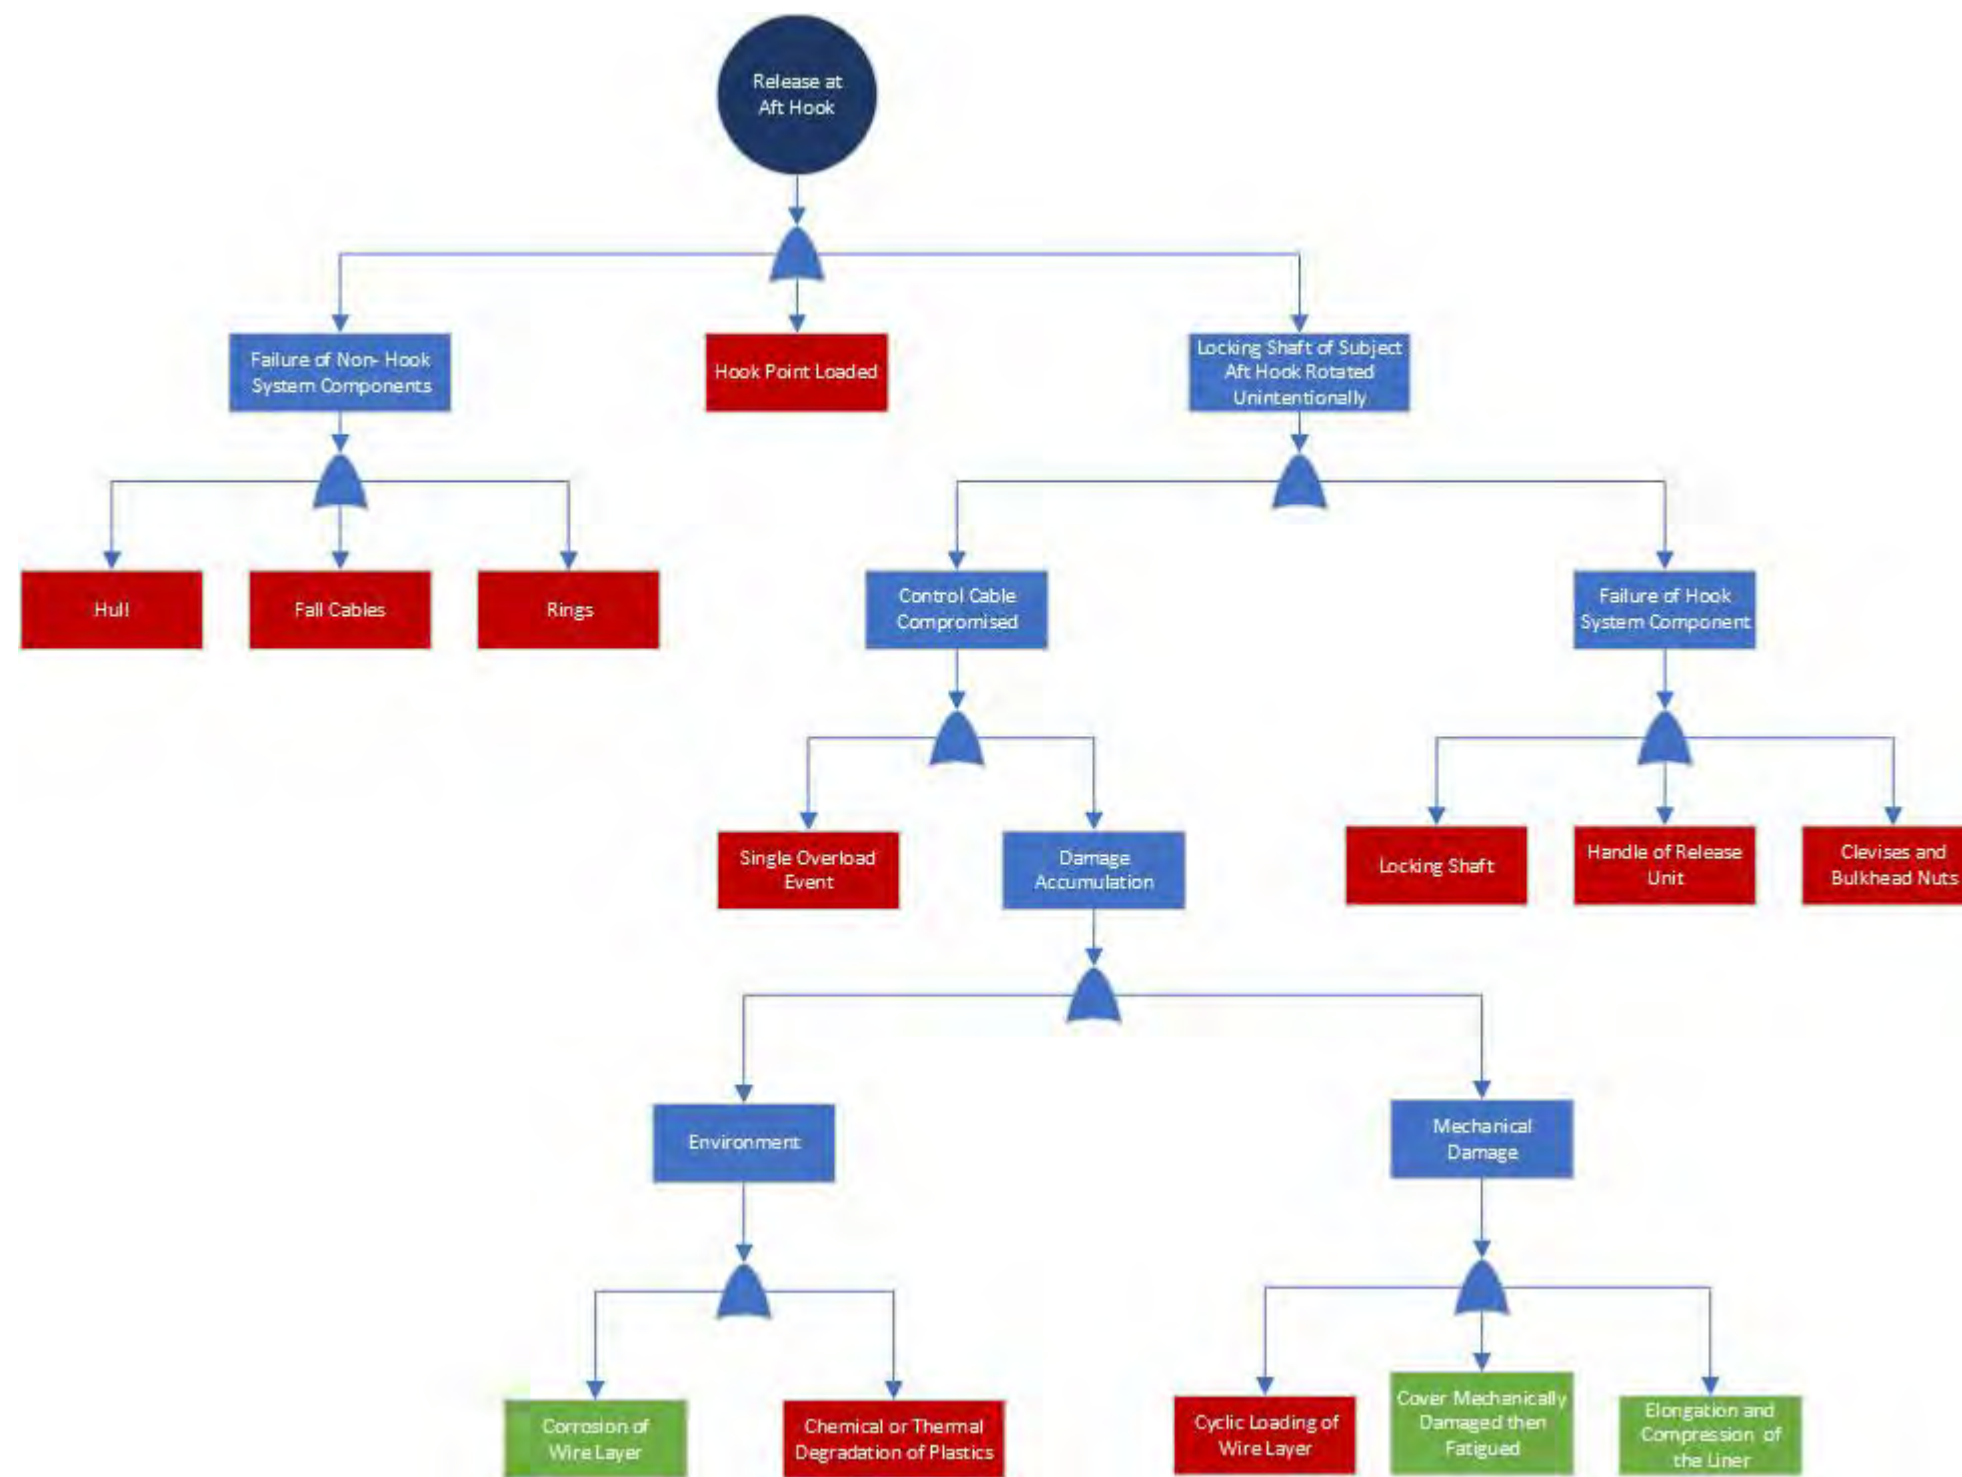
Figure 189 is a schematic showing the fault tree used to identify contributing factors to the release of the Subject Aft Hook.

Figure 189. Schematic showing the fault tree used to identify contributing factors to the unintentional release of the Subject Aft Hook. Green: Evidence from site, laboratory testing, and / or document review support that the fault tree event is a contributing factor. Red: Evidence from site, laboratory testing, and / or document review support that the fault tree event is likely not a contributing factor.
