# UNITED STATES COAST GUARD

### FLOATING OCS FACILITY - TENSION LEG PLATFORM

### LIFEBOAT FALL WITH LOSS OF LIFE ON JUNE 30, 2019

**SHELL AUGER FLOATING OCS FACILITY LIFEBOAT NO. 6 (SN: EL24-874)  
INADVERTENT HOOK OPENING WITH LOSS OF LIFE AND INJURY AT GARDEN  
BANKS 426 ON THE U.S. OUTER CONTINENTAL SHELF  
ON JUNE 30, 2019**

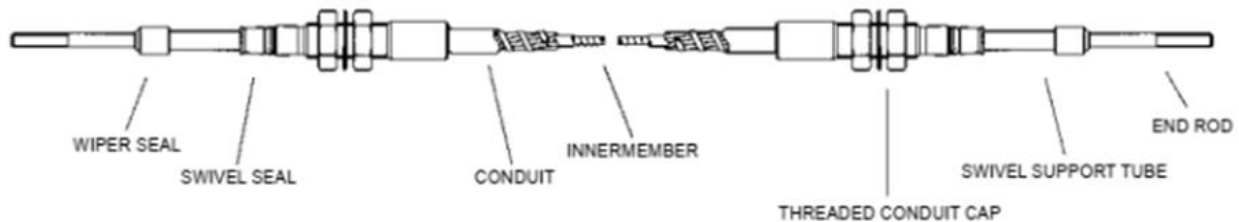
Image 4: Control cable components. Credit: Cablecraft, modified by the USCG.

The hook control cables are heavy duty low friction cables with threaded end fittings and four inches of travel at the end rods (see Image 4). Each cable has an outer conduit and an inner member. The conduit is comprised of three layers: a green plastic cover; steel reinforcement; and a white polyethylene liner. The conduit provides a protected path for the steel inner member. With the ends of the conduit fixed at each terminal point (provided it is not fully compromised), the conduit also controls the travel length of the inner member. The inner member transmits linear motion from the hook release unit to the locking shafts located within the hooks via the end rods.

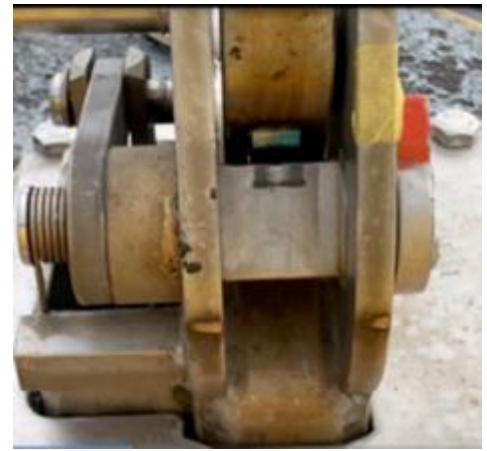
4.1.12. Boat Crew Person 1 had watched the hook locking shaft roll back into place. He looked for and saw the flat face of the locking shaft (see Figure 6). To him, this indicated that the locking shaft was in the correct position and the hooks were correctly reset. He also said he would generally look at the hook indicator on the side of the hook. He noted that if in the closed position, the arrow should be in the red; if in the open position, the arrow would indicate in the green.<sup>4</sup>

Figure 6: The “flat face” of the locking shaft on a LHR 3.5M2 hook (image does not depict Lifeboat No. 6’s hook). Credit: CG.

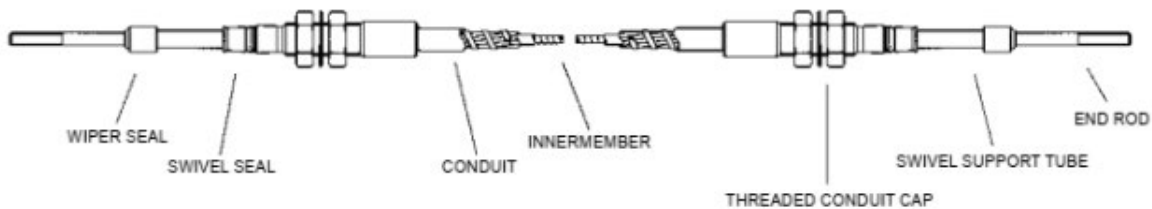
Figure 18: Control cable components. Credit: Cablecraft, modified by USCG to represent cables in Lifeboat 6.

4.2.3.2.25. The construction and components of the control cables are shown in Figures 17 and 18. All external components (conduit cap, support tube and end rod) are stainless steel. The metal components in the conduit (steel band and steel strands) are galvanized and sealed from the outside environment by the outer jacket (cover) and a series of seals from the conduit cap to the end rod. The inner member consists of steel strands and banding, with a thin outer cover that is hydraulically crimped to the end rods and moves within the polyethylene liner of the conduit.

4.2.3.2.26. The inner member transmits linear motion through the end rod. The end rod has two ends: one end attaches to a clevis that is pinned to the release unit and the other end attaches to a clevis that is pinned to the hook locking shaft. The support tube limits the amount of travel in the end rod; the end rods on Lifeboat No. 6 could move approximately 4 inches in either direction.

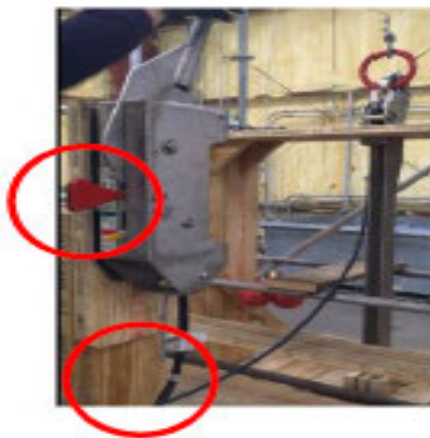
Image 50: The release handle is in the locked and closed position. However, the cable is damaged.

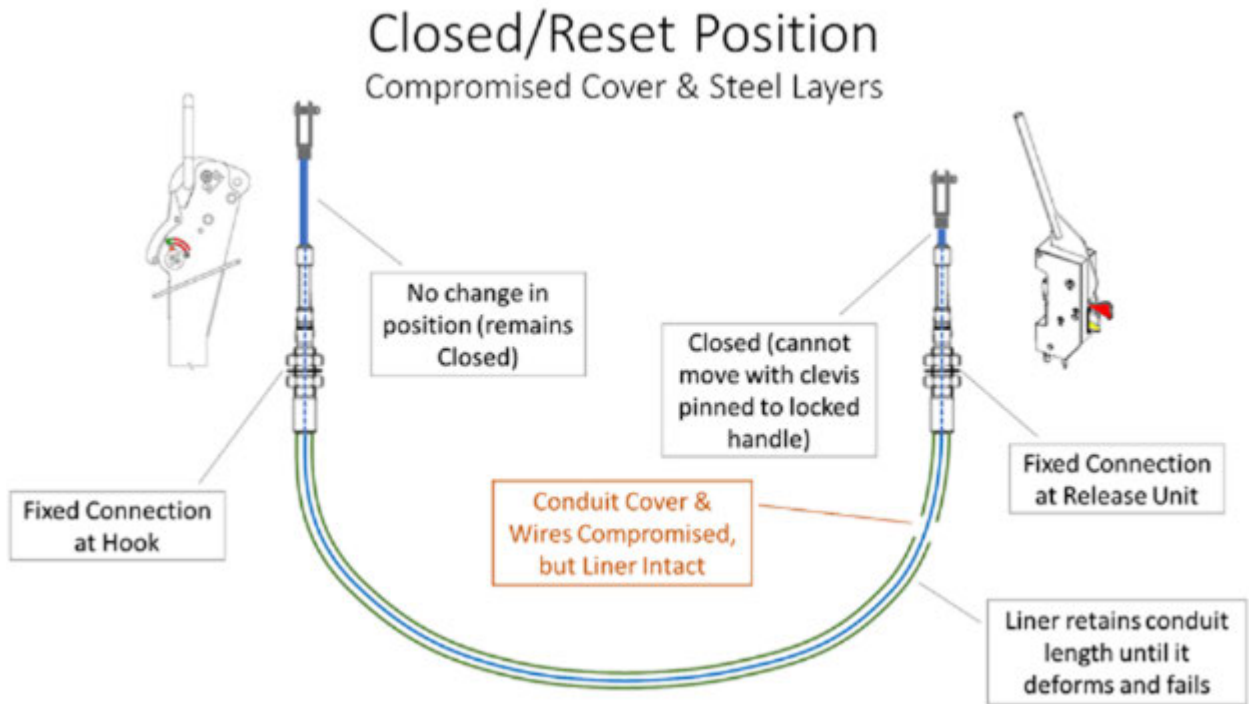
Figure 56: In this figure, the hook is closed or locked. The conduit is damaged, but the white polyethylene liner is intact. Credit: CG

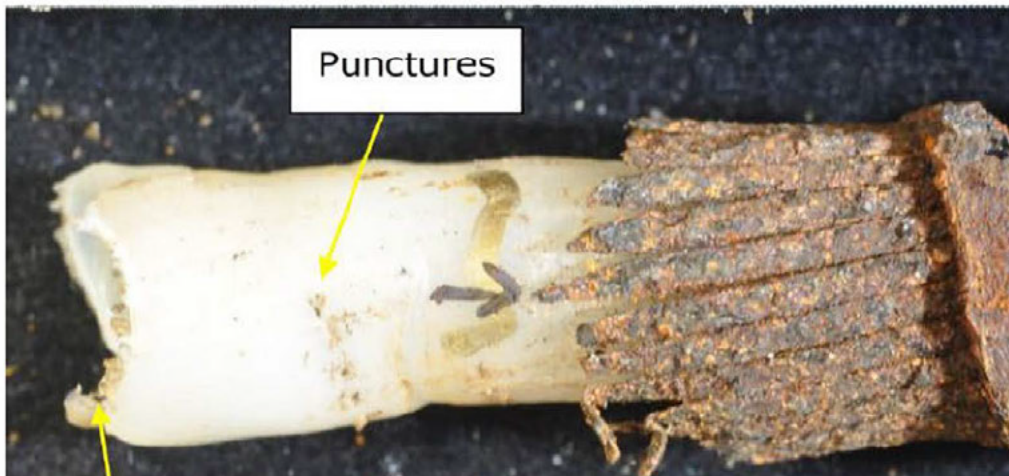
Figure 62 (below): Puncture marks found on the polyethylene liner of Lifeboat No. 6's aft control cable. Credit: DNV-GL.
