Final Report on the Investigation of the Macondo Well Blowout

**Deepwater Horizon Study Group
March 1, 2011**

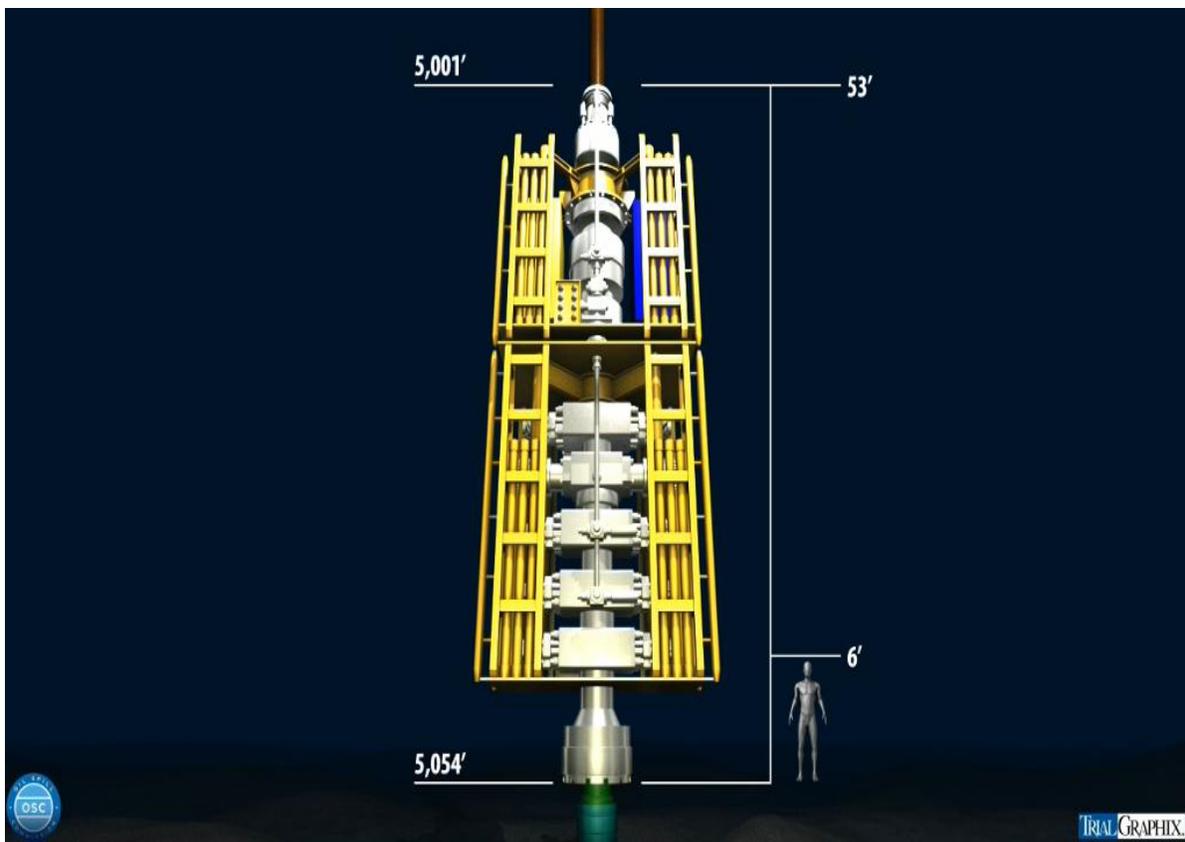
Figure 1.7 – Blowout Preventer (BOP).²⁶

At the depth and pressures encountered by the *Deepwater Horizon* well, MMS regulations require at least four remote-controlled, hydraulically operated valves, or rams during offshore operations.²⁵ All of the rams on the BOP failed to close properly during the blowout event that occurred on the *Deepwater Horizon*.

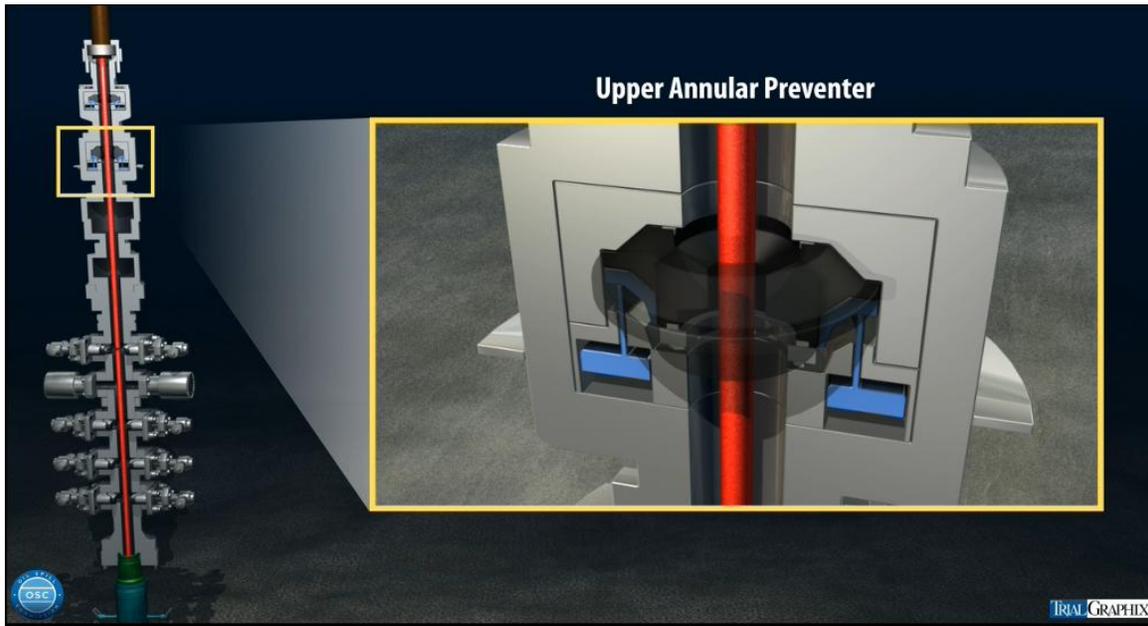
Figure 1.9 – Upper Annular Preventer.²⁷

Annular Preventers (Figure 1.9) are rubber donut shaped seals that close around the pipe sealing the well. They can also seal the well with an absence of pipe in the hole. Stripping occurs if an annular is closed around the pipe, and the pipe is moved upward or downward during this time. Witness accounts stated that stripping had occurred on the *Deepwater Horizon* and pieces of rubber were observed. The stripping could have weakened the annular preventers.

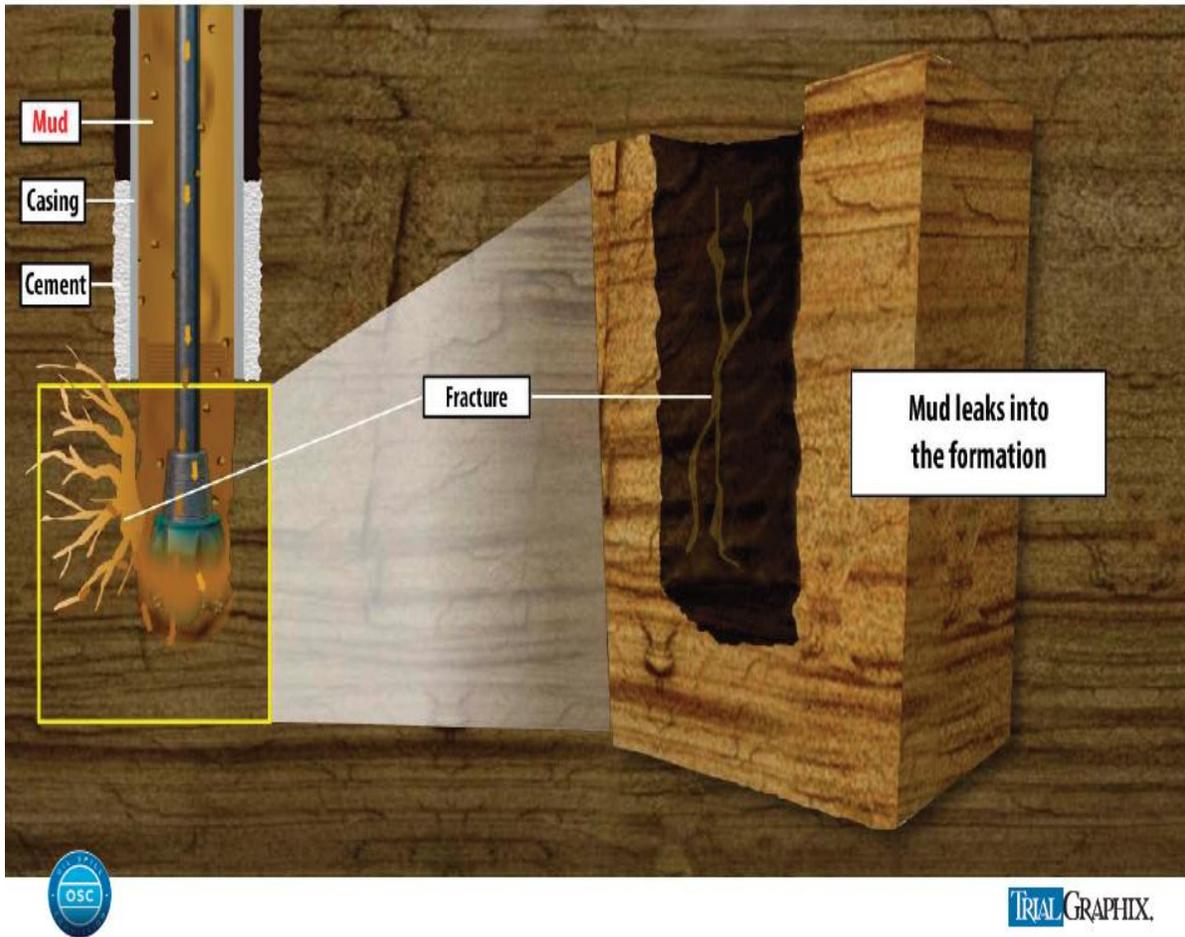
Figure 1.13 – Lost circulation.³³

Lost circulation occurs when the drilling fluid that is being used in the wellbore is lost in the formation rather than flowing up the annulus (Figure 1.13). Problems resulting from lost circulation may vary, but it can ultimately lead to catastrophic loss of well control—a blowout. Essentially, this occurs when the borehole cannot retain the fluid column. If the drilling fluid enters the formation, the fluid levels inside the wellbore will drop, lowering the hydrostatic pressure inside the hole which would allow gas or fluids to enter the borehole and flow up the formation casing or casing annulus.³²

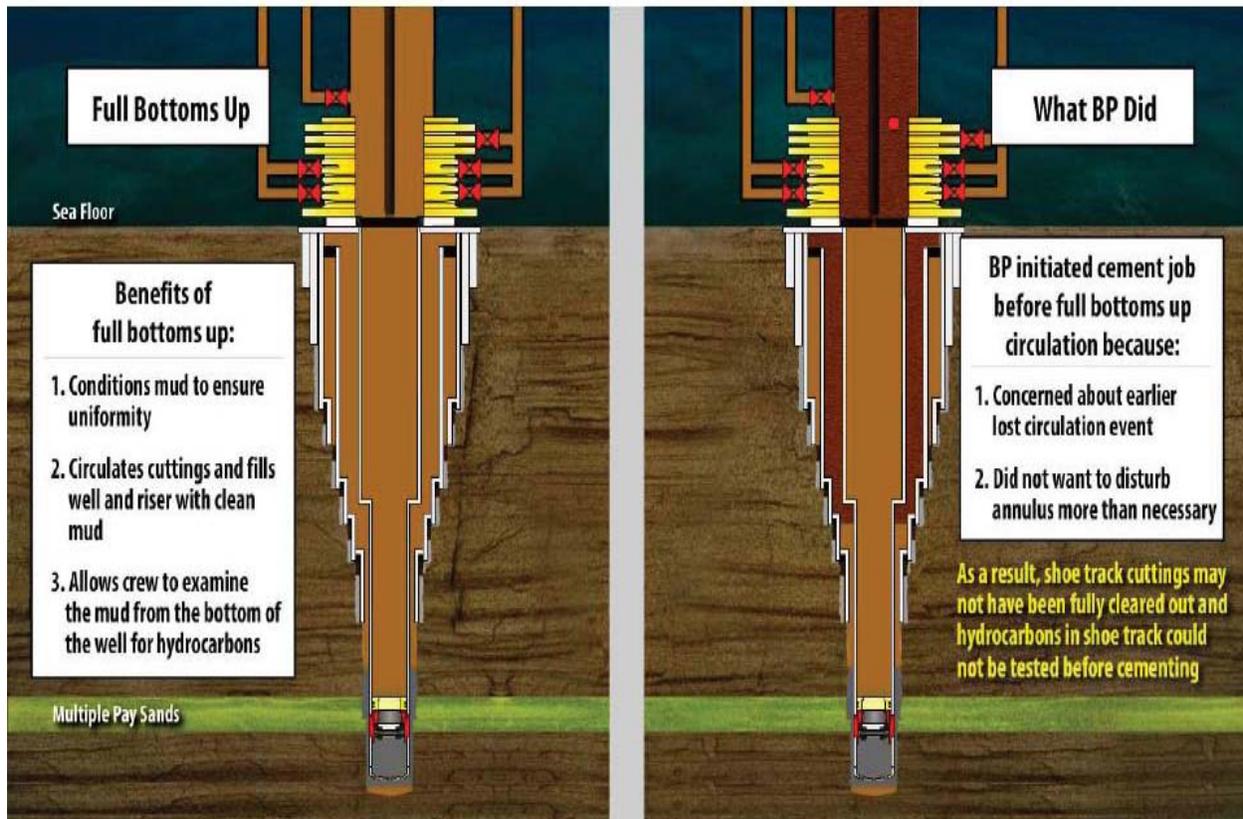
Figure 1.18 – Illustration of *bottoms up*.⁷⁰

BP made the decision not to do a complete *bottoms-up* circulation of the well before cementing that would remove hydrocarbons and debris in the bottom of the well (Figure 1.18). Due to BP engineer concerns for *wash out* in the weak formation at the bottom of the hole accompanied by disturbance of the lost circulation material that had been placed in this part of the well, only about half of the well-casing volume was circulated out.⁶⁵ The incomplete bottoms-up circulation did not meet Halliburton’s *best practices*.⁶⁶ This incomplete circulation would have left any hydrocarbons that remained in the well lingering in the upper part of the well.

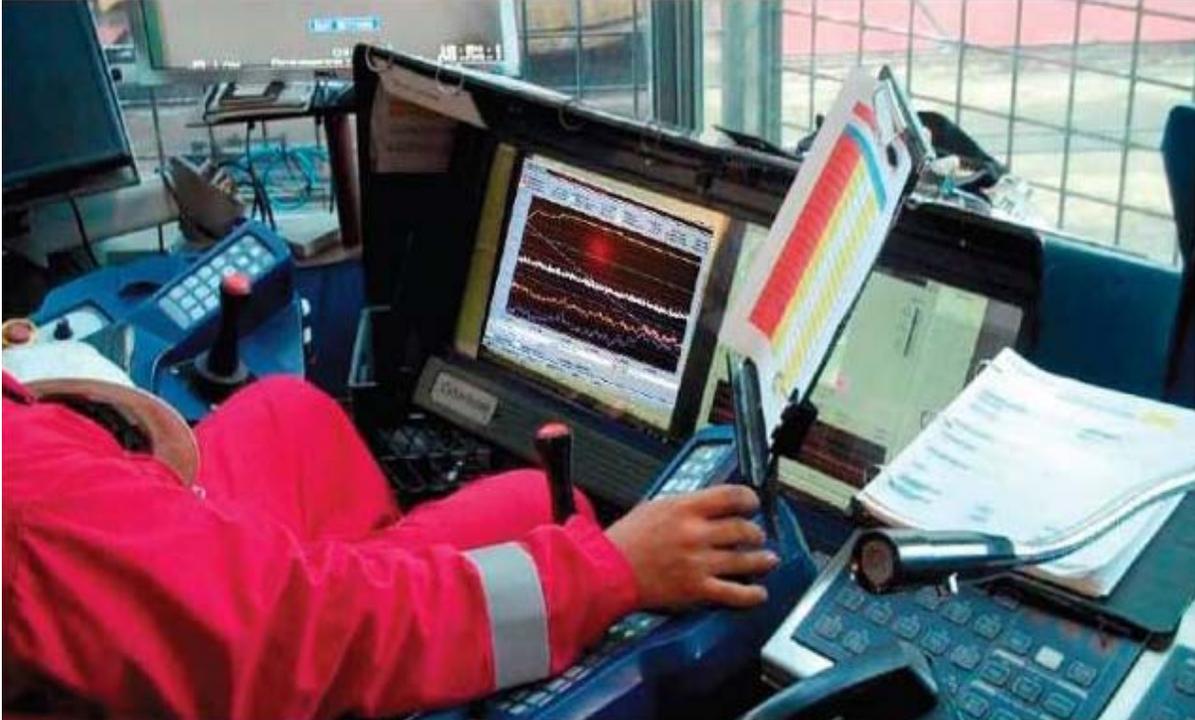
Figure 1.21 – View of the driller's data-panel.⁹⁹

April 20, 9:00 p.m. – Shortly after 9:00 p.m. pressure on the drill pipe increased from 1,250 psi to 1,350 psi. The drill pipe pressure should have decreased due to the removal of the heavier mud (14.7 ppg) and its replacement with the lighter weight seawater (8.6 ppg). This abnormality could have been detected from monitoring the drill pipe pressure data, and could have been the first clear indication of the flow of hydrocarbons into the well, visible to the crew.⁹⁸ Spacer fluid was then observed at the surface.

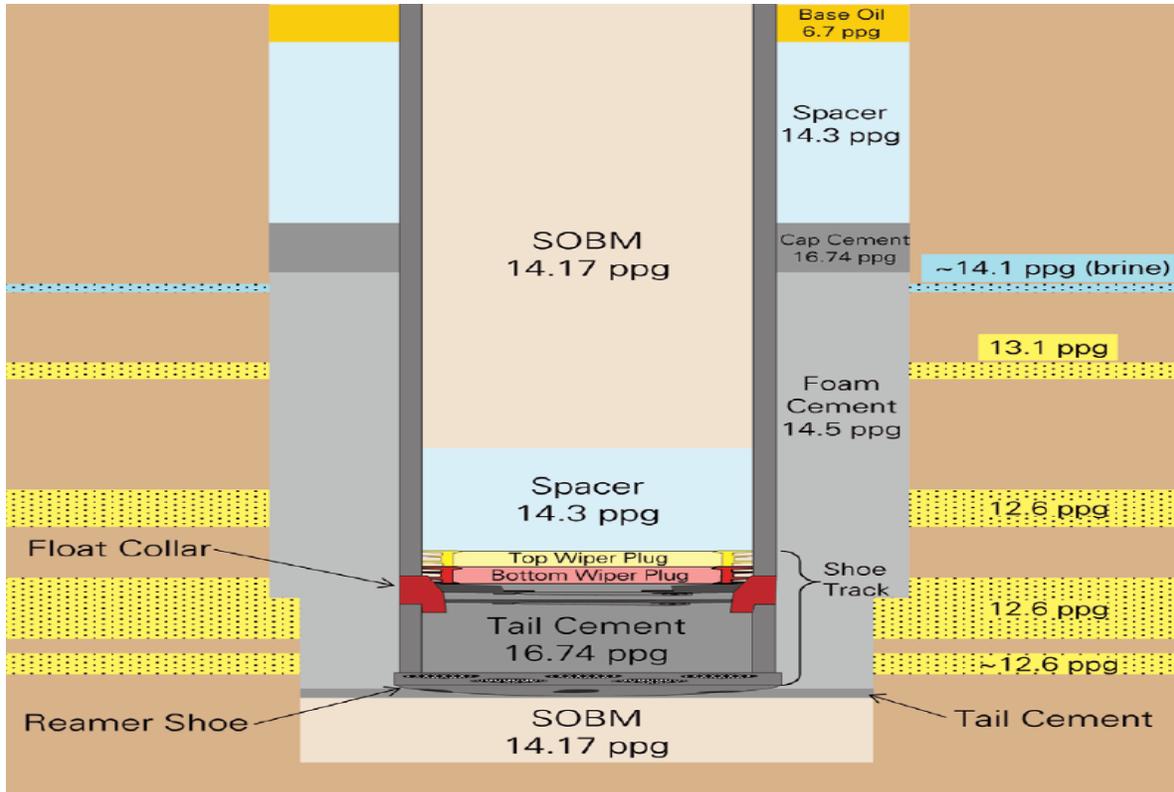
Figure 2.5 – Planned cement placement.²⁵

Figure 2.5 shows the planned cement and other well fluids placement under *ideal* conditions at the bottom of the well. Realization of this placement depends on the materials in the well at the bottom of the well after the long-string production casing was run, the performance of the double valve float collar, and the relatively weak formations under and around the float collar. Given the concerns for the weak formations in the bottom of the well, only partial circulation of the well fluids was performed after placement of the production string. This could have left cuttings in the bottom of the well—in and above the *rat hole* below the shoe track and reamer shoe. In addition, the relatively short distance between the bottom of the shoe track and the bottom of the rat hole combined with the lower density of the Synthetic Oil Based Mud (SOBM) relative to the density of the cement (16.7 ppg cap-and-tail cement and 14.5 ppg foamed cement) could have encouraged intermixing of the cement with the well materials and mud in the rat hole.

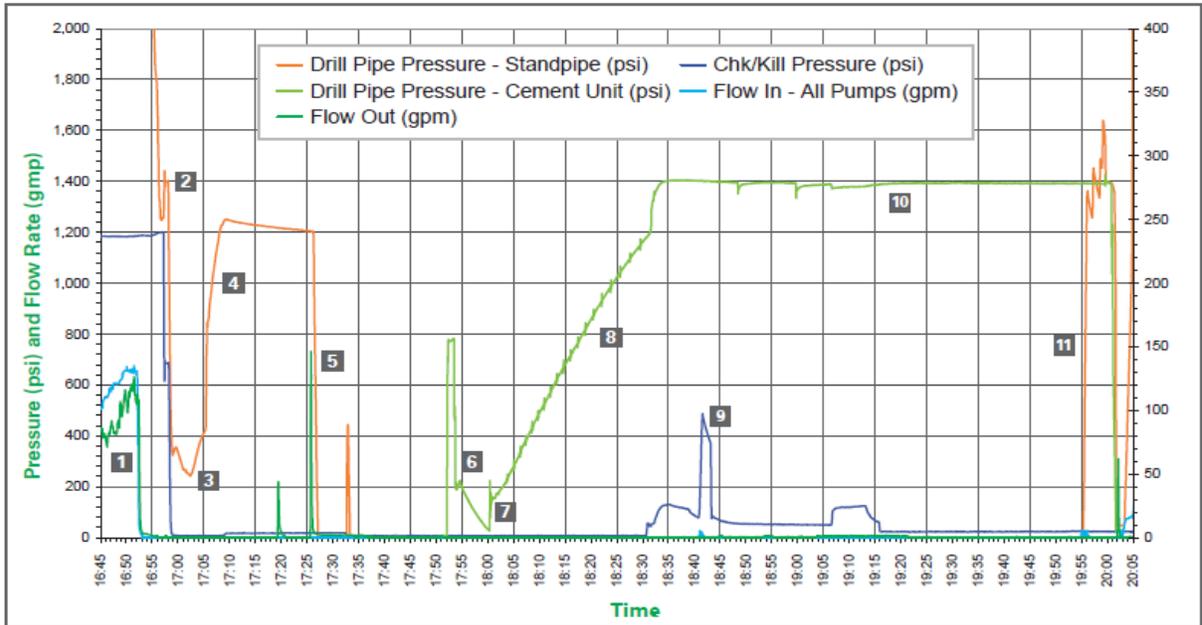
During the first attempt to perform the negative test, the BOP annular preventer was closed and pressure in the drill pipe was reduced. During this step, the real-time data indicated that the annular preventer was leaking (Figure 2.7). To correct the leak, the annular preventer closing pressure was increased to develop an effective seal with the drill pipe. The real-time data indicated that during this process approximately 50 bbl of spacer leaked downward past the annular preventer. This would have placed the spacer across the BOP kill line that would be used to perform the next negative test.³⁰ There is no information available to indicate the rig crew recognized that spacer was across the BOP kill line inlet at the BOP. Some of the heavy, viscous spacer could therefore have been pulled into the kill line bore running to surface as fluid was bled from it at surface, and could partially or completely block the kill line that was being used to conduct the negative pressure test.

| <p>1 Spacer displacement complete; mud pumps stopped.</p> <p>2 Annular preventer closed; attempt to bleed drill pipe pressure to zero.</p> <p>3 Drill pipe pressure decreases to only 273 psi; annular preventer leaking.</p> <p>4 Drill pipe pressure increases as annular preventer leaks; hydraulic closing pressure increased to seal annulus.</p> <p>5 Drill pipe pressure bled to zero for negative-pressure test.</p> <p>6 Decision made to conduct negative-pressure test via kill line; kill line opened; 3 bbls to 15 bbls bled to cement unit.</p> | <p>7 Shut in kill line at cement unit, drill pipe pressure starts to increase.</p> <p>8 Drill pipe pressure slowly increases to 1,400 psi.</p> <p>9 Fluid pumped into kill line to confirm full; kill line opened to mini trip tank for monitoring.</p> <p>10 Discussion ongoing about 'annular compression' and 'bladder effect' while monitoring kill line; drill pipe pressure static at 1,400 psi.</p> <p>11 Negative-pressure test concluded, declared a success; preparation made to continue displacement.</p> |

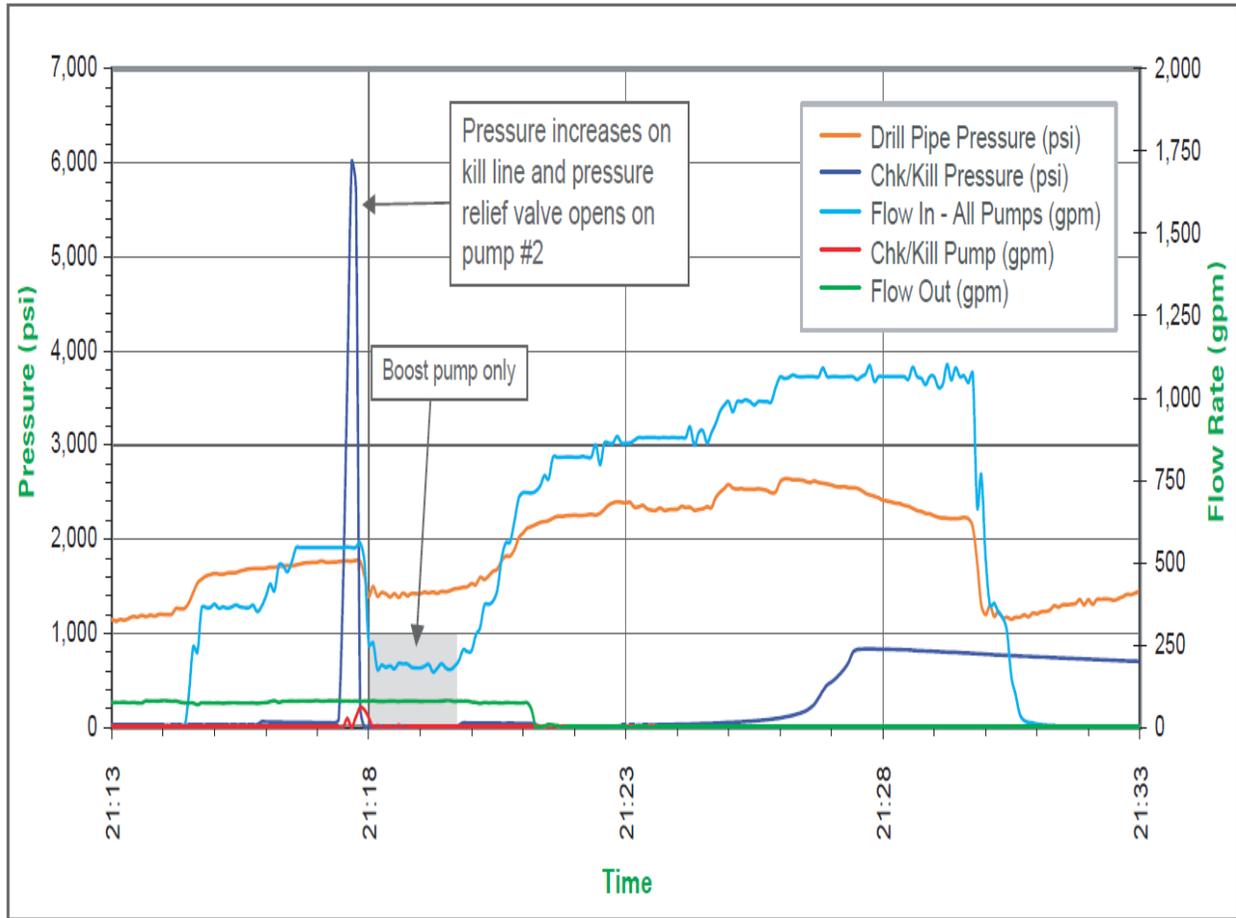
Figure 2.9 – Real-Time data (April 20, 2010) during overboard discharge operations.³⁷

Testimony and the available real-time data indicate that about 9:17 p.m. the rig crew was working to start mud pump #2. The pump was erroneously started with a closed discharge valve. This actuated a pressure relief valve (Figure 2.9). With the exception of pump #1, the other three pumps were shut down until about 9:20 p.m. when pumps #3 and #4 were brought online. The crew continued to work to start pump #2. Testimony indicates the off-duty senior tool pusher called the on-duty tool pusher about 9:20 p.m. to inquire about the results of the negative pressure test. The on-duty tool pusher advised the senior toolpusher that the test results were satisfactory and that the operations were “going fine.”³⁶ The evidence indicates the drill crew was still unaware the well was in a major control event was in process and the well needed to be shut in.

About 9:30 p.m., the mud pumps were shut down (Figure 2.9). Testimony has not disclosed why the pumps were shut down. Testimony provided by the chief mate indicate that about this time the toolpusher and driller were concerned with the *differential pressure* on the drill pipe.²⁸ The real-time data indicates that the pressure on the drill pipe was continuing to increase (Figure 2.10). The drill pipe pressure rose from 1,240 psi to 1,750 psi followed by a sudden pressure decrease to 750 psi and then another pressure increase to 1,400 psi then another decrease to 340 psi. Analyses indicate these changes were due to additional influx of hydrocarbons into the well bore, displacement of the fluids in the well bore, and actions taken by the crew to reduce pressure in the drill pipe.^{1, 28}

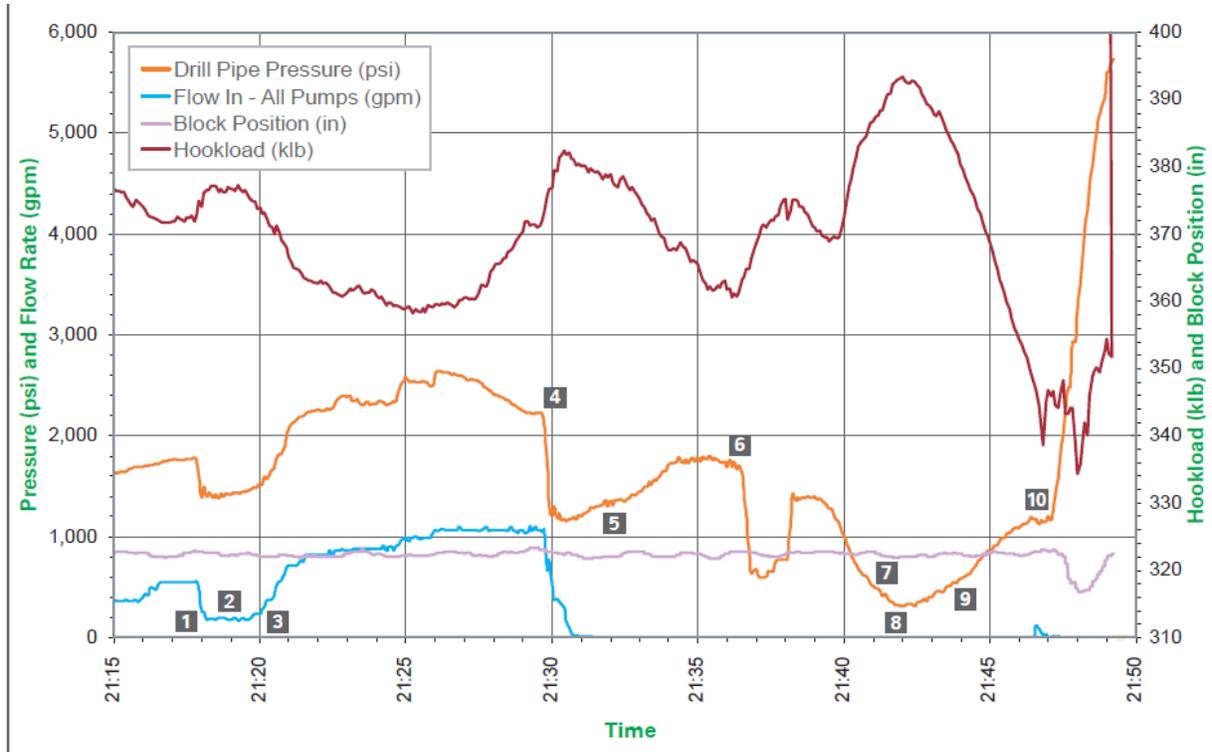
Figure 2.10 – Real-Time data (April 20, 2010) after mud pump shutdown.³⁸

| <p>1 Pressure relief valve on pump #2 opens; toolpusher called to rig floor.</p> <p>2 All pumps shut down except boost pump.</p> <p>3 Assistant driller called to pump room.</p> <p>4 Pumps shut off.</p> <p>5 Toolpusher and driller discuss 'differential pressure.'</p> <p>6 Opening of 4" surface line to bleed pressure.</p> | <p>7 Mud/water flows onto rig floor and then unloads through the derrick.</p> <p>8 Diverter and annular preventer activated; diverted to mud gas separator.</p> <p>9 Well site leader and senior toolpusher receive calls from rig floor; annular preventer attempting to close.</p> <p>10 BOP sealing.</p> |

Testimony indicates that about 9:47 p.m., the well site leader was notified that the well was being shut in, the senior toolpusher was notified of uncontrolled flow from the well, and that seawater and drill mud had started to flow out of the riser onto the rig floor. Note that the well site leader said his alarm clock showed 9:50 p.m. when he received the news, but his clock or the real time clock could easily have been different by a few minutes. The real time data,⁸ as partially duplicated in Figure 2.10 above, shows a sharp increase in drill pipe pressure starting at 9:47 p.m.

After about 9:40 p.m., the drill pipe pressure increased from about 340 psi and reached 1,200 psi about 9:47 p.m. (Figure 2.10). Testimony indicates that by about 9:47 p.m. seawater and mud were shooting up through the derrick, and shortly thereafter the diverter was closed and flow from the riser was routed to the mud gas separator (MGS) (Figure 2.11 and Figure 2.12).

Analysis of the available information indicates the BOP lower annular was closed at 9:50 p.m. and the pressure in the drill pipe began to increase. As the BOP annular pressure increased there was a very rapid increase in drill pipe pressure to approximately 5,700 psi at 9:49 p.m. (Figure 2.10). The increase in drill pipe pressure is thought to be due to pressurization and sealing of the lower annular.

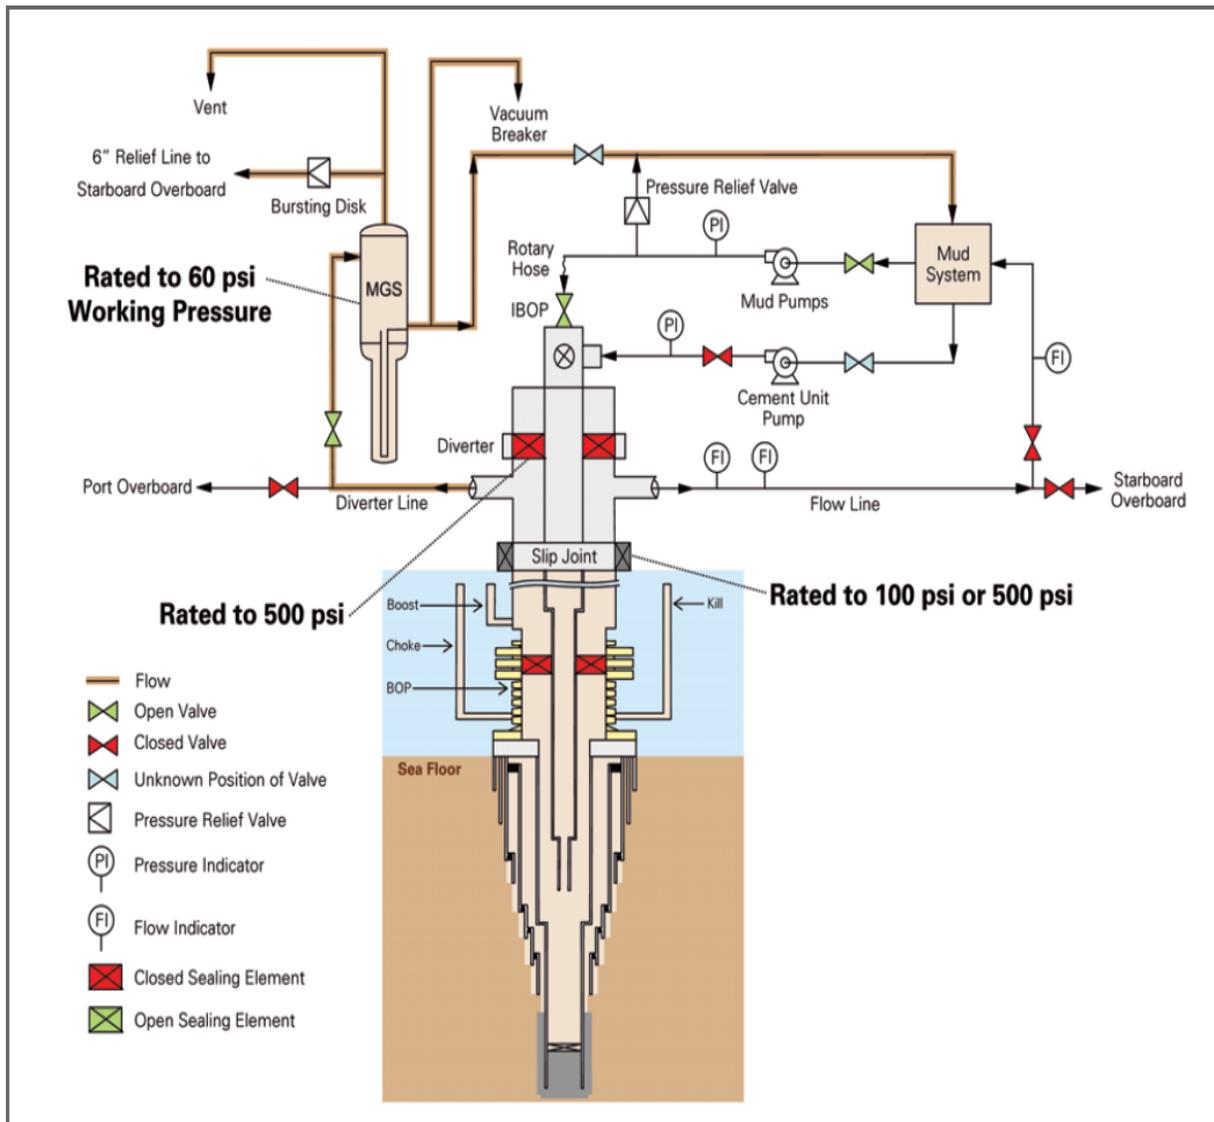
Figure 2.11 – Schematic of *Deepwater Horizon* surface equipment.³⁹

Subsequent hydrocarbon flow could have developed through the drill pipe inside the riser. There are a number of pieces of equipment that could have failed and allowed hydrocarbons to flow to the surface through the drill pipe (Figure 2.11) thereafter. Also, flow could have developed outside of the drill pipe (Figure 2.13). Following loss of power, the rig dynamic positioning system was inoperable. Rig drift-off following the loss of power could have caused the drill pipe to be pulled through the BOP destroying the annular seal and allowing resumption of flow up the riser. Analysis

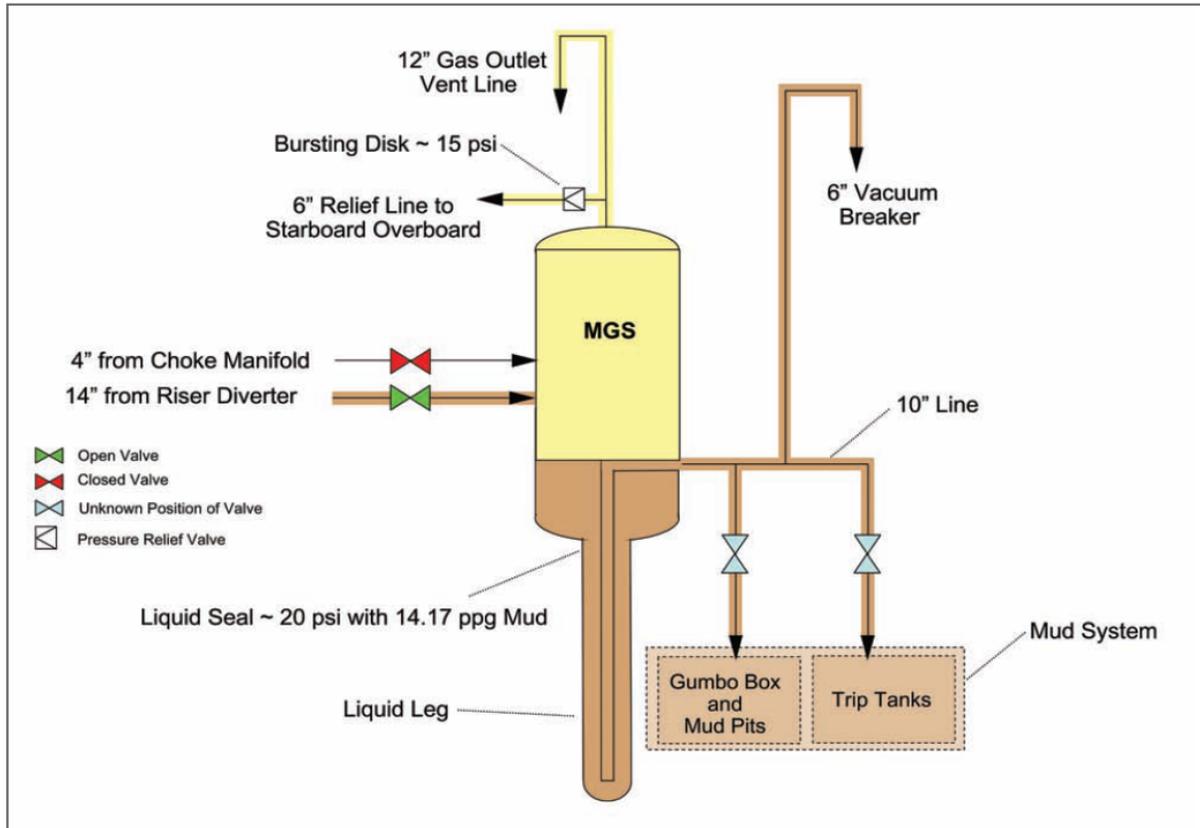
Figure 2.12 – Schematic of *Deepwater Horizon* Mud Gas Separator.⁴⁰

The Transocean operating procedures require the diverter to be closed with flow directed overboard if there is rapid gas expansion in the riser. If the expansion is slow, then the flow would be directed through the Mud-Gas Separator (MGS) unit. The MGS was used successfully during the March 8, 2010, well control event that resulted in stuck drill pipe that caused the necessity to sidetrack the well.

Returns blowing strongly from the riser were routed to the MGS unit rather than directly overboard through one of the 14 in diverter lines.⁴¹ As a consequence, MGS unit was quickly over-pressured and its capacity overwhelmed. That resulted in dispersion of gas and liquids over a large area of the vessel, including into electrically unclassified spaces where ignition sources may be present, i.e., spaces not classified as “explosion-proof” such as engine rooms. Although there is no record or testimony to prove it, it appears that the sealing packer on the riser slip joint leaked massively under the impetus of back pressure applied. First, there was active fire under the rig floor after the explosions according to testimony, and second, there was testimony of hearing a high pressure gas release from that direction preceding the first explosion.³²

Testimony indicates that about 9:45 p.m. water, mud, and gas exited the MGS vents—indicating failure of the low pressure, low capacity MGS unit. Once the MGS failed, high pressure flammable hydrocarbon gas and condensate vapor/mist (aerosol) was released to the rig decks. Gas-hissing noises were reported coming from different parts of the rig. The first gas alarm sounded about 9:47 p.m. accompanied by roaring noises and vibrations. About 9:50 p.m., the main power generation engines started over speeding followed by the loss of rig power and the first and second explosions. Testimony indicates the first explosion happened very close to the MGS—ignition caused by vapor ingestion in one or more of the power generation engines is deemed to be very likely based on the record and the historical database.⁴²

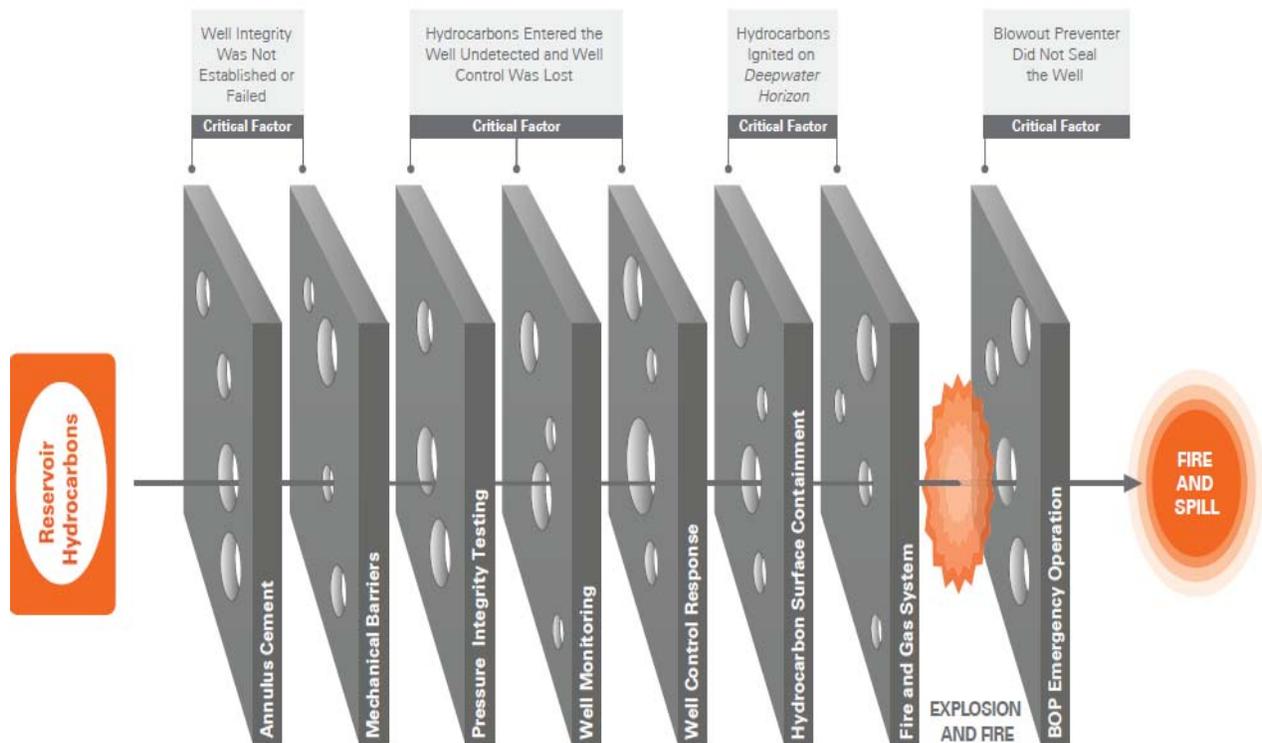
Figure 3.2 – BP’s analysis of defensive barrier penetration leading to the Macondo blowout.⁷

Application of Reason's OAT to the Macondo well disaster renders useful insights into both the causes of this disaster and into how the risks associated with such systems can be better *managed* in the future.⁵ It is obvious that multiple proactive, reactive, and interactive barriers were penetrated to develop the blowout (Figure 3.2). A critical proactive protective barrier that was penetrated was the plan for temporary abandonment of the Macondo well—specifically the plan for the negative pressure test and displacement of the mud from the well before a second barrier was in place. During the negative pressure test, interactive barriers were penetrated. Critical *signals* (e.g., drill pipe pressures, well fluid volumes) were not properly detected, analyzed, or appropriate action taken.⁶ After the well began blowing out, multiple reactive barriers were breached including diversion of the well effluents to the low capacity mud-gas separator rather than overboard.

There were critical defects embedded in BP’s defensive barrier system prior to the initiation of the failures including those associated with the design and construction of the long-string completion system with the *iffy* barriers.⁸ Another example is related to the *sketchy* negative test procedure sent by BP to the *Deepwater Horizon* on the morning of April 20, 2010. The procedure was a high hazard process in which a critical test was performed with minimal passive and active barriers. No definitive guidance, however, was designed or provided for interpretation of data derived from the negative tests or prescribed the corrective action required if the negative tests did not provide assurance that the well *pressure vessel* was intact. Evidence indicates that the drilling crew had not received any formal training in performing this critical test.
