REPUBLIC OF THE MARSHALL ISLANDS

DEEPWATER HORIZON MARINE CASUALTY INVESTIGATION REPORT

Official Number: 2213

IMO Number: 8764597

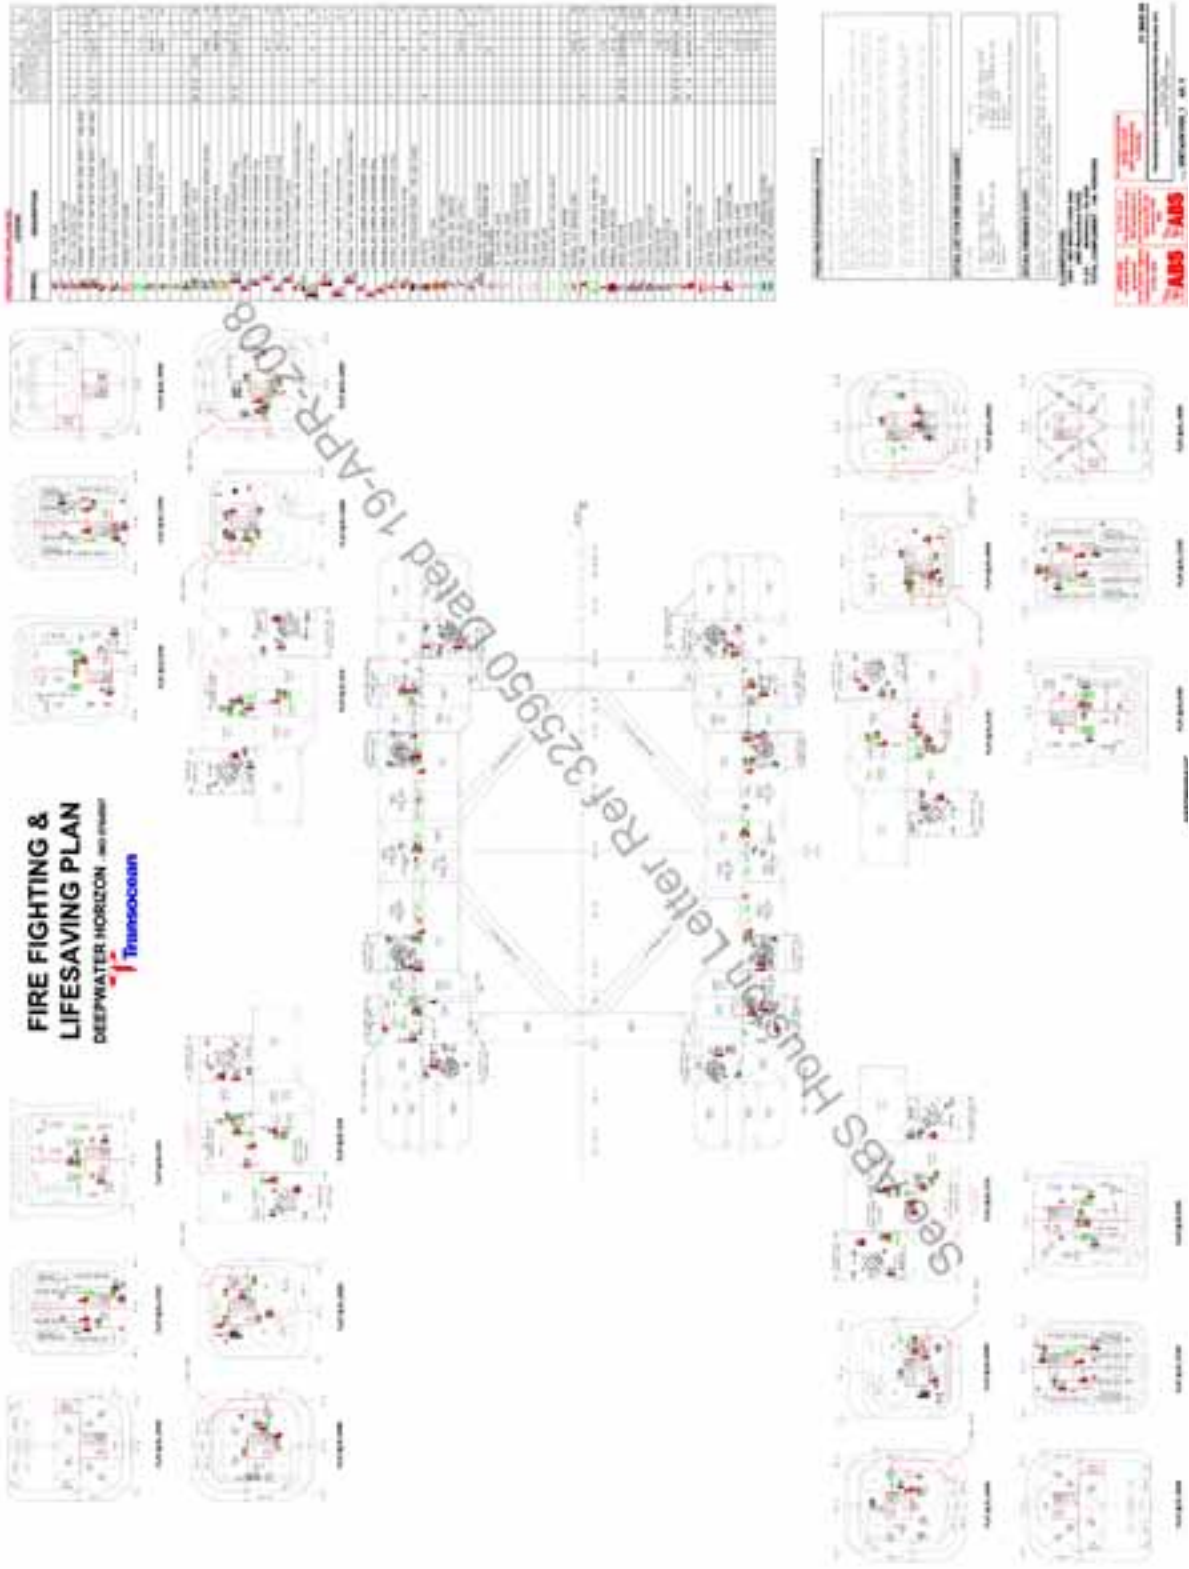
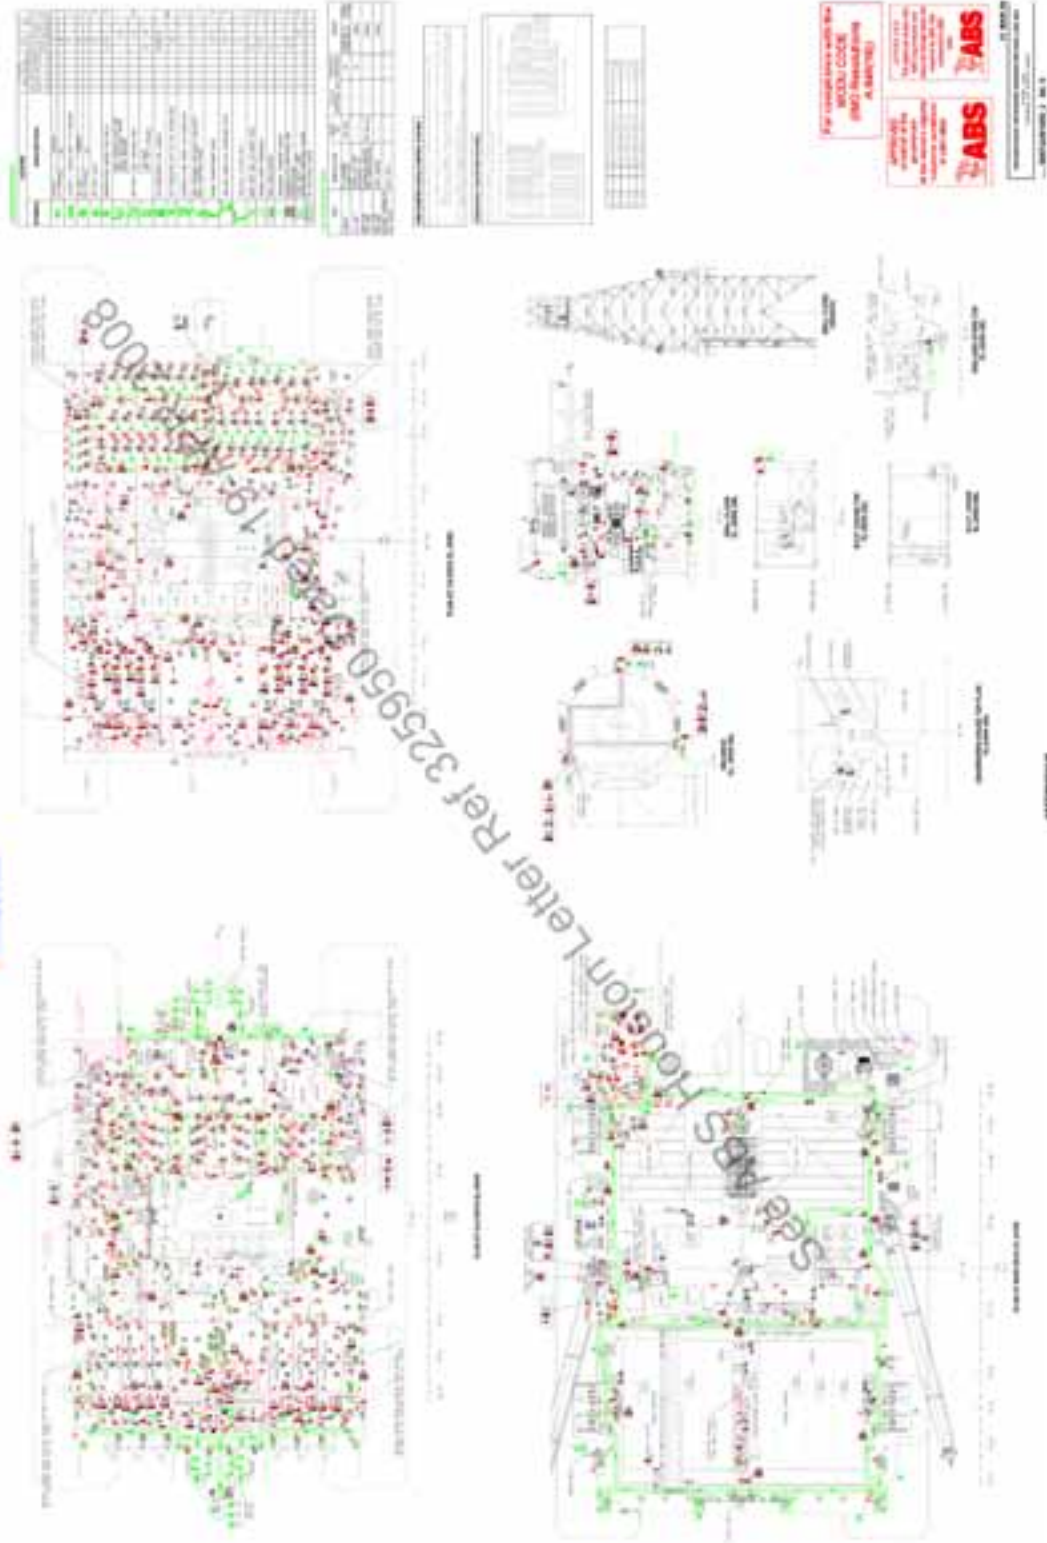
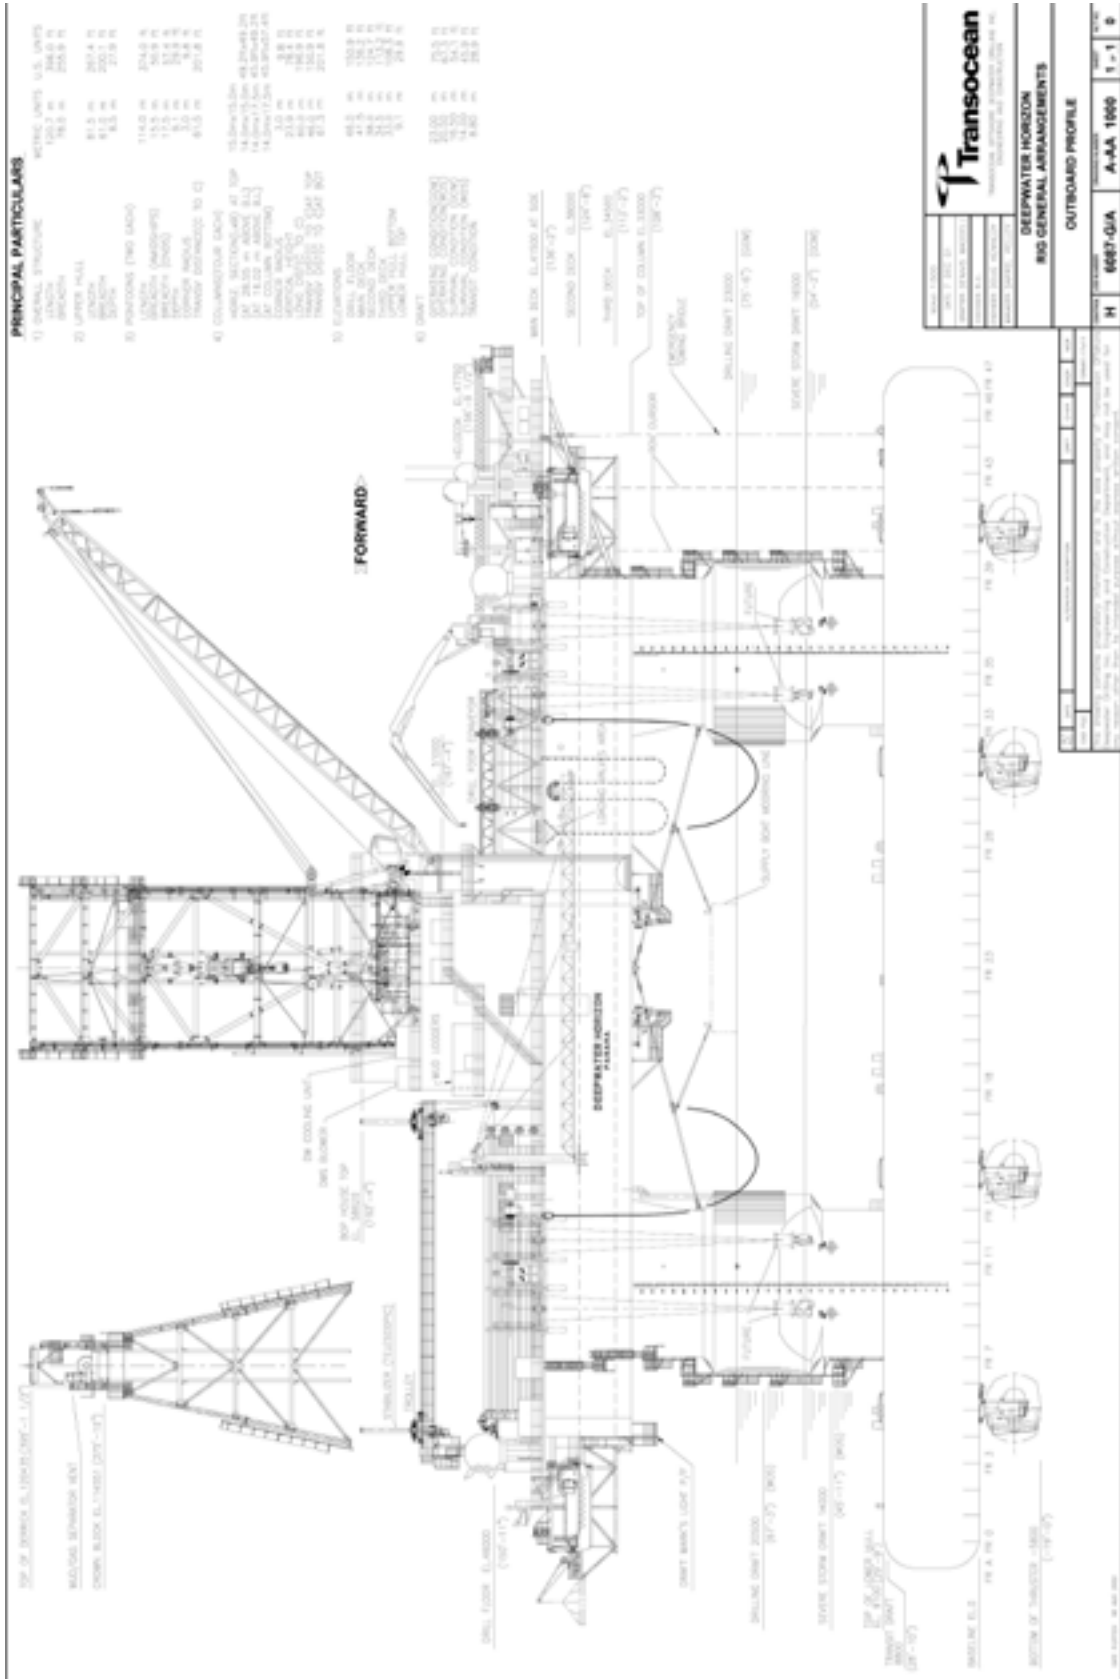
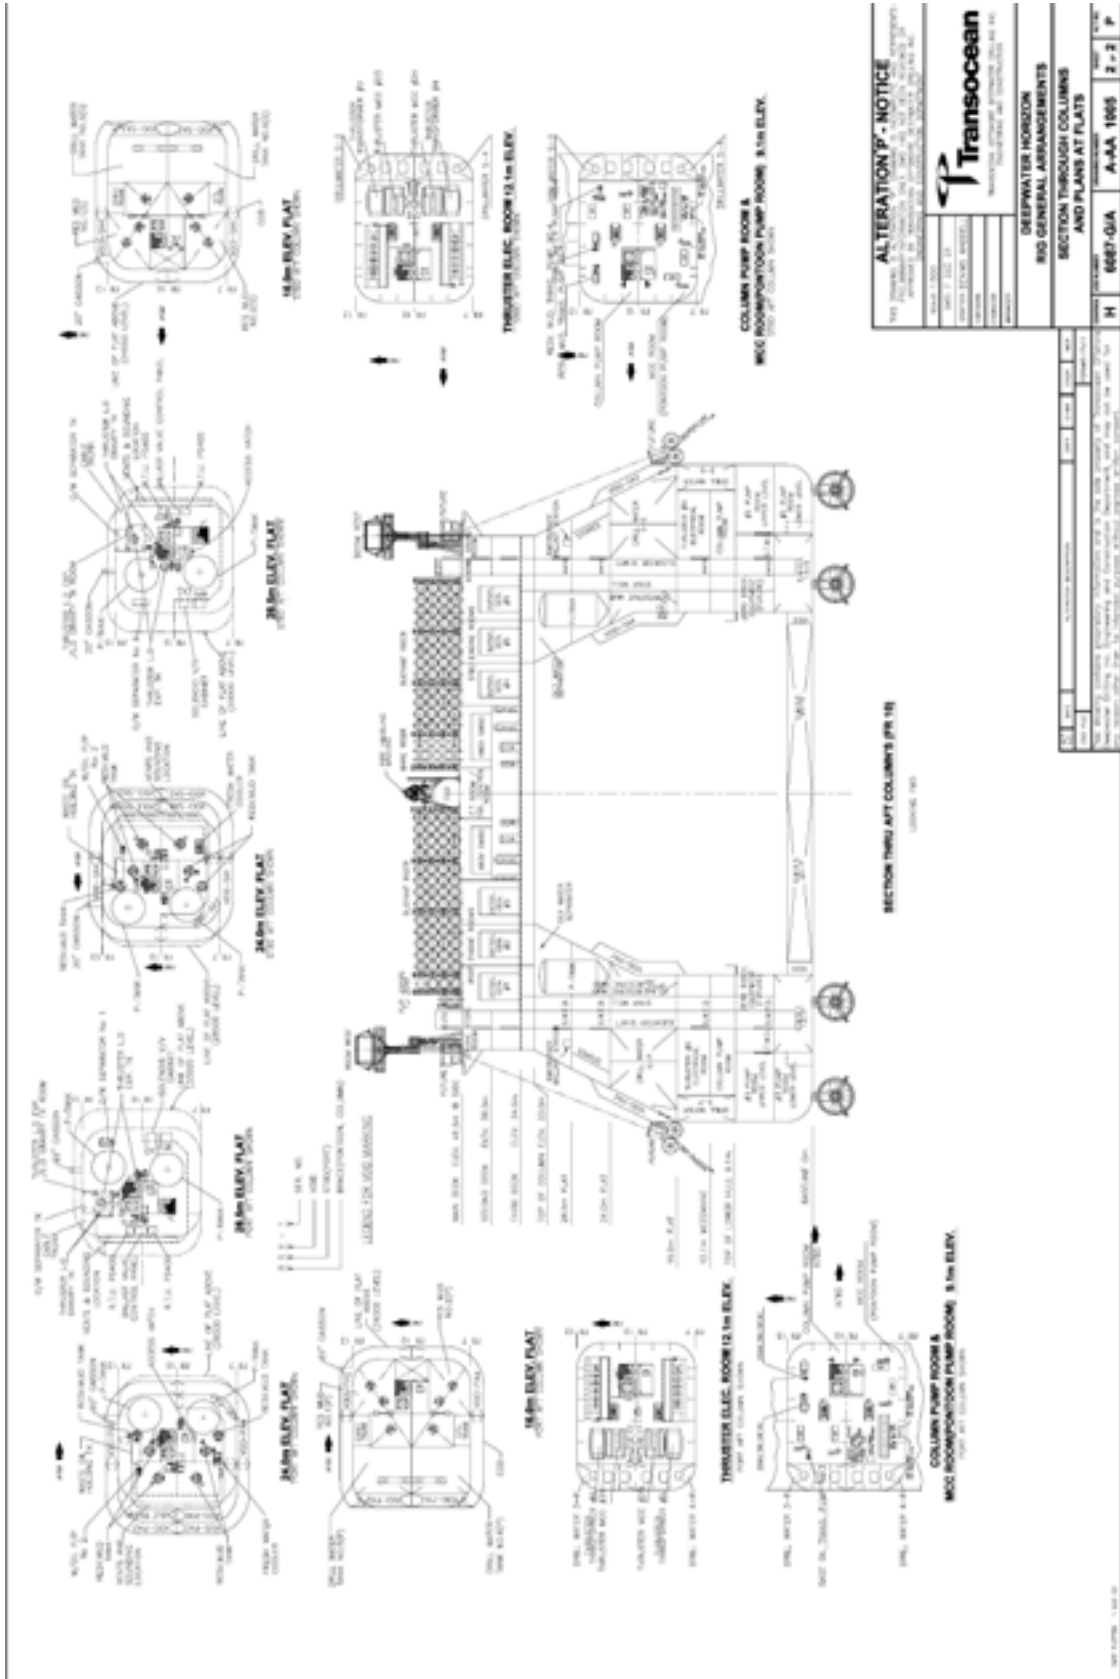
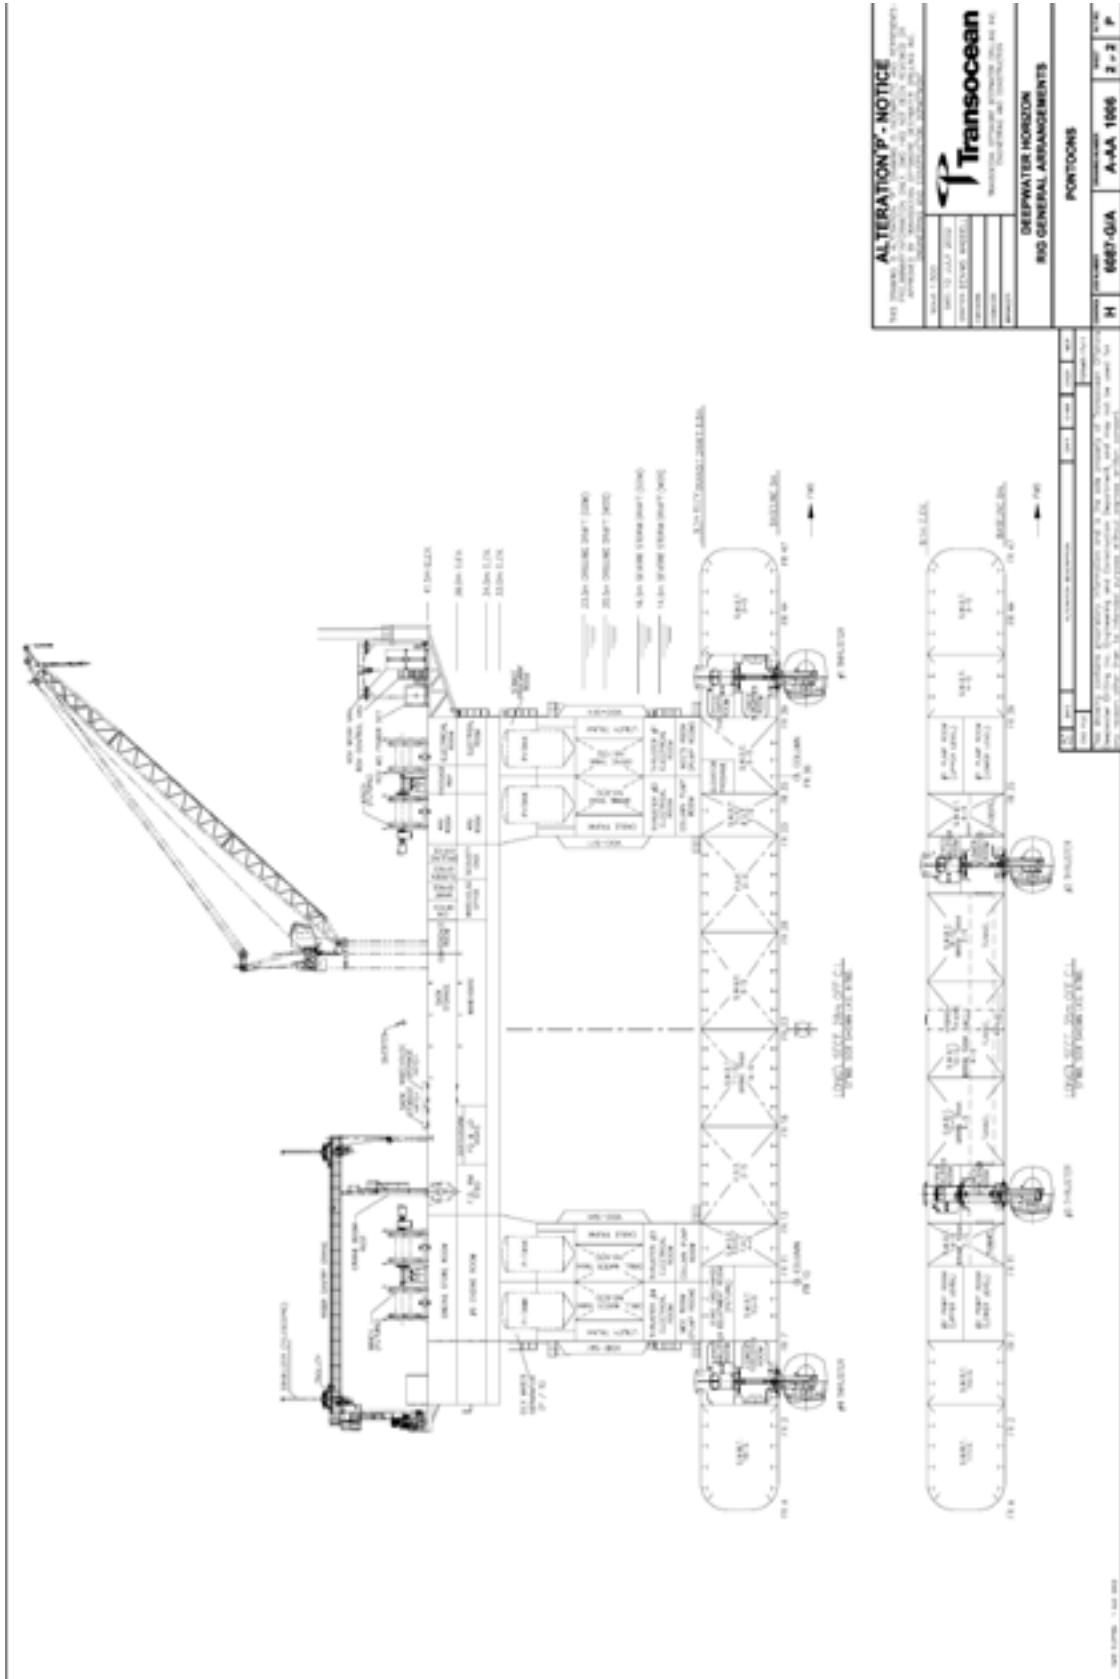
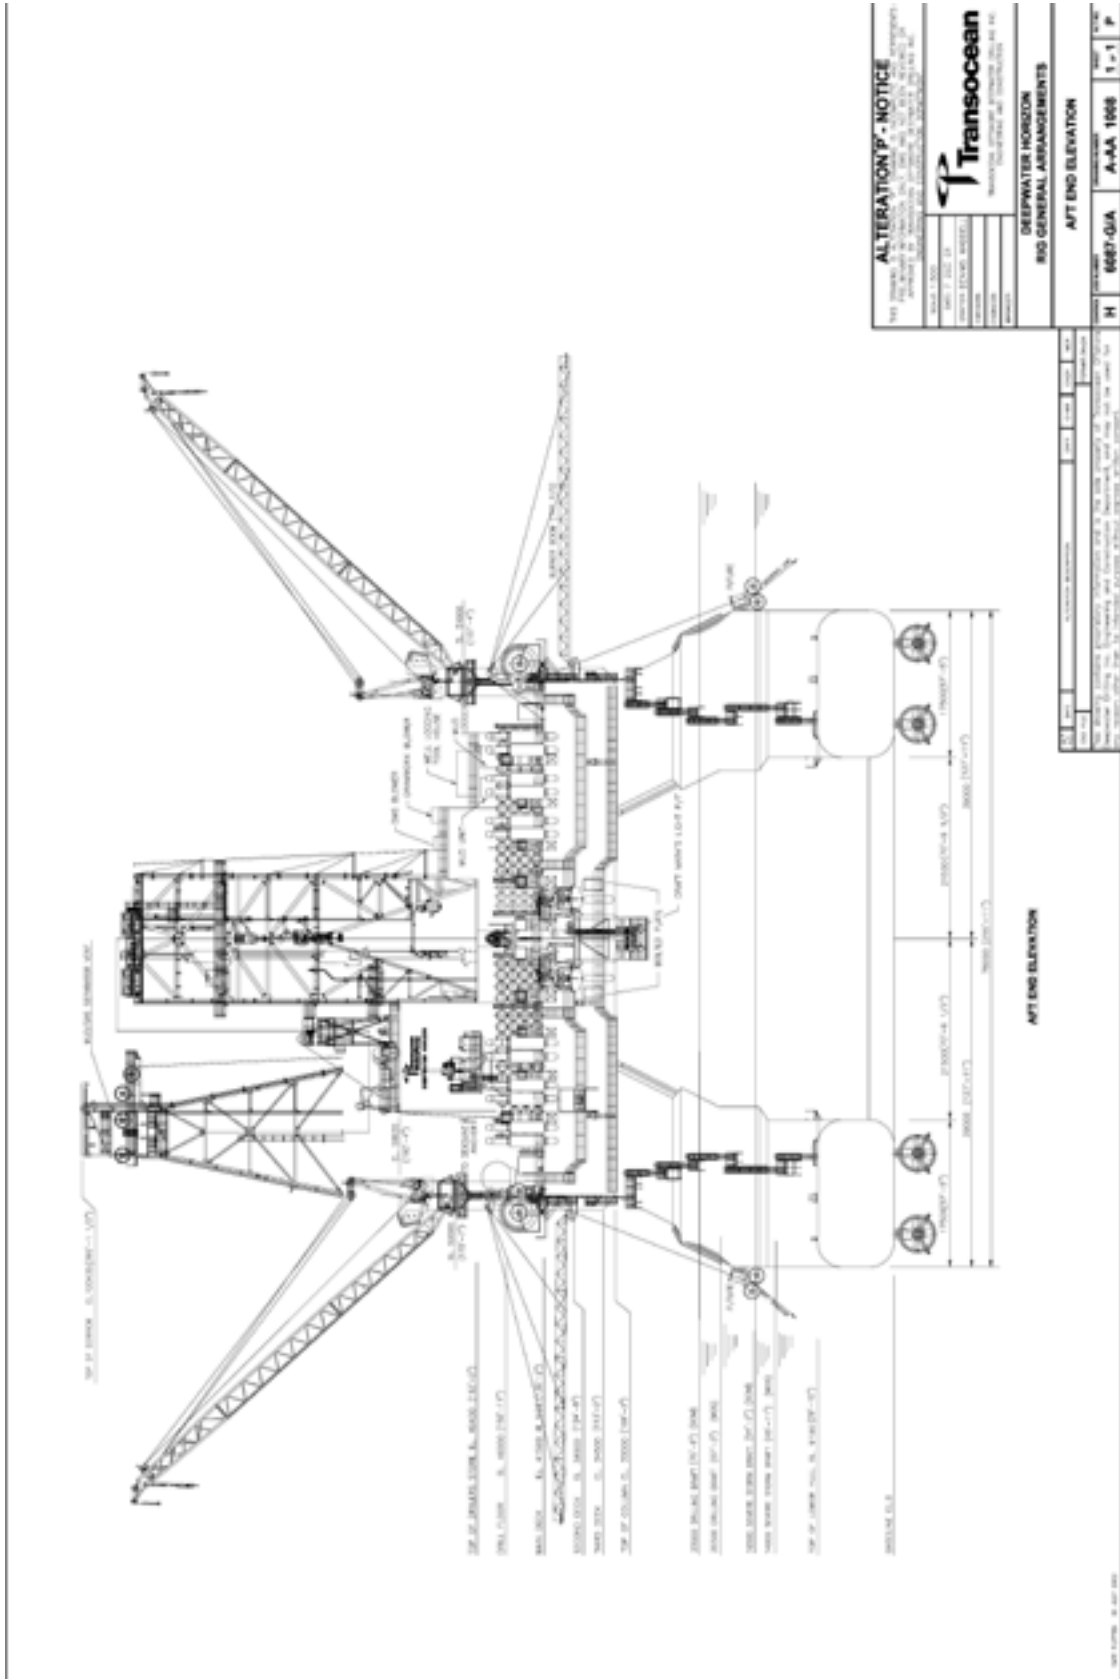
FIRE FIGHTING & LIFESAVING PLAN
DEEPWATER HORIZON - 001 014411

the jet fuel unit, see ABS MODU 4-4-1/37.5.1.		
	Survivor is requested to verify portable fire extinguisher is readily available for helifuel storage area.		
P-004	6087aUN1000 - Firefighting & Lifesaving Plan	O339(Oven)	Survivor
	Survivor is requested to verify appropriate quantity of "Portable Extinguisher Spare/Fire Hose Seares" that are stored on the 28500 Flat (not second deck as shown on symbol legend).
