# MACONDO WELL INCIDENT Transocean Investigation Report Volume I

June 2011

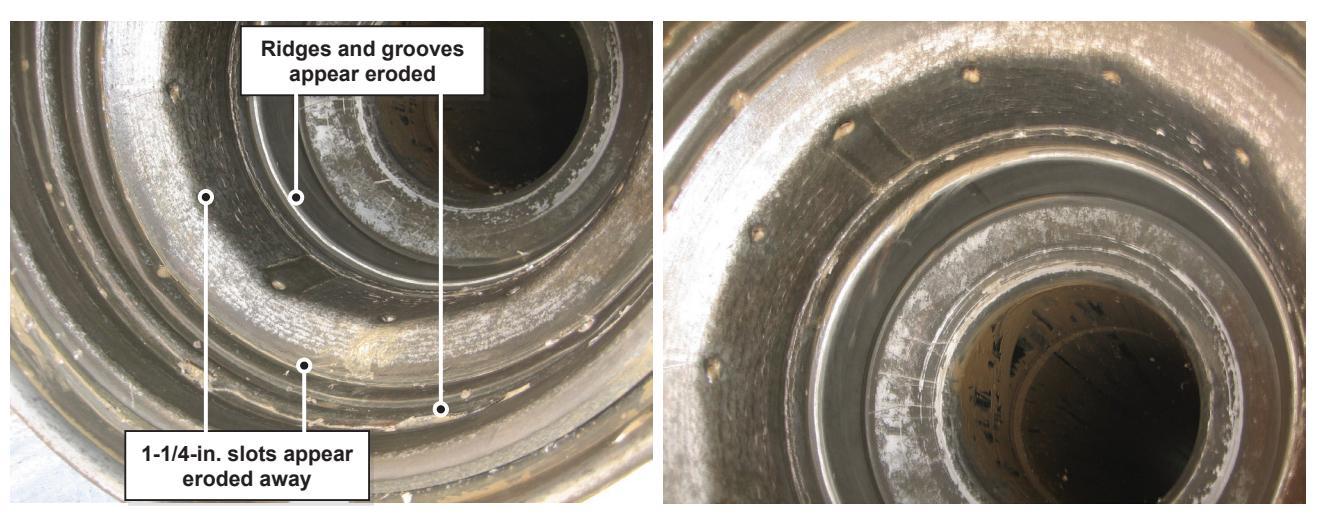
Figure 4 Macondo 9-7/8-in. Casing Hanger (Interior)

At the time this report was completed, the official Dril-Quip analysis of the wellhead, casing hanger, and seal assembly condition was still underway. However, the photographic evidence available to the investigation team does not appear to show flow around the outside of the production casing, hanger, and seal assembly; evidence of flow related to the blowout appears from the interior of the casing. *Figures 4 and 5* are photographs obtained after retrieval of the hanger assembly, showing the condition of the production casing hanger after it was retrieved from the well.<sup>8</sup>

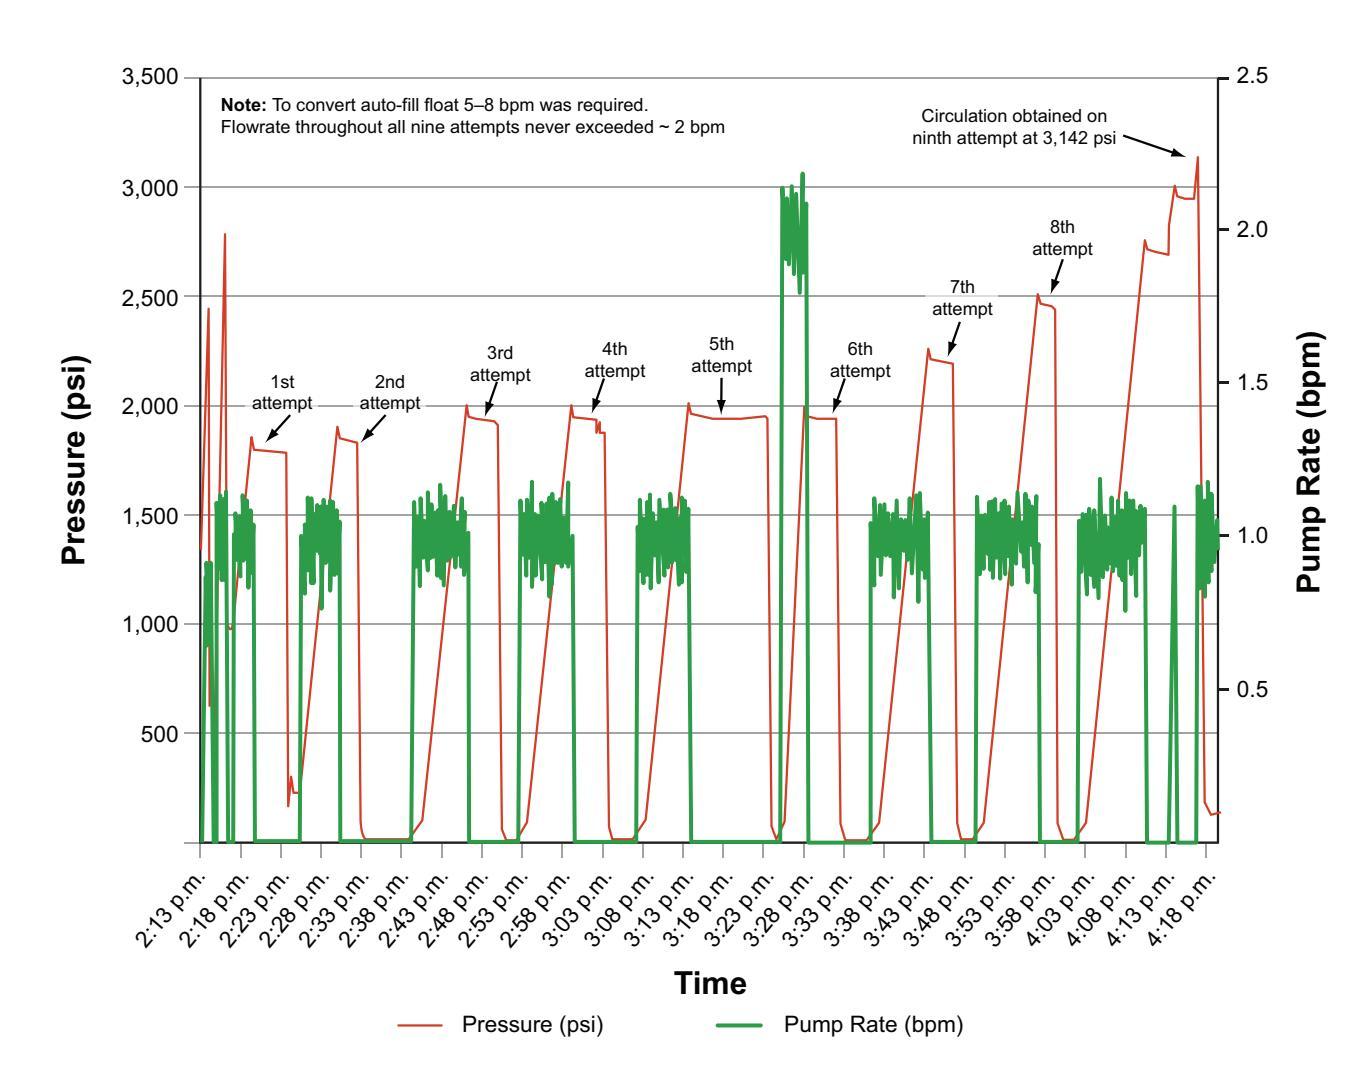
Figure 13 Nine Attempts Prior to Assumed Conversion of Auto-Fill Float Collar (April 19,2010)

There were a total of nine attempts to convert the auto-fill float collar, as can been seen in Figure 13:25

The first attempt to convert the float collar at the lower flow rate of 1 bpm failed to establish circulation. Instead, the pressure rose to 1,900 psi, indicating that debris or formation cuttings likely were blocking the drilling fluid from flowing through the float collar. During subsequent attempts, the BP well site leader and engineer called shore for approval from the BP onshore supervisor to increase pressure to 2,200 psi, then 3,000 psi, and finally 3,500 psi.<sup>26</sup> While pressure was increased with each successive attempt to convert the float collar, the BP onsite engineer contacted the onshore Weatherford representative, who informed him that the actuating ball would go through the tube but would not actually convert the floats if the pressure reached and exceeded 1,300 psi. There was no Weatherford representative on the rig dedicated to supervising the conversion process. However, an Allamon diverter tool representative familiar with the equipment was onboard and recommended procedures to convert the equipment.<sup>27</sup>

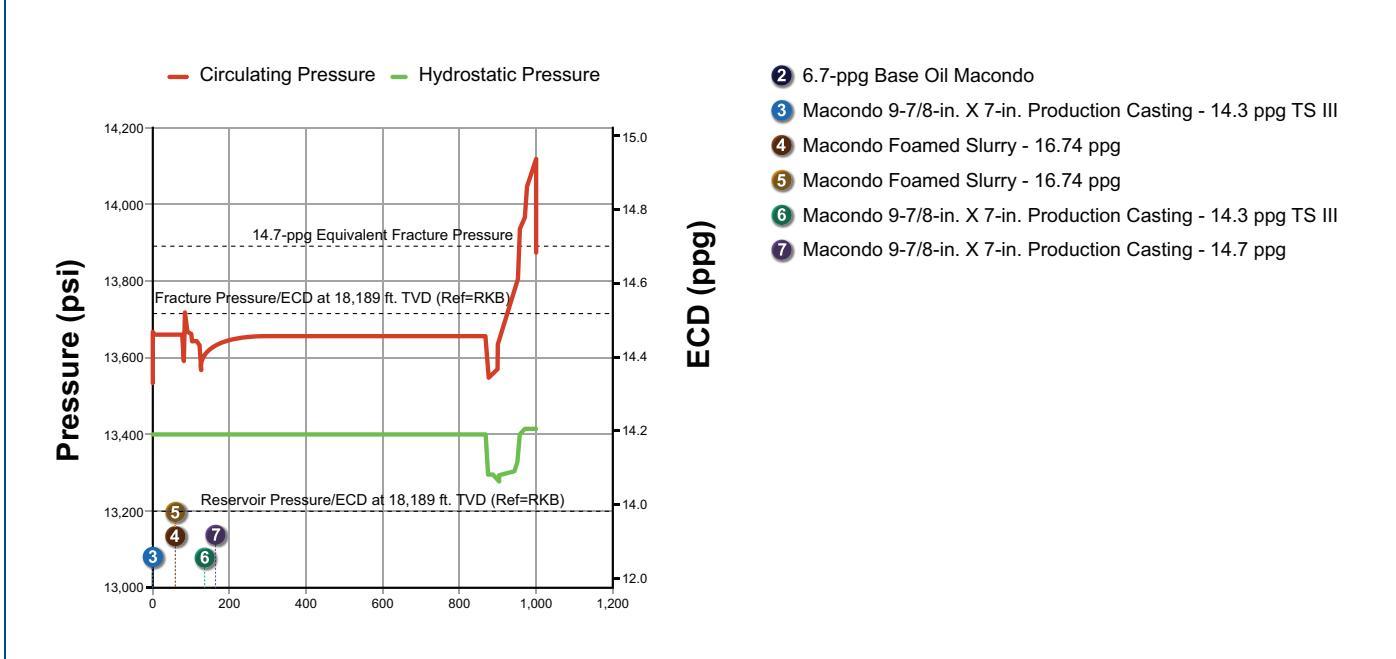
Figure 22 Circulating Pressure and Density Plot Showing Fracture Pressure would be Exceeded During Displacement (Circulating Pressure and Density at Reservoir Zone: Downhole Annular Pressure and ECD vs. Liquid Volume)

During the drilling of the final section of the well, BP correspondence noted that when picking up off bottom (lifting the drill string from the bottom of the well) with a 14.7-ppg equivalent circulating density (ECD) at 18,260 ft., the formations fractured and fluid was lost from the well to the formations.<sup>91</sup> Halliburton's April 18, 2010, report also showed that, according to its modeling, the ECD during cement displacement would exceed the fracture pressure at 18,189 ft. by more than 400 psi.<sup>92</sup> See Figure 22.

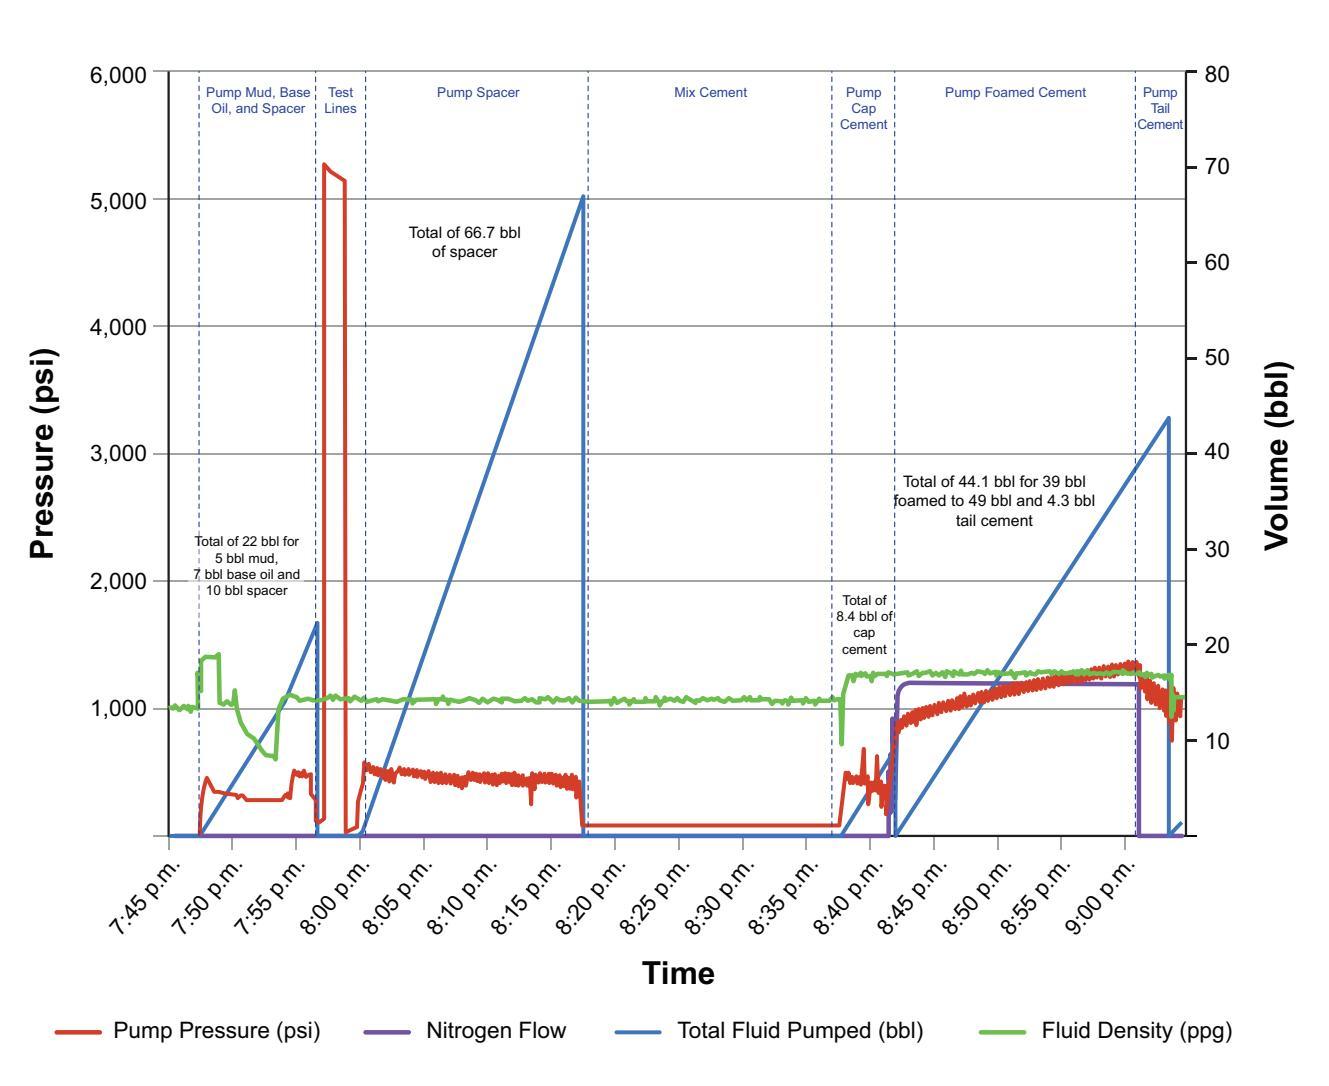
Figure 23 Actual Cement Volumes Pumped for 9-7/8-in. x 7 in. Production Casing (April 19, 2010)

Data recorded during the displacement of the cement shows a distinct change in the flow-out volume subsequent to bumping the bottom plug. The return flow rate decreased by approximately 0.4 bpm then remained constant until the end of displacement.<sup>94</sup> Normally, a small increase in flow rate may be expected as the foamed cement rises in the annulus and expands proportionally to the increase in its foam quality.

The decrease indicates that losses may have occurred when the fracture pressure was exceeded. This flowrate reduction would equal a 4.9-bbl loss over 12.5 minutes. The investigation team was unable to identify the specific loss zone and loss fluid. A 4.9-bbl loss of cement, approximately 10% of the planned total volume, would reduce the estimated top of cement by 96 ft. to only 412 ft. above the shallowest hydrocarbon-bearing sand, possibly compromising the effectiveness of the barrier. *See Figures 23 and 24.*

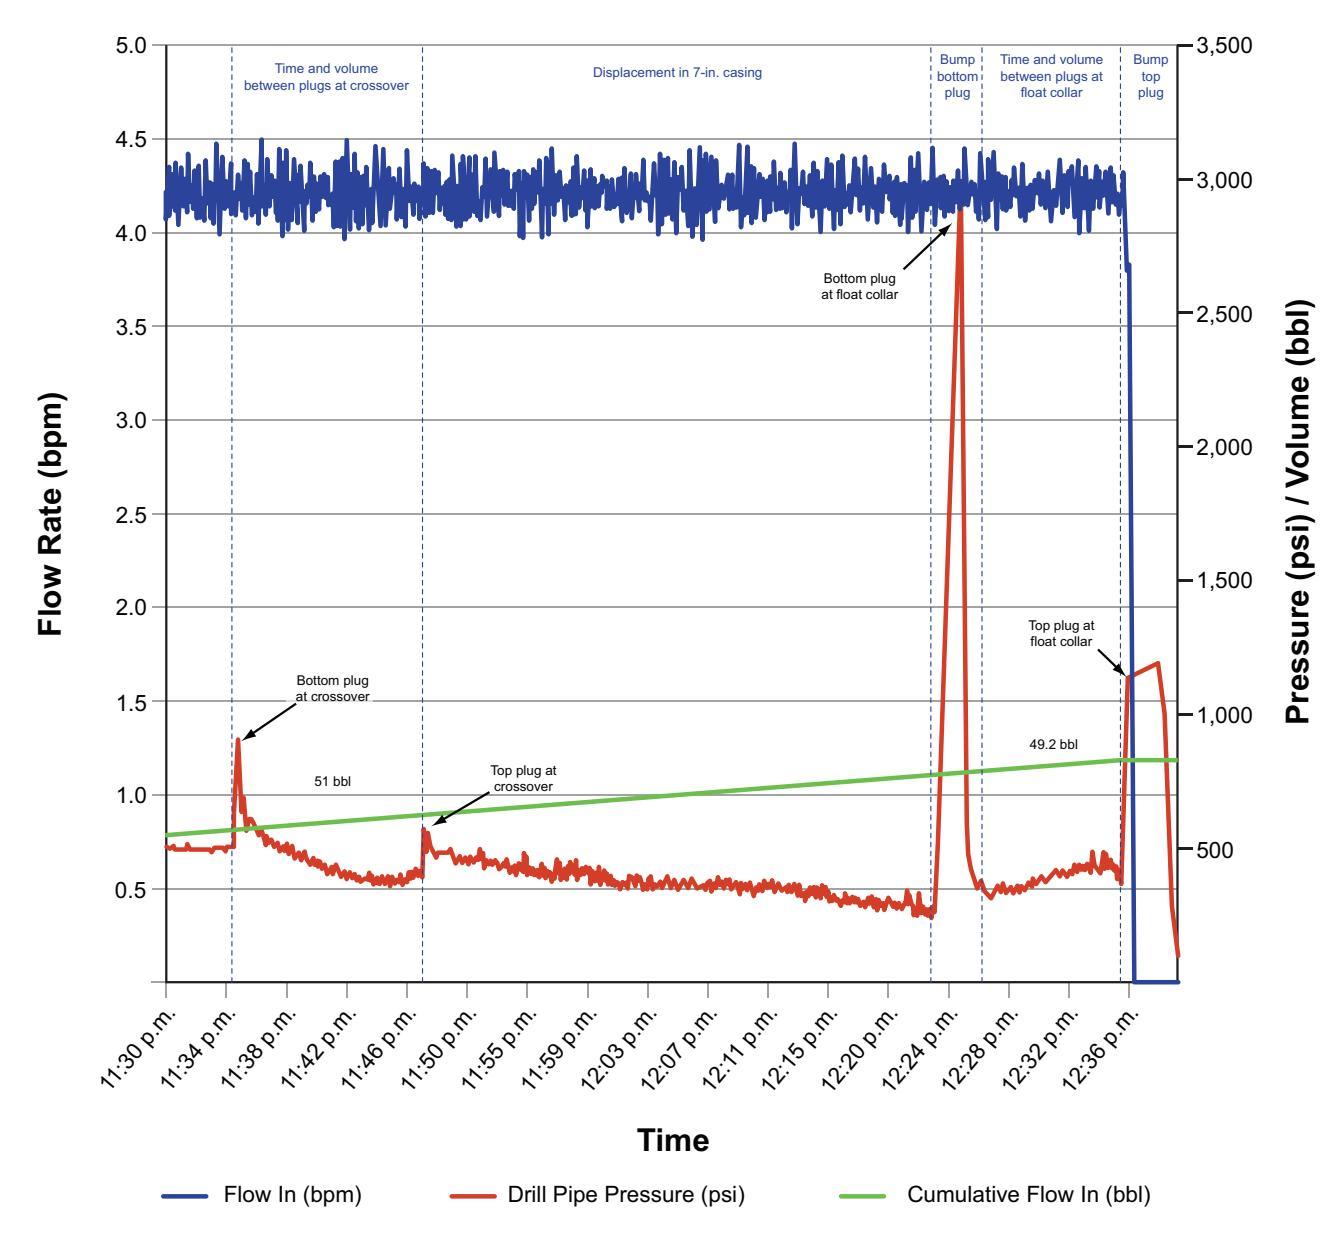
Figure 25 Reduction in Foamed Slurry Volume from 12,487 ft. crossover to 18,115 ft. (Float Collar)

The investigation team analyzed the cement volume to determine whether there was any evidence that contamination occurred during displacement. Volumes were calculated at two locations (*See Figure 25*):

- Where the plugs went through the 9-7/8-in. x 7-in. crossover at 12,487 ft.
- Where the plugs reached the float collar at 18,115 ft.

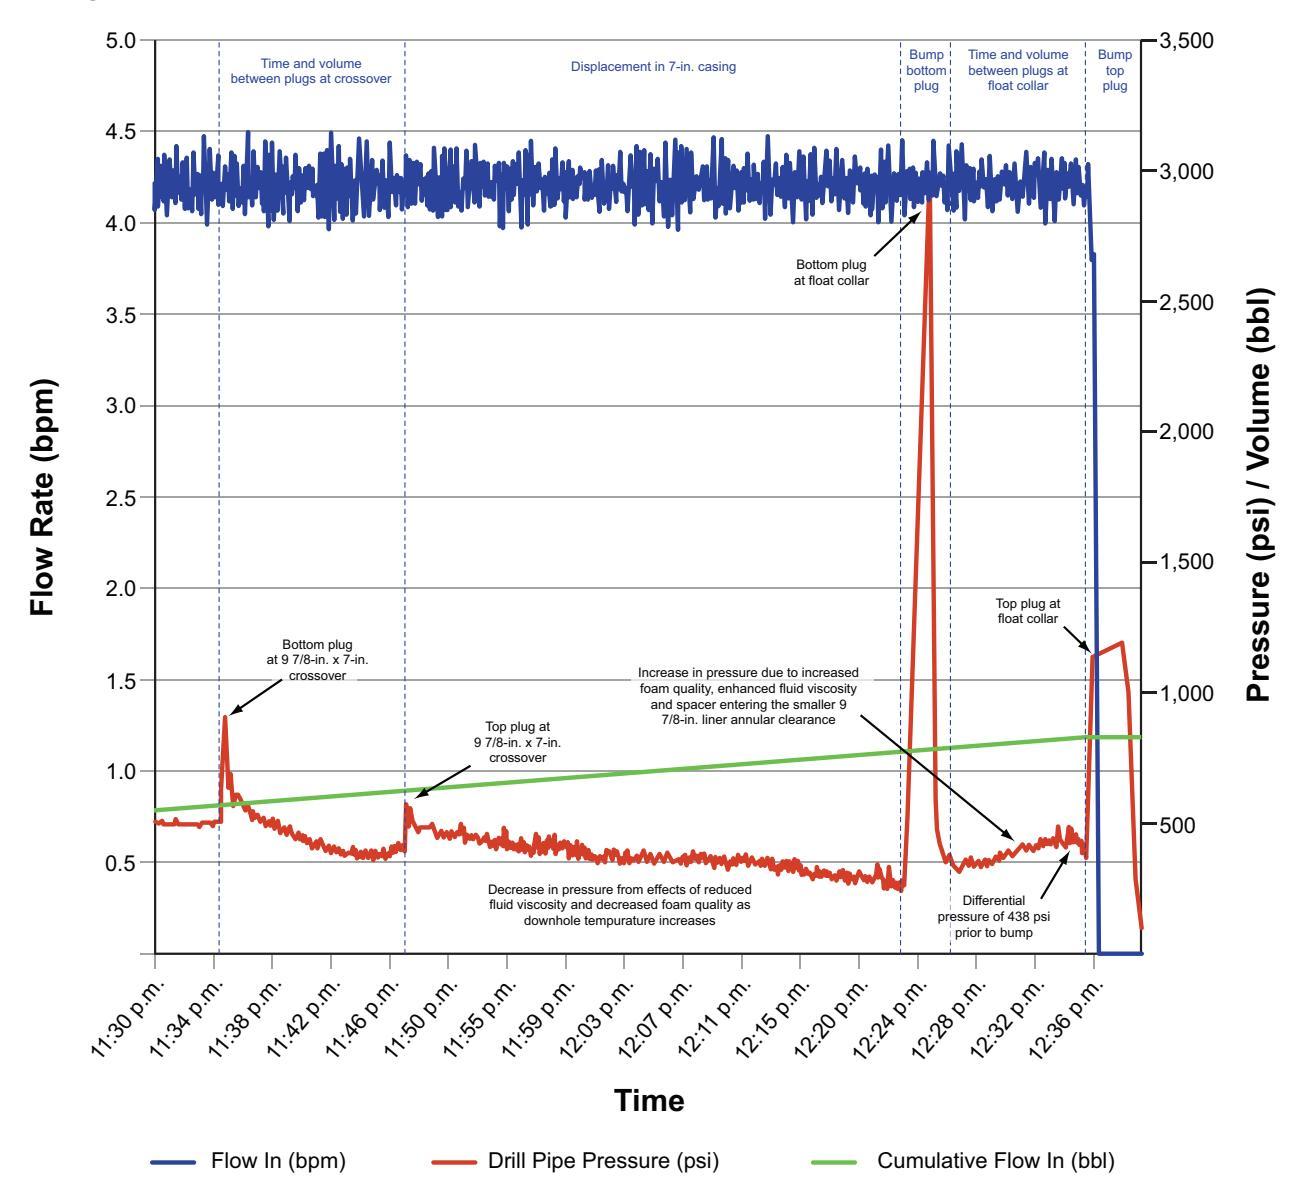
Figure 26 Differential Pressure at the End of 9-7/8-in. x 7-in. Production Casing Cement Program Displacement (April 19, 2010)

Once cement has been fully displaced, it should occupy the internal space within the casing shoe track and extend up to a pre-determined height in the annulus, as specified in the operator's well plan. Normally, a U-tube effect occurs because the longer cement column in the annulus exerts more pressure than the shorter cement column inside the casing. That difference in pressure, or lift pressure, must be determined accurately to confirm that the float collar is functioning properly. As noted previously, the float collar valves should block the back-pressure from the cement in the annulus, stopping the cement from flowing back into the casing. Lift pressure is the only way to test the effectiveness of the float collar once cementing operations are completed. *See Figure 26.*

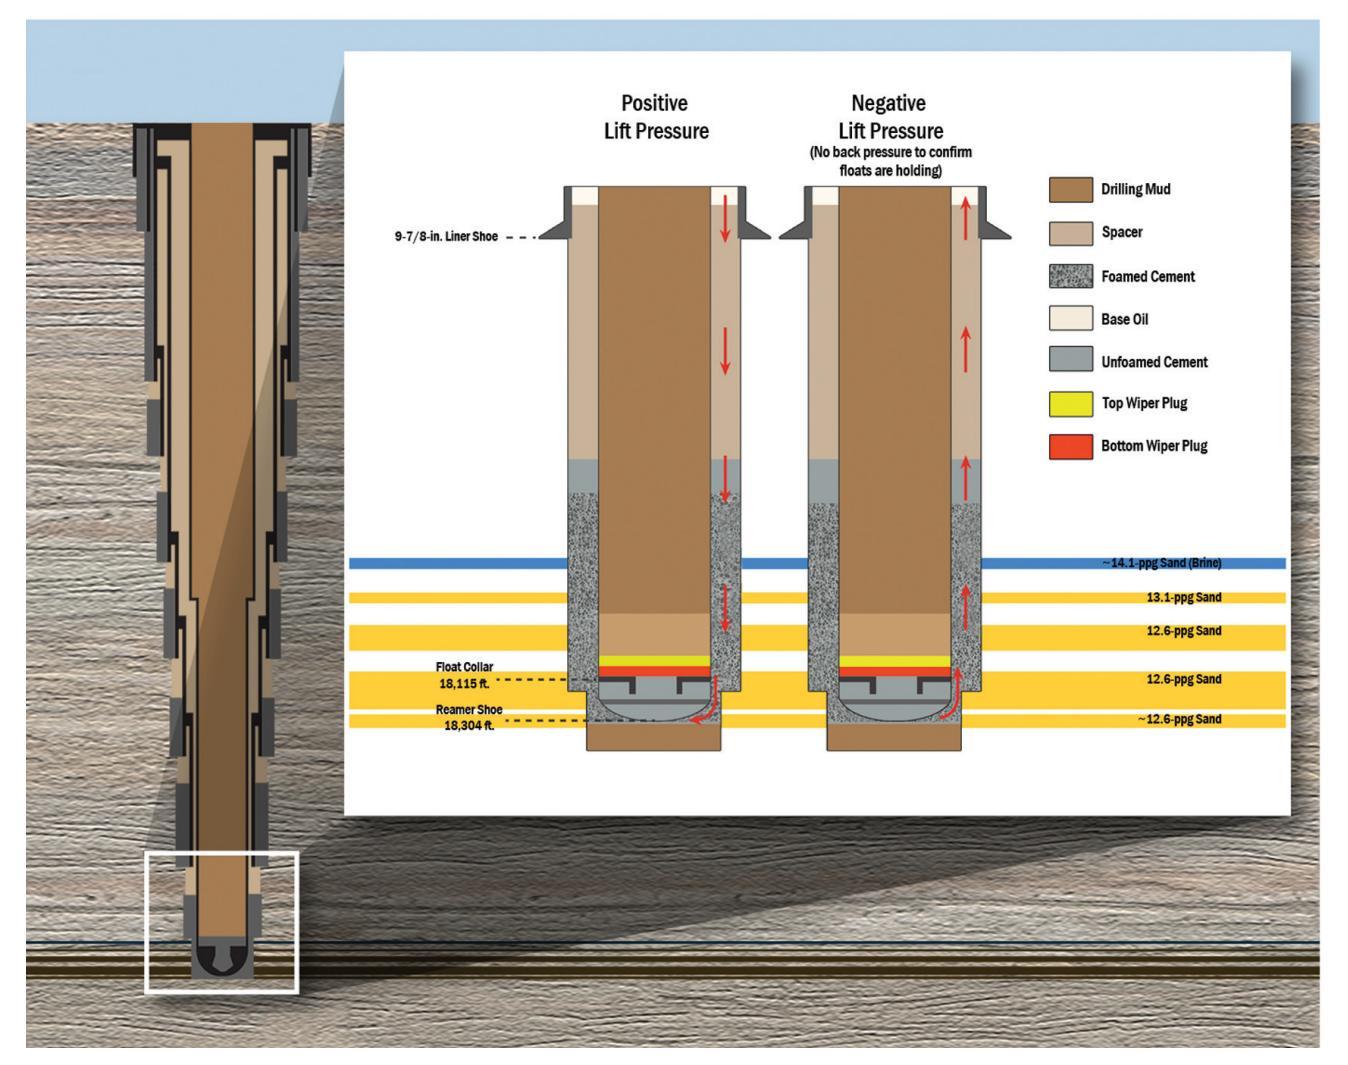
Figure 27 Expected (Positive) and Actual (Negative) Lift Pressure Post Cementing of the Production Casing

The discussion above on the lift pressure also can be correlated back to the cement program. At BP's direction, Halliburton incorporated base oil into the fluid schedule to minimize pressure on the formation.<sup>107</sup> Pumping base oil, which is much lighter than drilling mud, ahead of the spacer reduced the lift pressure by approximately 42 psi at the end of the job. This further ensured that there was no back-pressure to confirm whether the float collar was, in fact, holding.

*Figure 27* illustrates the expected direction of flow due to the U-tube effect (positive lift pressure) and the actual direction of fluid flow once displacement was completed (negative lift pressure) on the Macondo well.

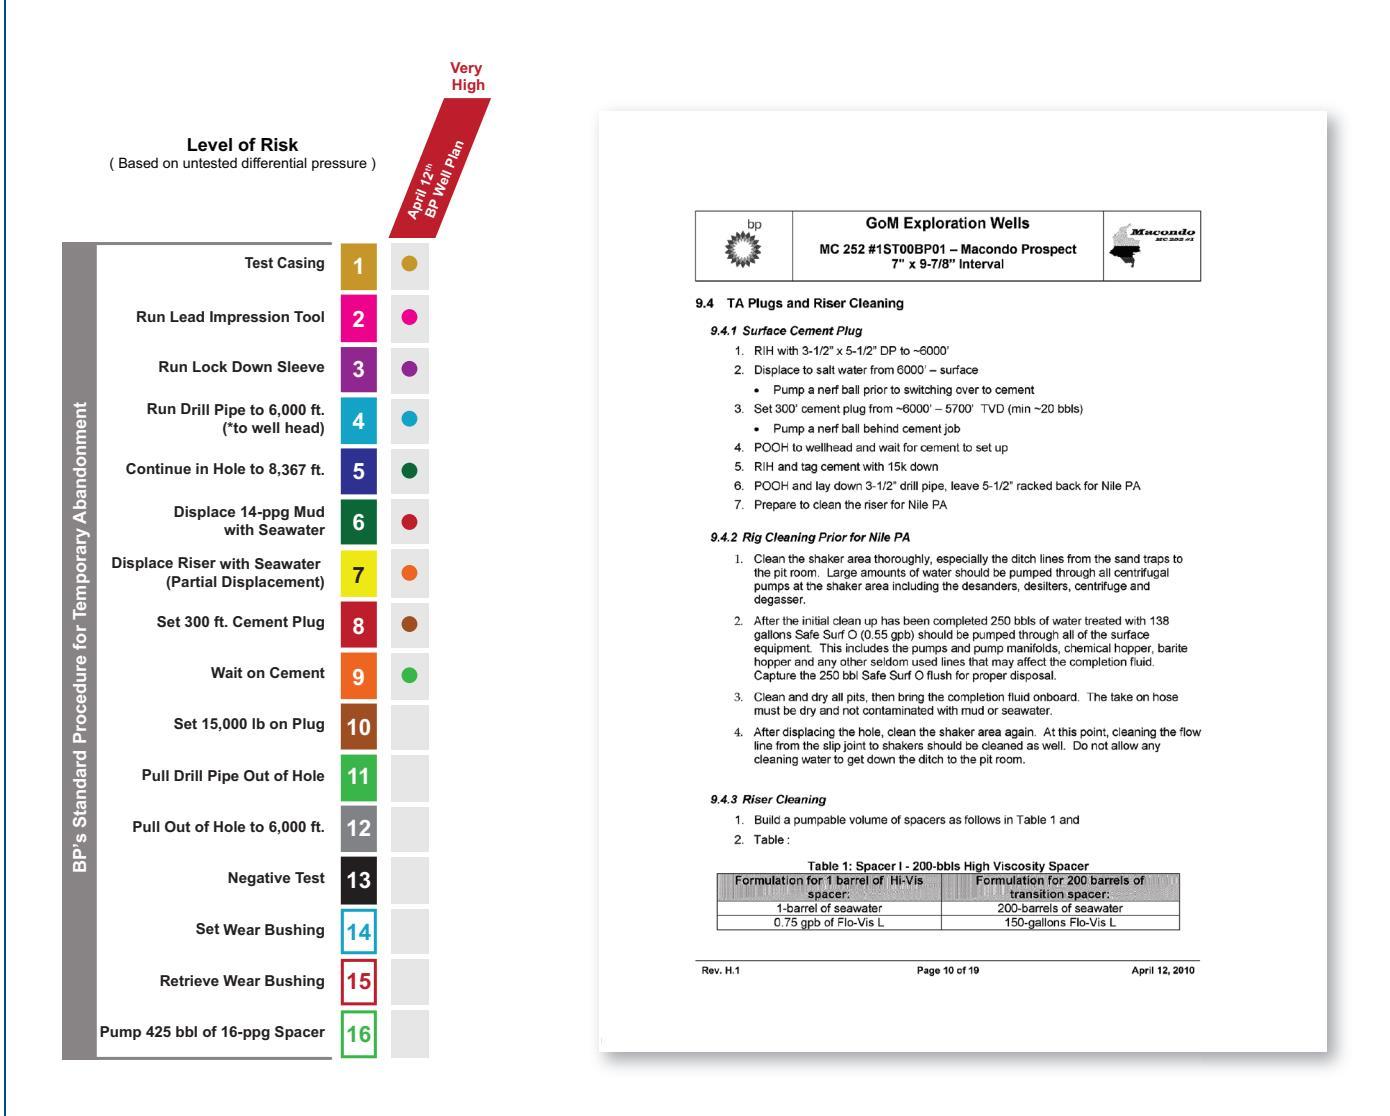
Figure 2 April 12 Temporary Abandonment Plan

The operator's original temporary abandonment procedure was dated April 12, 2010.<sup>5</sup> It directed the setting of the lock-down sleeve first to secure the production casing to the wellhead. Next, the well would be displaced with seawater to 933 ft. below the mud line, where a surface cement plug would be set. The April 12 plan did not include a negative pressure test to confirm the integrity of the cement barrier at the bottom of the well, which would have been the only (untested) barrier in place to prevent hydrocarbons from entering the wellbore when heavy drilling mud was to be removed and replaced, or displaced, with lighter seawater. See *Figure 3a*. The displacement phase of a temporary abandonment operation is particularly delicate as the well becomes underbalanced.

There is no indication that BP used a formal risk assessment to evaluate the April 12 plan.

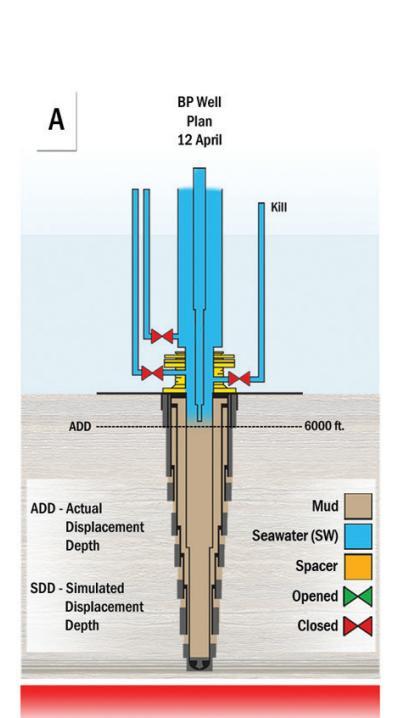
No negative test to simulate displacement · Well exposed to an untested differential pressure

of 1.752 psi after displacement

No secondary cement barrier in place prior to displacement

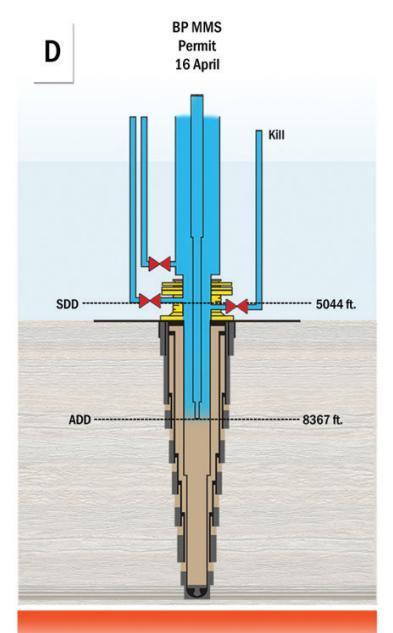
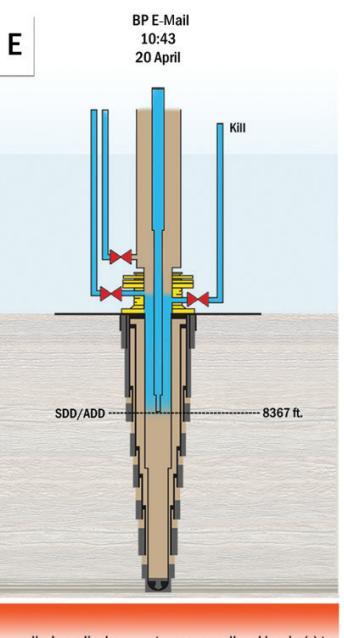
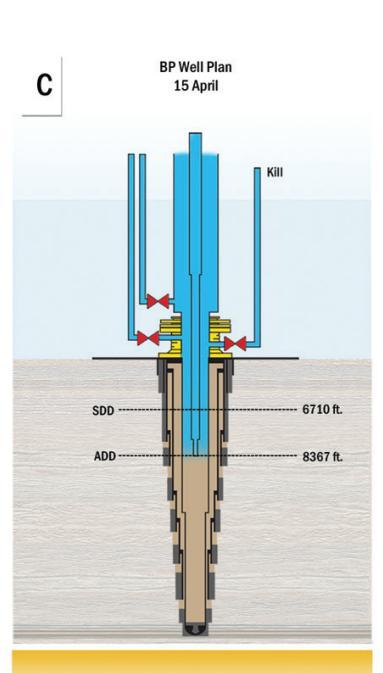
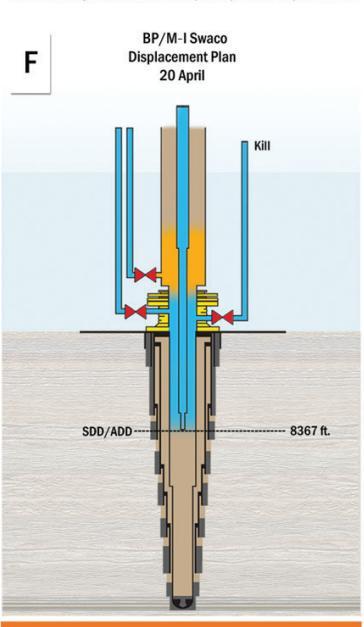
Figure 3 Risk Associated with Procedural Changes

Secondary cement barrier in place prior to negative test and displacement

Cement plug weight tested to confirm integrity
 Negative test more than adequate to simulate displacement · Well not exposed to an untested differential pressure

- Unusually deep displacement exposes well and barrier(s) to higher differential pressure
- Negative test does not simulate final displacement
- Well exposed to an untested differential pressure

of 970 psi after displacement • No secondary cement barrier in place prior to displacement

· Unusually deep displacement exposes well and barrier(s) to higher differential pressure Well exposed to an untested differential pressure of 970 psi

after partial displacement, before closing BOP No secondary cement barrier in place prior to displacement

• Well exposed to an untested differential pressure of 869 psi after partial displacement, before closing BOP

• No secondary cement barrier in place prior to displacement

Unusually deep displacement exposes well and barrier(s) to higher differential pressure

- Negative test does not simulate final displacement
   Well exposed to an untested differential pressure
- of 484 psi after displacement
- No secondary cement barrier in place prior to displacement

Because this temporary abandonment plan would have resulted in an inadequate negative pressure test prior to displacing the well, and because the well would be underbalanced with an insufficiently tested barrier, the April 15 procedure posed significant safety risks. *See figure 3c.*

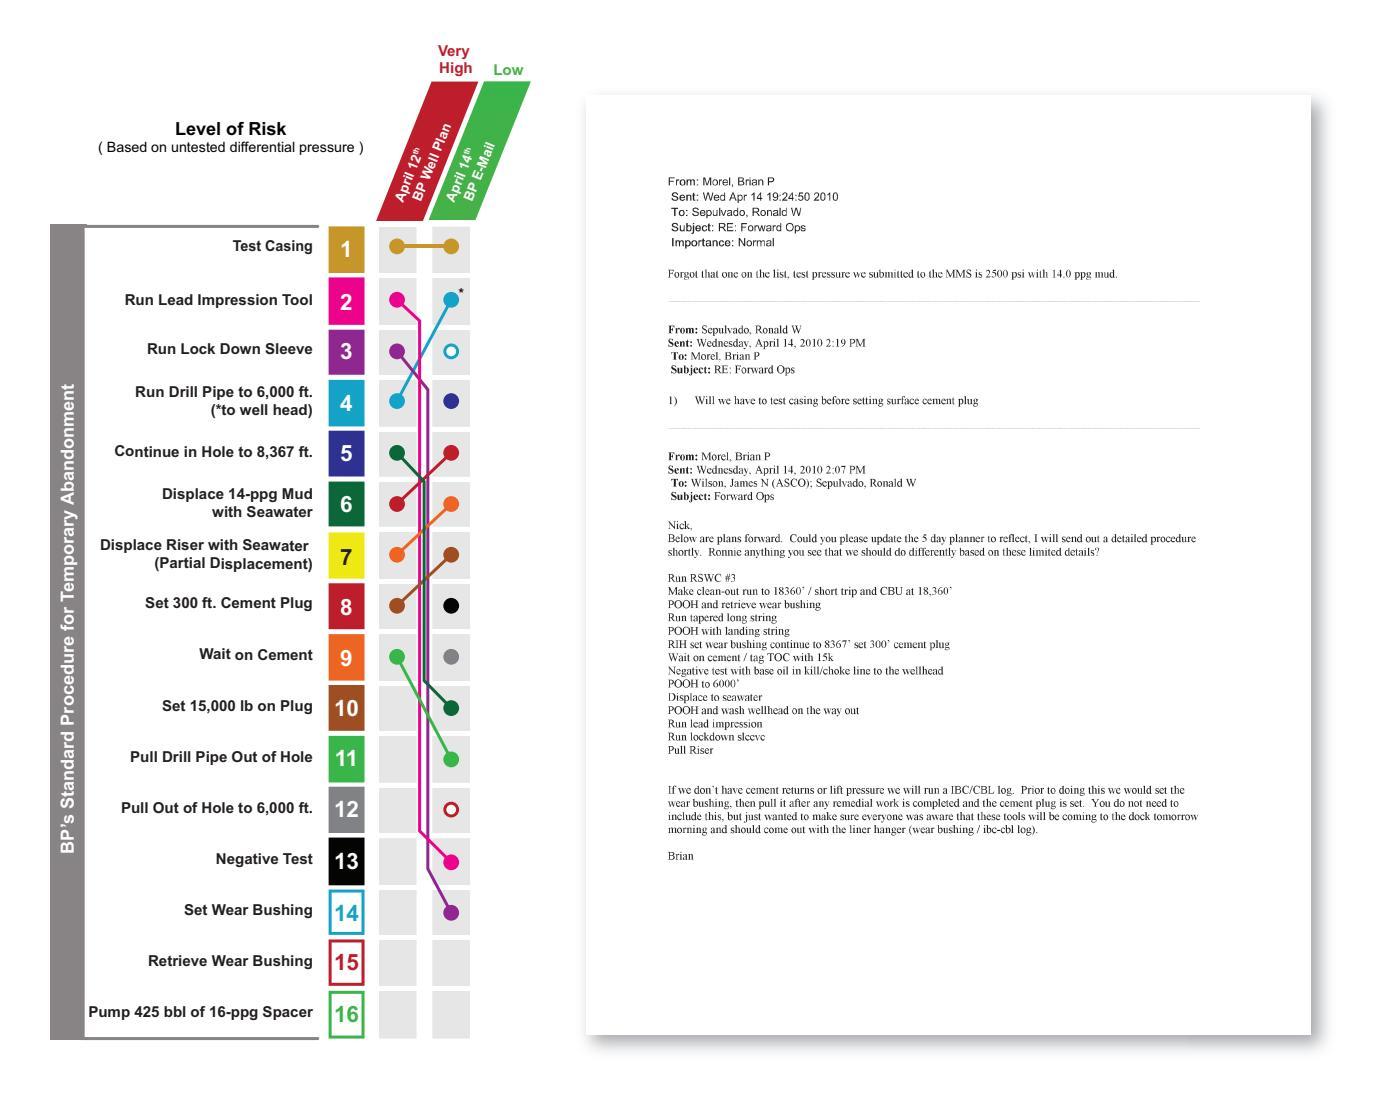
Figure 4 (a) Temporary Abandonment Plan Modifications - April 14 (b) April 14 Temporary Abandonment Plan

The April 14 version of the operator's temporary abandonment plan was e-mailed to the BP well site leader, or "company man," on the *Deepwater Horizon* by a shore-based engineer.<sup>6</sup> The safest of all five versions, the April 14 plan dictated that a surface cement plug be set in mud and that a negative pressure test be conducted before the heavy drilling mud was displaced with seawater. It also called for installing the lock-down sleeve last, which would have eliminated the risk of damaging the device when the drill pipe was run into the well to set the surface cement plug. See appendix F for a detailed discussion of the lock-down sleeve decision.

This plan also increased the depth from the top of the cement plug to 3,000 ft. below the mud line, significantly deeper than the MMS limit of 1,000 ft. below the mud line. That alteration (which required and eventually would receive MMS approval, though not in relation to this plan) was made to accommodate the lock-down sleeve installation. The sleeve is set in position with a running tool by applying weight, and the device manufacturer, Dril-Quip, recommends using 100,000 lb. That force is generated by hanging drill string from below the running tool. While the additional space created above the cement plug maximized the operator's options to use varying drill strings with differing weights to reach the 100,000-lb. threshold, it remains unclear why they chose 3,000 ft. in this and subsequent plans, including on April 20, when a shallower depth could also have been used to accommodate Dril-Quip's requirements.

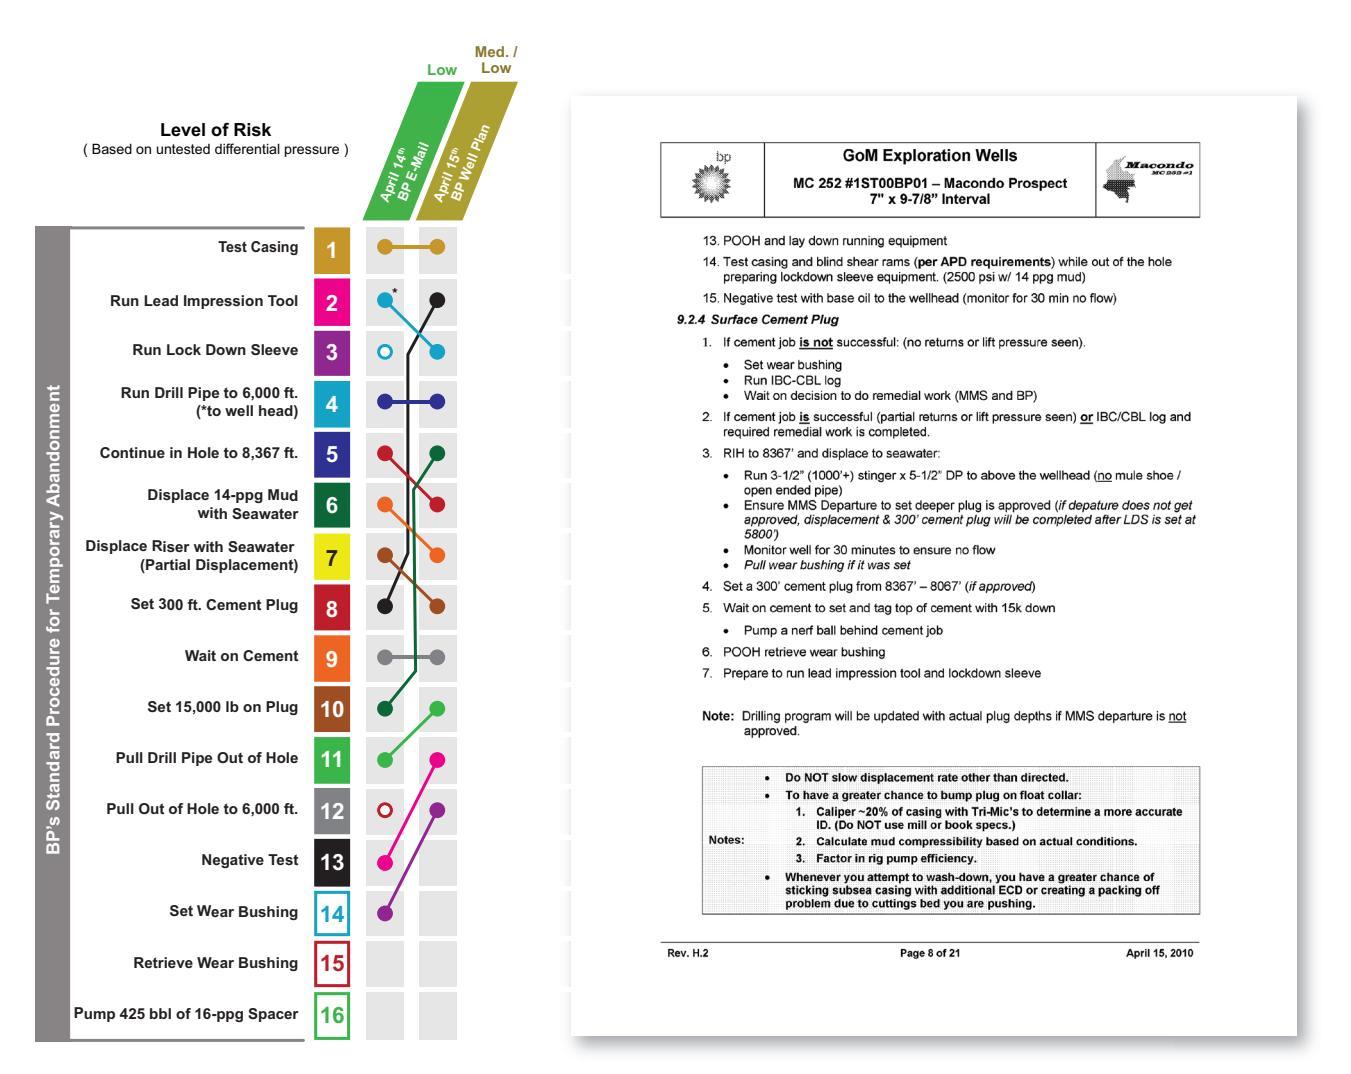
Figure 5 (a) Temporary Abandonment Plan Modifications - April 15 (b) April 15 Temporary Abandonment Plan

On April 15, BP altered the temporary abandonment plan again.<sup>®</sup> Although plugs are commonly set in mud, a well site leader recommended using seawater to reduce the risk of cement contamination.<sup>®</sup> This meant that the well would be displaced with seawater without a secondary barrier in place, which significantly increased the risk of the temporary abandonment operation. The well would be underbalanced with only the insufficiently tested cement at the bottom of the well, serving as a barrier to pressure in the formation.

The unusually deep seawater displacement to the planned cement plug depth — 3,300 ft. below the mud line instead of 933 ft. — also meant that the negative pressure test would no longer be adequate to test the well to the full under balanced condition in the procedure. The April 15 procedure kept the same negative pressure test as the April 14 plan, displacing the choke or kill lines with base oil to the wellhead.<sup>10</sup> However, because of the unusually deep seawater displacement to the planned cement plug depth, the negative pressure test would not simulate the conditions that would exist when the BOP stack and riser were removed.<sup>11</sup> Displacing the lines with base oil simulates seawater to a depth of only approximately 1,643 ft. below the mud line, significantly less than the 3,300 ft. below the mud line planned for setting the cement plug.

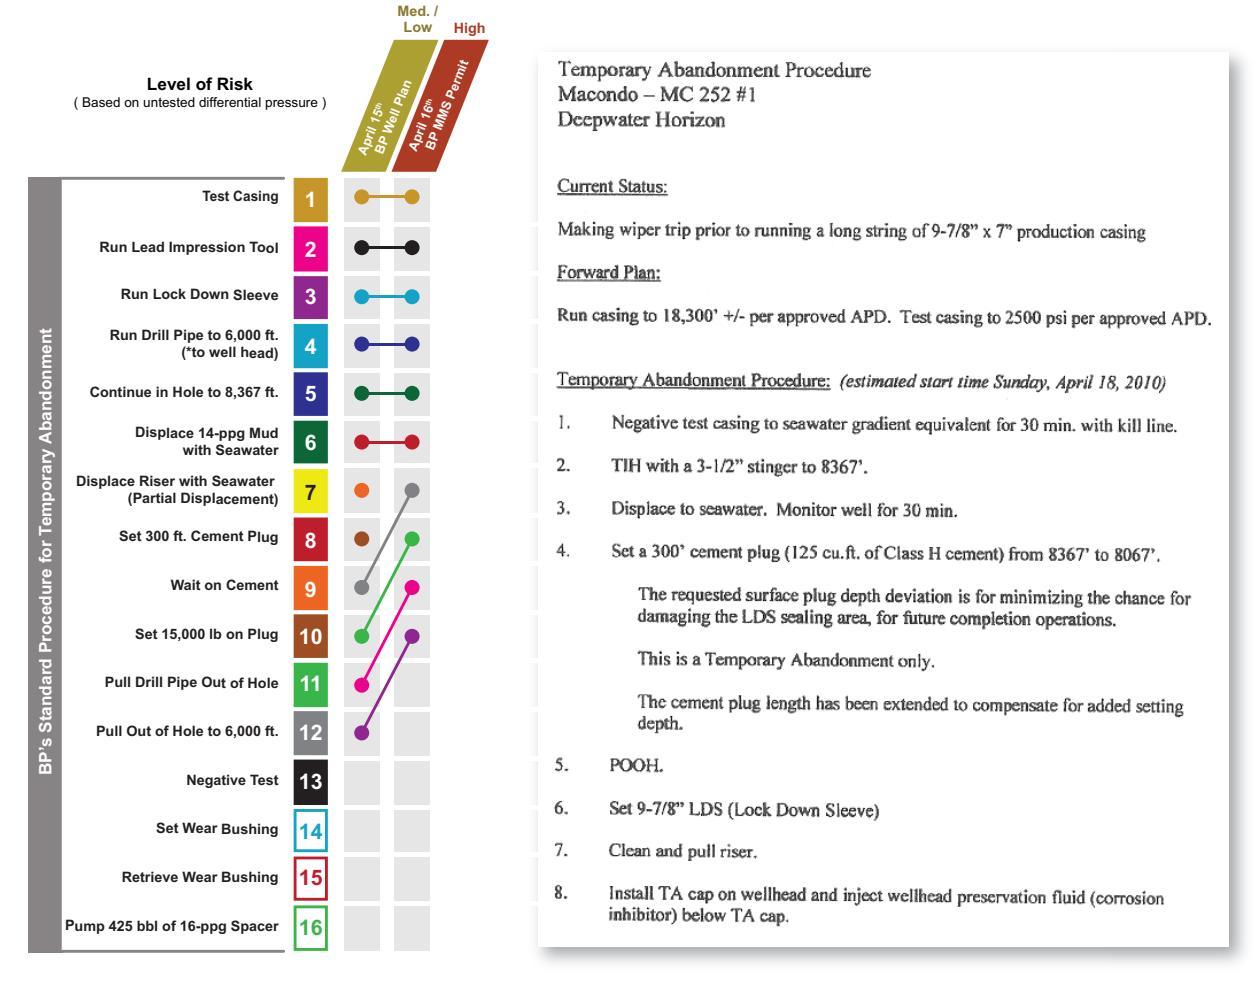
Figure 6 (a) Temporary Abandonment Plan Modifications - April 16 (b) April 16 Temporary Abandonment Plan

BP adopted another plan on April 16, one that would ultimately be the MMS-approved plan.<sup>12</sup> In this version, the negative pressure test would be conducted with seawater rather than base oil in the kill line. The seawater would compromise the negative pressure test even further, as it would simulate a displacement with seawater to just 5,044 ft., despite the planned displacement to 8,367 ft. In addition, this plan again specified setting the surface cement plug *after* conducting the negative pressure test and displacing the well. Thus, no secondary cement barrier would be in place while conducting the negative pressure test and before the well was exposed to additional underbalance from a displacement at 8,367 ft.

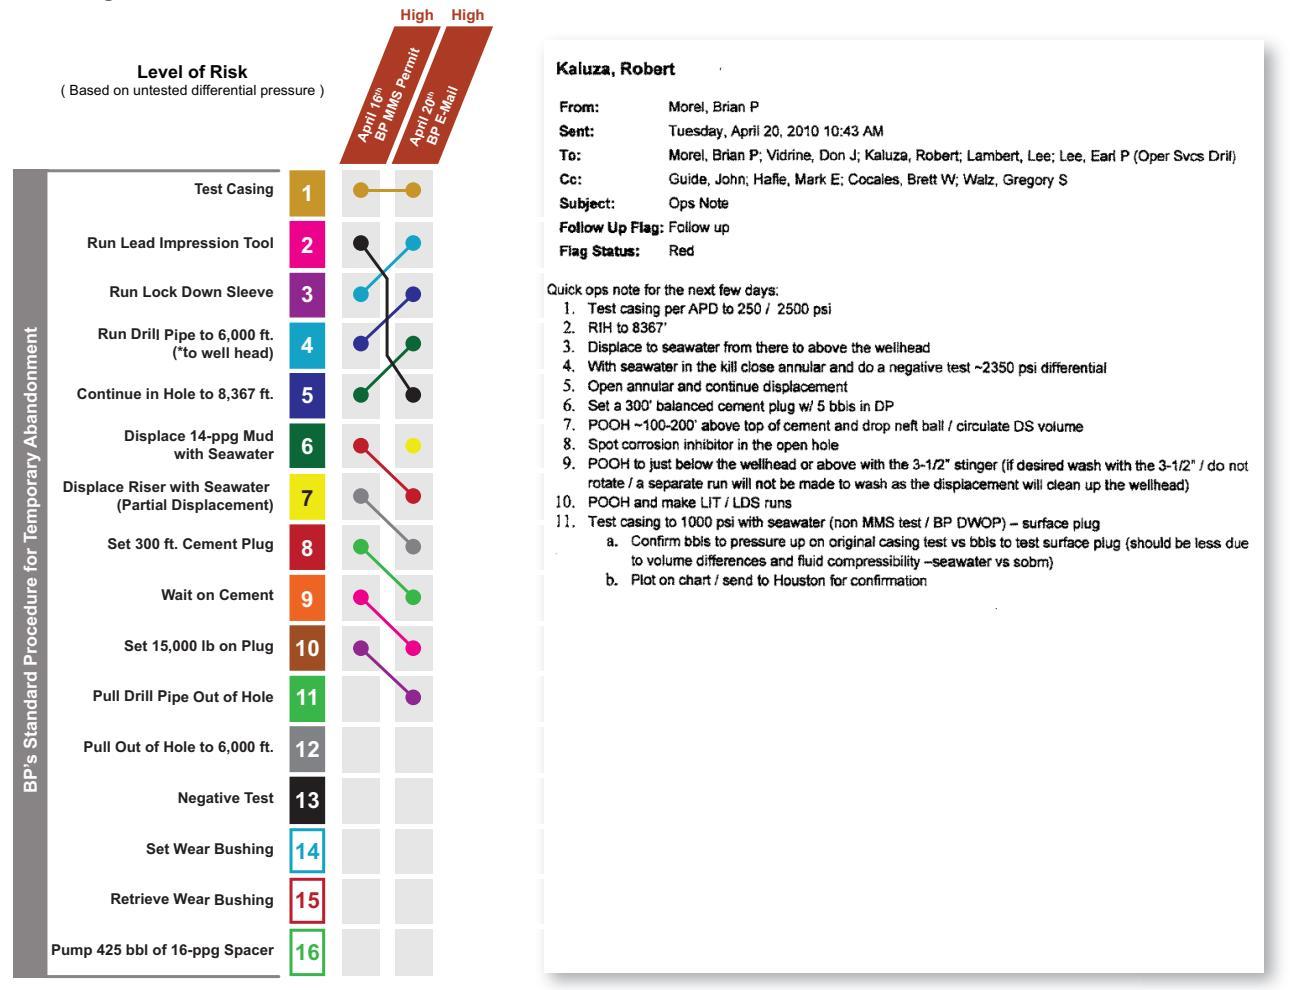
Figure 7 (a) Temporary Abandonment Plan Modifications - April 20 (b) April 20 Temporary Abandonment Plan

On April 20, at 10:43 a.m., after the temporary abandonment operation was underway, a BP engineer e-mailed a final temporary abandonment plan to the well site leader on the *Deepwater Horizon*. This plan was simply a bulleted outline with a minimum level of detail, as denoted by its title, "Quick Ops Note." A more detailed procedure likely would have aided the well site leader and the drill crew in identifying anomalies during the temporary abandonment operation.

Furthermore, while BP never sought MMS approval for the April 20 procedure that was ultimately used — which included several changes from the MMS-approved April 16 plan — BP still anticipated monitoring the kill line during the negative pressure test as stipulated in the April 16 plan. To simulate and test conditions for the planned displacement depth of 8,367 ft., while also monitoring the kill line, the April 20 plan called for a partial displacement prior to the negative pressure test.<sup>A</sup> With seawater in the kill line, the partial displacement would establish a continuous column of seawater to 8,367 ft., thus properly simulating conditions that would allow for the safe removal of the BOP stack and riser.

Despite properly simulating the final temporary abandonment conditions, the following decisions resulted in a procedure that contained unnecessary risk: (See Figure 3e)

- The partial displacement called for the removal of primary well control prior to closing the BOP stack and conducting the negative pressure test, and without a laboratory test confirming the cement setting properties and integrity of the cement barrier at the bottom of the well.
- Seawater displacement to 8,367 ft. (3,300 ft. below the mud line) was unusually deep and resulted in a significantly greater differential pressure across the well's only cement barrier.
- The surface cement plug would not be set until after full displacement, creating a condition where only one cement barrier would be in place while underbalancing the well.

Despite these risks, and the remaining questions about the conversion of the float collar and the laboratory test results for the cement, as noted above, there is no indication that a formal risk assessment was performed to evaluate this final temporary abandonment plan.
