# MACONDO WELL INCIDENT Transocean Investigation Report Volume I

June 2011

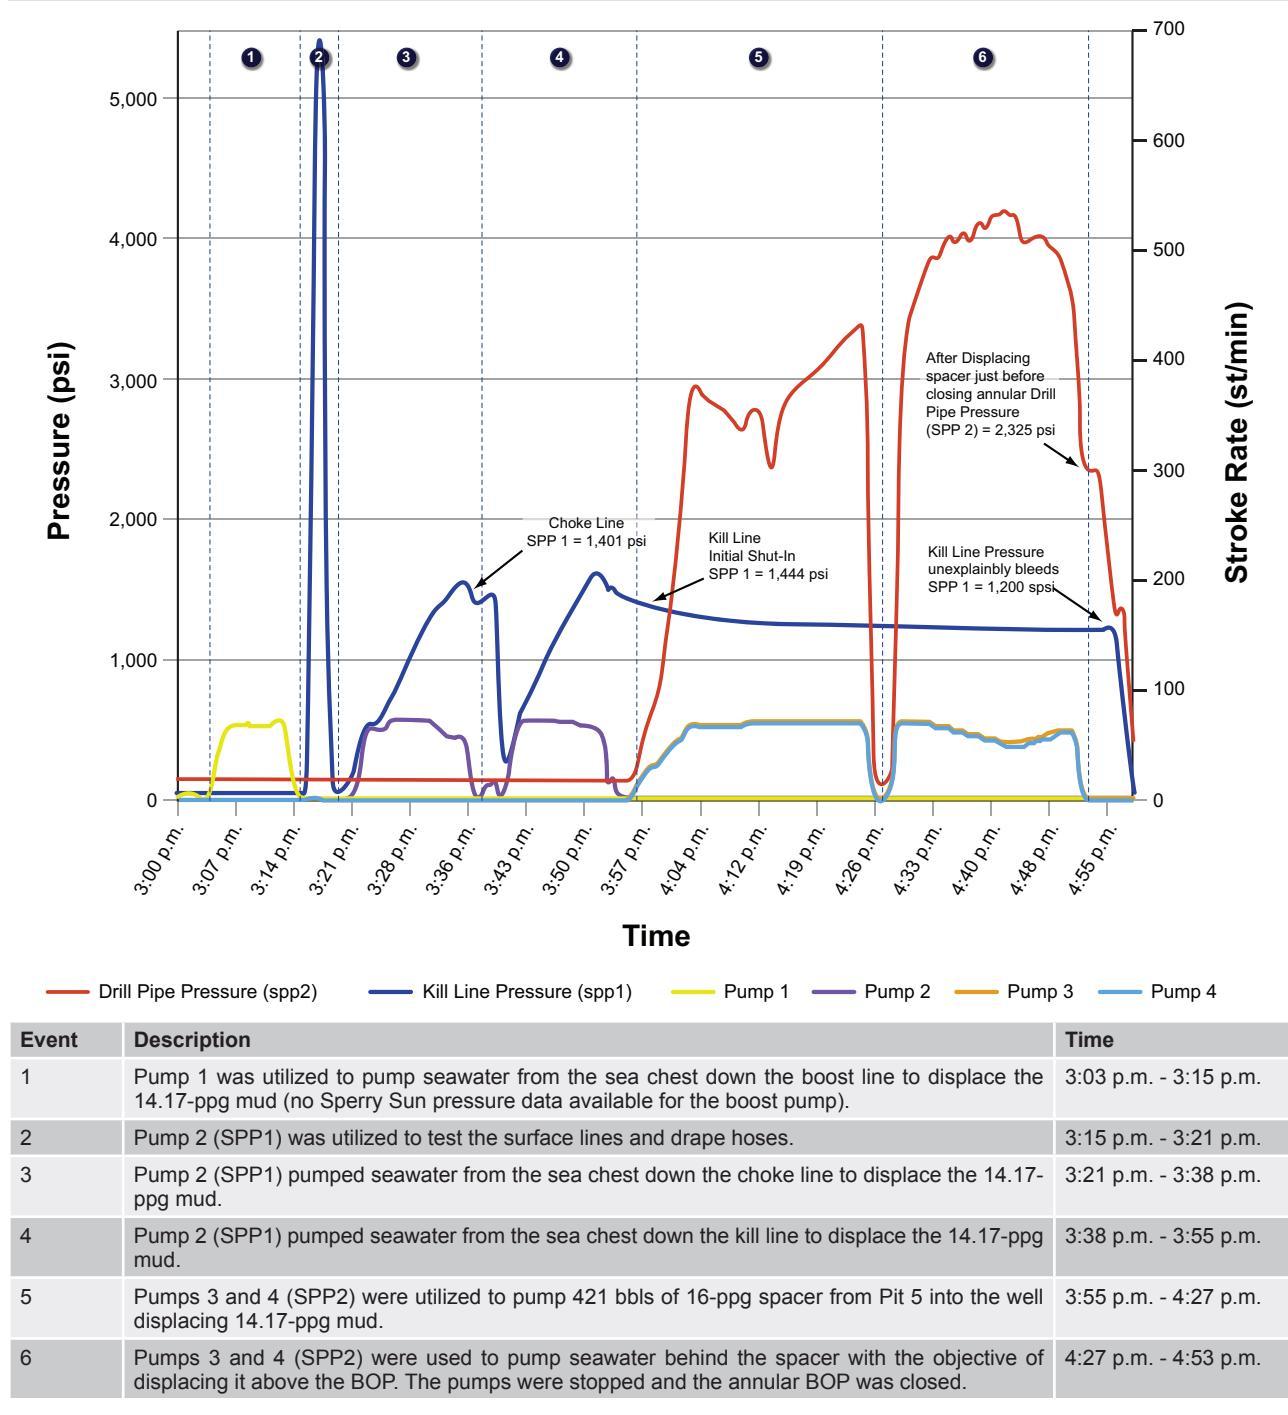
Figure 9 Overview of Events during the Initial Displacement from 3:03-4:53 p.m.

In accordance with the M-I SWACO procedure, the crew first displaced the boost, choke, and kill lines with seawater.<sup>32</sup> See *Figure 9, Events 1, 3, and 4.* Next, the crew pumped the spacer down the drill string<sup>33 c</sup> (See Figure 8, Event 6 and Figure 9 *Event 5*) and then followed that with seawater in the well to displace the spacer.<sup>34</sup> See Figure 9, Event 6.

Pumps 3 and 4 pumped seawater during displacement of the spacer.<sup>37</sup> See Figure 9, Event 6. At most, 353 bbl of seawater were pumped.<sup>38</sup> This was 3 bbl more than the procedure specified but 32 bbl less than the amount necessary to fully displace the spacer.<sup>39</sup> Based on the displacement volume specified in the procedure and amount of seawater that was pumped, 16-ppg spacer was present in the annulus below the closed annular preventer as the crew proceeded into the negative pressure test.<sup>40</sup>

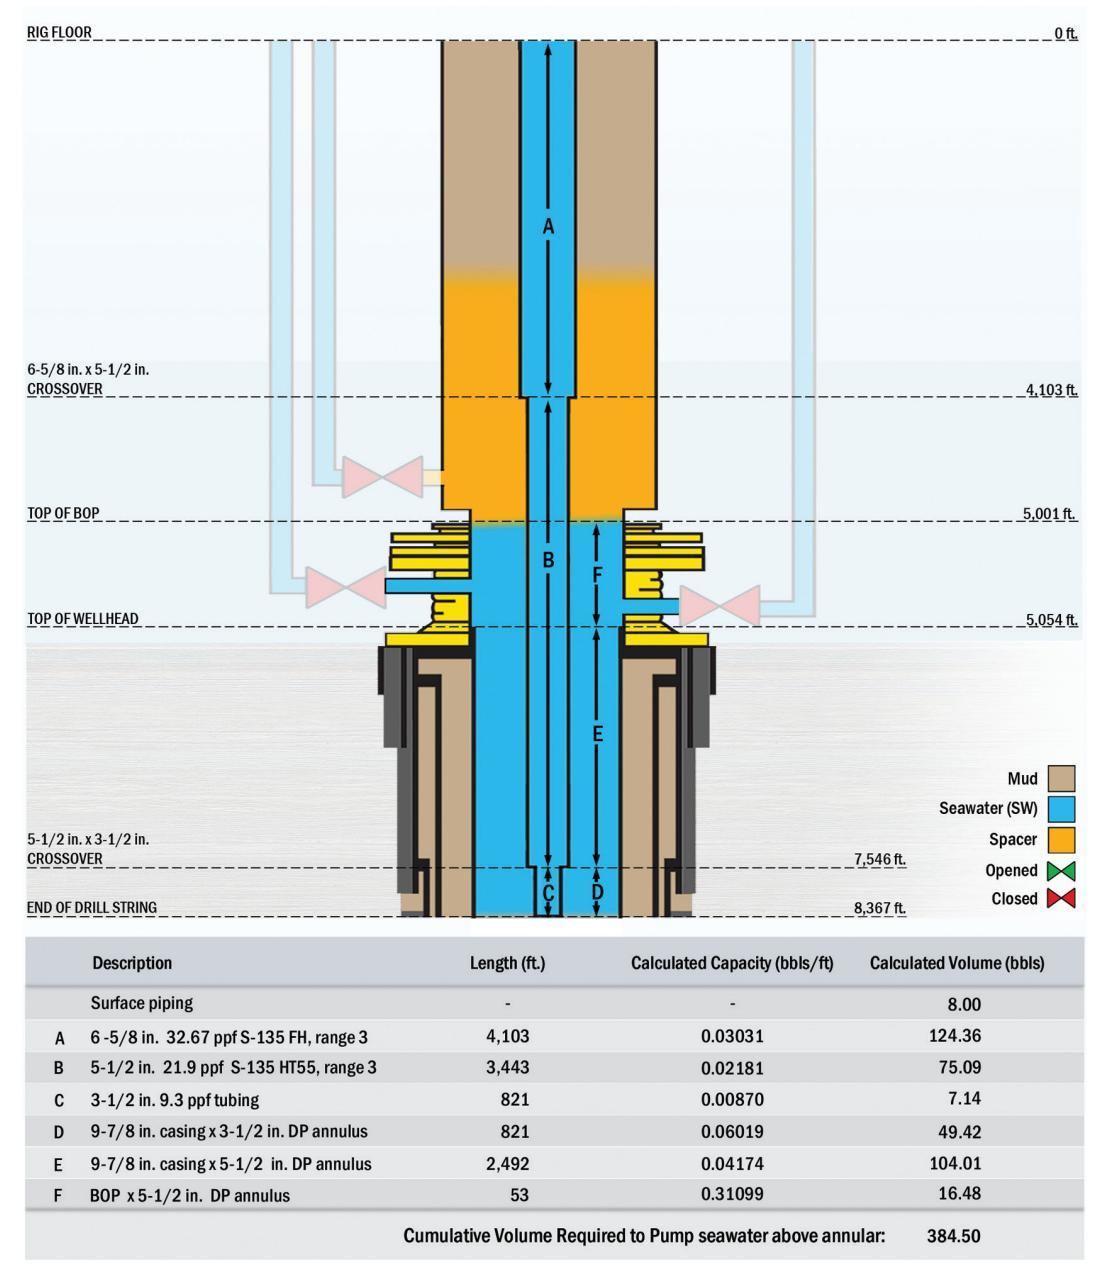
Figure 10 Volume of Seawater Necessary to Displace Spacer

BP decided to use 425 bbl of the 16-ppg spacer, more than double the average spacer volume used previously. <sup>31, B</sup> The high volume of the spacer complicated the drill pipe pressure readings as the spacer moved through the well.

The M-I SWACO procedure called for pumping 775 bbl of fluid into the well — 425 bbl of spacer and 350 bbl of seawater — to move the spacer through the well and above the BOP stack.<sup>35</sup> (See Figure 10) Based on the known geometry of the well and the configuration of the drill string, the M-I SWACO calculation was incorrect; the volume of seawater necessary to displace the spacer was 385 bbl (including 8 bbl to displace surface piping).<sup>36</sup> See Figure 11. The procedure was 35 bbl short of the seawater required to put the spacer above the BOP stack.

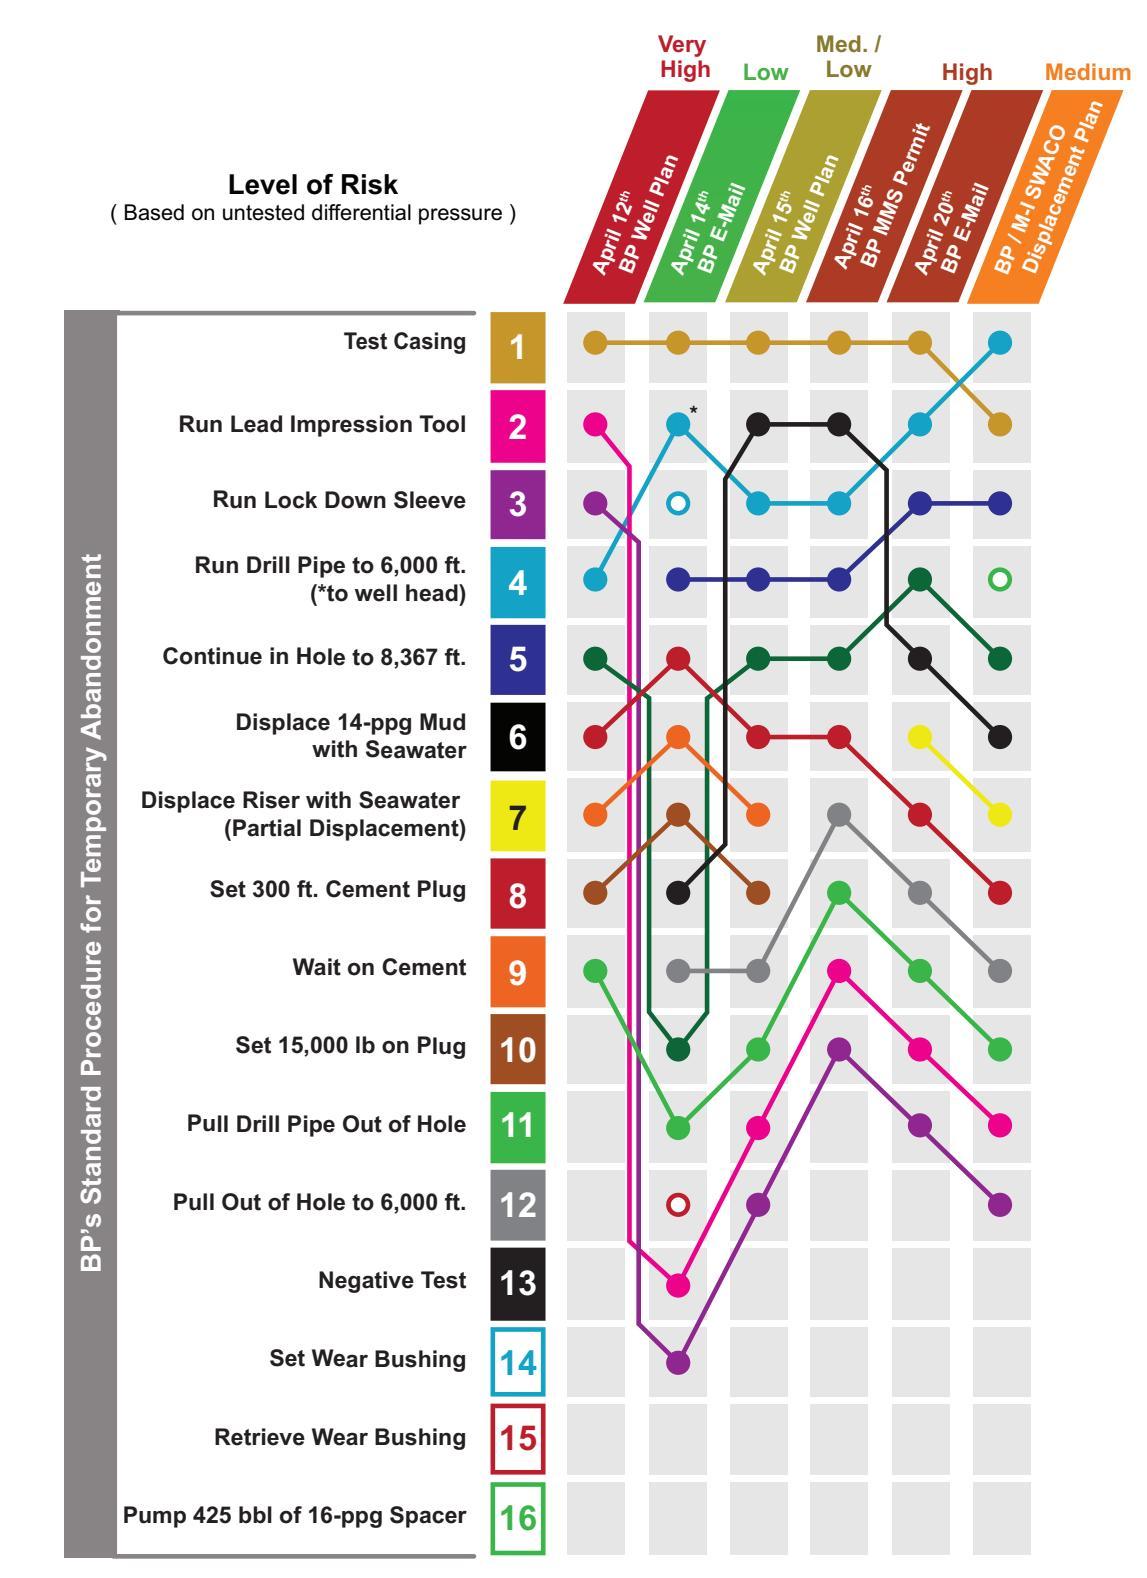
Figure 12 Lifecycle of BP's Temporary Abandonment Plan Modifications from April 12 to April 20, 2010, and MI-SWACO Displacement Plan, as Compared to BP Standard Procedure for Temporary Abandonment

*Figure 12* illustrates how BP's five temporary abandonment plans and the M-I SWACO displacement plan changed and compared to BP's standard procedures for temporary abandonment. As can be seen, the plans varied significantly from each other and from BP's standard protocol, and introduced risk and confusion into the final procedure.

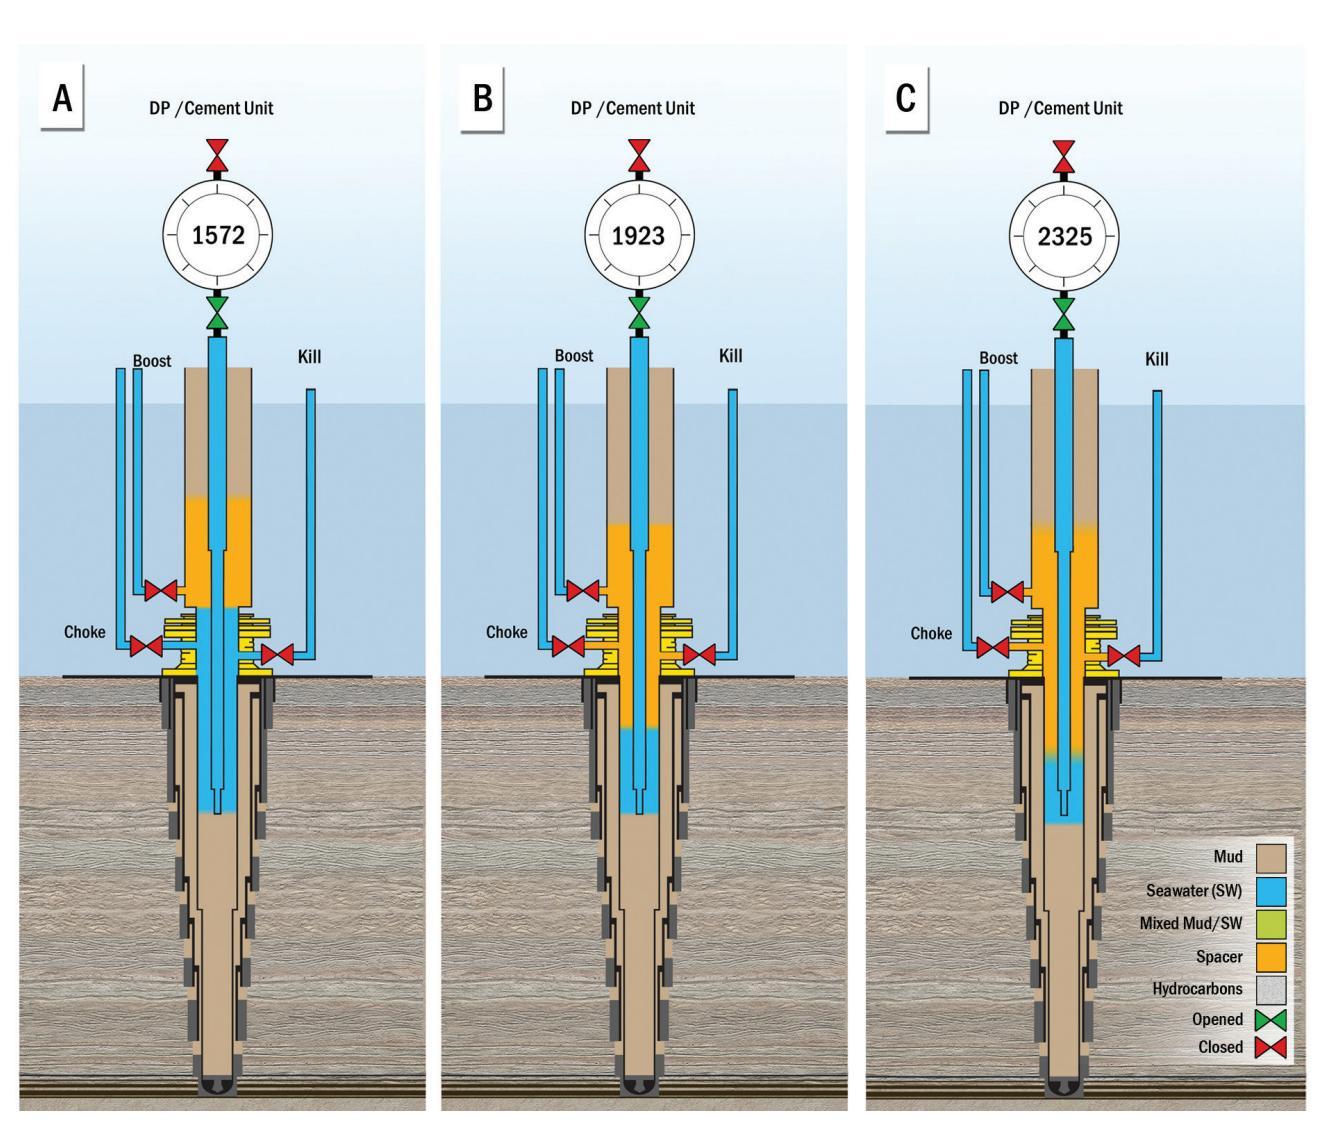
Had the spacer been displaced above the annular BOP, the drill pipe pressure should have been 1,572 psi when the pumps were shut down and the lower annular BOP element was closed at 4:53 p.m.<sup>48</sup> *See Figure 13a*. Had the underdisplacement been the result of the calculation errors alone, the drill pipe pressure would have been 1,923 psi.<sup>49</sup> *See Figure 13b*. Instead, the actual pressure recorded was 2,325 psi, which indicates the spacer had been under displaced and suggests that it was not just a result of calculation errors, but also seemingly lower pump efficiencies and potential downhole losses.<sup>50</sup> *See Figure 13c*. The additional heavy fluid that remained in the well below the annular BOP as a result of the underdisplacement resulted in a higher drill pipe pressure. The displacement procedures gave no guidance as to what the drill pipe pressure should have read when the mud pumps were turned off before the negative pressure test.<sup>51</sup> There also was an apparent inability to track the volume of mud returning from the well compared to the theoretical volume pumped into the well. These factors caused the underdisplacement of the spacer to go unidentified.

**Figure 13** (a) Represents the planned partial displacement with the spacer above the BOP. (b) Represents underdisplacing the spacer by 32 bbl as a result of the calculation errors in the displacement procedure. (c) Represents the pressure observed after turning off the pumps and closing the annular, and suggests that the spacer was underdisplaced by more than just 32 bbl as a result of calculation errors, seemingly lower pump efficiencies, and potential downhole losses.

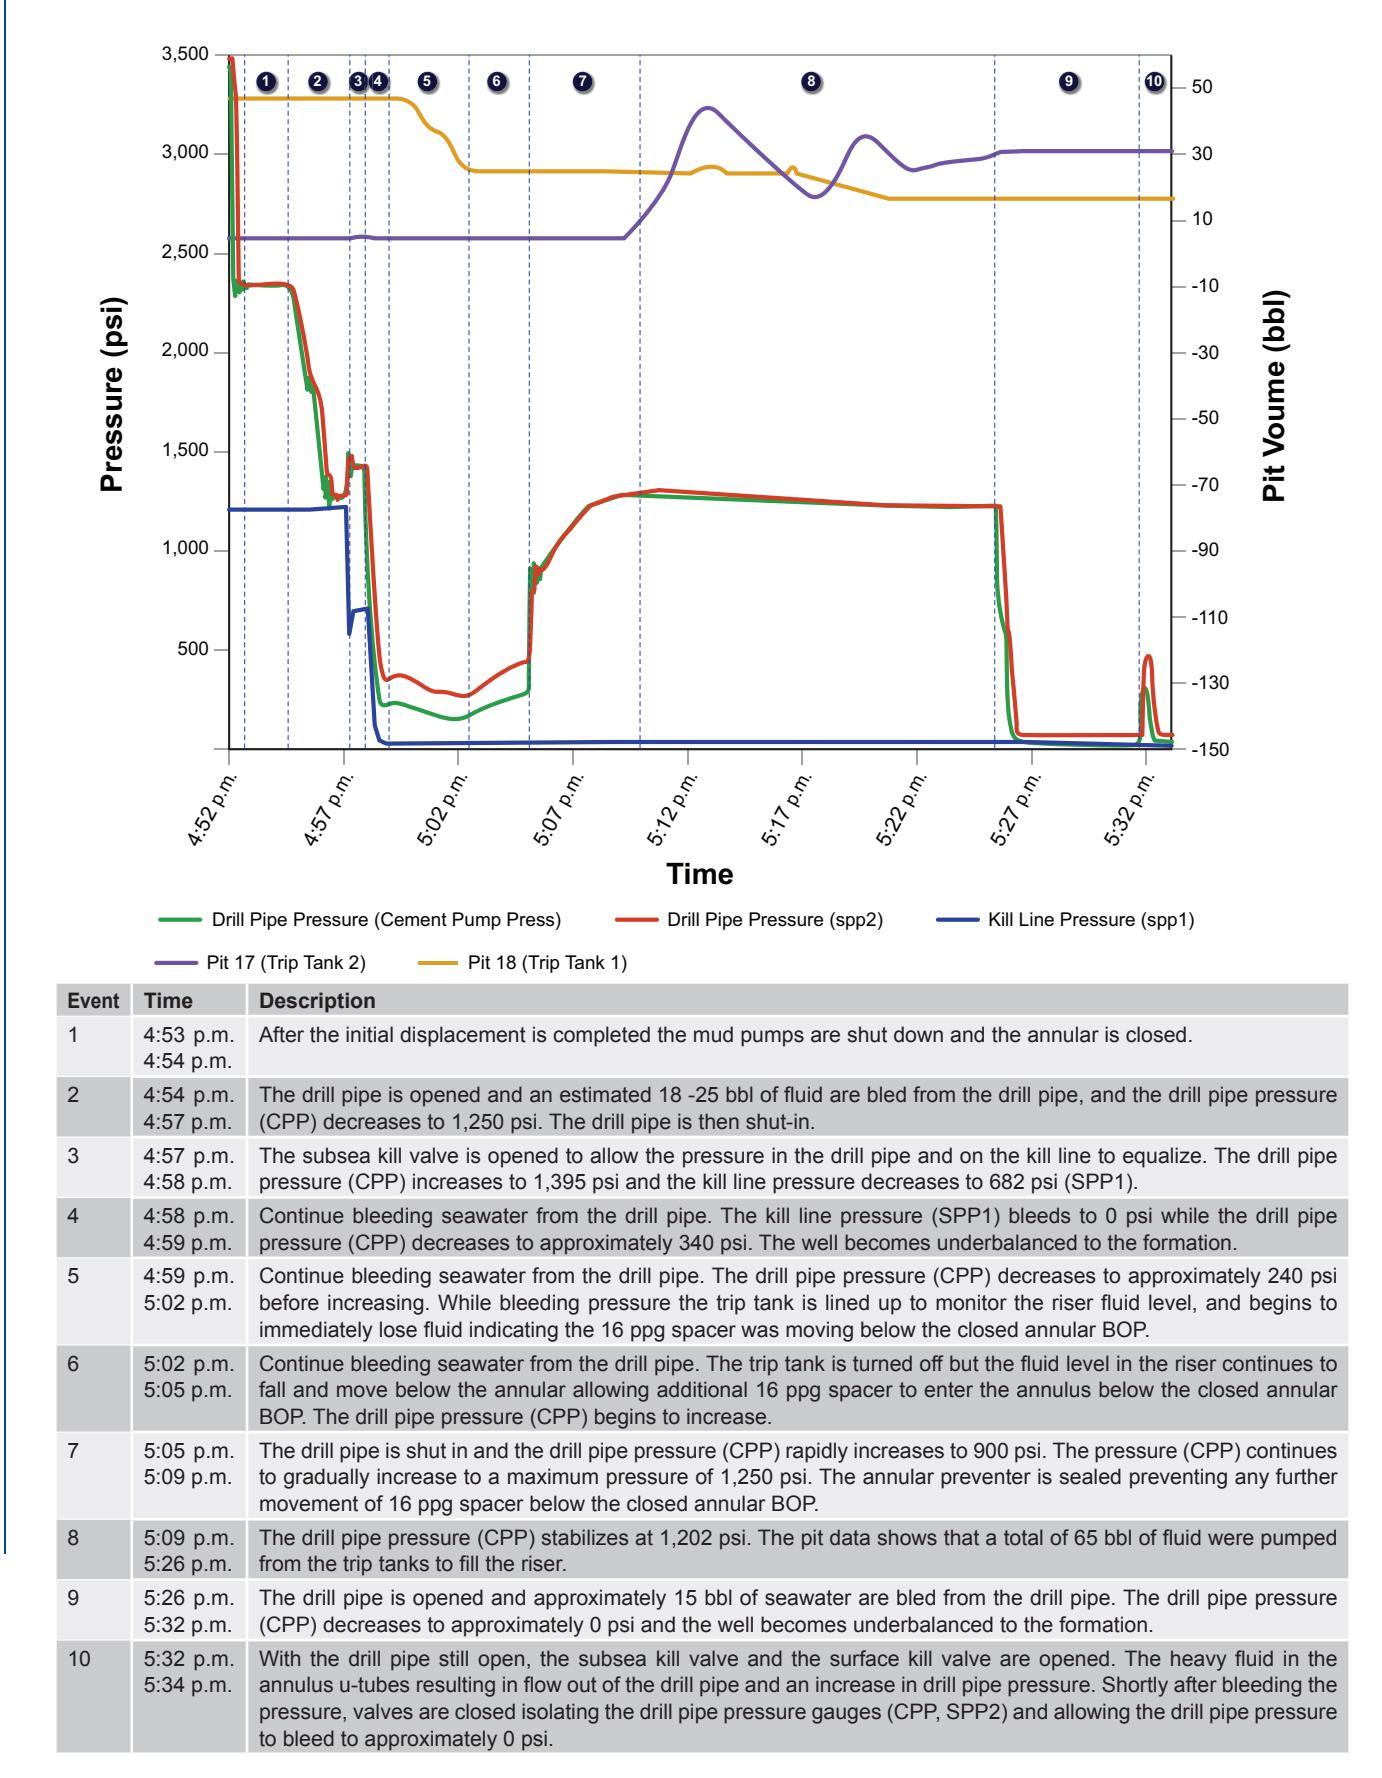
Figure 15 Overview of Events during the Negative Pressure Test from 4:53–5:34 p.m.

After the lower annular BOP element was closed, the pressure on the drill pipe was 2,325 psi, and the pressure on the kill line was approximately 1,200 psi.<sup>53</sup> See Figure 17 and Figure 15, Event 1. At this time, the drill pipe and the kill line were closed off from one another by a subsea kill valve at the BOP stack, and the pressure on the drill pipe was bled down to equalize with the kill line pressure. When the drill pipe was opened and 18–25 bbl of fluid were bled from the drill pipe, the drill pipe pressure decreased to 1,250 psi.<sup>54</sup> See Figure 15, Event 2.

The drill pipe was opened and additional fluid was bled from the drill pipe to intentionally underbalance the well and test the barriers in place.<sup>59</sup> See Figure 15, Event 4. A trip tank, a small mud tank used to monitor fluid levels within the wellbore while the mud pumps are turned off, was lined up to monitor the fluid level in the riser.<sup>60</sup> Once lined up, the fluid level in the trip tank began to decrease immediately, confirming that fluid in the riser was falling and moving below the lower annular BOP element.<sup>61</sup> See Figure 15, Event 5.

The heavy fluid in the annulus and the continued movement of fluid through the annular BOP prevented the drill pipe pressure from being bled to 0 psi.<sup>62</sup> As seawater was bled from the drill pipe, fluid continued to move below the annular BOP. The drill crew ceased pumping fluid from the trip tank into the riser.<sup>63</sup> See Figure 15, Event 6.

The drill pipe was shut in, and the heavy fluid in the annulus rapidly pushed the drill pipe pressure to 900 psi.<sup>64</sup> See Figure 15, Event 7. Once the drill pipe pressure stabilized, the pressure gradually increased to 1,250 psi.<sup>65</sup> See Figure 19 and Figure 15, Event 7. The annular closing pressure was then increased, preventing any further movement of fluid below the closed annular BOP.<sup>66</sup>

Based on the total volume of fluid pumped from the trip tank into the riser, the team calculated that 65 bbl of spacer moved below the annular.<sup>67</sup> See Figure 15, Events 5 and 8. Estimates of the initial underdisplacement combined with the total volume of fluid that moved below the annular indicate there were 136 bbl of spacer below the annular.<sup>68</sup>

The BP well site leader then directed the drill crew to bleed the drill-pipe pressure to 0 psi.<sup>71</sup> The drill crew underbalanced the well a second time, bleeding approximately 15 bbl of seawater from the drill pipe to bring the drill pipe pressure to 0 psi for monitoring.<sup>72</sup> See Figure 15, Event 9. However, with the drill pipe still open, the BP well site leader instructed the drill crew to switch from monitoring the well on the drill pipe to monitoring on the kill line as specified in the approved MMS plan.<sup>73</sup> Consequently, at 5:32 p.m., the drill crew opened the kill valves, and the heavy fluid in the annulus fell, pushing fluid up and out of the drill pipe to the cement unit.<sup>74</sup> See Figure 15, Event 10. The Halliburton cementer called the rig floor, stating that 3–4 bbl of seawater had flowed back to the cement unit.<sup>75</sup> Upon post-incident review, this data further confirms heavy fluid in the annulus below the closed annular BOP.

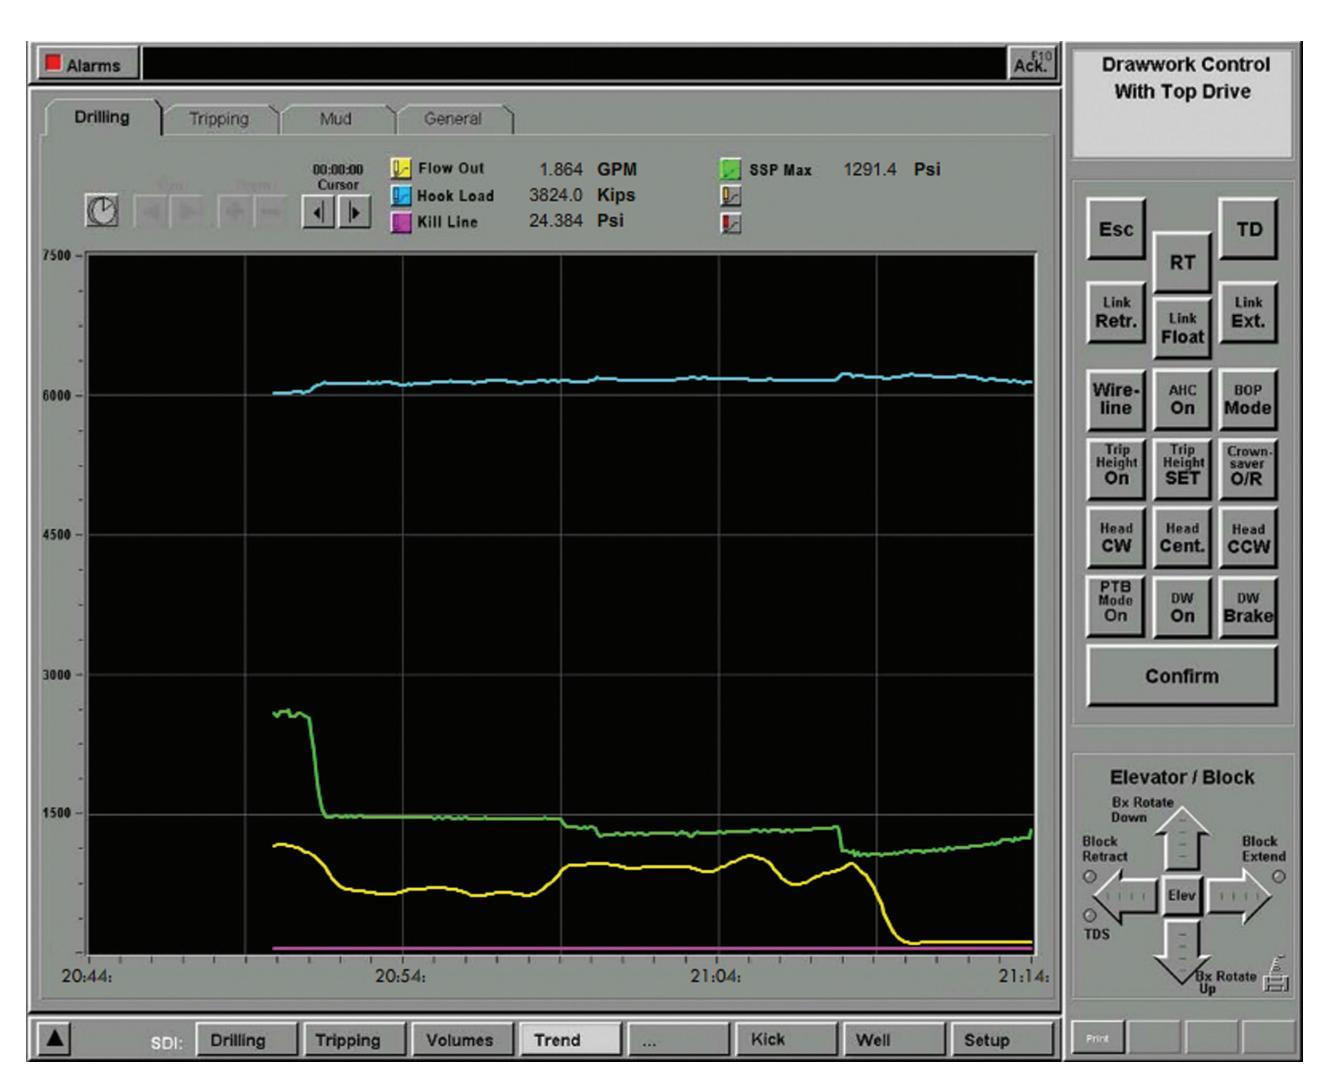
Figure 4 Sheen Test on Simulated Hitec Screen

Several of the investigative reports on the Macondo incident err in their conclusions in this area of well data monitoring, assuming and portraying the information viewed by the drill crew in a misleading fashion. For example, multiple analyses assume the driller was monitoring drill pipe pressure using a 0–1,700 psi scale display on the Hitec screen. See Figure 3. While such scale adjustments are useful in post-incident analysis as a method of identifying trends, the driller's screen typically would display pressures in a 0–7,500 psi scale. See Figure 4.

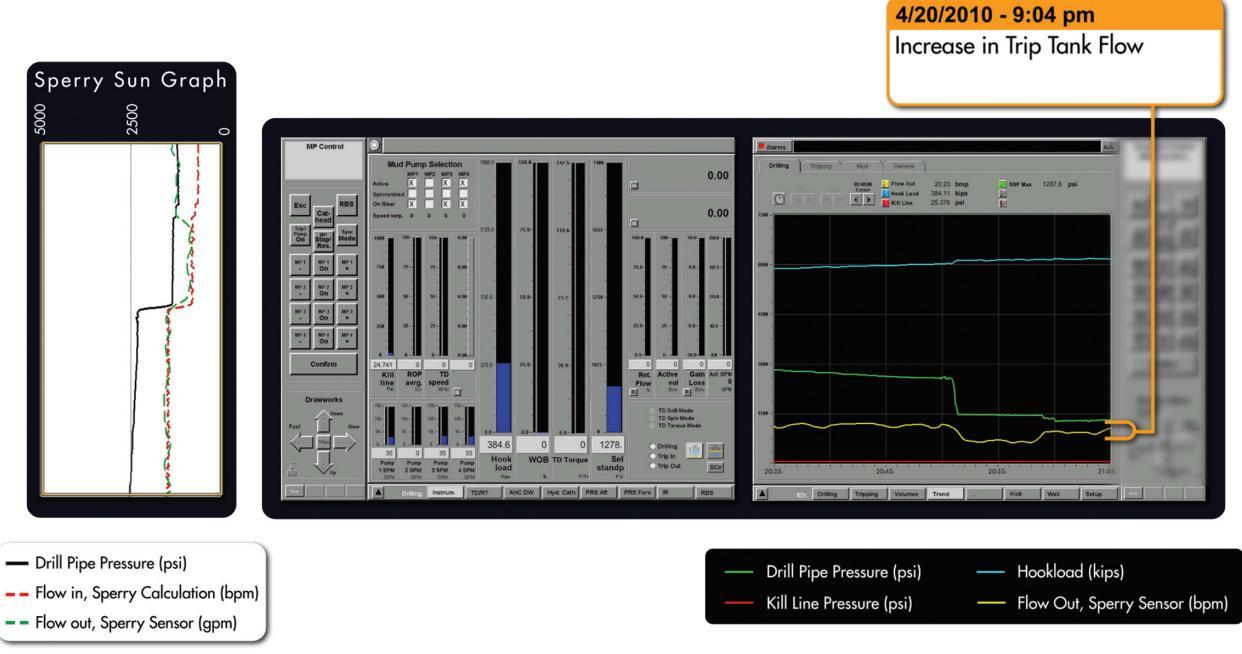
the well.<sup>15</sup> It is believed that the driller saw an expected flow increase and subsequent decrease as the trip tank pump was turned on and off, respectively, which masked evidence of the influx. Based on post-incident calculations, the investigation team determined that approximately 16.5 barrels (bbl) of hydrocarbons entered the well during the course of the trip tank dump. *See Figure 7*.

Figure 7 9:04 p.m. Increase in Flow during Trip Tank Dump

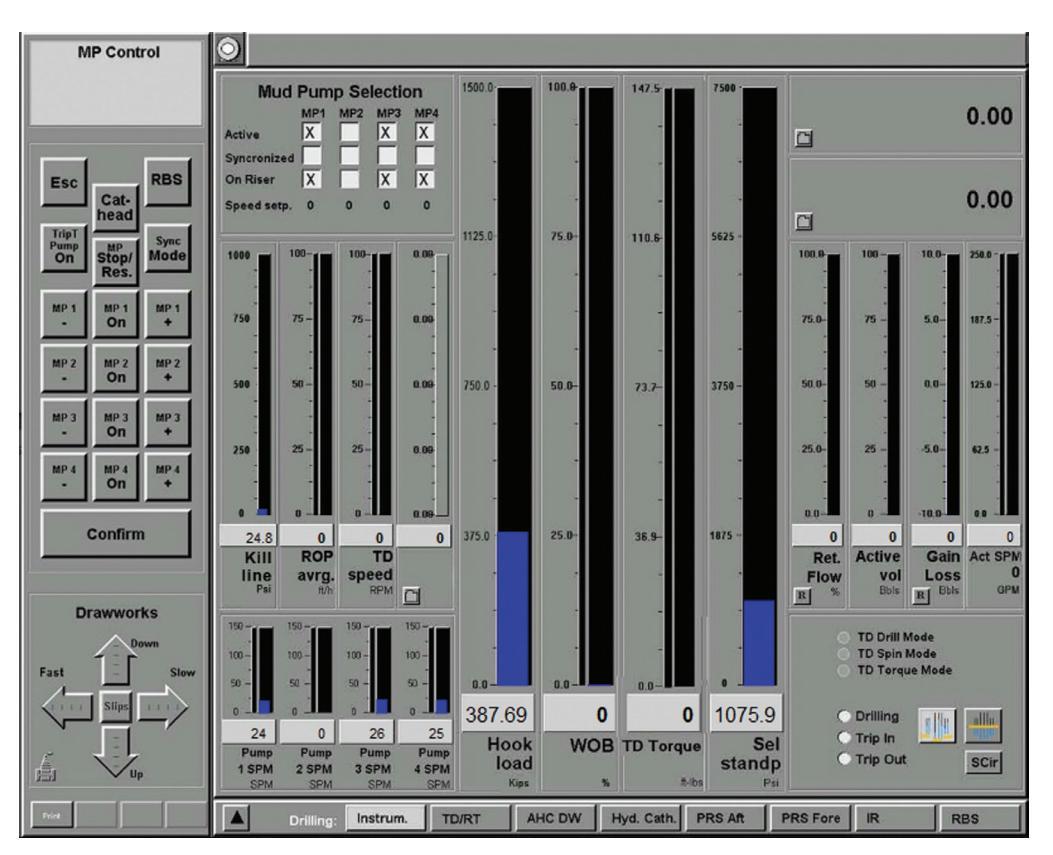
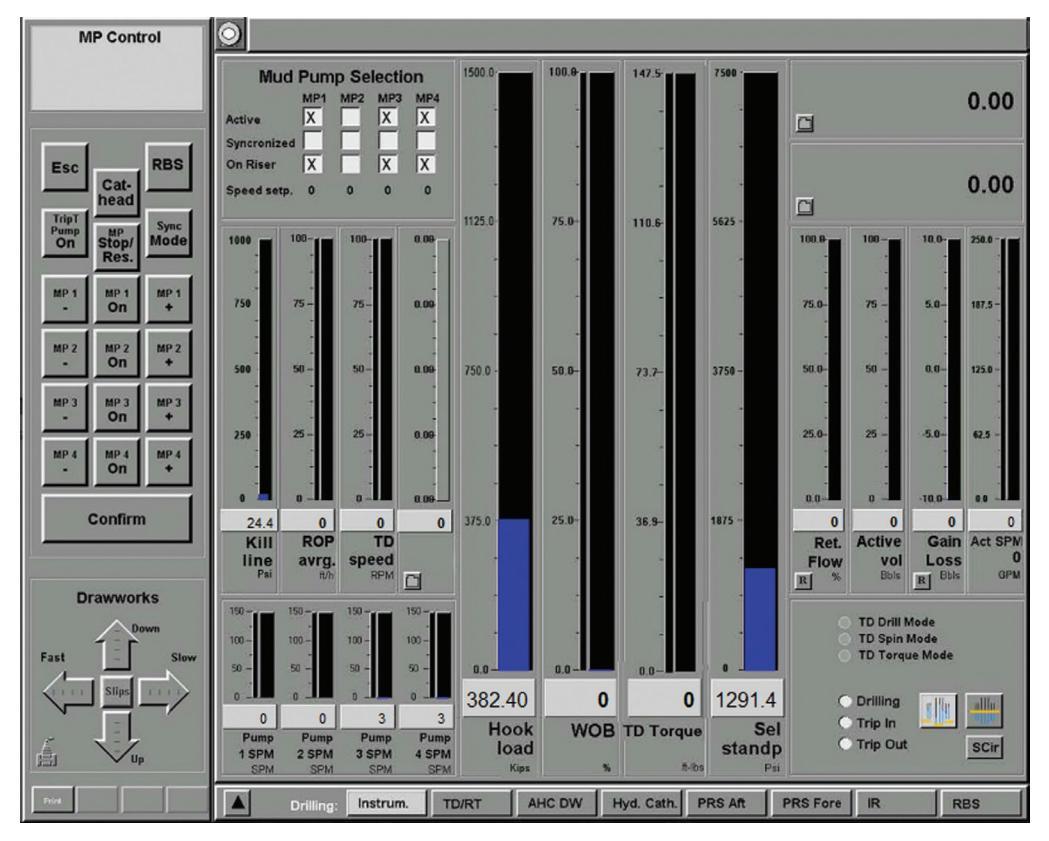
Pressure at 9:14 p.m. (End of Sheen Test) Figure 8 Change in Drill pipe Pressure from 9:08–9:14 p.m.

During the sheen test, post-incident analysis reflects that pressure gradually increased by 189 psi. The investigation team believes this may not have been readily observed on the 0–7,500-psi display monitored by the drill crew, as explained previously.<sup>22</sup> See Figures 8 and 9. Post-incident analysis of the data shows that for the first 30–40 seconds after the pumps were shut down, the pressure appeared stable. Given stable pressure readings and confirmation of no flow from the shaker room, the driller would have then likely prepared for the next displacement phase by setting up mud pump 2 to pump down the kill and choke lines.

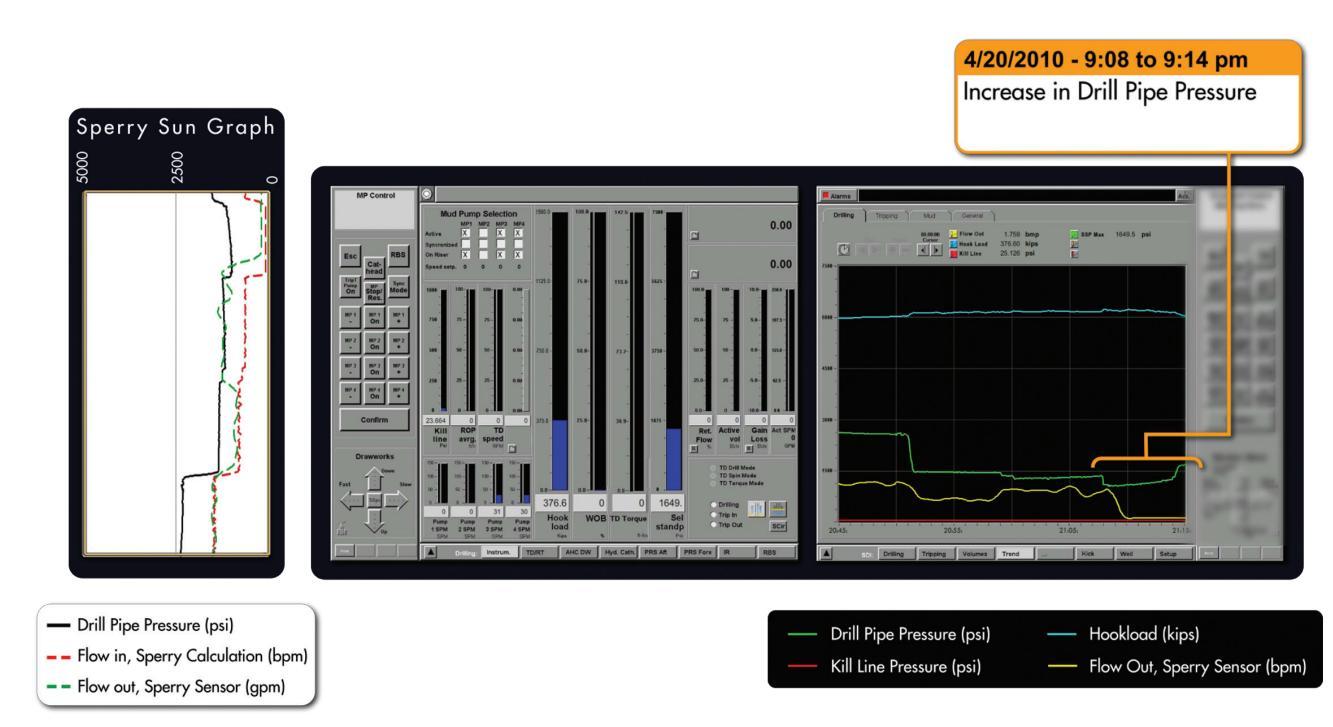
Figure 9 9:14 p.m. End Static Sheen Test

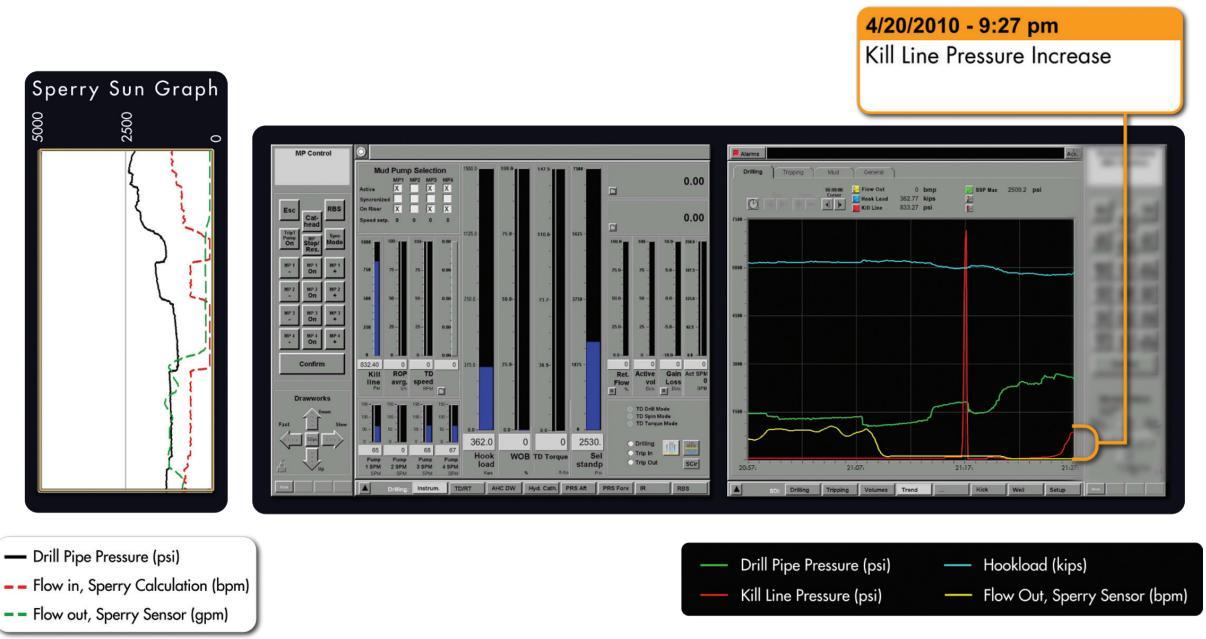
The pressure on the kill line began to increase very gradually at 9:22 p.m. after the valve had been opened. From 9:26–9:27 p.m., pressure increased to 833 psi.<sup>32</sup> *See Figure 10*. The investigation team could not determine a reason for the erratic pressure build — initially slow and then more rapid in the kill line pressure reading. The kill line could have been plugged with spacer material. Within the next two minutes, the drill crew likely discussed the anomalous differential pressure readings between the kill line and drill pipe.<sup>33</sup> The investigation team believes this is the first indication that the drill crew recognized an anomaly in the well.

Figure 10 9:27 p.m. Kill Line Pressure Climbs to 833 psi.

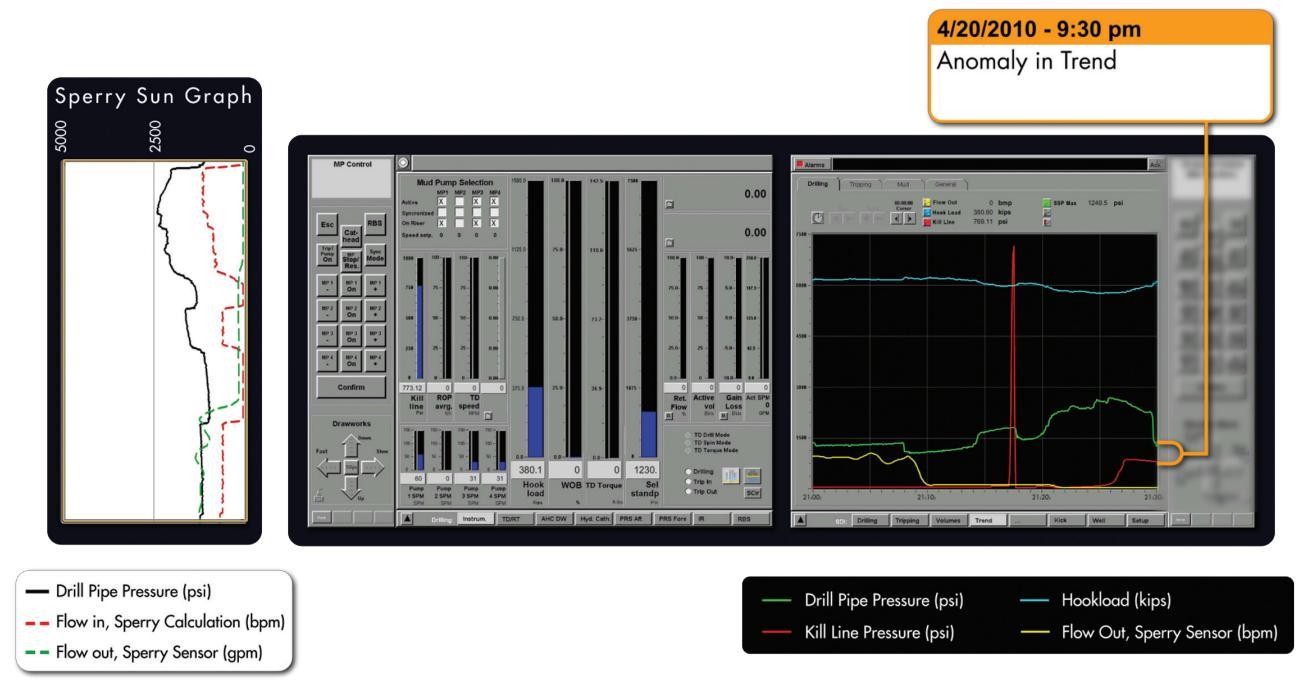
The Sperry Sun data shows that at 9:29 p.m., the drill crew shut down the pumps, likely to assess the significance of the pressure readings. Pumps 3 and 4 were stopped first, followed by pump 1.<sup>34</sup> At 9:31 p.m., the drill pipe pressure fell due to the shutdown of the pumps but did not match the kill line pressure as it should have.<sup>35</sup> *See Figure 11*. The investigation team believes that the drill crew monitored the pressure after the final pump ramped down to observe a trend. Once the pumping activity ceased, the well should have been in a static state, with no pressure changes evident; from 9:31–9:32 p.m., the pressure remained constant.

Figure 11 9:31 p.m. Pumps Stopped to Determine Pressure Difference

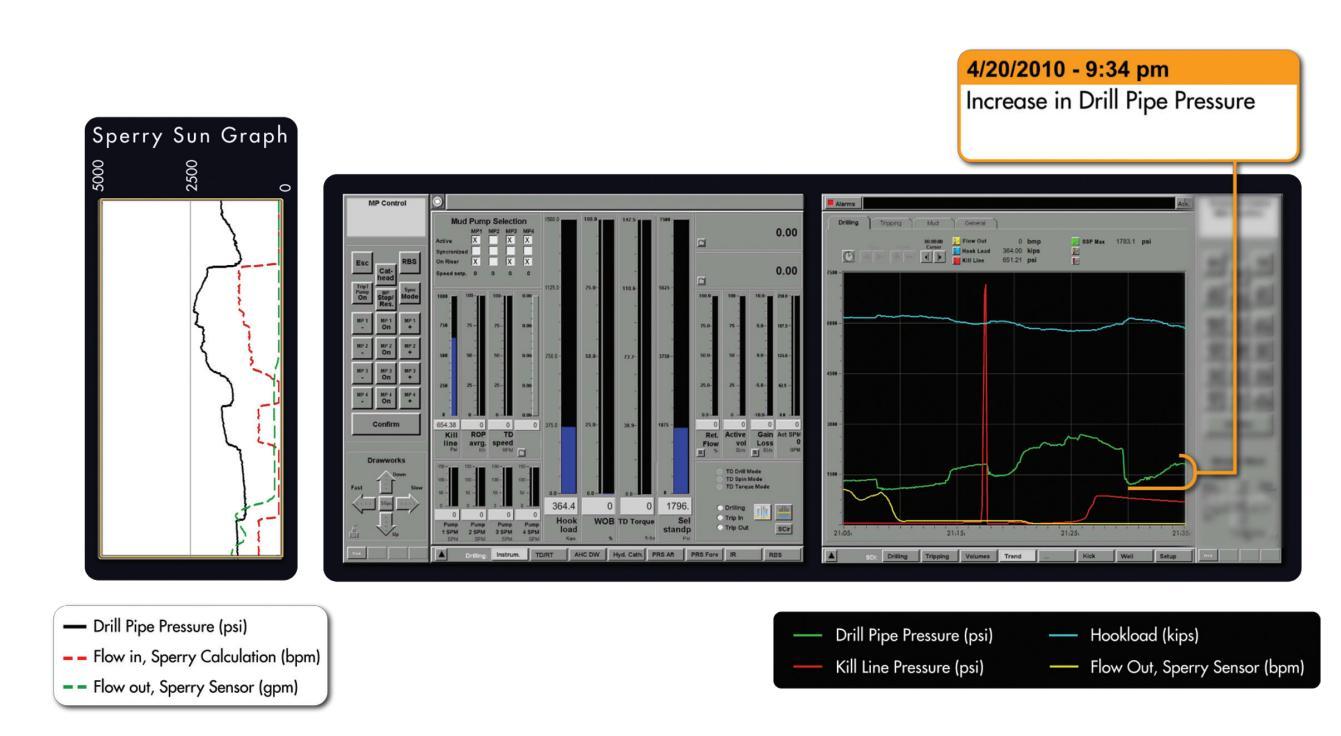
During the discussion of the anomaly, the drill pipe pressure rose from 1,400 psi to 1,800 psi between 9:32 p.m. and 9:34 p.m., when it again leveled and became constant.<sup>36</sup> *See Figure 12*. What the drill crew did not know was that the constant pressure was due to 14-ppg mud, which was now moving into the riser. As it moved, the heavy fluid column began to shorten in height and nearly balanced the change in pressure from spacer moving out of the riser and down the flow line. A condition existed where fluids were moving and the pressures were remaining constant due to the specific combination of fluid densities in the well and the geometry of the wellbore. The discussion likely turned to what caused the increase in the drill pipe pressure and why it did not match the kill line pressure.

Figure 12 9:34 p.m. Pressure Increase With Pumps Offline

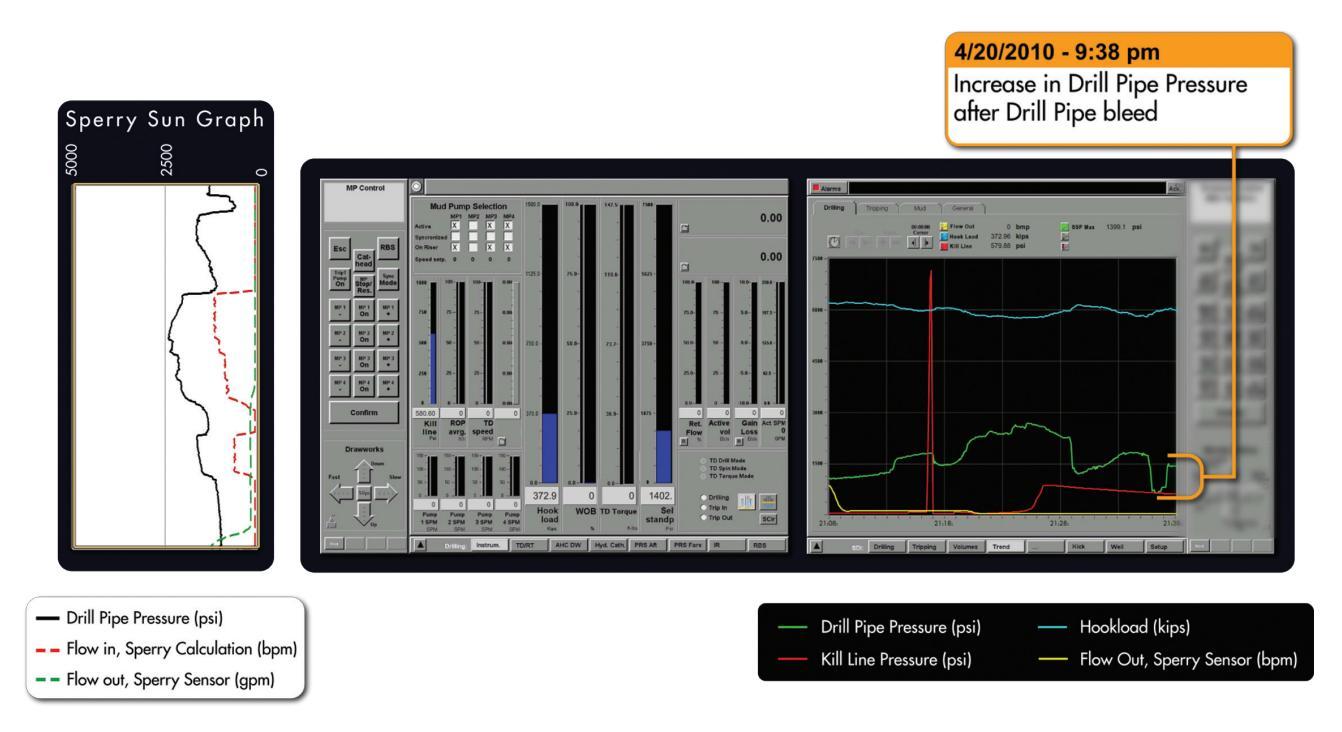
At 9:36 p.m., the driller instructed a floor hand to bleed the drill pipe on the standpipe manifold, and for the next one-and-a-half minutes, flow was taken from the drill pipe.<sup>37</sup> Based on the experience and work of the investigation team, the team concluded that the action taken to bleed pressure from the drill pipe is consistent with a belief by the driller that a plug existed. At this time, the well had taken more than 385 bbl of fluid from the formation and was flowing at more than 38 bpm with mud and hydrocarbons still below the drill string.<sup>38</sup> The driller instructed the floor hand to close the valve when the drill pipe pressure approached the kill line pressure.<sup>39</sup> Once the drill pipe was shut in, the drill pipe pressure immediately built to 1,400 psi, 300 psi lower than before the bleed off, and then remained constant until 9:39 p.m.<sup>40</sup> See Figure 13. It is apparent the drill crew was taking measures to understand the well condition. From analysis work by the investigation team, the lower pressure after the bleed-off indicates that mud was still below the drill string at this time, as it was sucked into the drill pipe and caused a lower pressure reading when the valve was closed.

Figure 13 Drill Pipe Pressure Builds after Bleed

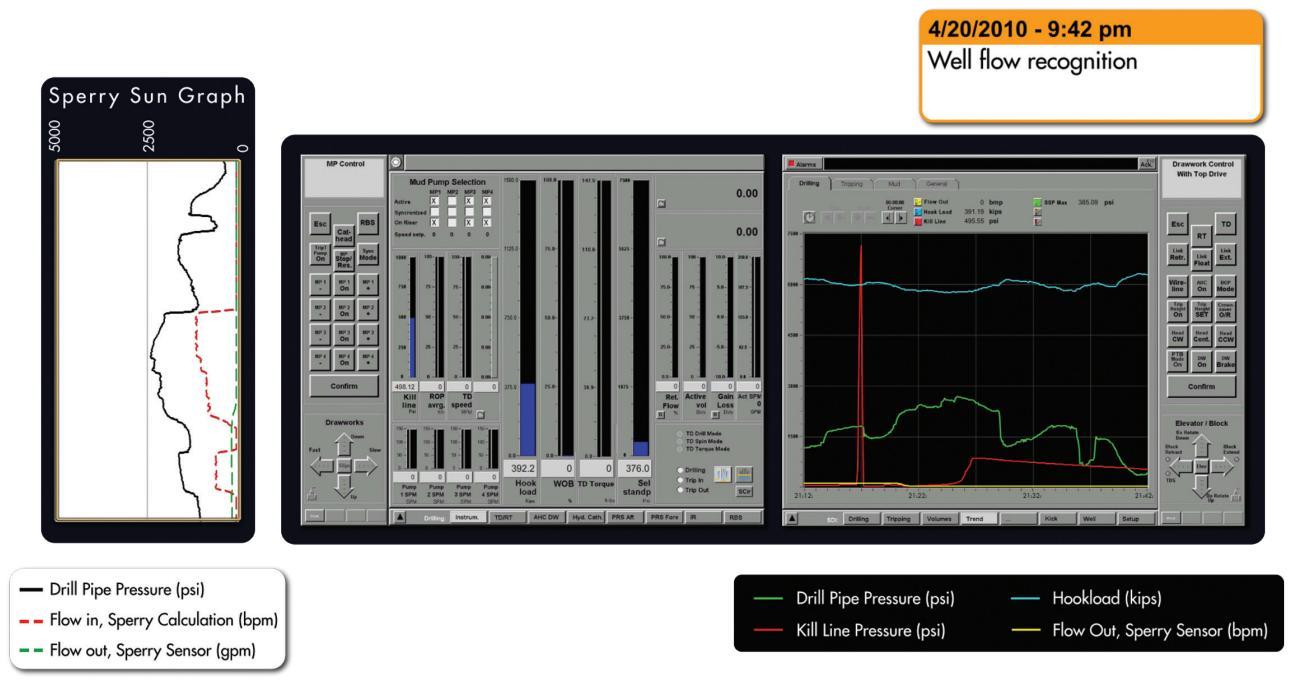
At 9:39 p.m., the drill pipe pressure began to decline as hydrocarbons began to move upward past the end of the drill pipe. The pressure drop is a clear signal to a driller of a kick as, under normal drilling conditions, when hydrocarbons enter the well, they will lower pressure readings. The driller routed the well returns to the trip tank to check for flow. By 9:42 p.m., the trip tank began to fill rapidly, and the driller recognized the well was flowing.<sup>41</sup> *See Figure 14*.

Figure 14 9:42 p.m. Trip Tank Fills

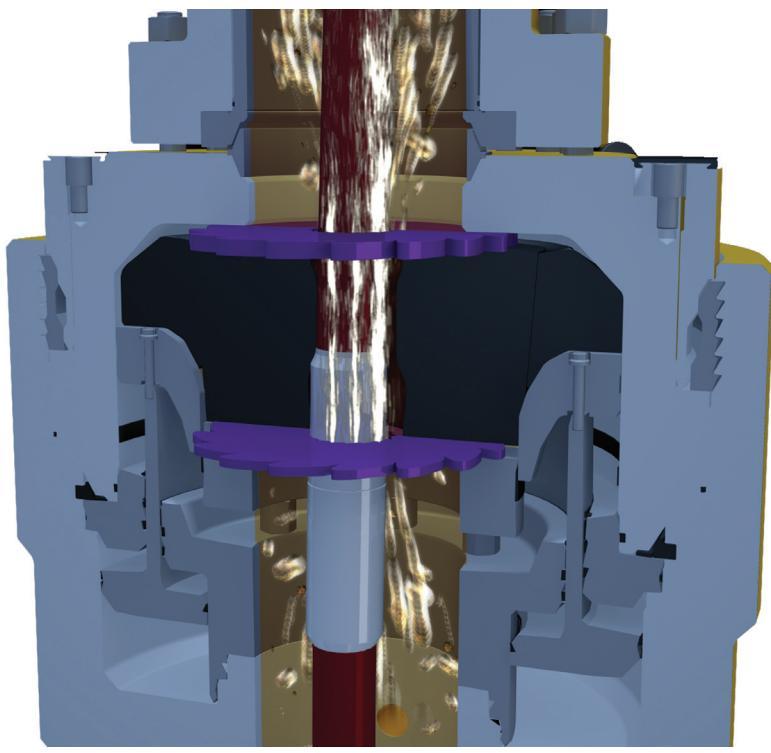
Figure 11 Drill Pipe Tool Joint Lifted by Flow into Upper Annular
