# MACONDO WELL INCIDENT Transocean Investigation Report Volume I

June 2011

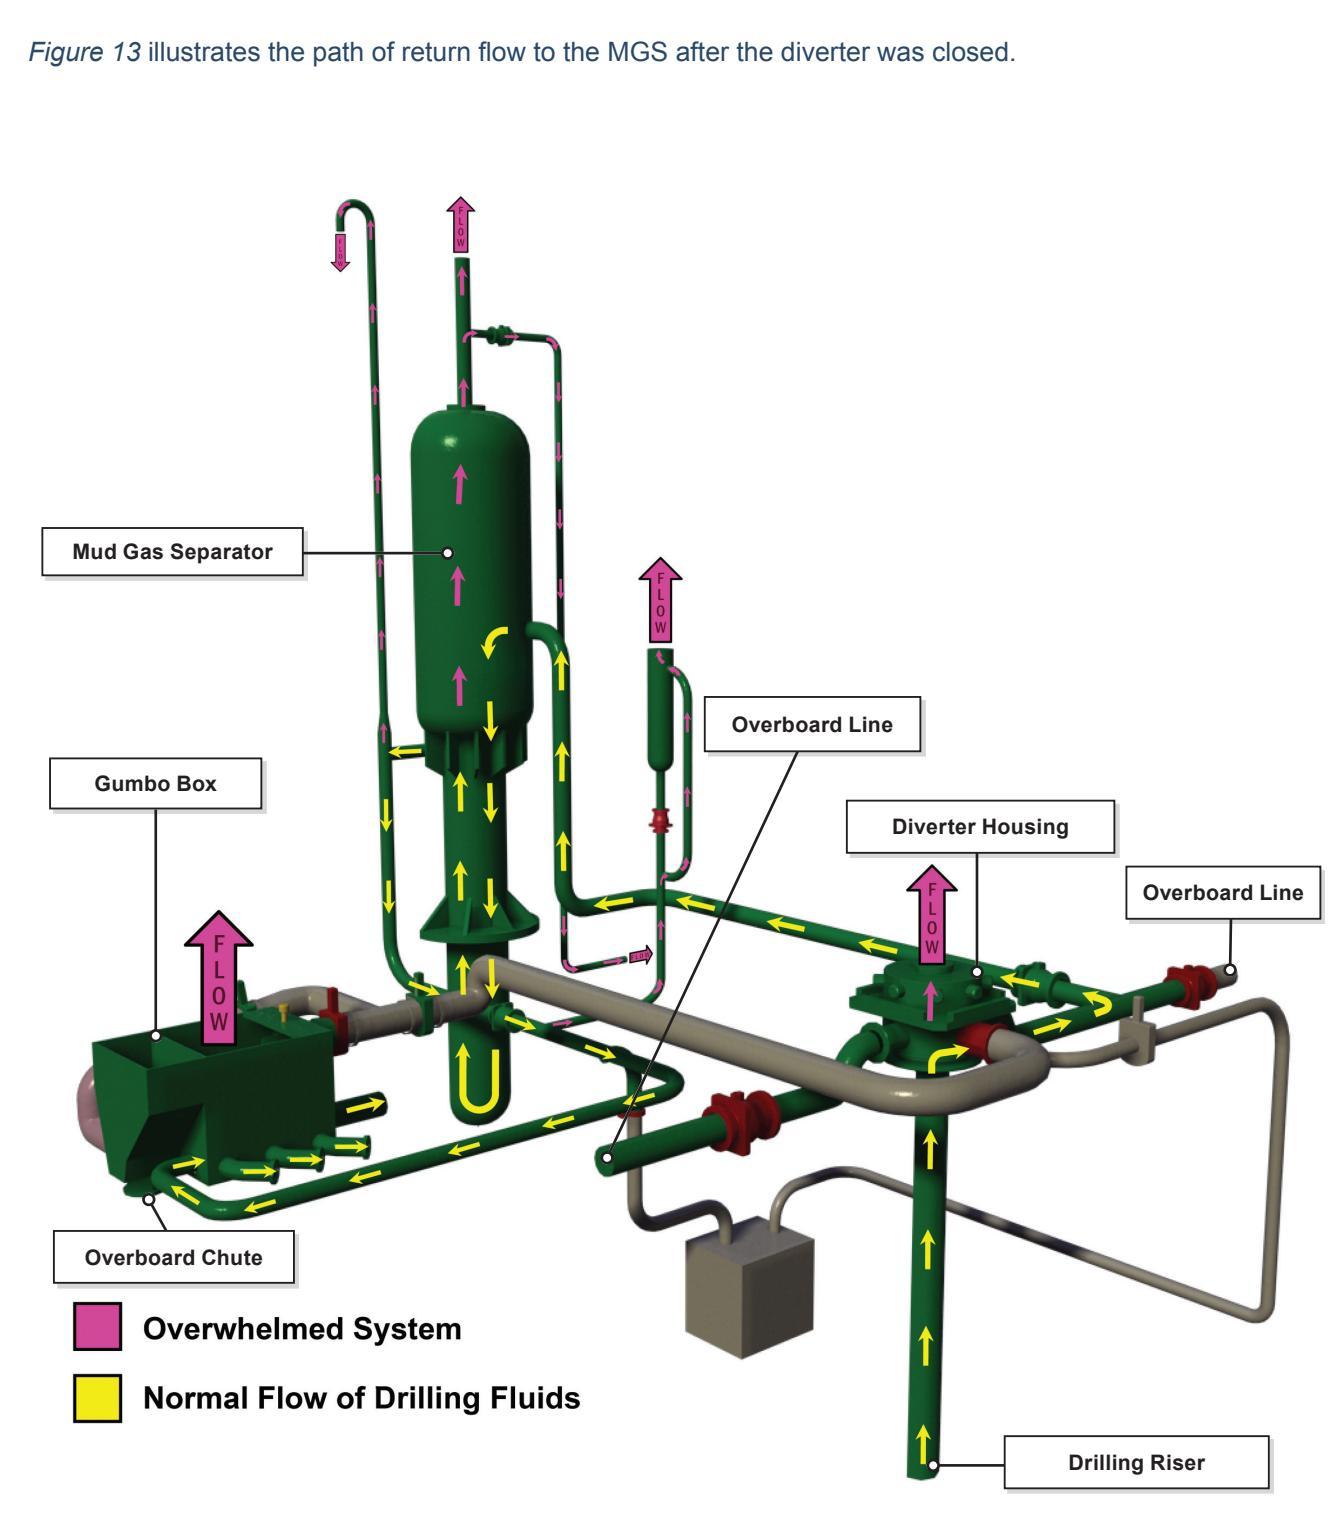
The gas expanded as it moved up the riser, pushing mud onto the drill floor.<sup>76</sup> The drill crew closed the diverter packer to redirect the flow from the well to the MGS pursuant to BP and Transocean standard practice.<sup>77</sup> As the flow from the well increased due to the rapid expansion of gas in the riser, the flow rate exceeded the capacity of the MGS.<sup>78</sup> At approximately 9:48 p.m.,<sup>79</sup> witnesses said mud began flowing out of the MGS vacuum breaker line located halfway up the derrick, and fluid overflow from the MGS filled the mini trip tank.<sup>80</sup> See Figure 13.

Figure 13 Path of Return Flow after Diverter was Closed and then Overcome

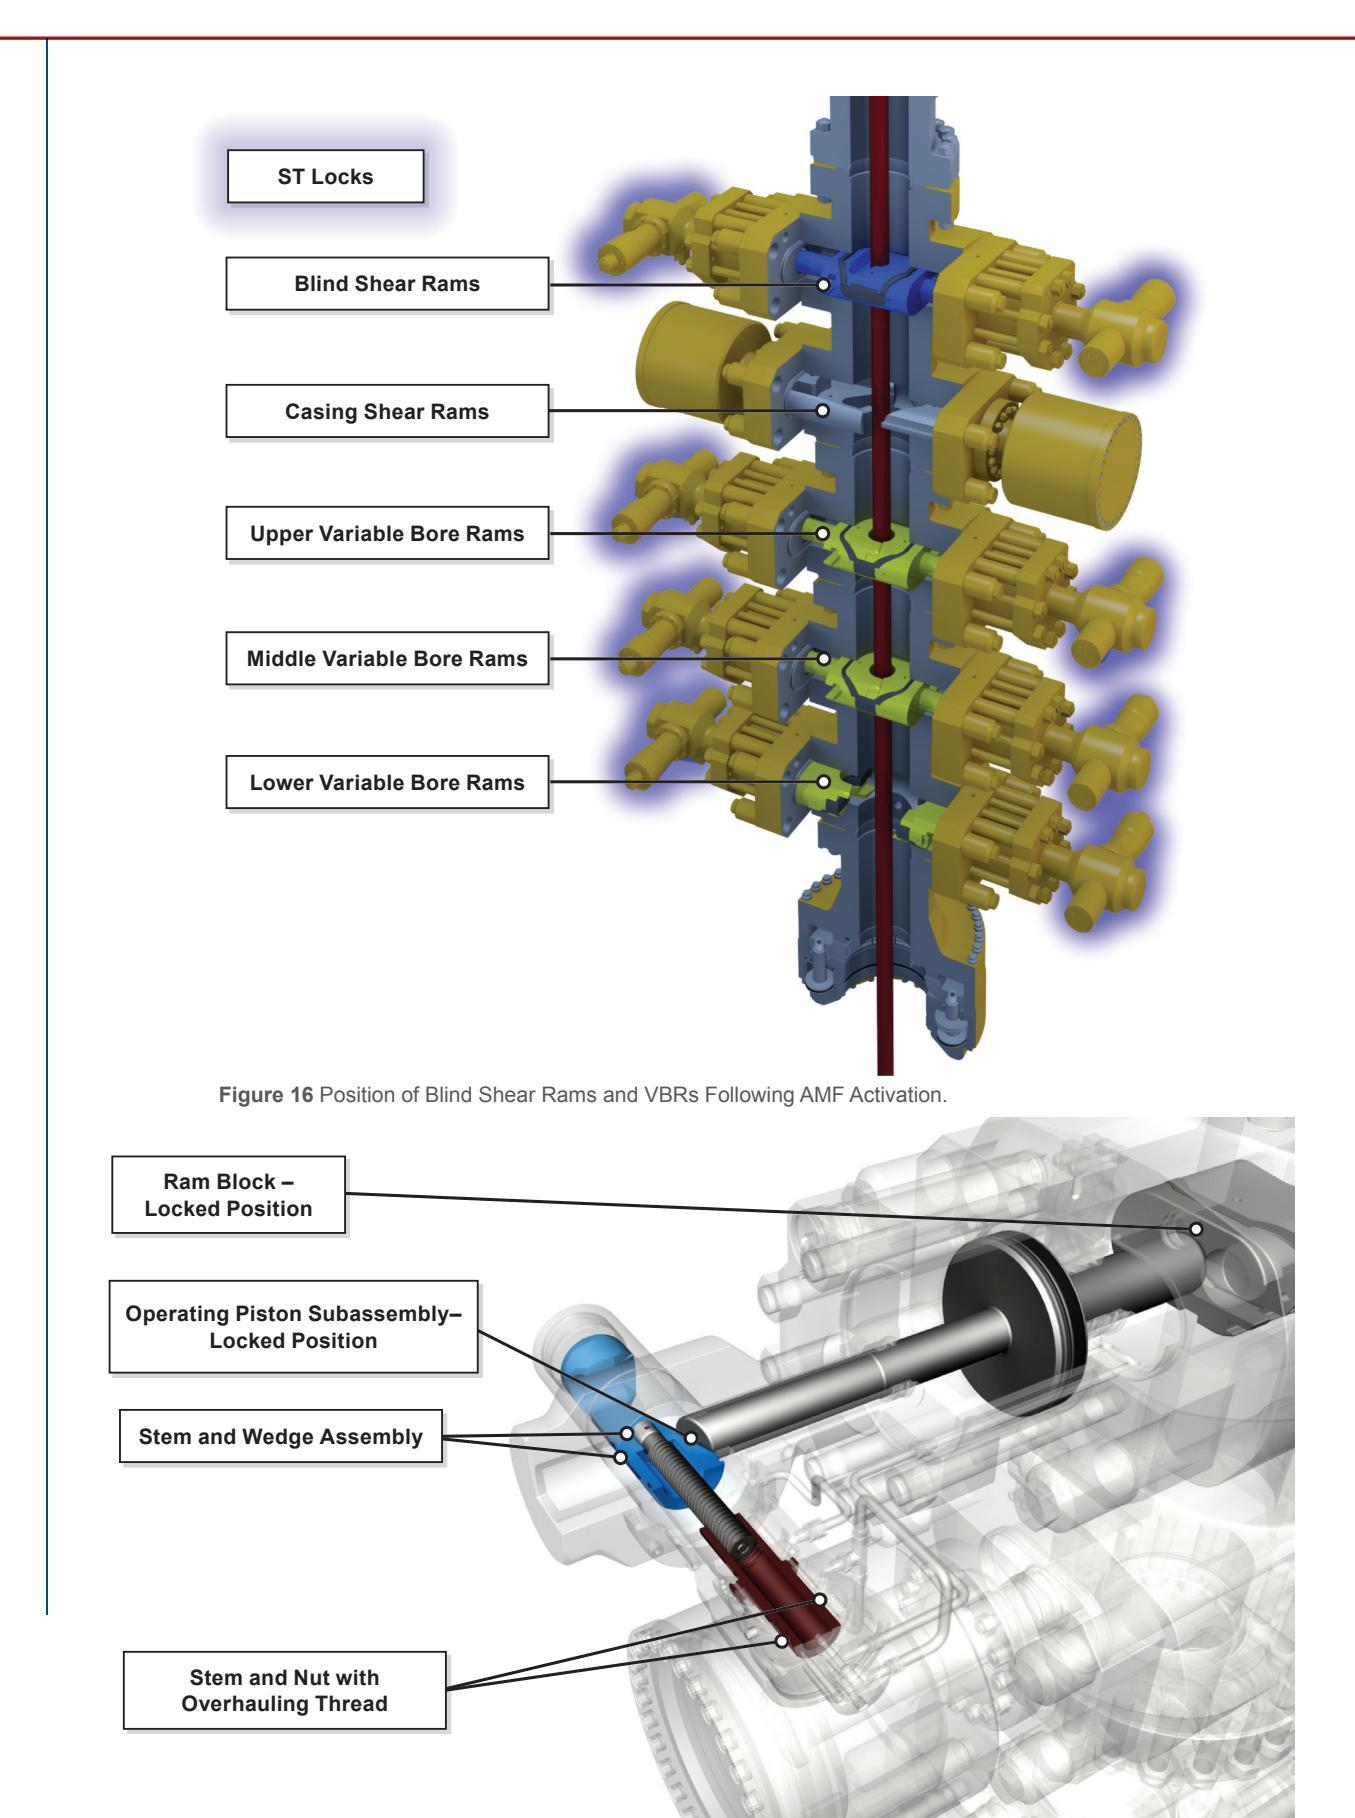
Figure 17 Blind Shear Ram ST Lock in Locked Position Following AMF Activation

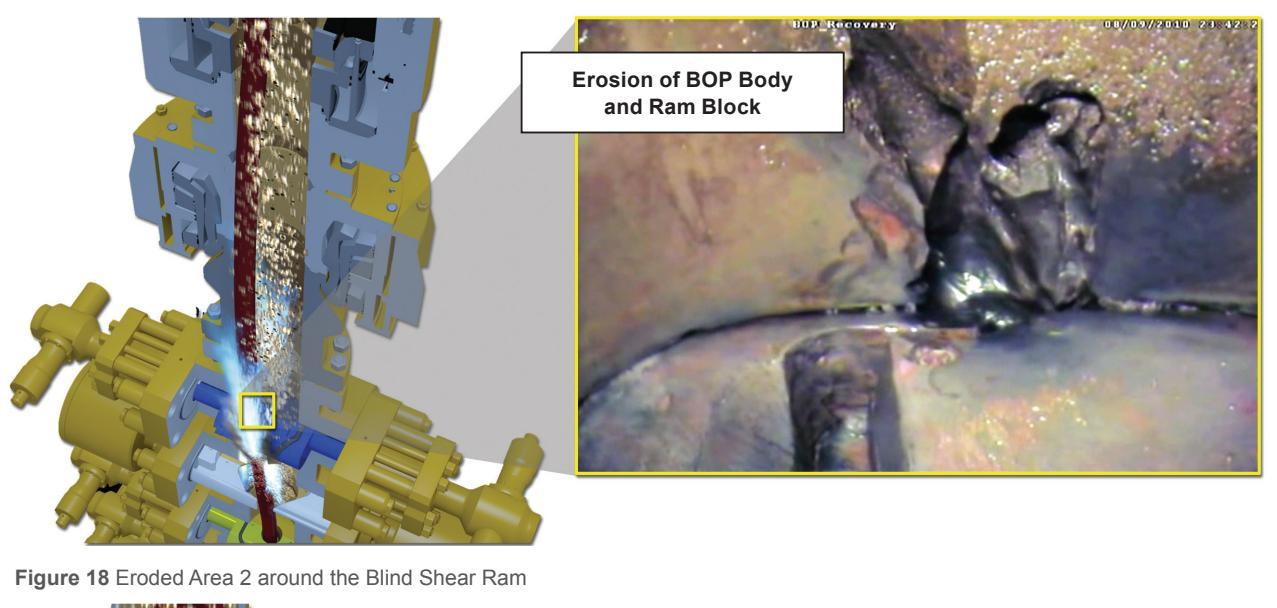
Figure 19 illustrates the sheared pipe being forced above the annular from the flow of hydrocarbons.

Figure 19 Sheared Drill Pipe Forced through Upper Annular

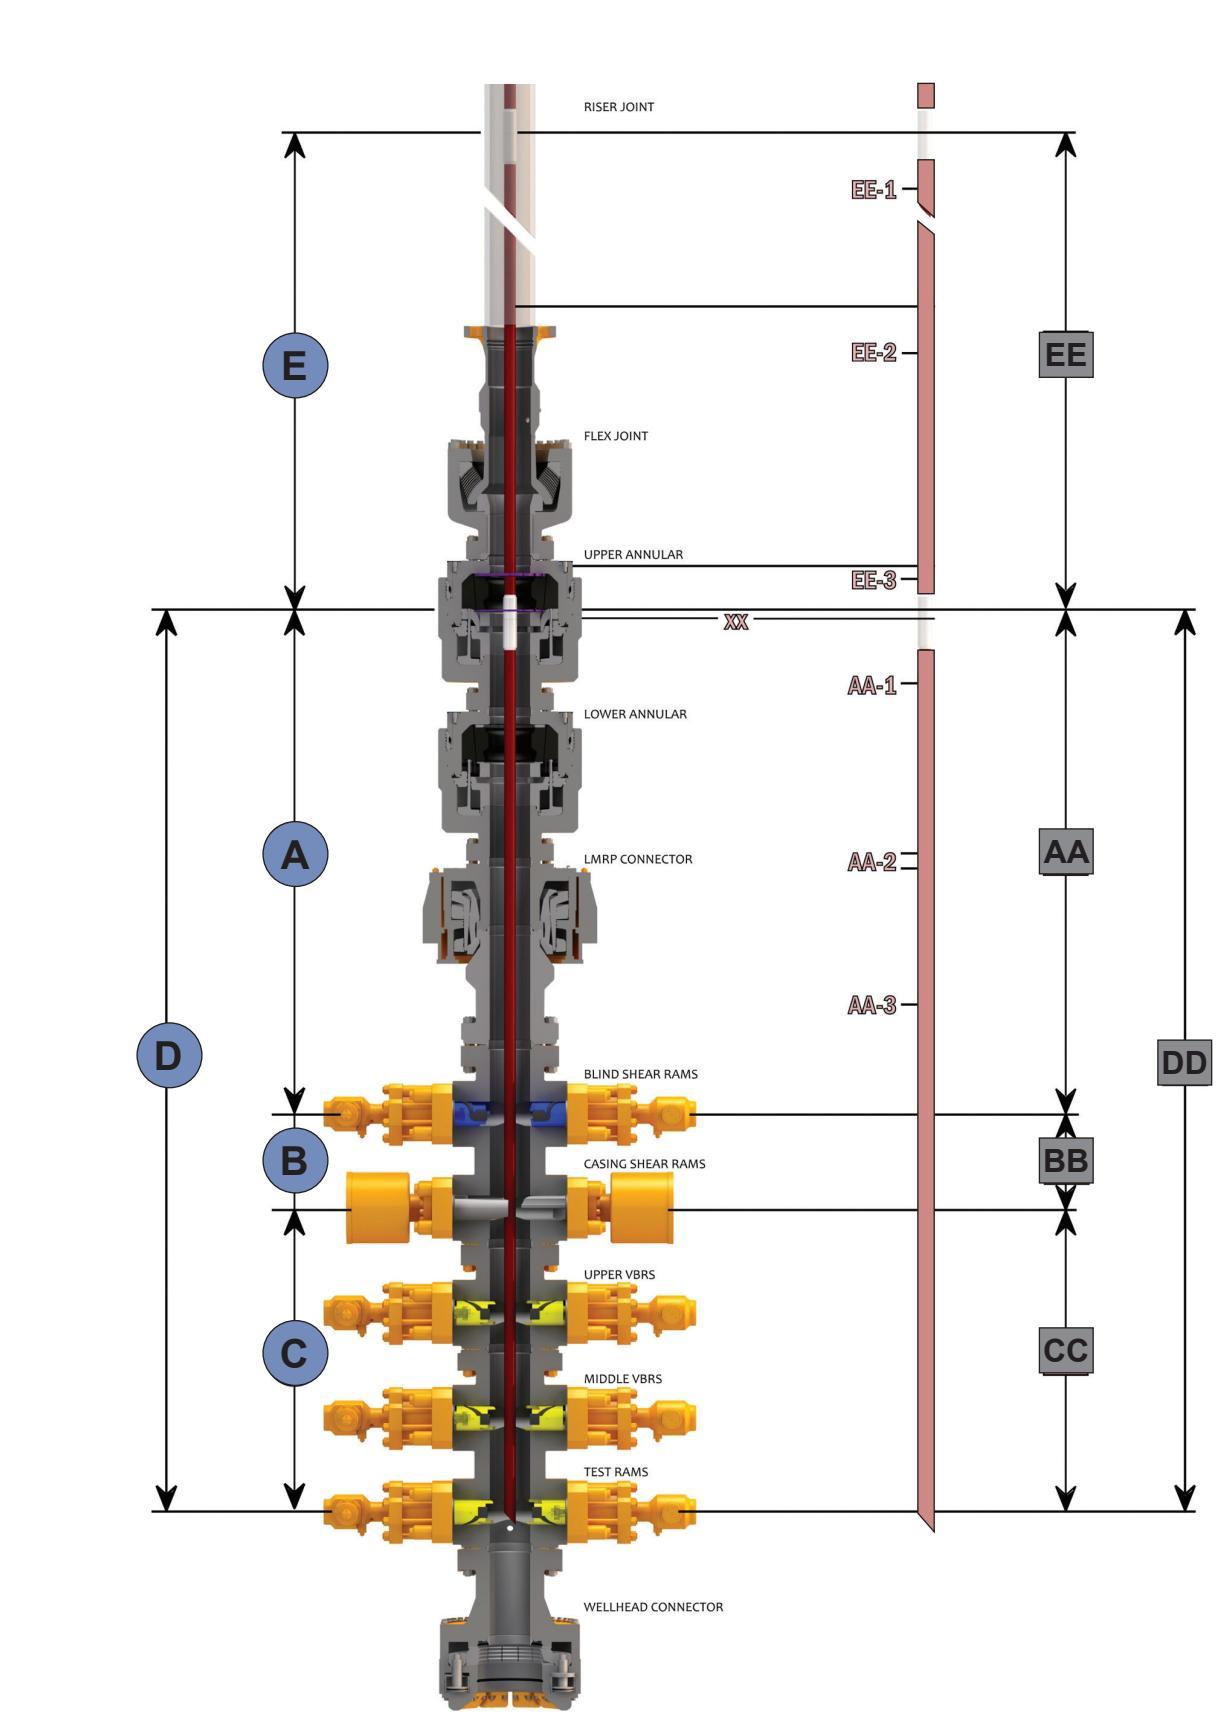
Figure 21 Drill Pipe Location in the BOP at the Time the BSR Cut the Pipe

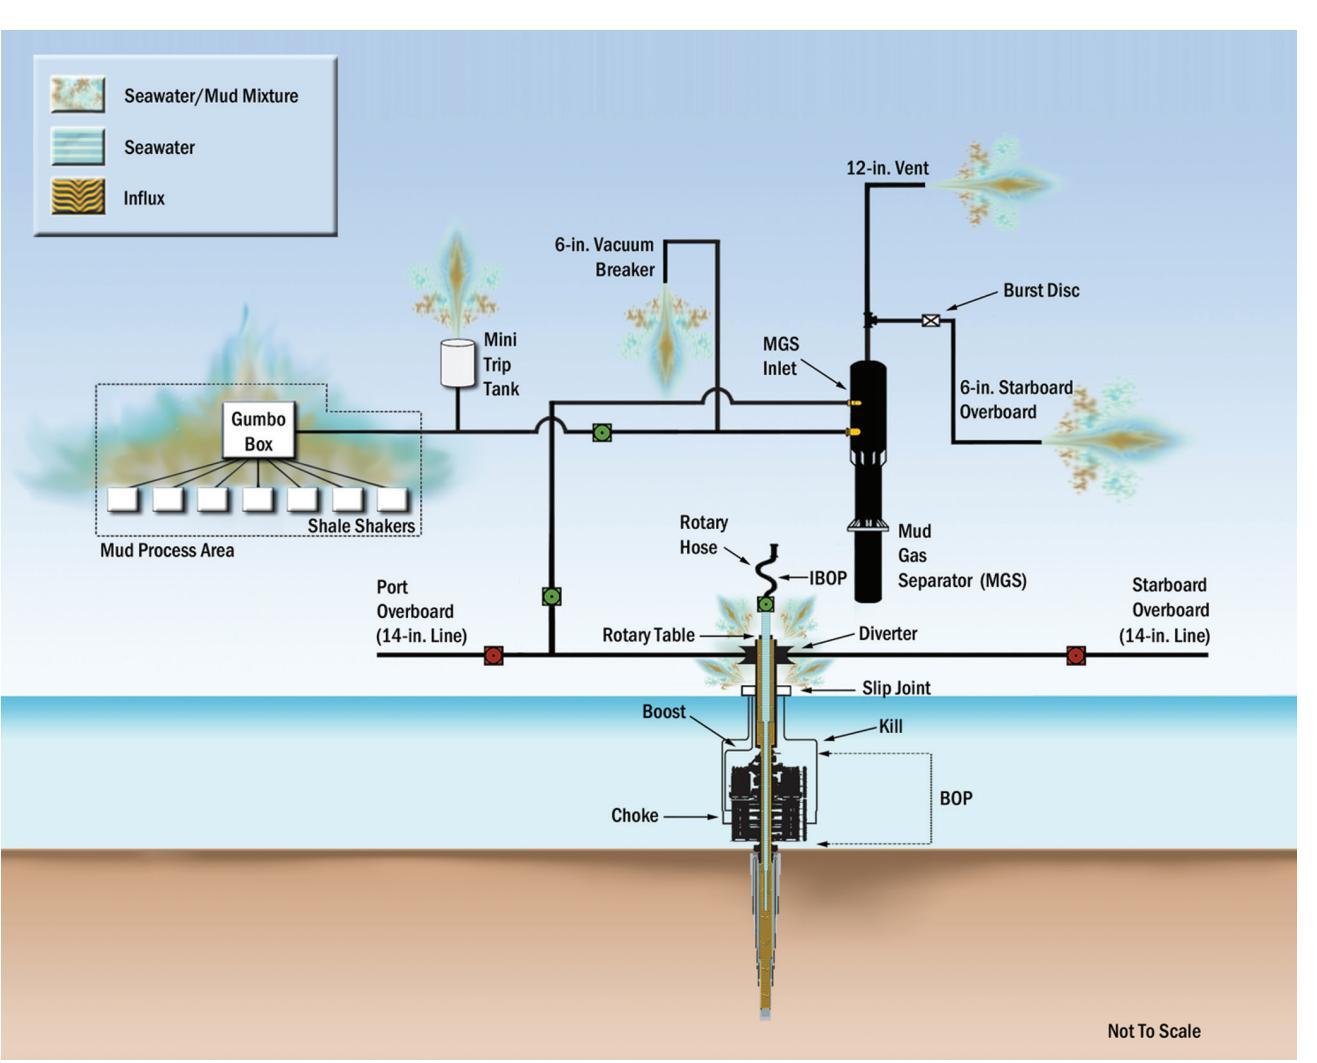
- 1. *The main 12-in. gas vent line up the derrick:* This line directs separated gas to the top of the derrick, where it exits to the atmosphere through an angled rain deflector. The 12-in. vent line is not goose-necked and would have directed flow to the port side of the rig.<sup>7</sup> See Figures 1 and 3.
- 2. The 10-in. return line to the gumbo box: This line returns separated mud from the MGS into the gumbo box and then to the shale shakers. The MGS is rated for 2,000 gpm; when this is exceeded, the mud seal is pushed out and allows gas and liquids through the lines to the shaker house. Gas would have dispersed into the gumbo box and then into the shale shaker room. See Figure 1.

Figure 1 Gas Release Points

- 3. *The 6-in. pressure relief line:* This line protects the MGS from over-pressure by providing a relief flow path. It is activated by a rupture disk that gives way at 15 pounds per square inch (psi), directing flow overboard to starboard through a 6-in. line.<sup>®</sup> The pressure relief rupture disk likely opened when mud was forced upward in the 12-in. gas vent line, increasing internal pressure in the MGS. The witnesses who reported seeing flow diverted overboard during the incident may have observed it exiting the relief line.<sup>®</sup> *See Figure 1.*

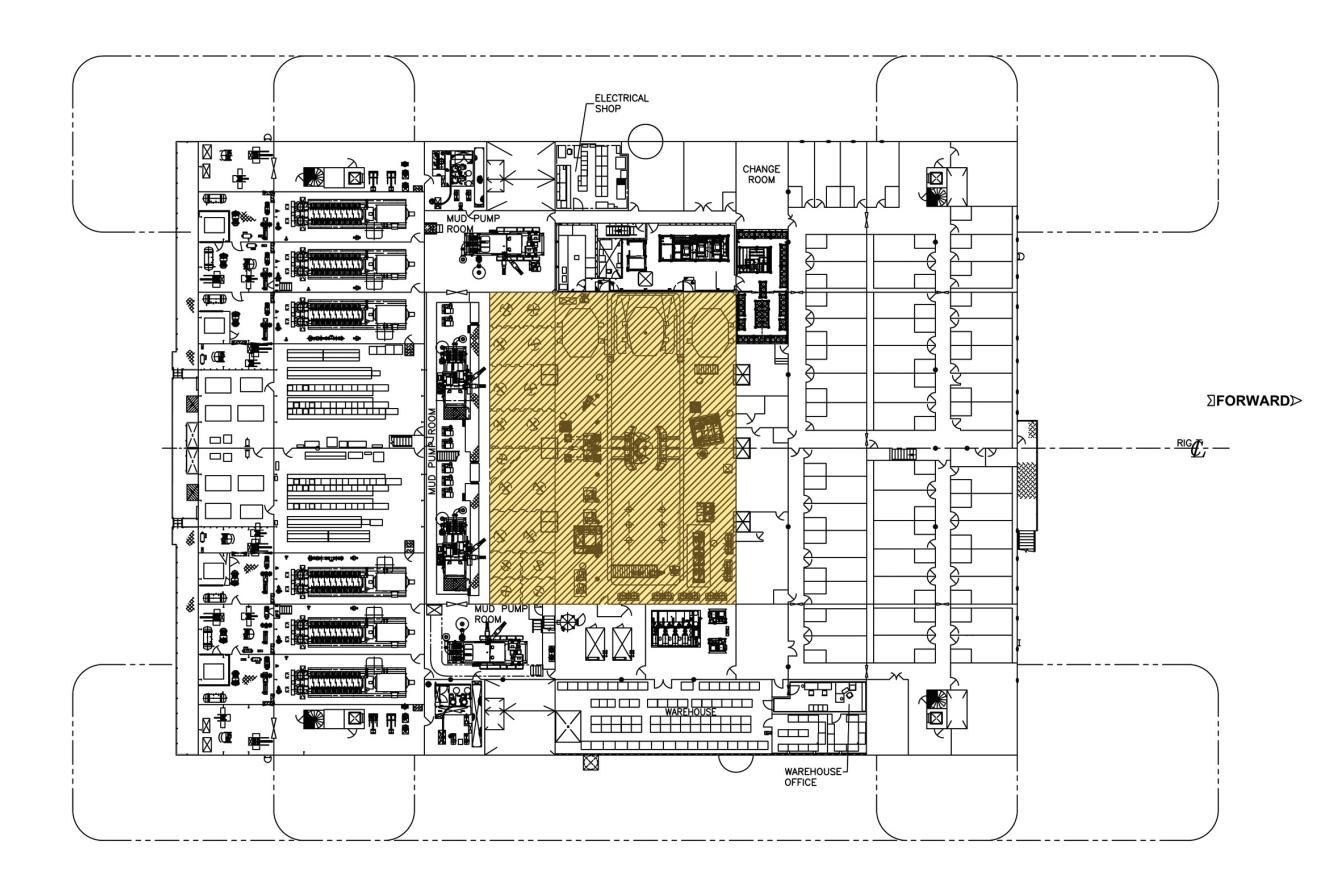
Figure 14 Third Deck Zone 2 - Yellow

- Zone 0: Explosive gas/air mixture is continuously present or present for long periods of time. There were no Zone 0 areas on the *Deepwater Horizon*.
- Zone 1: Explosive gas/air mixture is likely to occur during normal operations.
- Zone 2: Explosive gas/air mixture is not likely to occur or, if it does occur, will exist only for a short period of time.

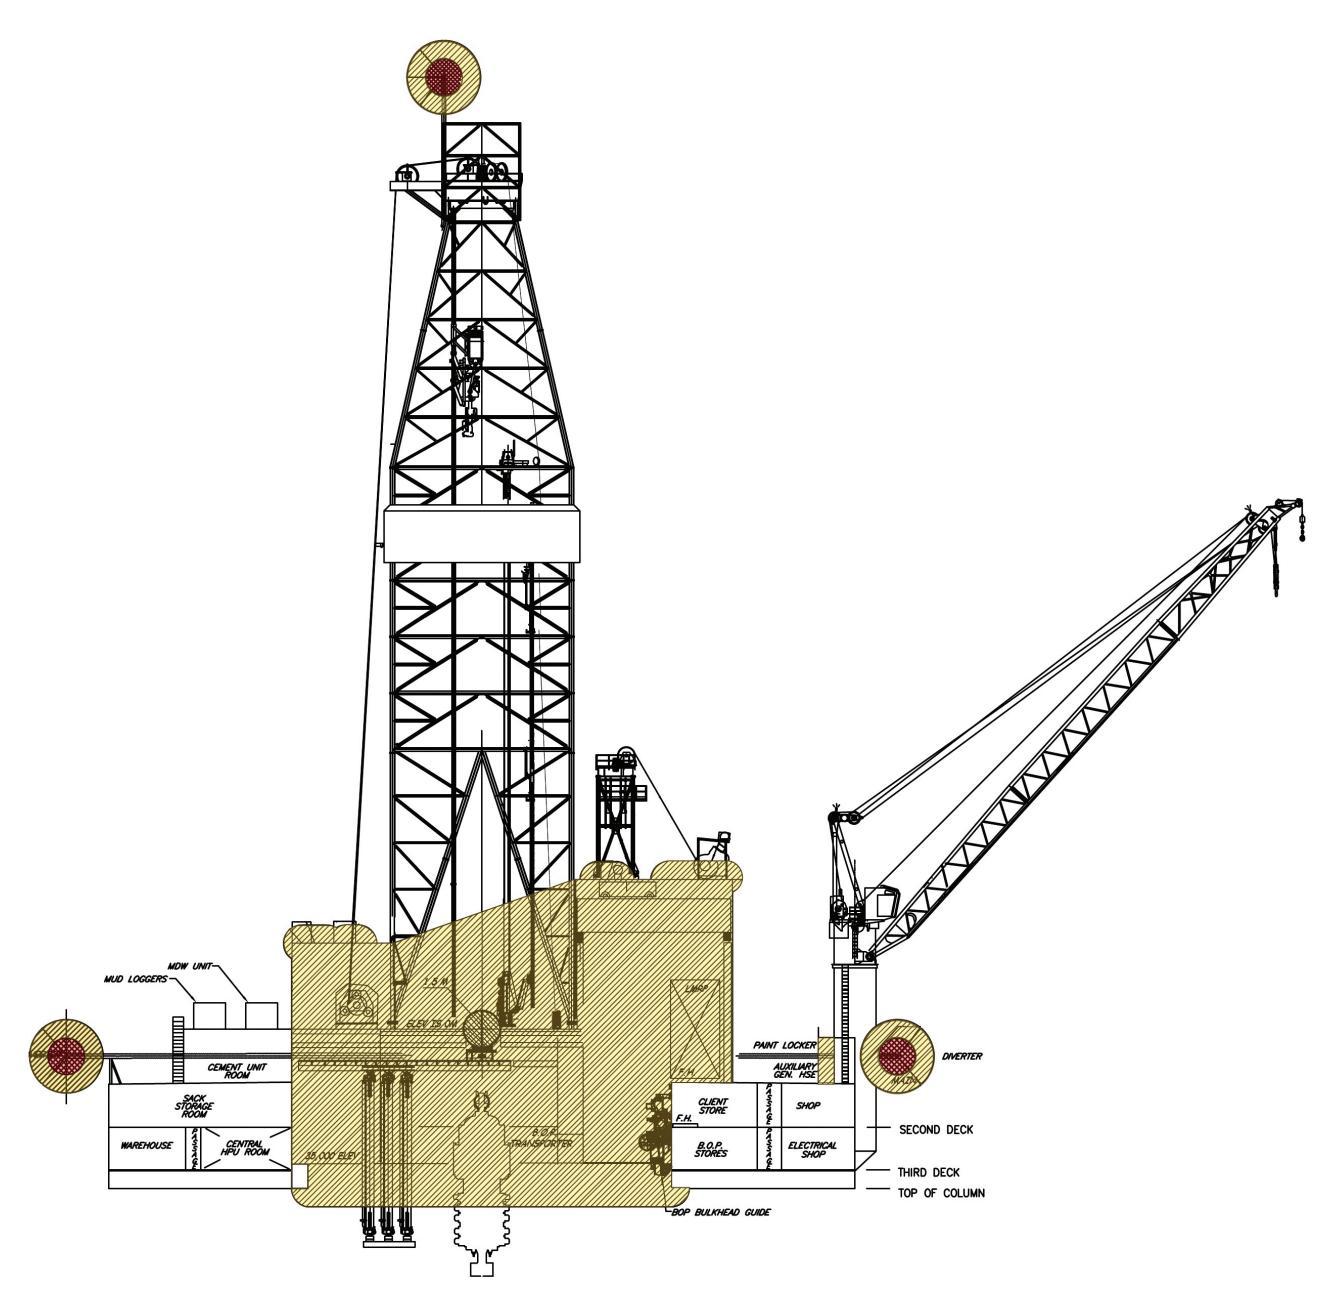
Figure 15 Drill Floor and Derrick Zone 1 - Red, Zone 2 - Yellow

Rig design takes into account the potential for an explosive gas/air mixture in each area. Areas with a high probability or possibility were classified as "hazardous." The main hazardous areas on the *Deepwater Horizon* were the drill floor, derrick, moon pool, and associated drilling process areas, such as the shale shaker and mud pit rooms. *See Figures 12–15*. The majority of the *Deepwater Horizon* was classified as non-hazardous. The hazardous areas on the *Deepwater Horizon* complied with ABS classification, flag state, and international standards.<sup>27</sup>

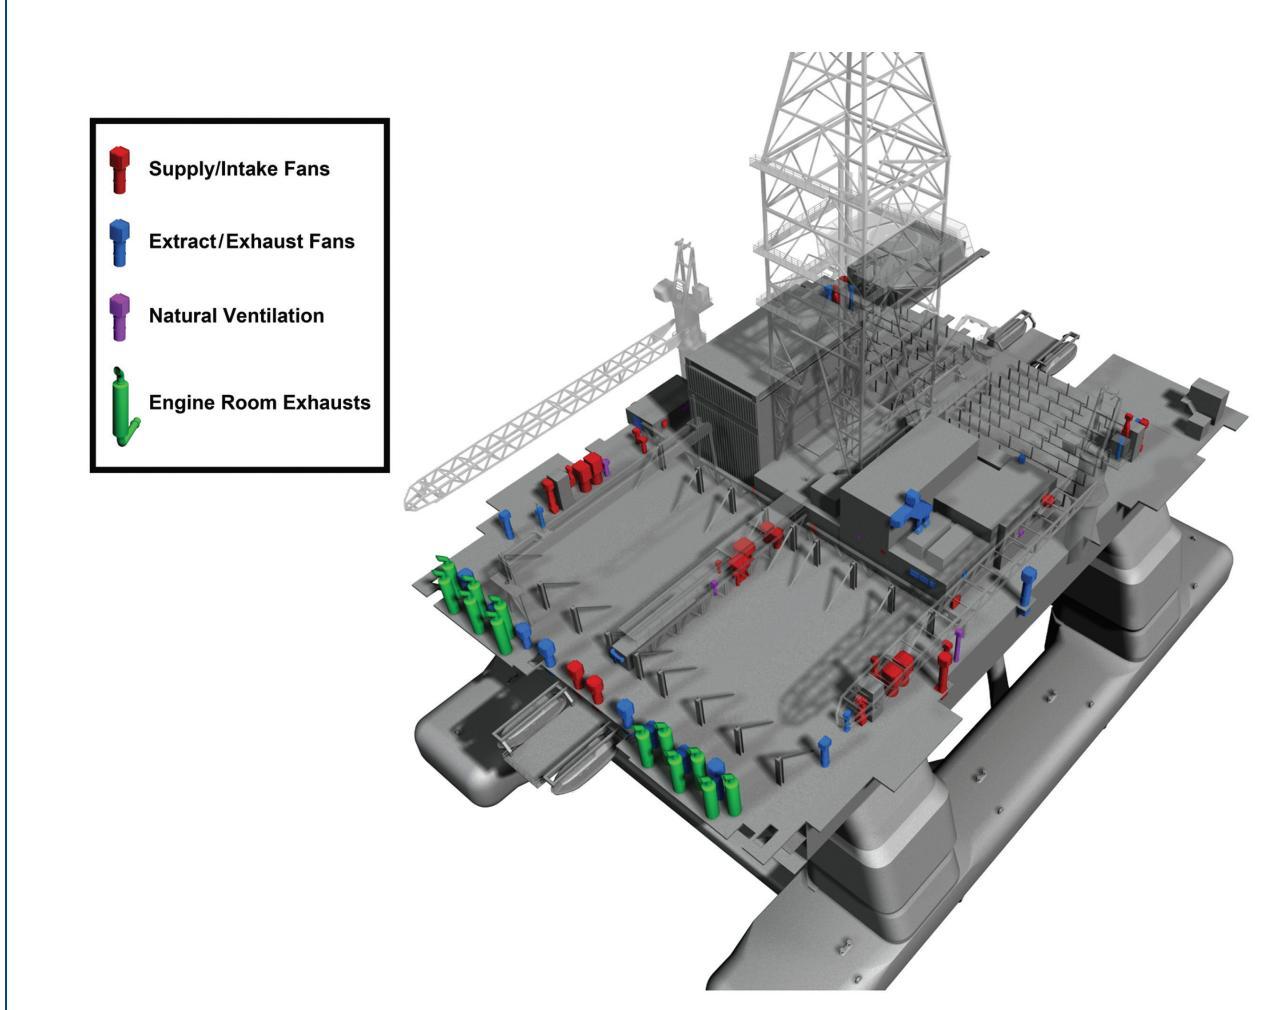
Figure 16 Principal Venitlation Inlets and Exhaust (Viewed from Starboard Aft)

The HVAC system on the *Deepwater Horizon* had a number of constituent parts.<sup>30</sup> The HVAC system was interconnected with the fire and gas detection system and emergency shutdown (ESD) system.<sup>31</sup> The HVAC system was maintained under the *Deepwater Horizon* planned maintenance system and was independently inspected by ABS for rig classification and to ensure compliance with its MODU code requirements. It also was inspected separately by the MMS.<sup>32</sup> The principal ventilation inlets and exhaust for areas (excluding the living quarters) are shown in *Figures 16 and 17*.

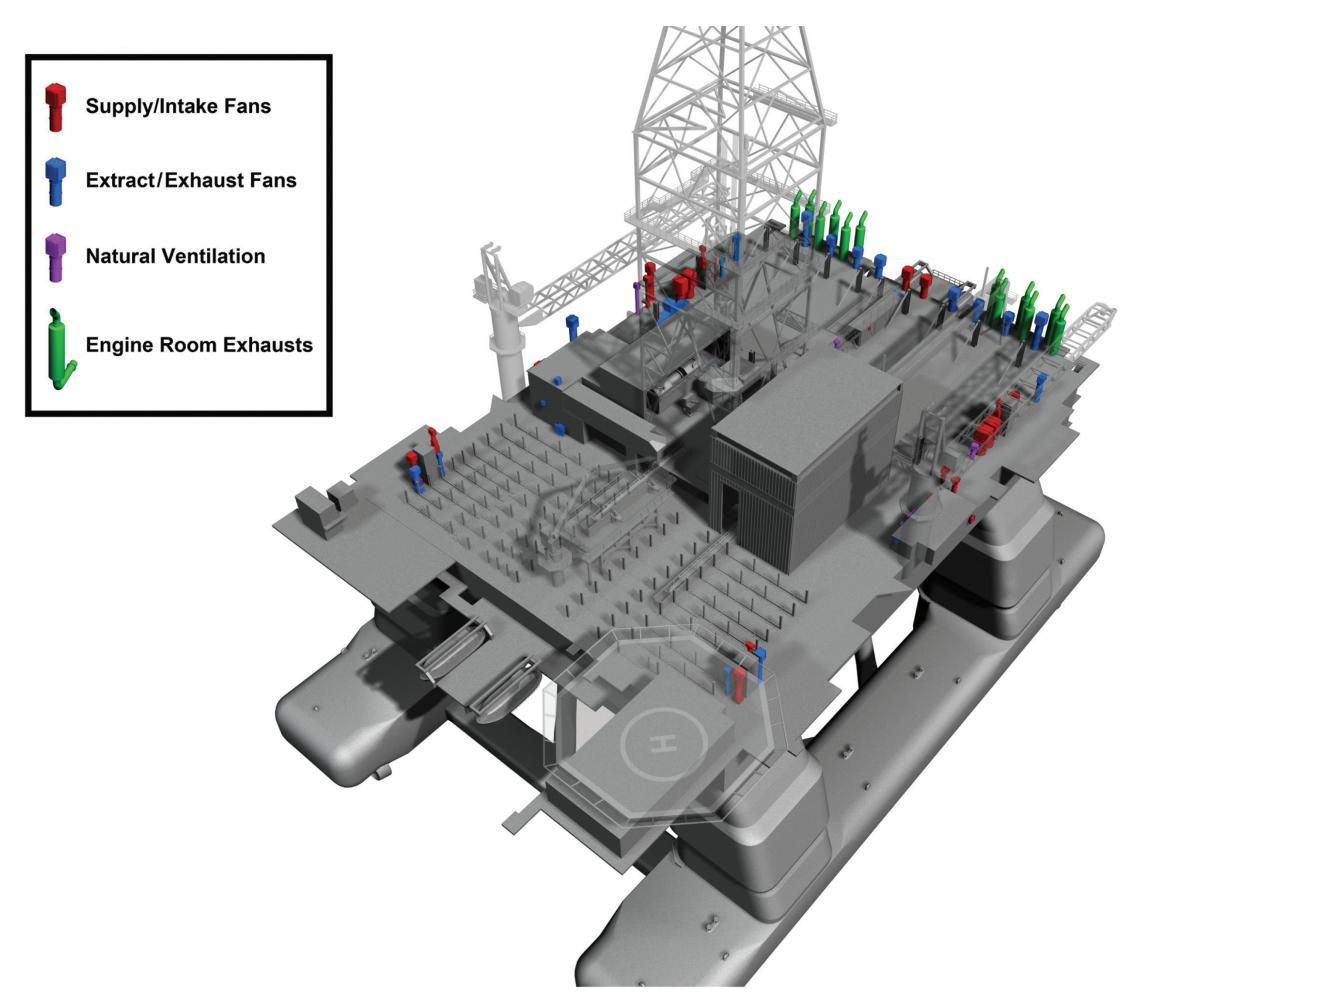
Figure 17 Principal Ventilation Inlets and Exhaust (Viewed from Port Forward)

The investigation team believes that, at the time of the incident, both the supply and exhaust fans were running in accordance with normal operating practice. The gas alarms activated in the shale shaker area at about 9:47 p.m.<sup>39</sup> As a designated hazardous area, the ventilation in the shale shaker room was not designed to shut down automatically.<sup>40</sup> Instead, the system was designed to sweep gas from the room by exhausting gas/air mixture from the room while replacing it with fresh air.<sup>41</sup>

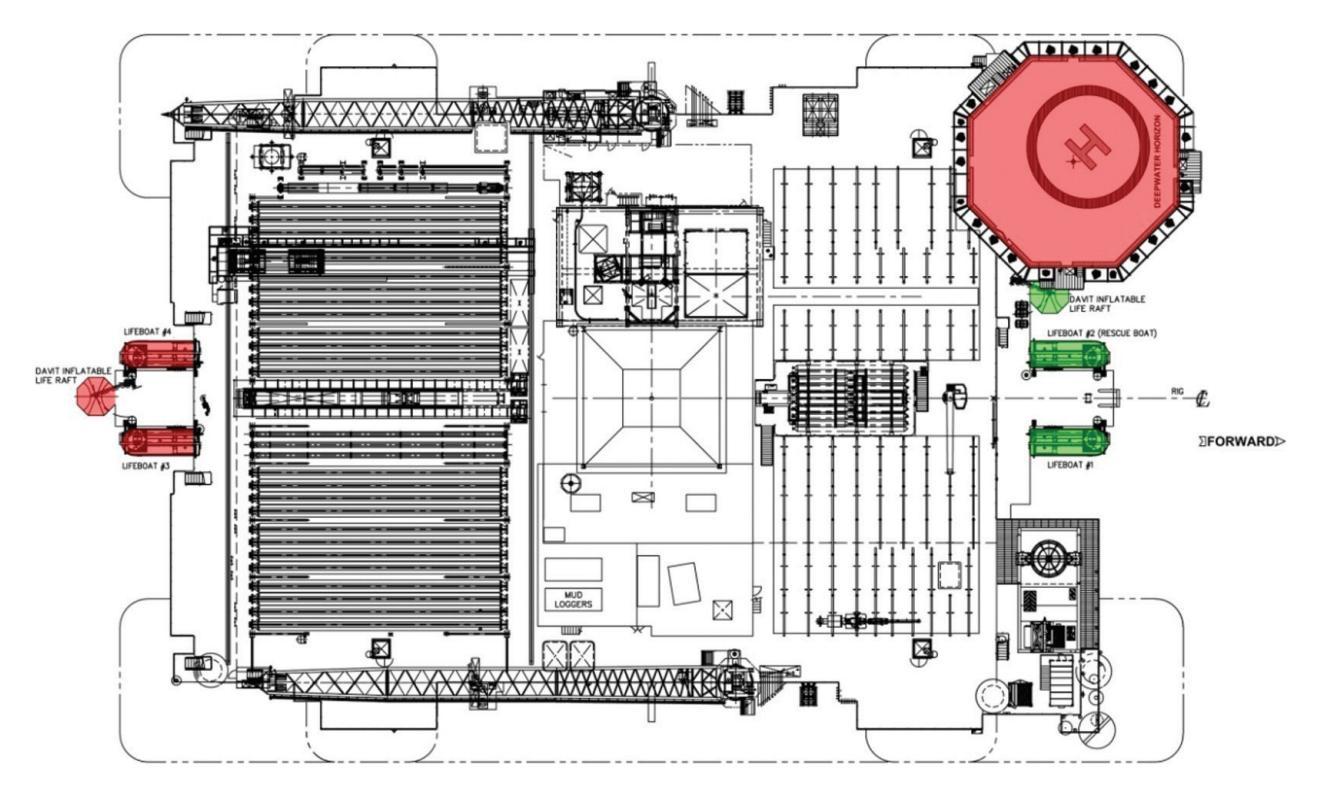
**Figure 2** Evacuation Points – Lifeboats and Life Raft Used in Evacuation Highlighted in Green; Impaired Evacuation Systems Highlighted in Red.

- Lifeboats: The Deepwater Horizon had four lifeboats two located at the forward end of the rig adjacent to the living quarters and two at the aft on the second deck level. See Figure 2. Each lifeboat was designed and certified to carry 73 people so that even if the rig had been at its full capacity of 146 (instead of the 126 onboard that day), every person could have been evacuated using only the two accessible lifeboats.<sup>51</sup>
- 2. Life Rafts: The *Deepwater Horizon* was equipped with six self-inflating life rafts. The life rafts were located next to the lifeboats, three forward and three aft, on the second deck level. *See Figure 2*. The

One hundred<sup>B</sup> of the 115 survivors evacuated the *Deepwater Horizon* on the forward lifeboats — No. 2, which launched first, followed by No. 1. Access to the aft lifeboats was blocked by damage from the explosions.<sup>53</sup> *See Figure 2*. Not all evacuated in their designated lifeboats,<sup>54</sup> and it has not been possible to establish how many people were in each lifeboat. The OIM checked the condition of its davits of lifeboat No. 1, and one injured person on a stretcher was loaded into this boat.<sup>55</sup>
