National Transportation Safety Board

Marine Accident Brief

Subsea Pipeline Damage by Tug and Barge *Valiant/Everglades*

Accident no.	DCA15LM003
Vessel name	Tug <i>Valiant</i> and barge <i>Everglades</i>
Accident type	Loss of propulsion/pipeline damage
Location	Gulf of Mexico about 120 nautical miles southeast of Galveston, Texas 28° 14' N, 92° 46' W
Date	November 17, 2014
Time	0600 central standard time (coordinated universal time – 6 hours)
Injuries	None
Damage	Natural gas pipeline: est. \$2 million
Environmental damage	None reported
Weather	Northerly wind 30 knots with gusts to 35 knots, visibility 8 nautical miles, wave height 8–10 feet
Waterway information	Gulf of Mexico, open water, East Cameron production field

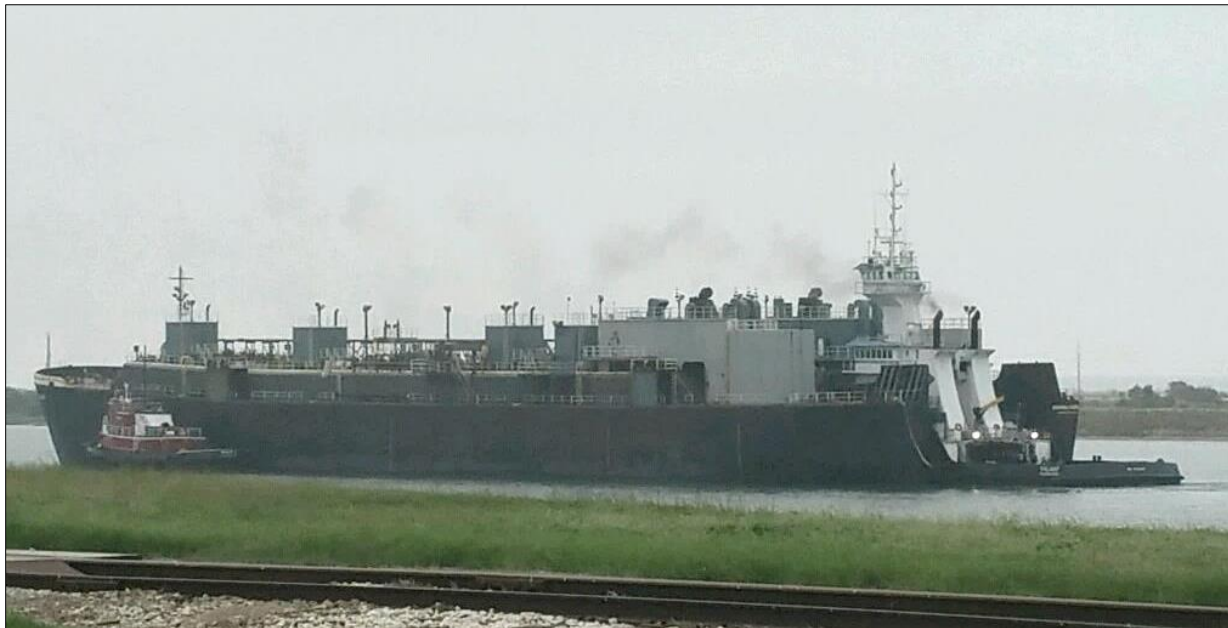
Tug *Valiant* and barge *Everglades* under way in Port Arthur, Texas. (Photo by Kirby)

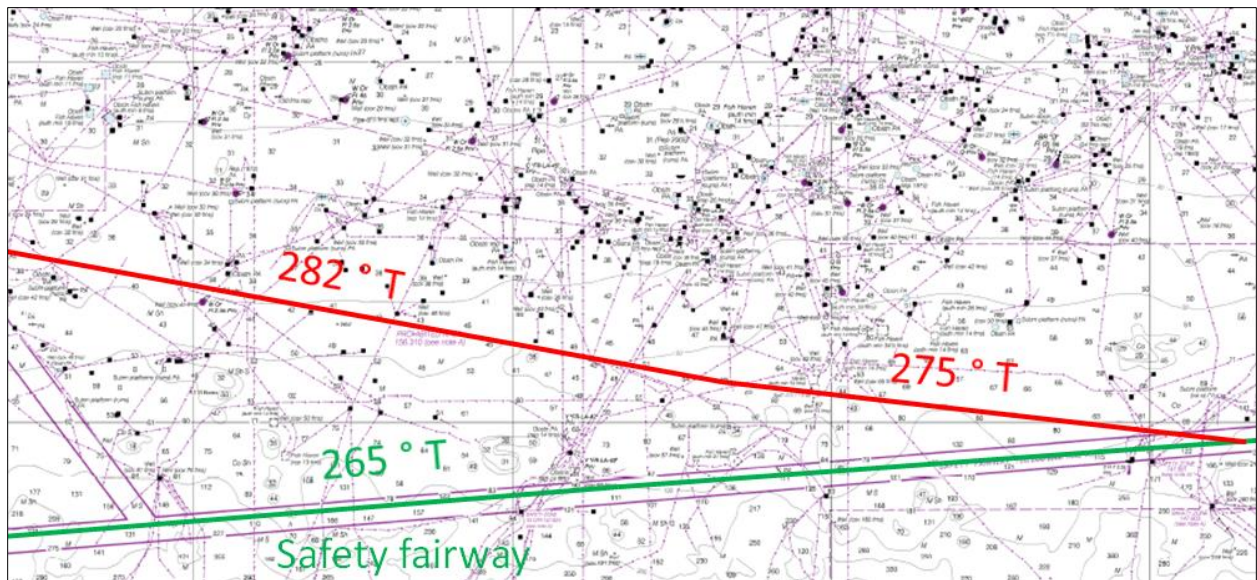
Excerpt from NOAA chart 11340 indicating planned route through safety fairway (in green) and modified route sailed (in red).
