# **NATIONAL TRANSPORTATION SAFETY BOARD**

## **MARINE ACCIDENT REPORT**

**CAPSIZING AND SINKING OF THE  
U.S. MOBILE OFFSHORE DRILLING  
UNIT OCEAN RANGER OFF THE  
EAST COAST OF CANADA  
166 NAUTICAL MILES EAST OF  
ST. JOHN'S, NEWFOUNDLAND  
FEBRUARY 15, 1982**

NTSB-MAR-83-2

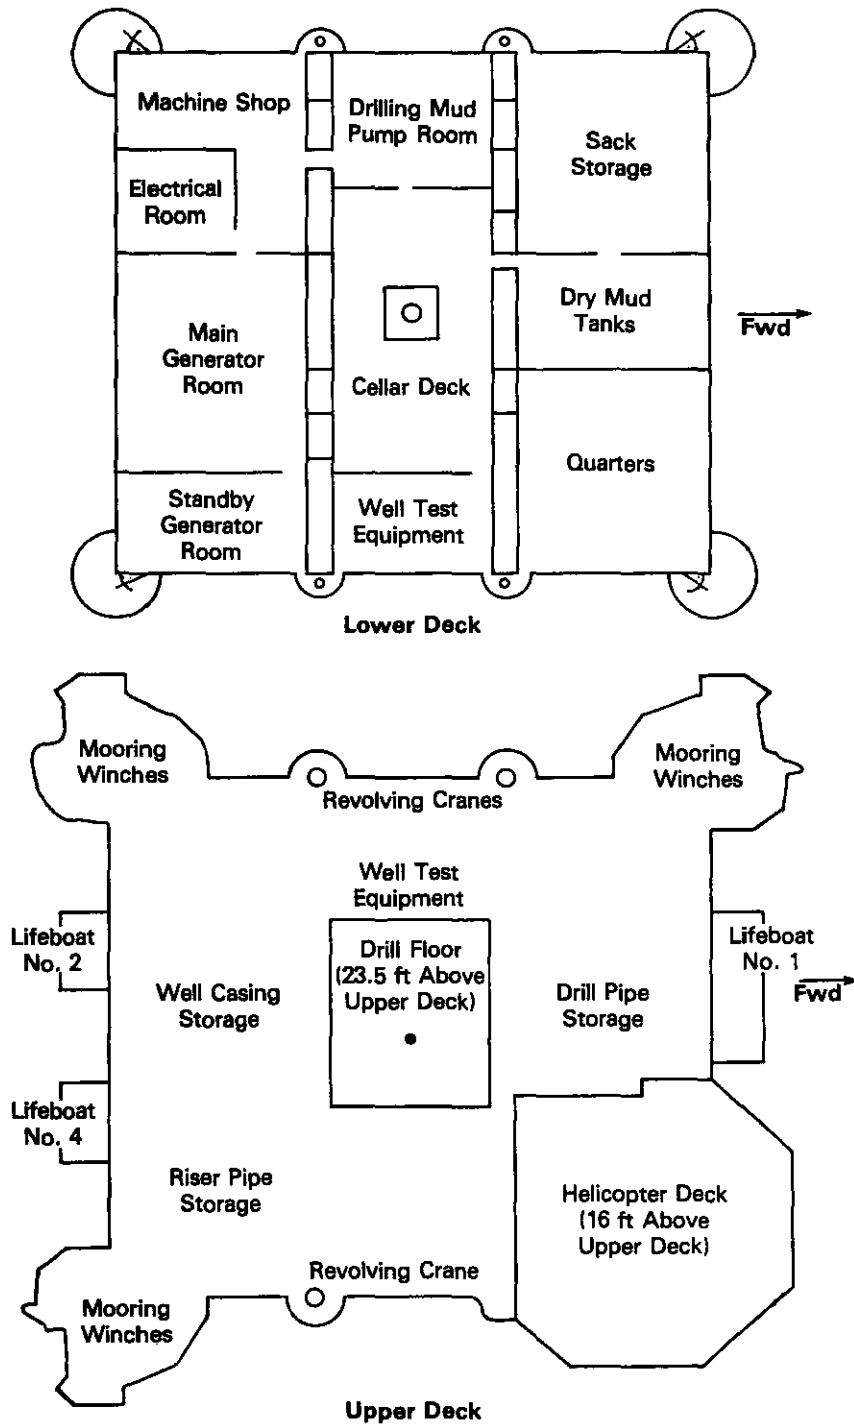
Figure 3.--Lower and upper deck arrangements.

The divers burned out one of the broken portlight frames (D on figure 3) from the ballast control room in the starboard column and entered the ballast control room through a 30-inch hole. Inside, they found the doors to the lower portion of the control panel open. The manual brass actuating rods were inserted in many of the valve control solenoids for the individual tank valves in both the port and starboard hulls. All but one of the solenoids with the rods inserted was found in the activated position. All 64 solenoid valves, together with the switch panels and the mimic boards, were removed. A

The underwater video tapes taken in March 1982 and the July 1982 diving survey both show two broken portlights. One portlight was behind the tank gauges (portlight D, figure 3) and the other one was the after portlight on the portside near the front of the ballast control console (portlight C, figure 3). With the OCEAN RANGER on a heading of 311°, the forward broken portlight would have been facing in the direction of about 245°, and the after portlight would have been facing in the direction of about 175°. The weather observer aboard the OCEAN RANGER reported that the wind and waves shifted from 220° to 270° between 1730 and 2330 on February 14. From the radio communications and the intercepted transmissions, it was not possible to determine whether both portlights or only one portlight broke around 1900, nor was it possible to determine from the intercepted transmissions whether the second portlight broke between 2100 and 2200. However, the intercepted transmissions indicated that the crew of the OCEAN RANGER was experiencing some problems with the control panel. If portlight C had broken between 1900 and 2200, water may have splashed on the ballast control panel and caused an electrical malfunction. Any water entering through portlight D would be partially deflected by the gauge panel and should not have immediately affected the control console. The cause of the breaking of the portlights could not be determined specifically; it may have been caused by hydrostatic pressure, debris or ice in the water, or hoses or lines swinging in the wind. The Safety Board believes that the USCG should evaluate the adequacy of existing standards for portlight installations in those ballast control rooms located in columns of semisubmersible MODU's.

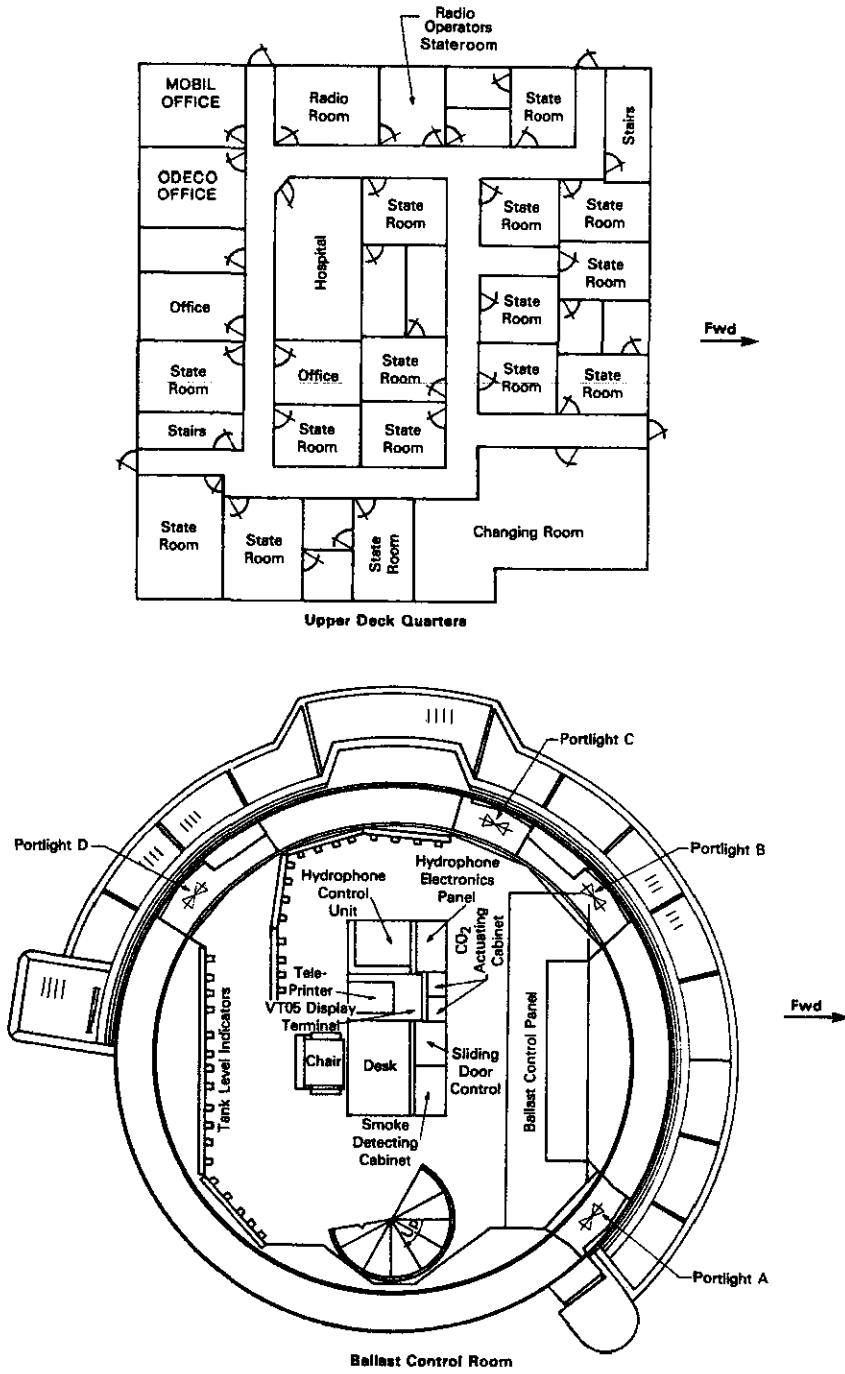
Figure 4.--Upper deck quarters and ballast control room arrangements.

The ballast control room contained the ballast control panel in the forward end of the circular room. One portlight was located on each side of the control panel (see A and B on figure 4); one portlight was located aft of portlight B (see C on figure 4); and one portlight was located in the after end of the control room behind the tank level indicators (see D on figure 4). The portlights were of standard marine design with tempered glass and metal deadlights with securing devices. The port tank level indicators were located on the starboard side of the control room, and the starboard tank level indicators were located on the portside. Two "bubble" type inclinometers were mounted in the control room—one in a fore and aft direction for observing trim, and the other one in an athwartship direction for observing heel. Each inclinometer had two spirit tubes—one with graduations from 0° to 5° and the other one with graduations from 0° to 15°. A similarly mounted pair of inclinometers also were located in the ODECO office. A desk was located in the center of the room with two VHF radiotelephones, sound-powered telephones, and a video display unit with roll, pitch, heave, wind, and wave information. A hydrophone control unit, a carbon dioxide (CO<sub>2</sub>) actuating cabinet, a smoke detecting cabinet, and an H<sub>2</sub>S gas detecting unit were also located in the center of the room. Access to the control room was gained by a circular ladder within the column from the lower deck of the upper hull. On the outside of the column, a vertical ladder was enclosed in a cage leading down from the upper hull to a walkway that extended two-thirds of the distance around the column at the control room level outside all four portlights. A handrail on the column extended around the outside of the portlights, slightly below their centers.

From February 18 to March 2, 1982, a side scan sonar survey was conducted of the wreckage of the OCEAN RANGER. The survey showed the drilling unit resting on the bottom in an inverted position about 500 feet southeast of the wellhead and drill pipe and other debris scattered 900 feet from the sunken drilling unit in a northwest to southeast direction. (See figure 6.) The derrick is located about 200 feet northwest of the OCEAN RANGER. The survey indicated that anchor cables in the fore and aft direction had parted while at least one transverse anchor cable to each corner column remained intact. A videotape survey conducted in early March 1982 did not indicate any structural damage to the hull, except minor damage to the bows of both lower hulls and two broken portlights in the control room. The portlight behind the tank gauges (portlight D, figure 4) and the next portlight near the portside of the control console (portlight C, figure 4) were broken. The deadlights on all control room portlights were found closed.
