MARINE ACCIDENT REPORT

**EXPLOSION AND FIRE ABOARD THE
U.S. MOBILE OFFSHORE DRILLING UNIT
ZAPATA LEXINGTON
GULF OF MEXICO
SEPTEMBER 14, 1984**

NTSB/MAR-85/11

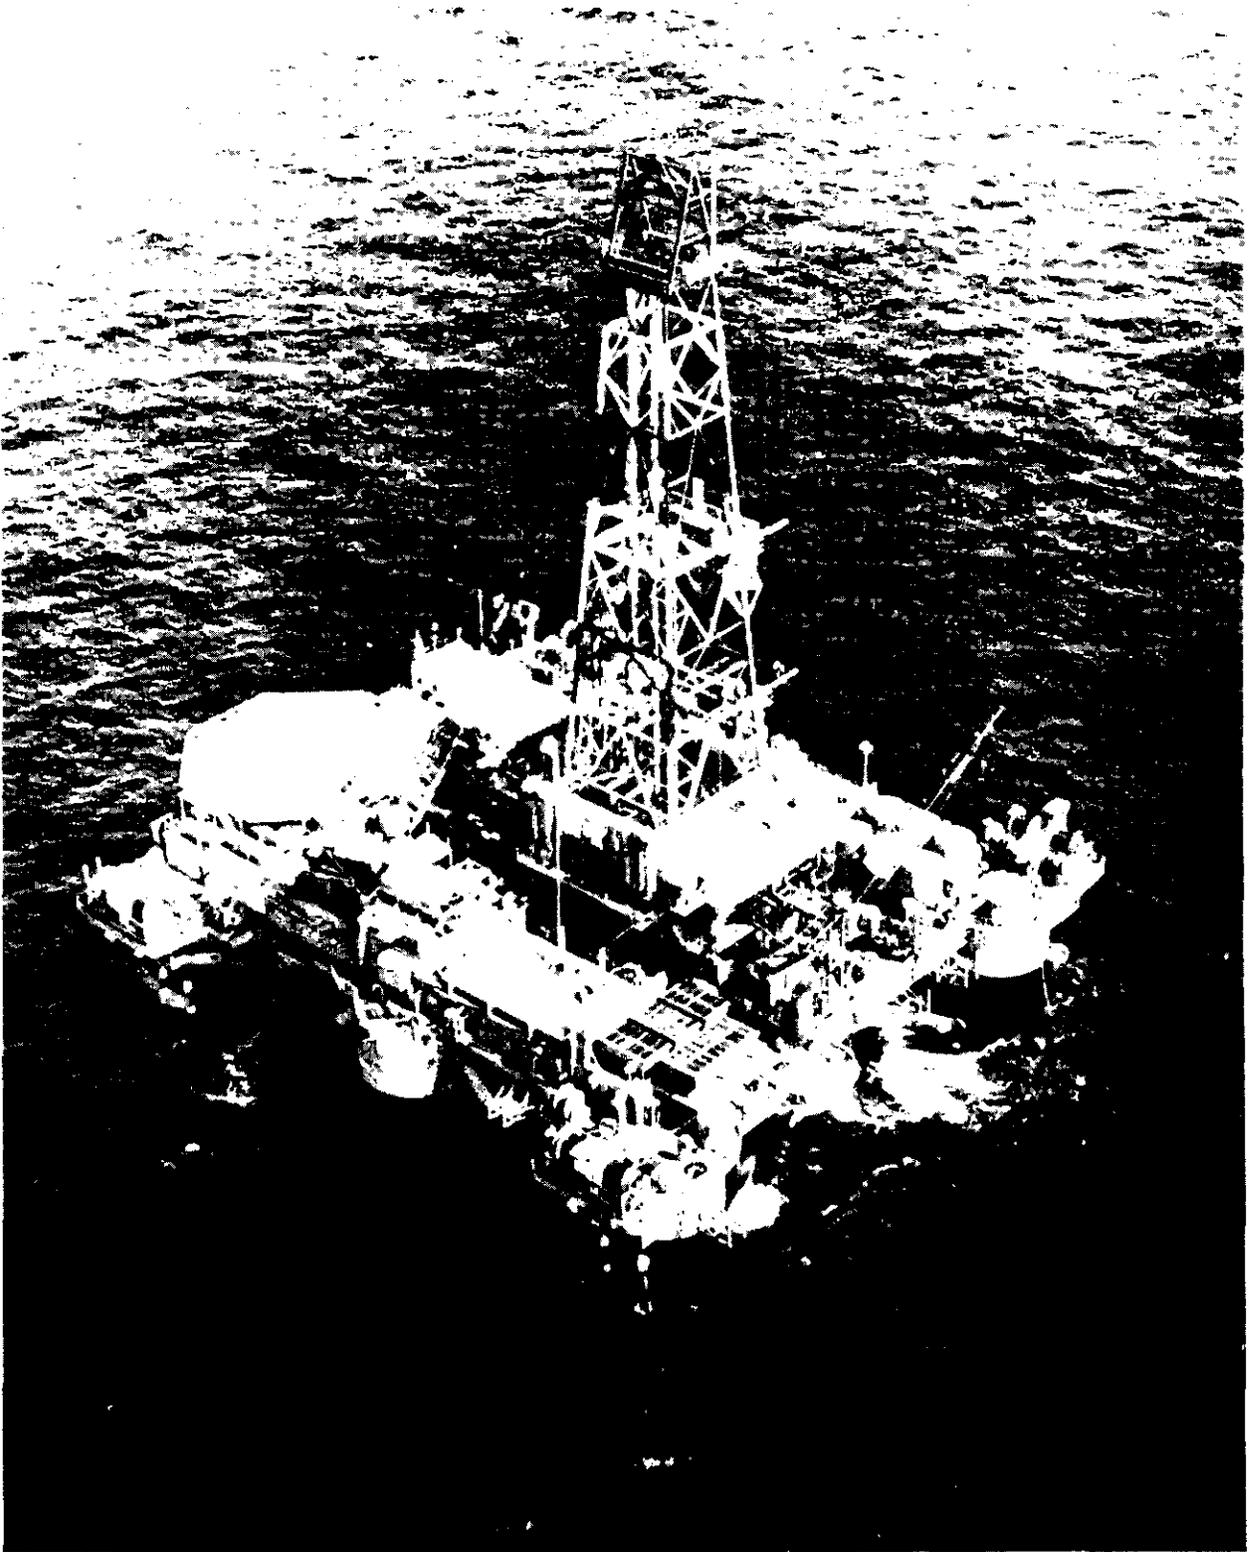
Figure 1.--U.S. mobile offshore drilling Unit ZAPATA LEXINGTON.

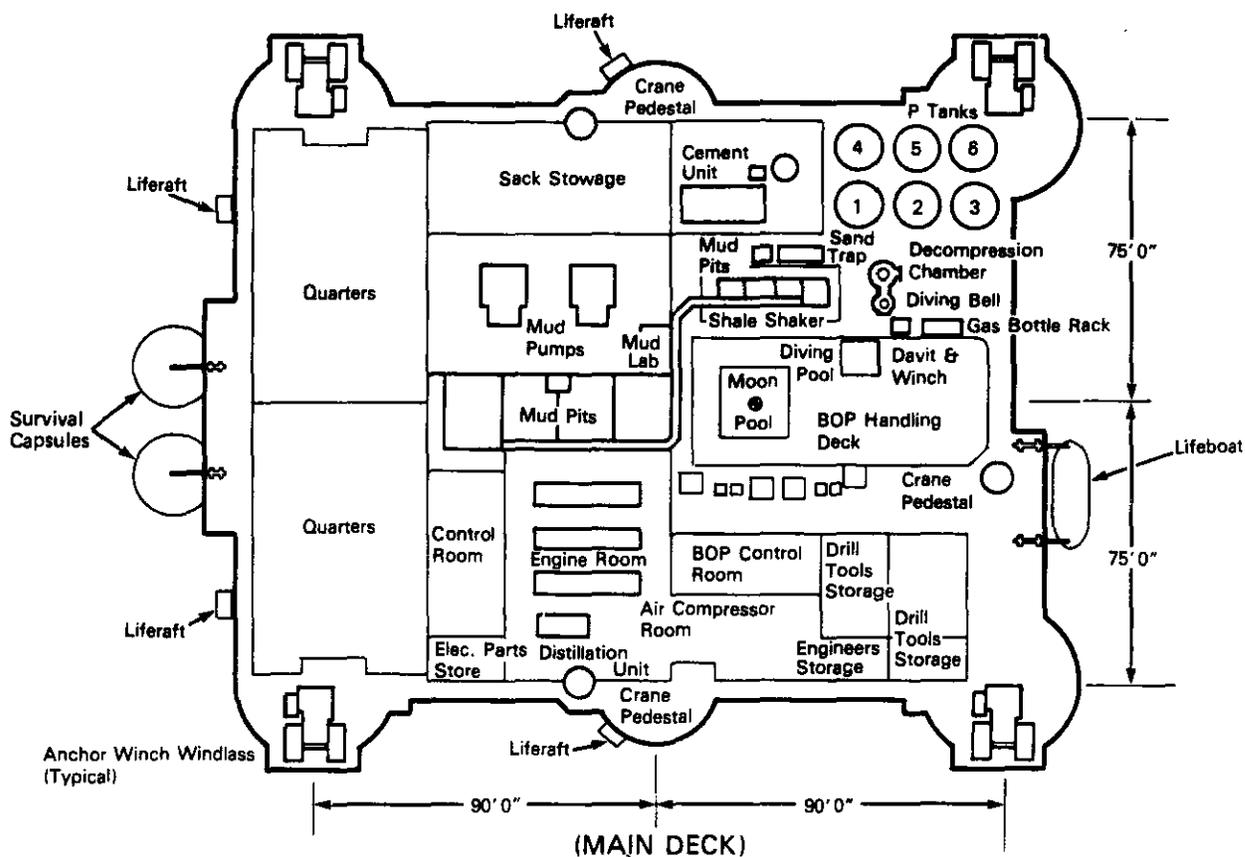
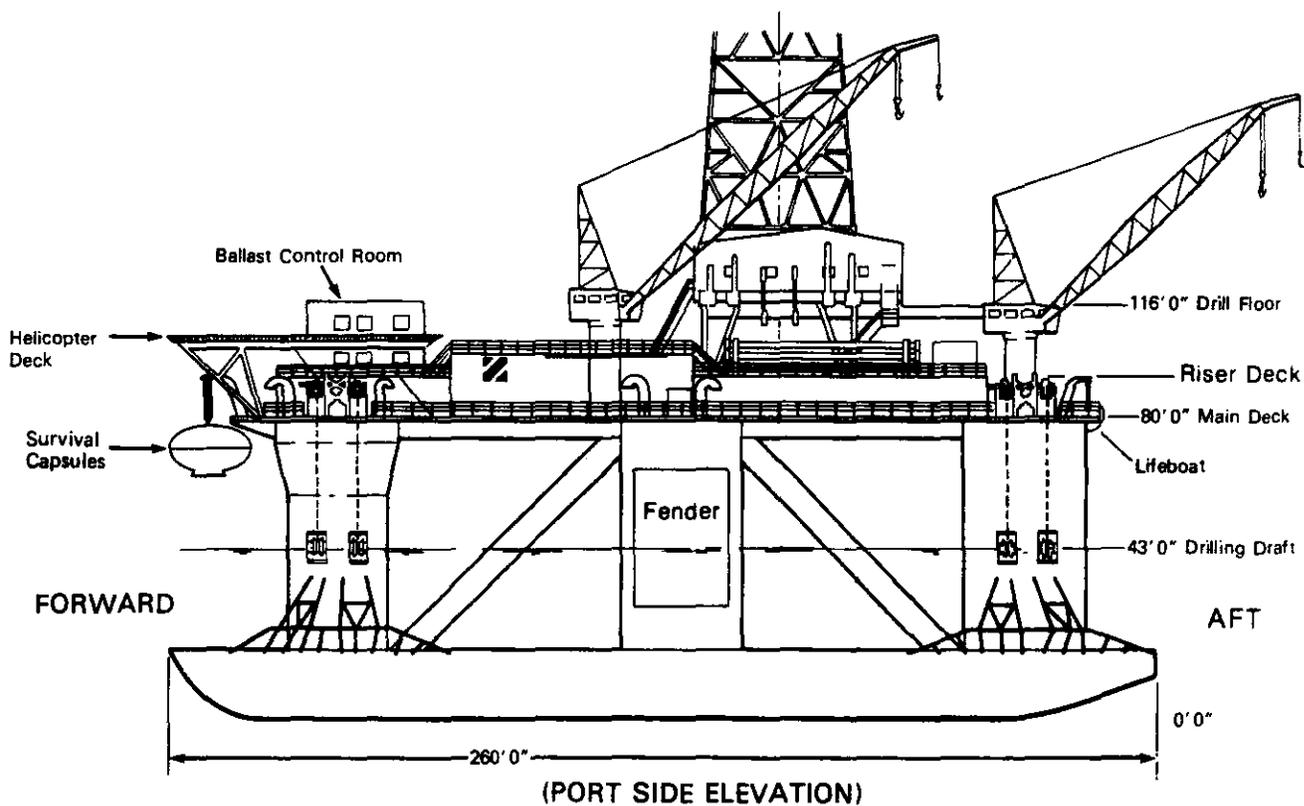
Figure 2.--Main deck arrangement and elevation of the ZAPATA LEXINGTON.

Conoco representative from reaching it to communicate with the senior toolpusher on the drill floor where the controls to the diverter system were located. Standing about 10 feet from the gumbo box, he shouted to his assistant and the two rig crewmen on the deck, "It's time to leave." The four persons ran from the area as a flash of fire erupted near the gumbo box and instantly enveloped the entire area in flame, including the shale shaker room below and the drill floor above at the base of the derrick [7]. (See figure 2.)

The main deck, which measured 260 feet by 190 feet, was located at the 80-foot level above the base line and arranged with living quarters at the forward end for 82 persons. The derrick and drill floor was located on the 116-foot level toward the after end of the rig (see figure 2). A 160-foot derrick located over the drill floor contained the equipment for handling the drill string [11] and subsea components.
