# **NATIONAL TRANSPORTATION SAFETY BOARD**

## **MARINE ACCIDENT REPORT**

**EXPLOSION AND FIRE ONBOARD  
THE U.S. MOBILE OFFSHORE DRILLING UNIT  
GLOMAR ARCTIC II IN THE NORTH SEA,  
130 NAUTICAL MILES EAST-SOUTHEAST  
OF ABERDEEN, SCOTLAND  
JANUARY 15, 1985**

**NTSB/MAR-86/03**

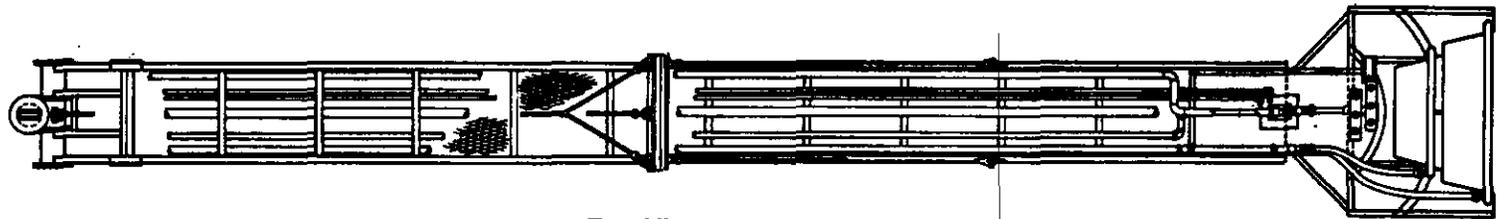
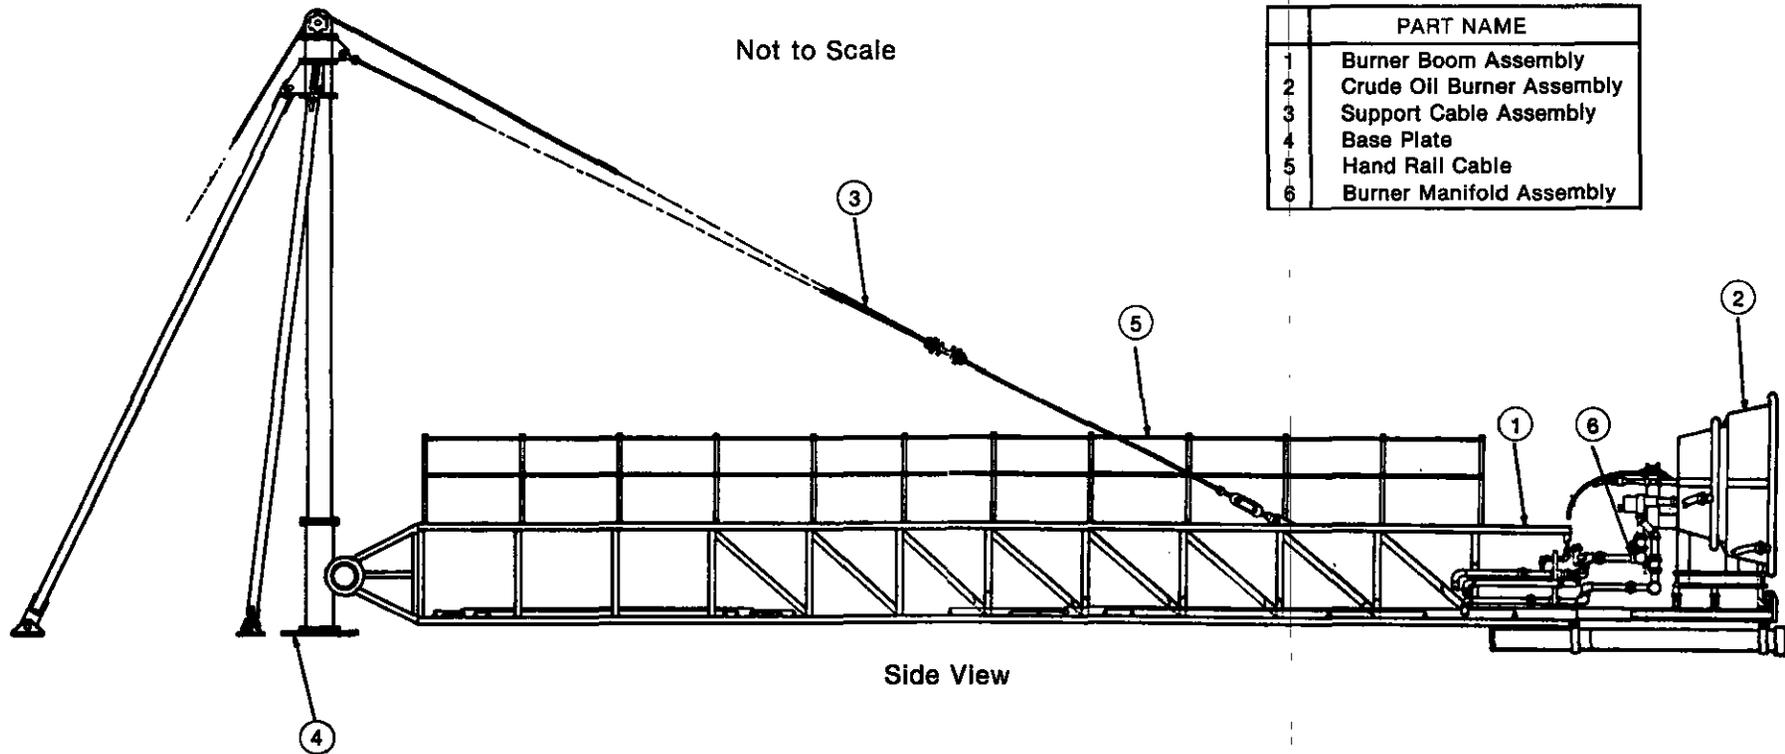
Figure 2.--Burner boom.

Burner Booms.--The GLOMAR ARCTIC II was fitted with two 70-foot-long steel burner booms, one each on the port and starboard sides of the main deck (see figure A-1, appendix A, and figure 2) with one end of the boom attached to a pivot point at midships. The booms were fabricated and installed during the MODU's construction and were a part of the vessel's permanent equipment. Each burner boom provided support for the crude oil, atomizing air and water pipelines and the crude oil burner assembly located at the boom's extreme outboard end. With the use of the pivot, the boom could be oriented to suit the wind direction and keep the flame's heat and smoke away from the MODU. When the burners were not in use, the booms could be brought in and secured alongside the MODU's main deck.

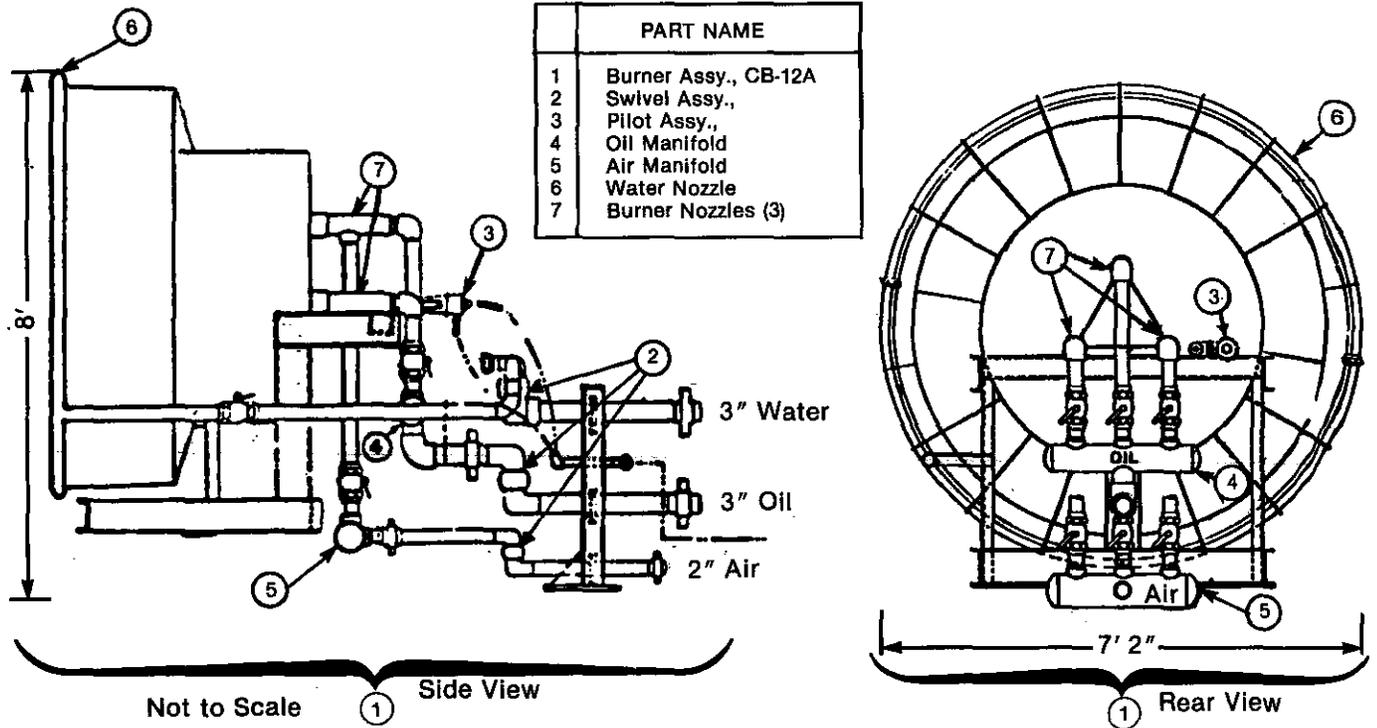
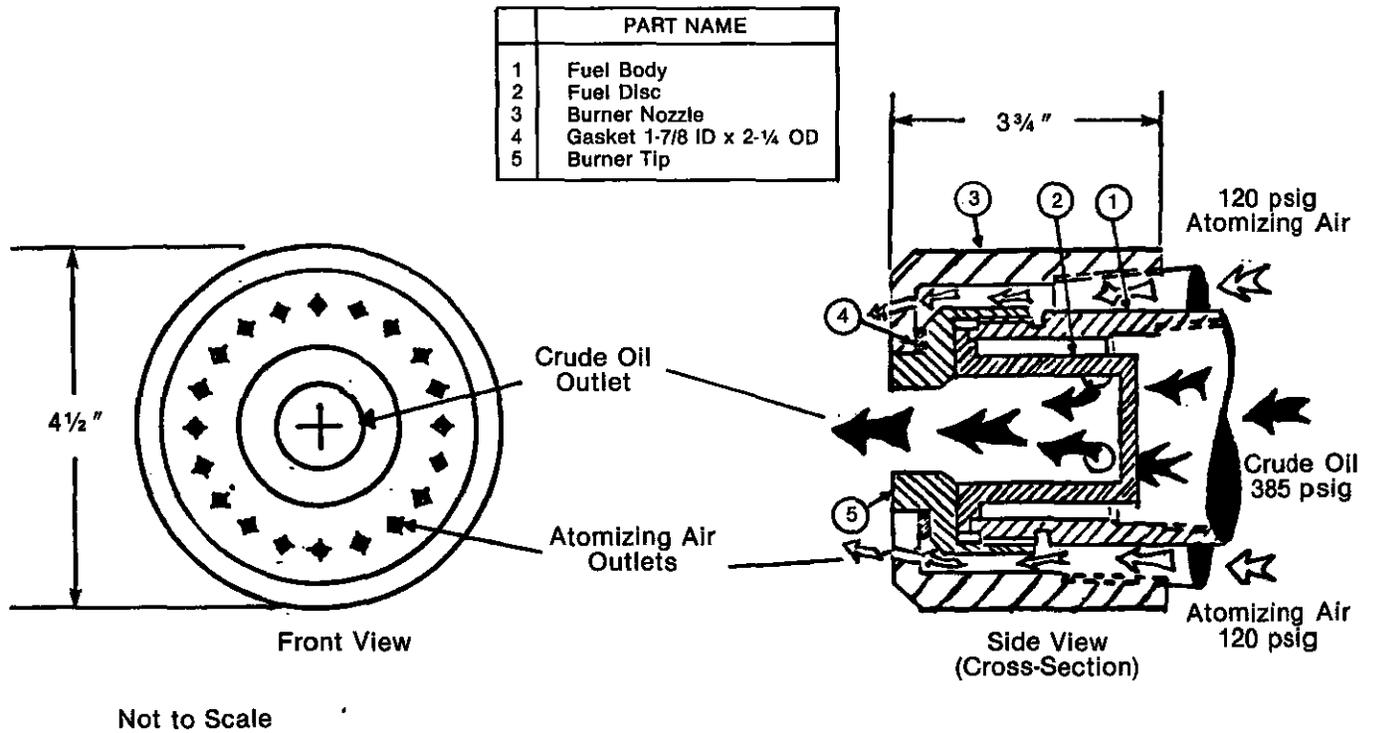
Figure 3.--Crude Oil Burner & Nozzle Assembly.

A member of the well test crew said that about 1305 the port crude oil burner oil flow was obstructed. The well test crew closed the choke valve which stopped the crude oil flow and drained the crude oil burner supply pipeline and then cleaned the three burner nozzle assemblies (see figure 3) on the port crude oil burner. Each burner nozzle was unscrewed and removed, including the Flexitallic compression gasket, 2/ and then the 20 atomizing air holes in each burner nozzle were cleaned. (See appendix B.) The burner tips (see figure 3-B), were removed as necessary so that petroleum wax and other well solids could be cleared by hand. Seawater was pumped into the system at the choke valve manifold and flushed through the crude oil supply pipe to the crude oil burners. The burner tips, Flexitallic compression gaskets, and burner nozzles then were reinstalled onto each nozzle assembly and the crude oil burner was ready for use. According to the Phillips Petroleum drilling supervisor, the procedure applied to the crude oil burners is the only maintenance performed by the well testing crew after testing has been suspended or stopped. The drilling supervisor also said that he was not aware of any user manual applicable to the burner nozzle assembly and that there was none aboard the GLOMAR ARCTIC II. Well test No. 2 resumed at 1700 on January 10 and continued until January 12 when an equipment malfunction caused the test to be terminated. At 2100 on January 13 well test No. 2A was begun.

Crude Oil Burners.--The Otis crude oil burners, model CB-12A (see figure 3), were portable (about 1,600 pounds), temporary equipment and had been installed on the GLOMAR ARCTIC II on October 15, 1984. The main components of each burner unit included three burner nozzle assemblies, a crude oil manifold, an atomizing air manifold, the frame and can assembly, and a water ring. Each burner nozzle assembly (model 80 B 190) included a fuel body, fuel disc, burner tip, Flexitallic gasket, and a burner nozzle. The crude oil burners were designed by National Airoil Burner Company (NAO) of Philadelphia, Pennsylvania, and manufactured, with the exception of the nozzle assemblies, by Merpro Ltd. of Montrose, Scotland in 1983.
