Issued August 9, 2022

MIR-22/18

# Contact of Bulk Carrier *Ocean Princess* with Oil and Gas Production Platform SP-83A

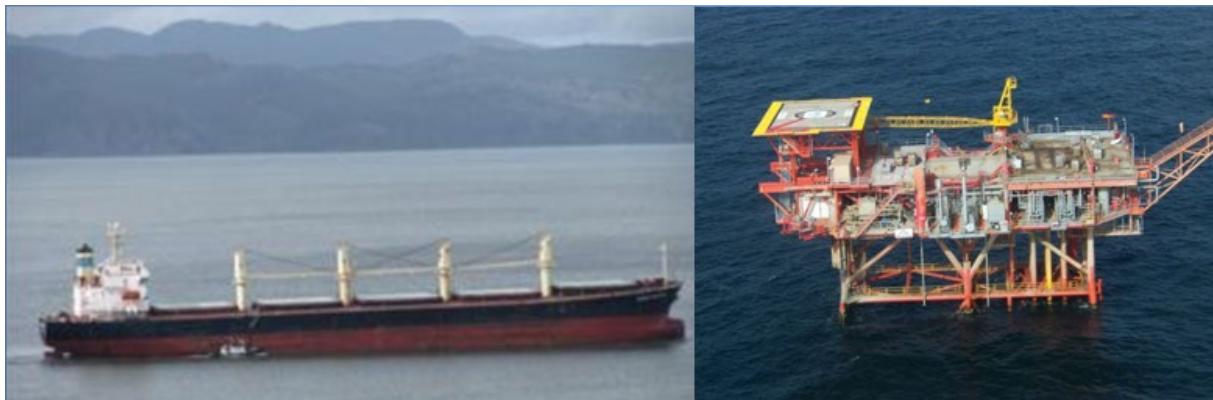
**Figure 1.** *Ocean Princess* under way before the casualty (left); SP-83A before the casualty (right). (Sources: ©Malcom Cotte MarineTraffic.com; Arena Offshore)
