# United States Coast Guard

**Report of the Investigation into the  
Circumstances Surrounding the Capsize of  
the Liftboat SEACOR POWER (O.N.  
1115290) Approximately 7 Nautical Miles  
South of Port Fourchon, LA in the Gulf of  
Mexico Resulting in the Loss of 13 Lives on  
April 13, 2021.**

**THE CAPSIZING OF THE COMMERCIAL LIFTBOAT SEACOR POWER (O.N. 1115290) RESULTING IN MULTIPLE LOSSES OF LIFE APPROXIMATELY SEVEN NAUTICAL MILE SOUTH OF PORT FOURCHON, LA IN THE GULF OF MEXICO ON APRIL 13, 2021**

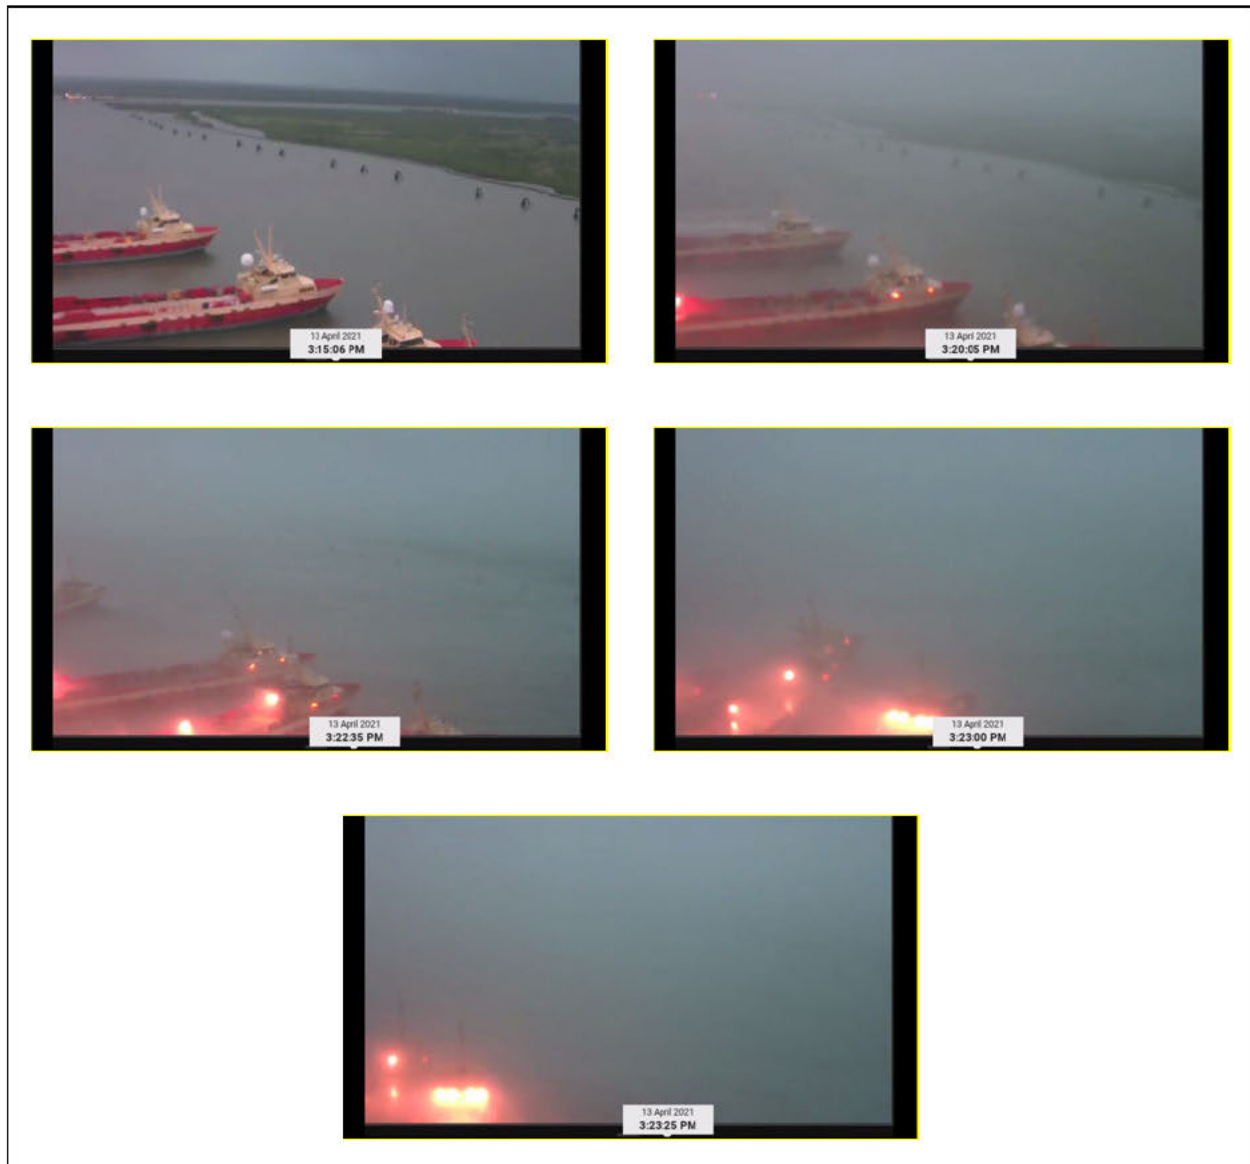
Figure 8: Images from C-Port Drydock Camera

8.1.30. At 1521, C-Port Drydock West camera recorded the arrival of a second, stronger squall.<sup>16</sup> The HOS Port North Yard camera, 100 yards west of C-Port Drydock, also recorded the arrival of the second squall. That camera showed zero visibility at the peak of the squall, and recorded intense winds for 108 minutes, or 1 hour and 48 minutes.<sup>17</sup> At 1522, the second squall reached the camera at the Baroid Dock in Bayou Lafourche, 1.5 miles south of C-Port Drydock. The squall was moving south, toward SEACOR POWER.<sup>18</sup>

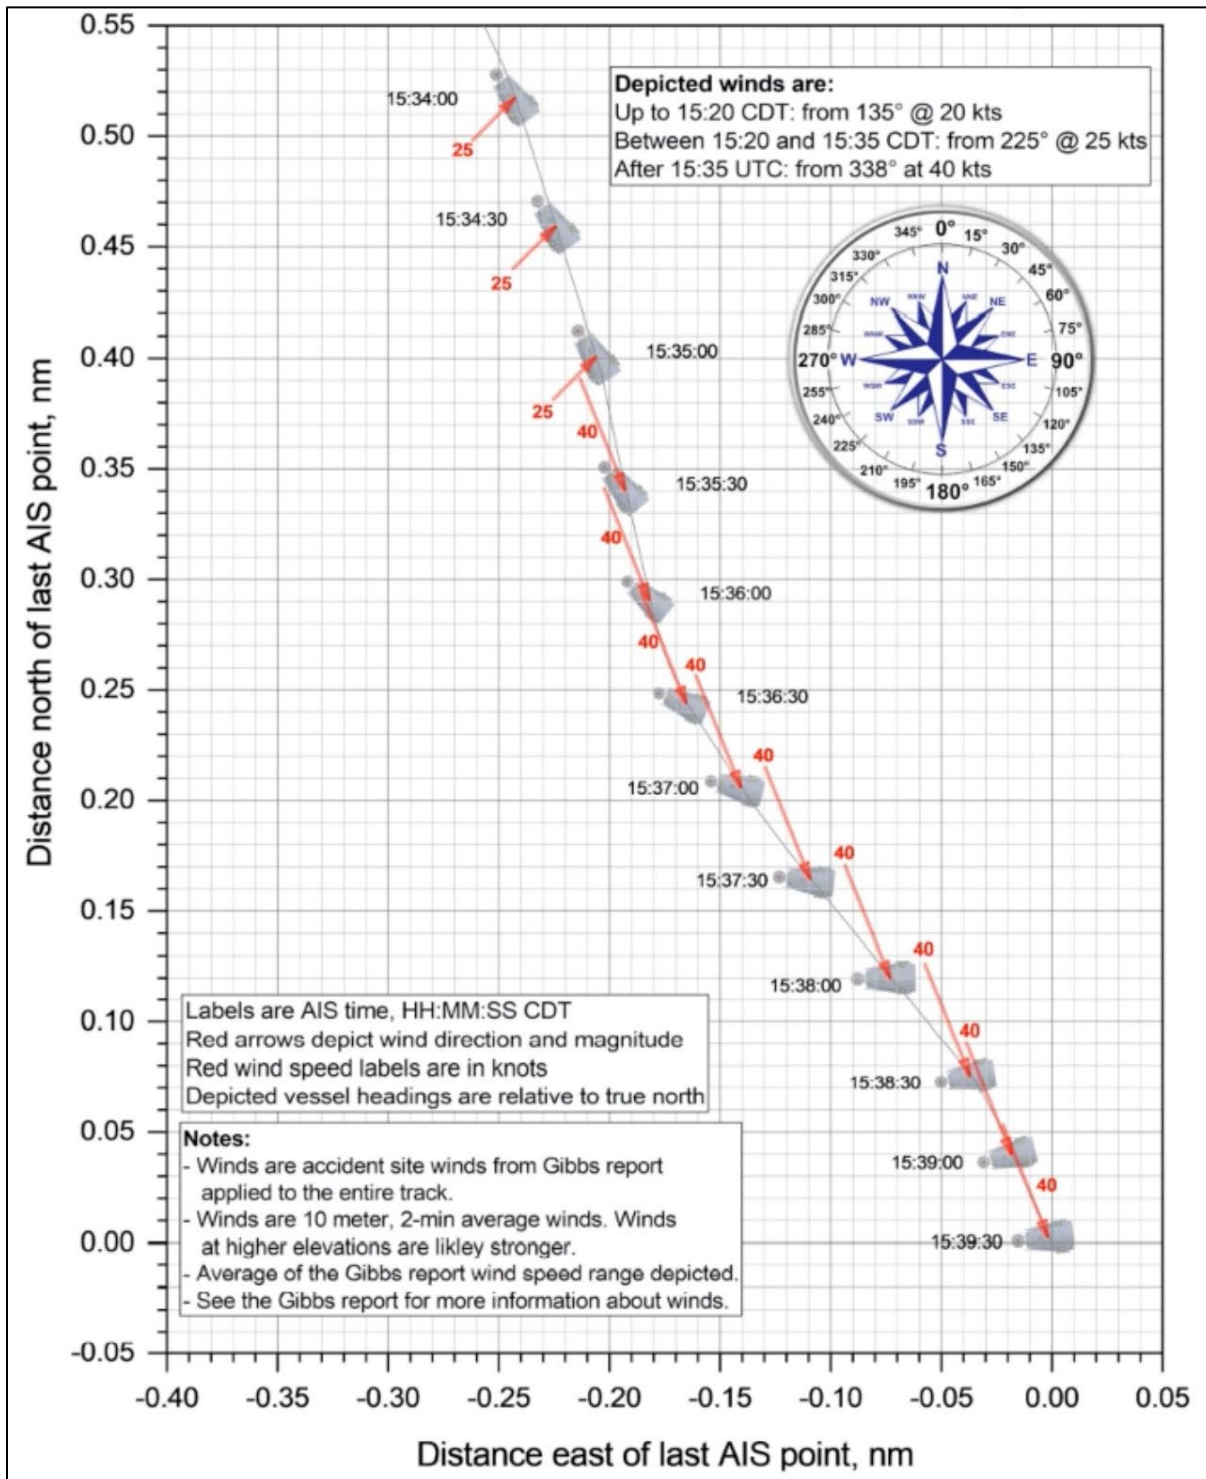
Figure 9: SEACOR POWER's final AIS transmission locations and headings with wind speeds from Exhibit 249 (provided by NTSB)

- 8.1.31. At 1530, the ROCKFISH Master observed wind speeds of 30 to 35 mph that increased to 95 mph.
- 8.1.32. At 1532, SEACOR POWER encountered the second squall. The First Mate observed white-out conditions, and the visibility reduced from 5-6 miles down to approximately 100 yards (about the length of the vessel). Between 1532 and 1534 the vessel's speed increased from 6 to 8.5 knots.<sup>19</sup>

8.1.33. At approximately 1535, SEACOR POWER's First Mate disengaged the inboard engines and engaged the power take off (PTO) for the hydraulic system connected to the vessel's legs. His intention, as discussed with the Master, was to lower the legs to the seafloor in order to arrest the vessel's movement, a term called "soft tag". As the First Mate lowered

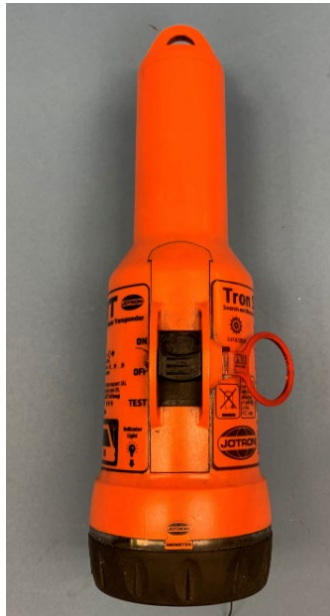
Figure 13: Image of SART aboard SEACOR POWER (Exhibit 154)

pocket knife. Between 1539 and 1830, the First Mate saw four vessels pass by, but none of the vessels' crews saw him. He caught the attention of the crew aboard the fifth vessel. Throughout his time in the water, the First Mate held the SART above the water. He held onto the SART's antenna (narrow end) and had the body (wide end) on top. He saw the SART's indicator/activation light illuminated.

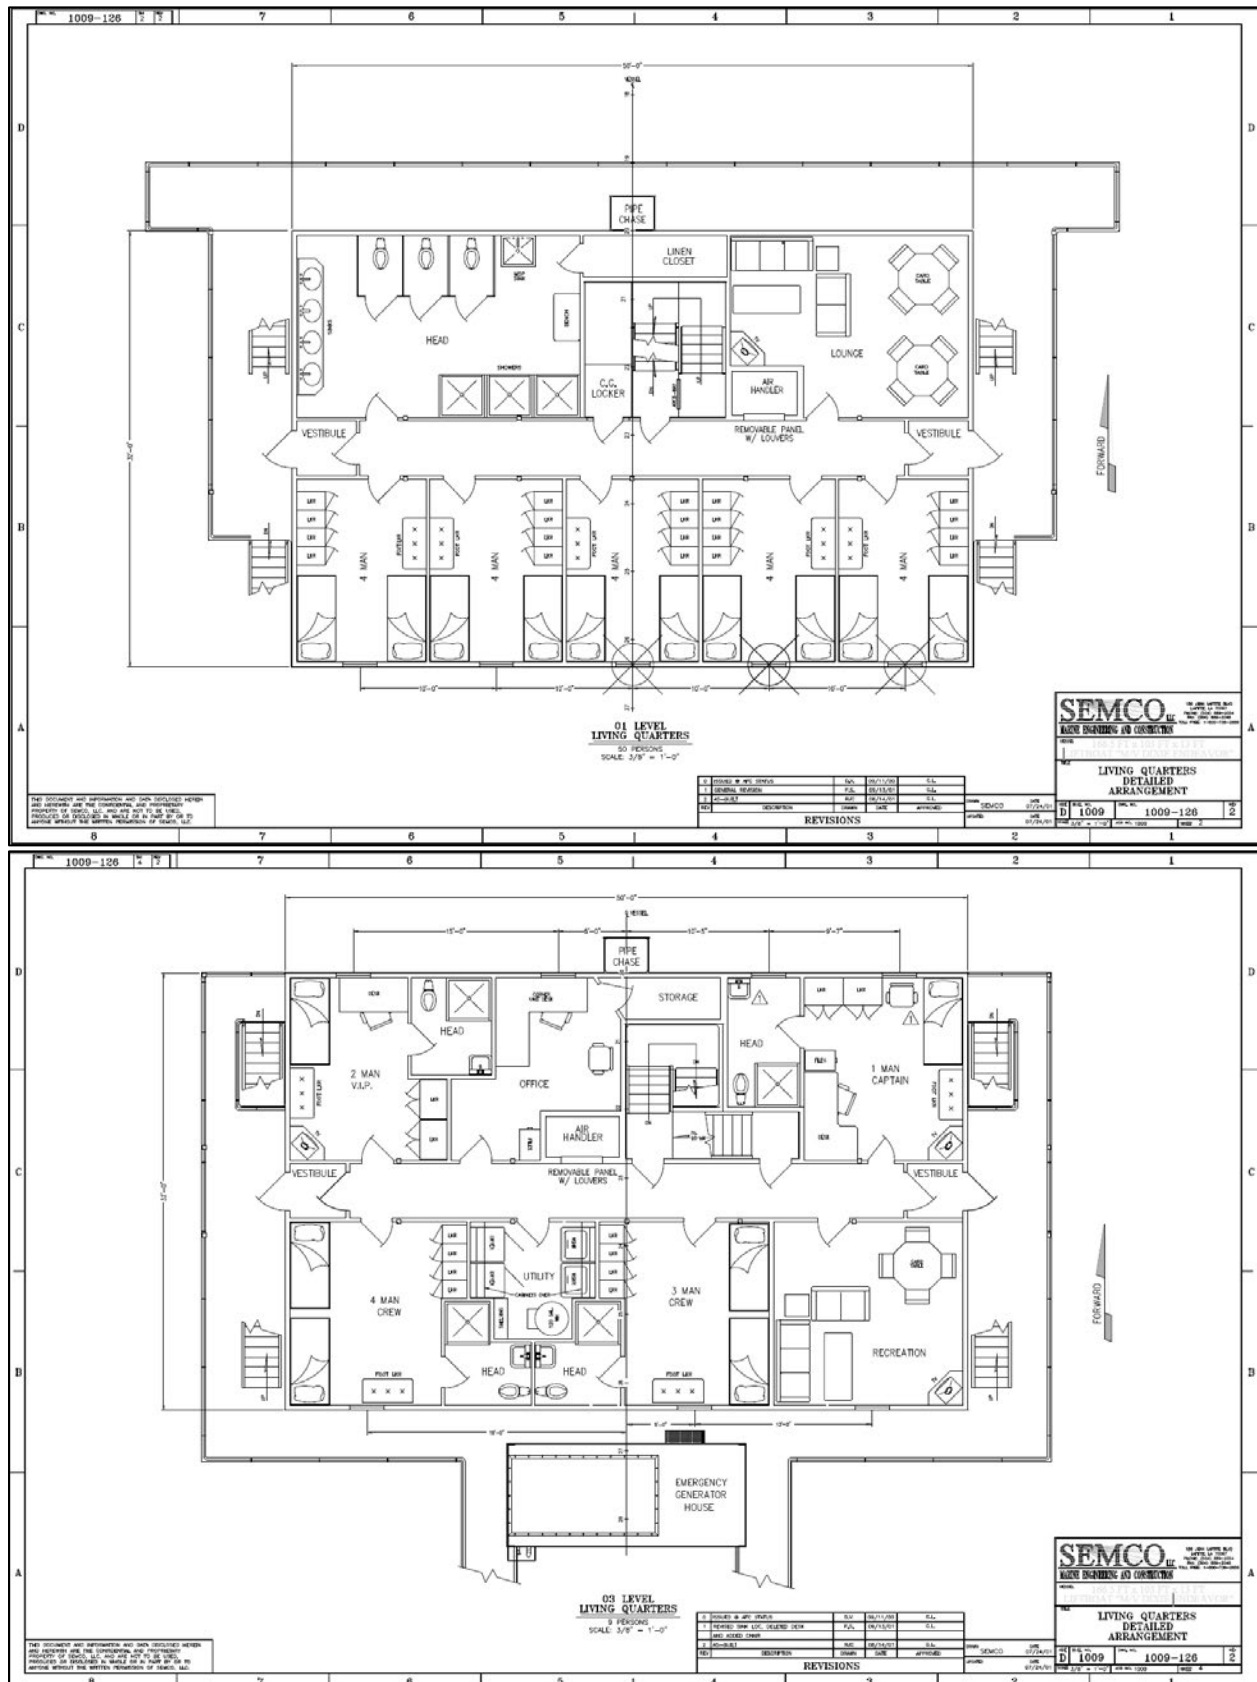
Figure 14: Living Quarters Arrangement on SEACOR POWER 01 Level (top, Exhibit 94) and 03 Level (bottom, Exhibit 96)

8.1.41. A/B 1 climbed up the ceiling in the 01-level passageway (hallway) to the portside exterior door, where A/B 3 pulled him out onto the port side of the deckhouse/superstructure. Neither A/B 1 nor A/B 3 were wearing a lifejacket.

- 8.1.42. Cardinal Worker 2 tried to find a lifejacket in his stateroom, but he did not find one. He crawled out of his room, via a crawlspace in the ceiling, and into the hallway. He saw the hallway was flooded with seawater up to the centerline (about halfway) and opened the hallway door. Cardinal Worker 2 then climbed back into his stateroom once Cardinal Worker 4 broke the window and exited.

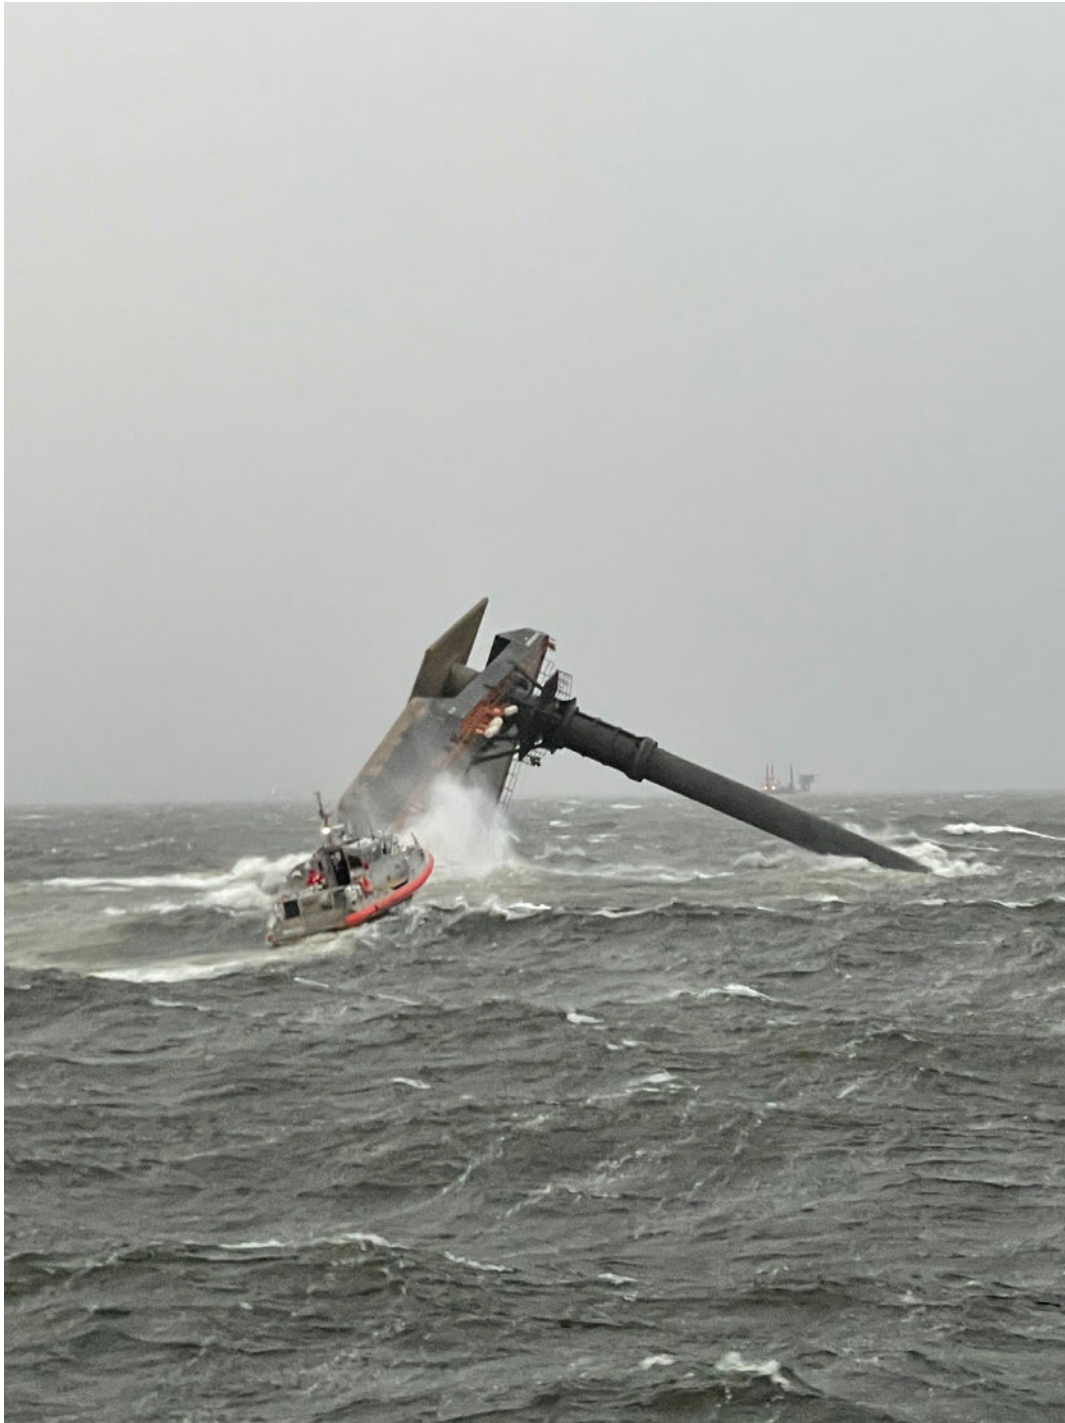
Figure 17: Image of capsized SEACOR POWER from April 14, 2021

- 8.1.36. At 1537, SEACOR POWER capsized to starboard.<sup>20</sup> The First Mate grabbed onto the port side pilothouse door as the vessel rolled. He saw the Master fall through the starboard pilothouse window. The First Mate attempted to signal distress. He pressed a button on the GMDSS console until he heard an audible beep.
- 8.1.37. Data from the Automatic Identification System (AIS) indicated that at 1537, Fishing Vessel CAPT JACK II was transiting within one nautical mile of SEACOR POWER and Offshore Supply Vessel CAT ISLAND was transiting within 0.5 miles of SEACOR POWER. Liftboat ROCKFISH was jacked up at South Timbalier Block 24, 2.5 miles east of SEACOR POWER. Offshore Supply Vessel CHRISTIAN CHOUEST was located 4.5 miles west of SEACOR POWER.<sup>21</sup>

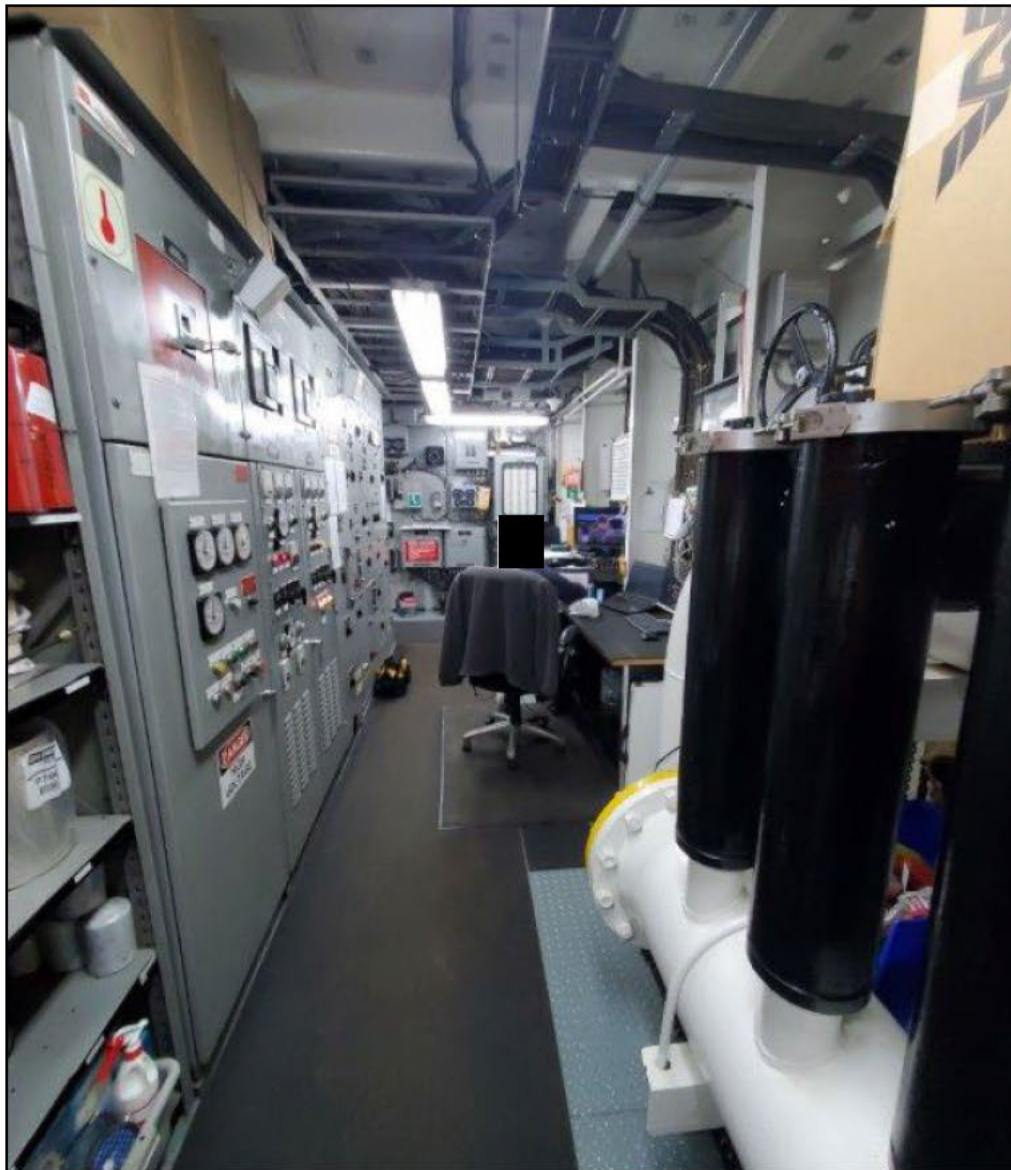
Figure 35: SEACOR POWER Engine Control Room (Exhibit 202)

- 8.7.45. The Off-Boat Chief Engineer stated that there were not any alarms to indicate flooding in the legs.
- 8.7.46. The Off-Boat Chief Engineer stated that there were two engine rooms on either side of the vessel, with the control room in the middle. There were watertight doors on each side of the control room. If he left the engine room and went out on deck he would close the watertight door. He said the watertight doors in the engine room had indicator lights on the bridge, and those lights showed whether the doors were open or closed. The First Mate stated the same thing. There were cameras in each engine room, with display monitors on the bridge.

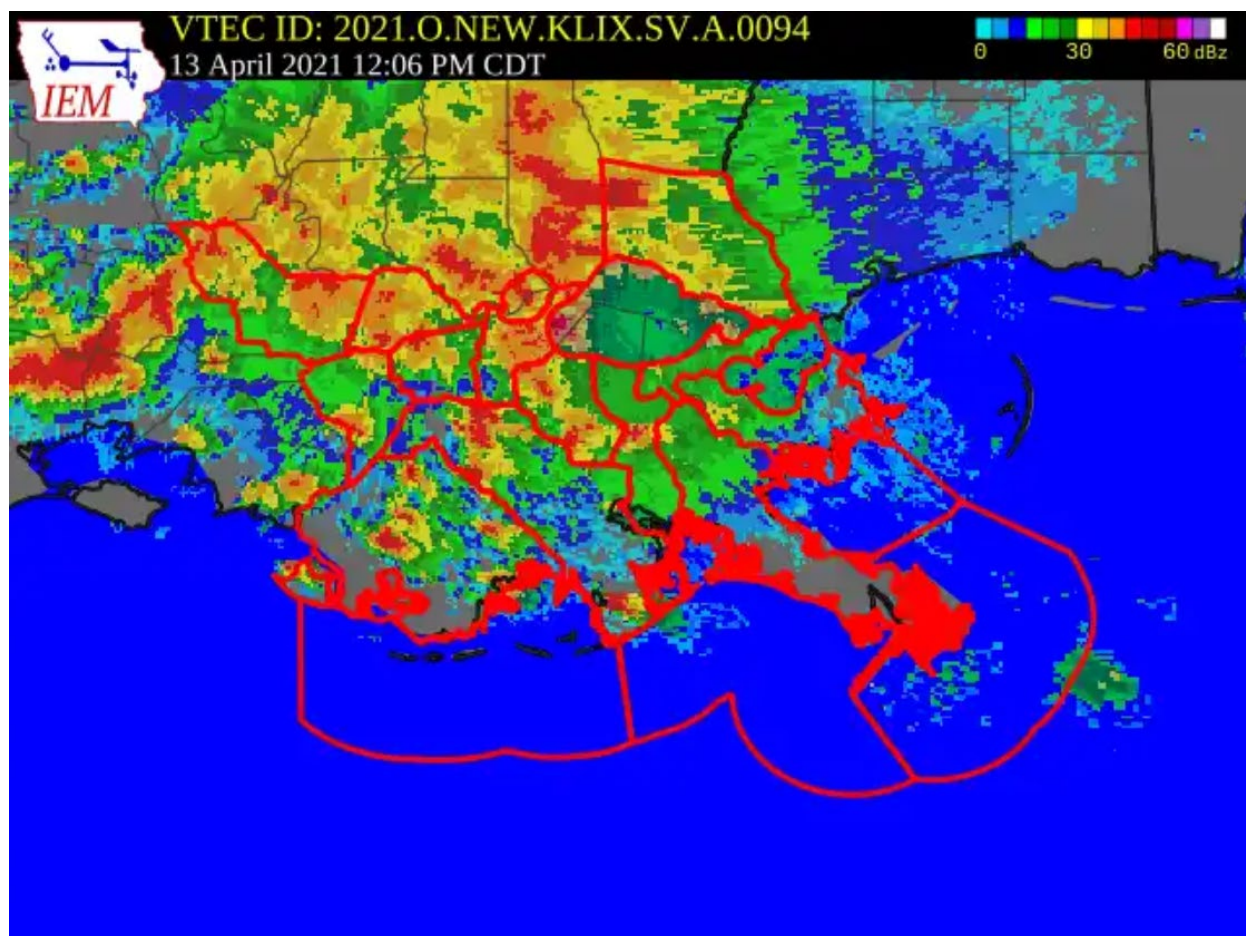
8.8.50. At 1205, the NWS's Storm Prediction Center in Norman, Oklahoma issued Severe Thunderstorm Watch Number 94. This watch pertained to portions of Southeast Louisiana and Coastal Waters. The latitudes and longitudes cited in the watch identified that the watch pertained to an area that covered from 40 miles northwest of New Orleans to 55 miles southwest of Boothville. The primary threats included scattered damaging wind gusts to 70 mph and scattered large hail events.<sup>188</sup> The NWS website stated that the Coast Guard broadcasted Special Marine Warnings and Marine Weather Statements on NAVTEX, but land based weather products, such as Thunderstorm Watches, were not on the list of products that the Coast Guard broadcasted via NAVTEX.<sup>189</sup>

Figure 39: Warning Zone for Severe Thunderstorm Watch #94

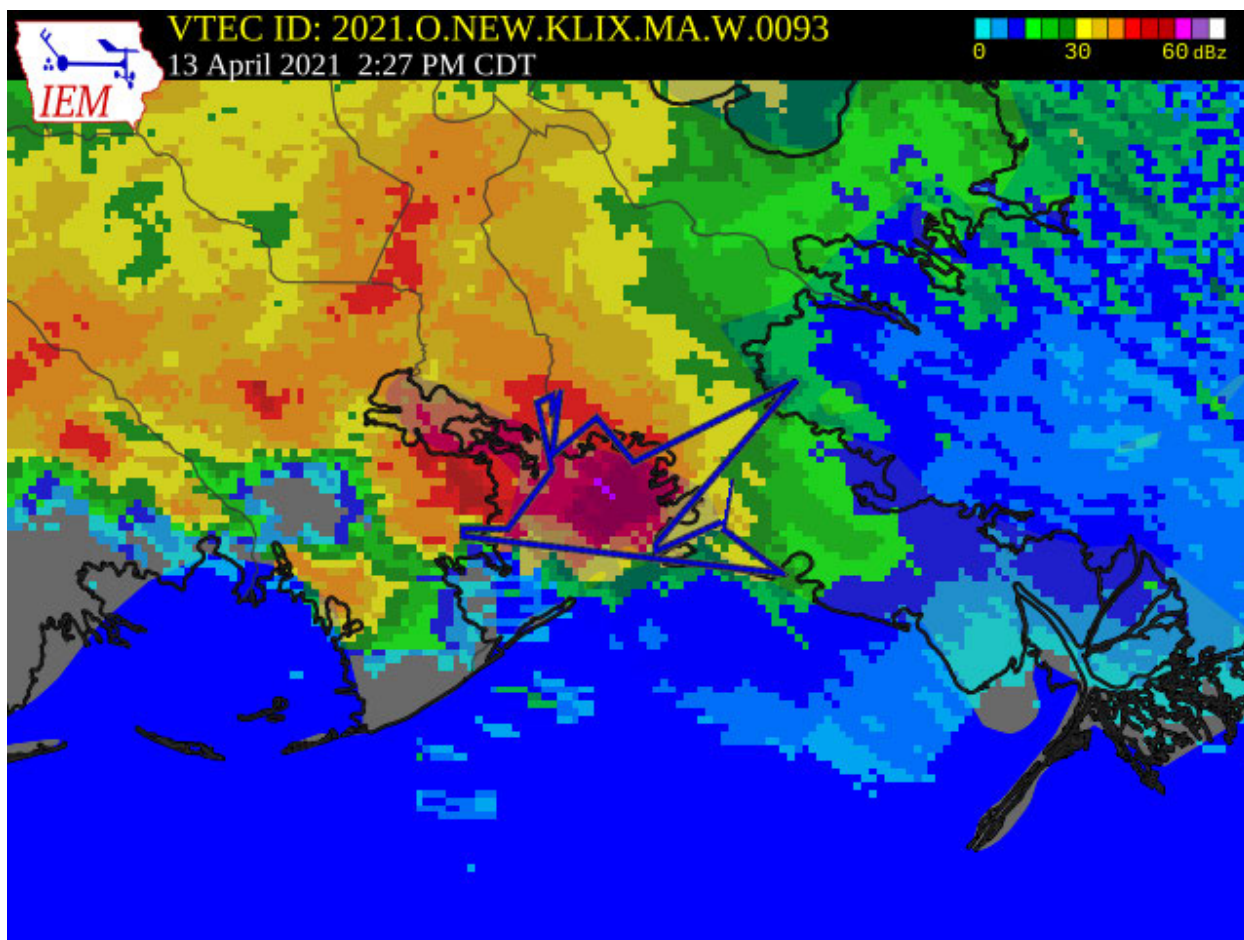
- 8.8.62. At 1427, the NWS issued a Special Marine Warning for Breton Sound, and for coastal waters, from Southwest Pass to Port Fourchon, out to 20 nautical miles. This warning noted a severe thunderstorm was located 9 nautical miles northwest of Barataria Bay (northeast of Port Fourchon), moving east at 15 knots, and impacting Barataria Bay. This did not apply to SEACOR POWER's location or planned trackline. The hazards included wind gusts of 34 knots or greater and large hail.<sup>195</sup> The Lead Forecaster stated that this warning was associated with the line of thunderstorms that was moving south. The warning pertained to the edge of the storm, which was actually moving to the east when the warning was issued. The western part of the storm was not as strong and did not warrant a warning at that time.

Figure 40: Applicable zone for and radar image Special Marine Warning issued at 1427 on April 13, 2021 (not for SEACOR POWER's location or intended location)

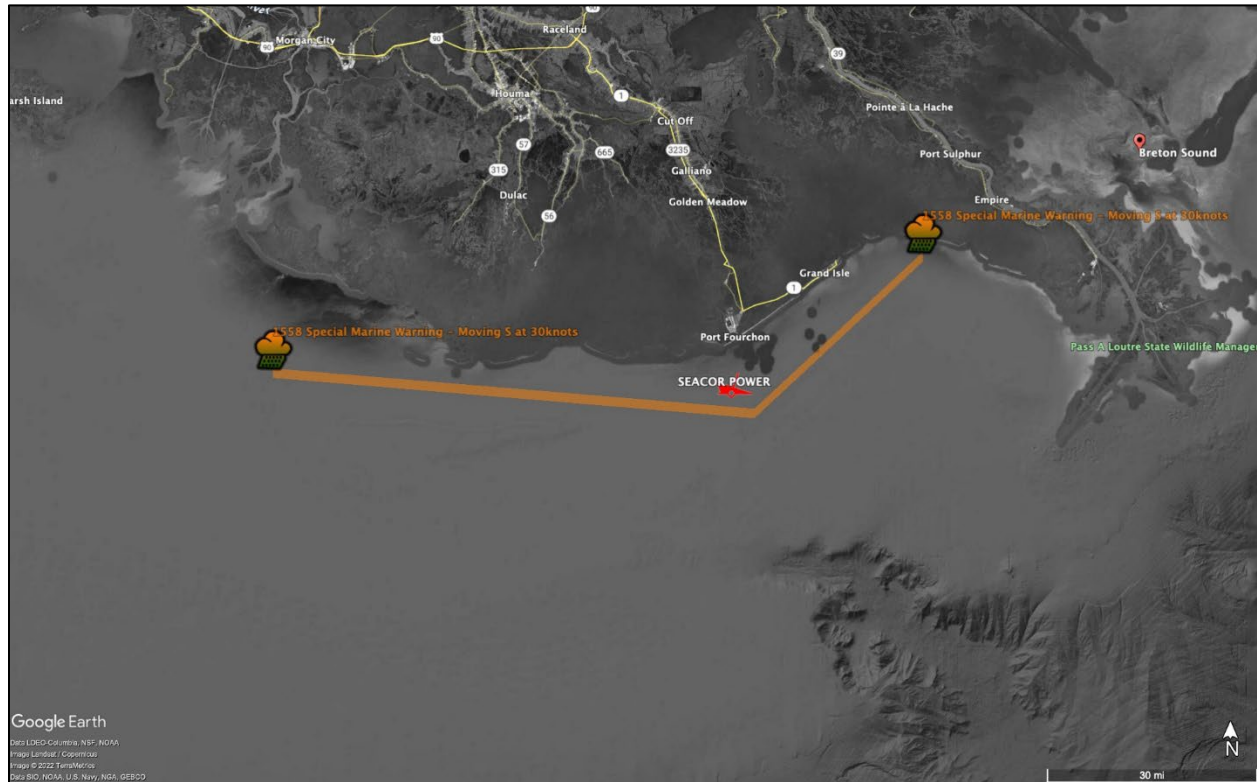
8.8.79. At 1558, the NWS issued a Special Marine Warning for coastal waters, from Southwest Pass to the Atchafalaya River, out to 60 nautical miles. This warning noted strong thunderstorms extending from 10 nautical miles southeast of Barataria Bay, to seven nautical miles northwest of LOOP, to nine nautical miles east of Eugene Island 105, moving south at 30 knots, and impacting the LOOP. This warning noted that the line of thunderstorms had already moved to the south of SEACOR POWER's location. The hazard associated with this line of storms was wind gusts 34 knots or greater.<sup>215</sup>

Figure 44: Plotted line of thunderstorms from NWS Special Marine Warning at 1558 showing the line south of SEACOR POWER

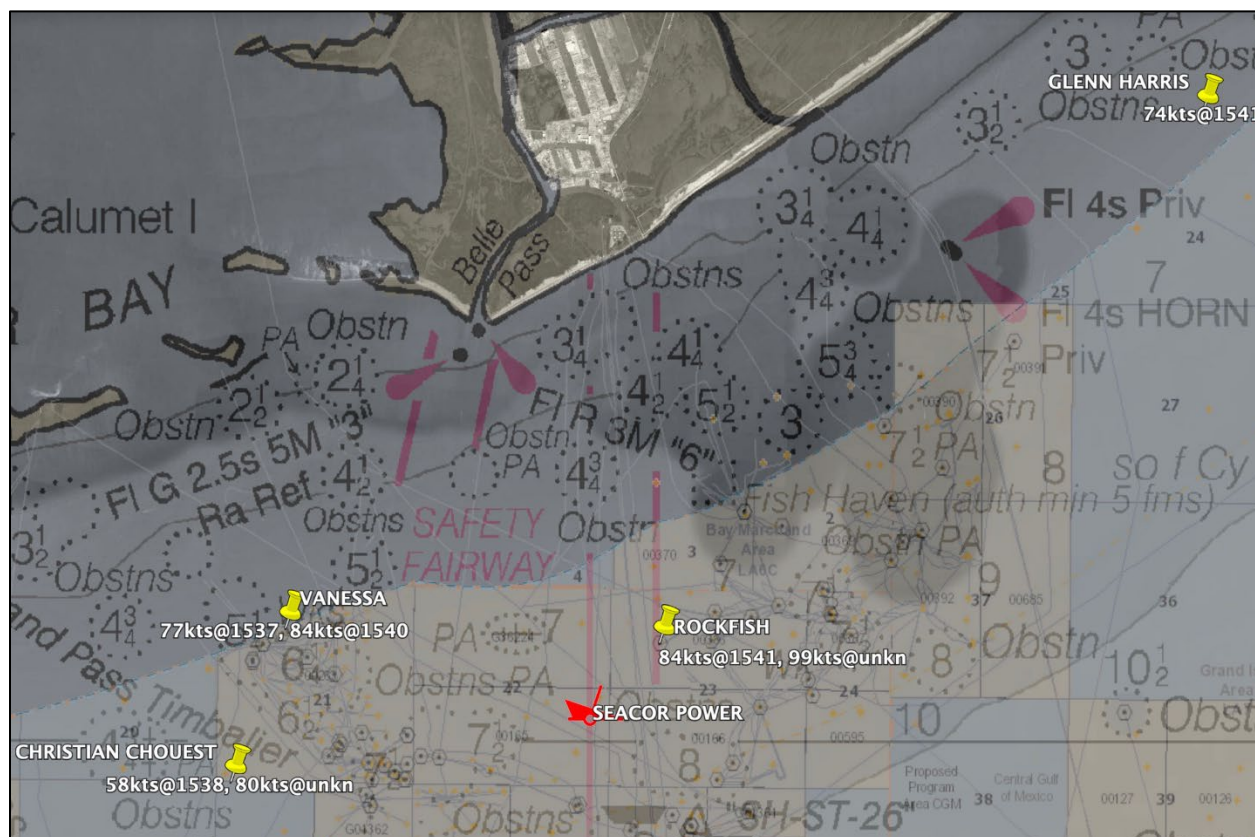
Figure 45: Wind speed observations near the capsized time, normalized to a 33 foot height above sealevel

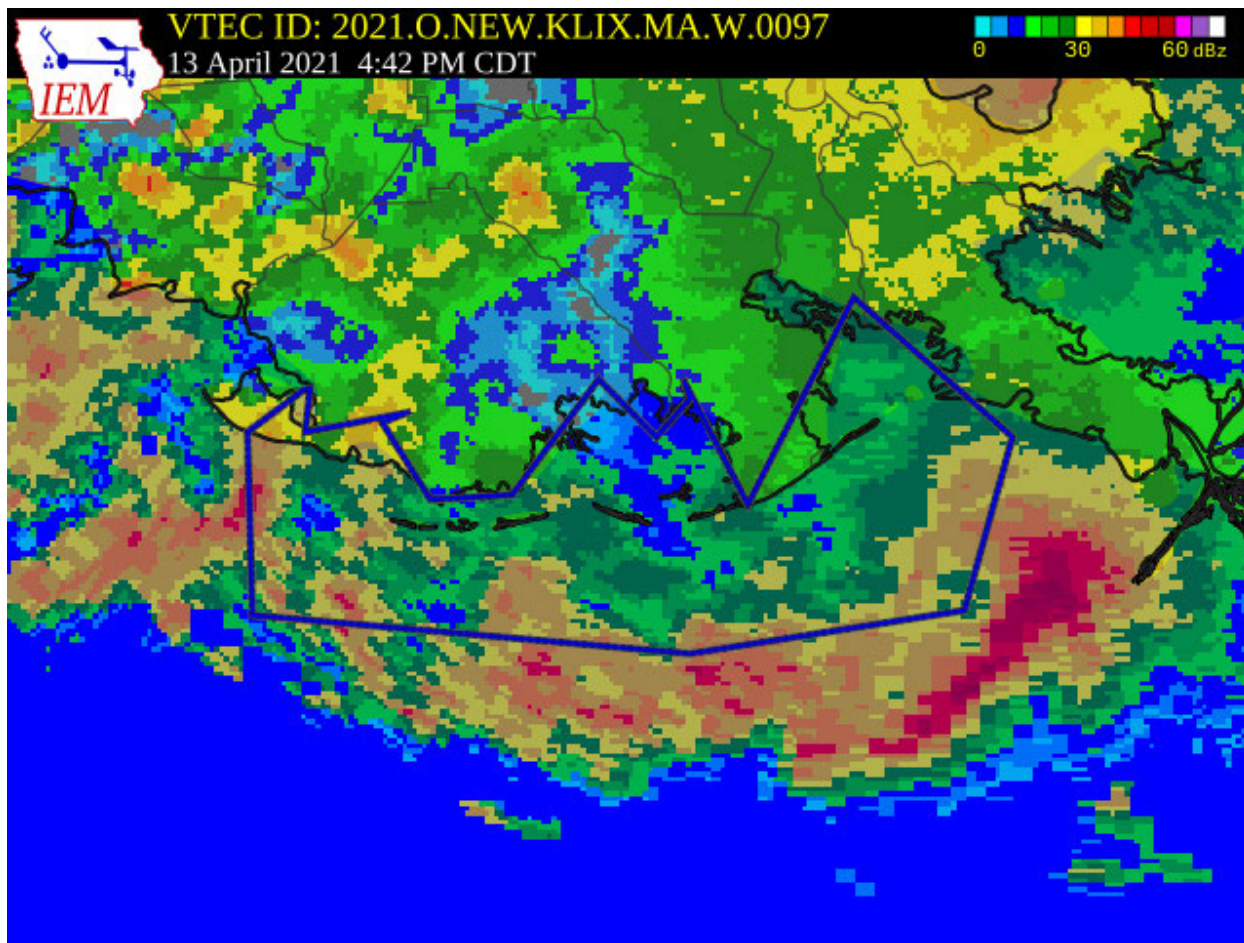
noted strong winds (34 to 50 knots) behind a gust front that extended from six nautical miles east of Barataria Bay, to eight nautical miles southeast of Timbalier Bay, to nine nautical miles south of Point Au Fer Island. The NWS obtained the information to generate this warning from buoy data.<sup>222</sup>

Figure 46: Applicable zone and radar image for Special Marine Warning issued at 1642 on April 13, 2021

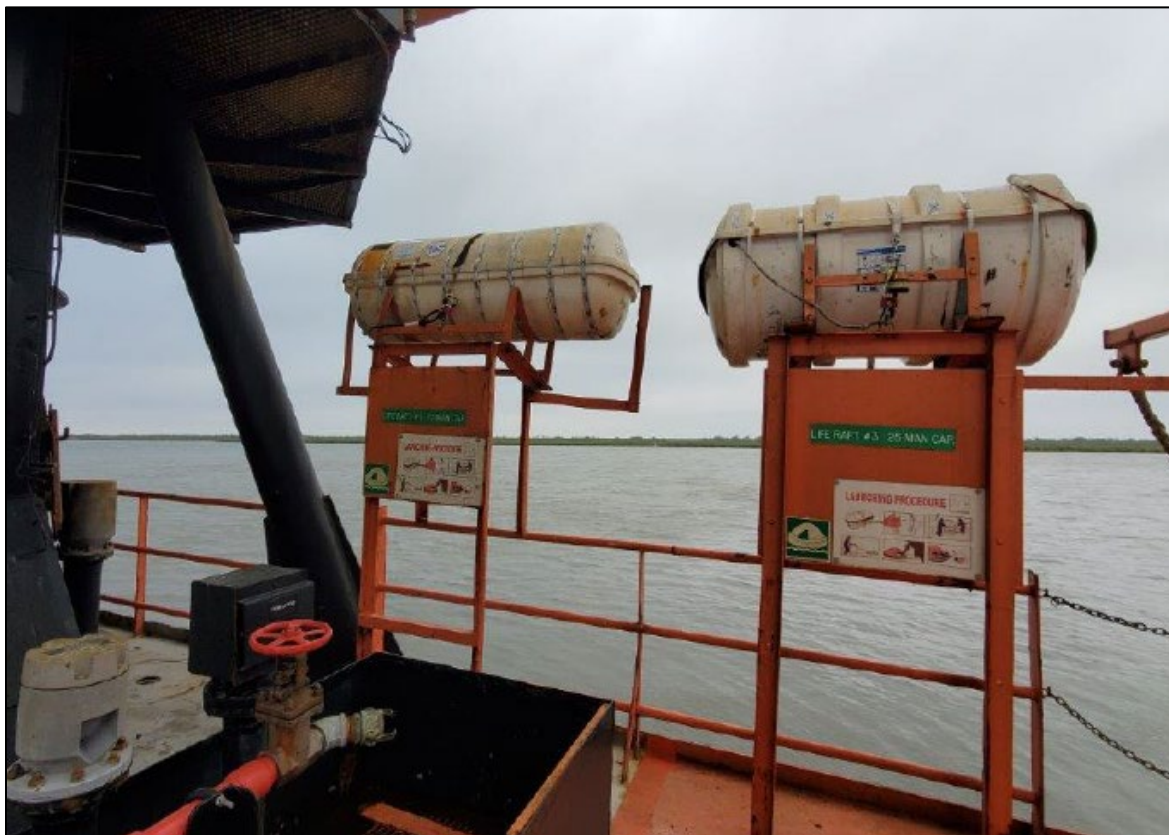
8.9.2. SEACOR POWER's inflatable liferafts were stored on the main deck, aft of the forward legs and around amidships. There were three on each side, and the total capacity of all six liferafts was 150. All of the liferafts were up to date on their life raft servicing.<sup>232</sup>

Figure 47: Liferafts stowed on SEACOR POWER (Exhibit 202)

- 8.9.3. During the capsizing, the three liferafts on the port side remained in their racks. The crew did not manually release these port side liferafts, and the rafts were not submerged, so they were not automatically deployed by the hydrostatic release. They remained up and out of the water, and they were still secured on the vessel, in their cradles, the morning after the incident. One of the liferafts on the starboard side released and was observed next to the boat on the morning of April 14<sup>th</sup>.

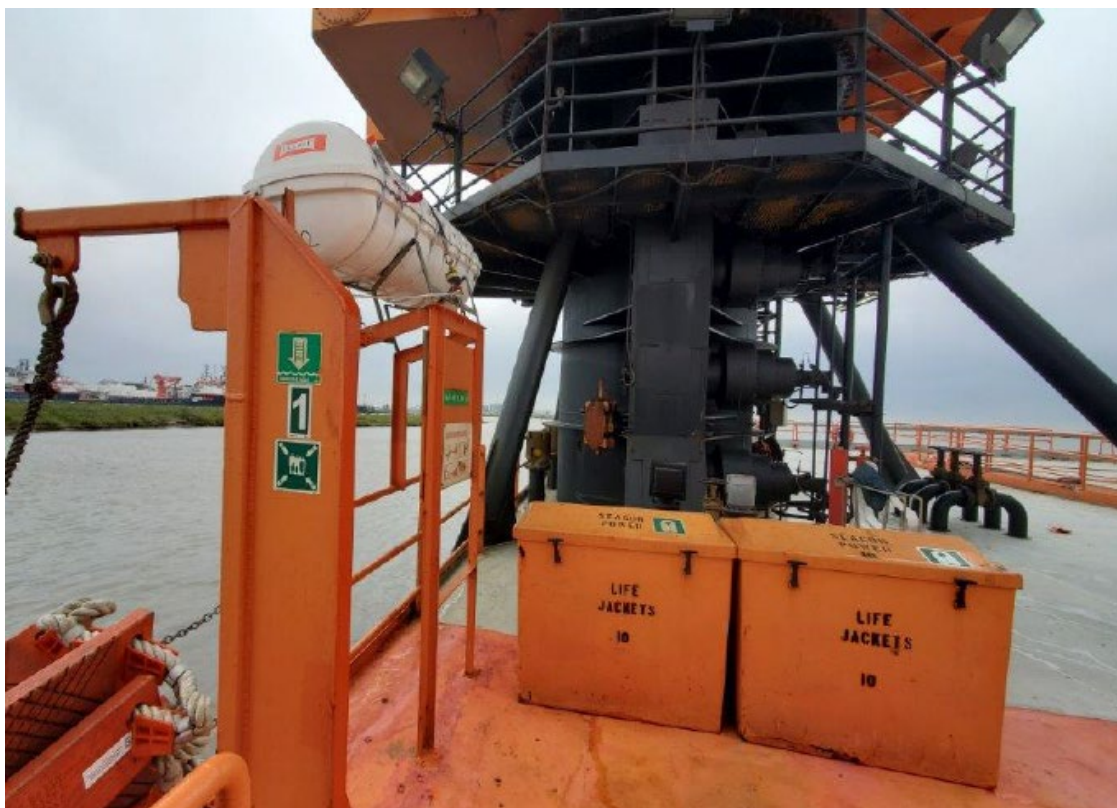
- 8.9.10. The First Mate stated that there were lifejackets stored on SEACOR POWER's bridge. The Off-Boat Master said that the vessel had lifejackets stored in each stateroom. He also stated that the vessel had two boxes of lifejackets at the muster station, which was on the main deck. These two boxes were in addition to the required complement of lifejackets. The extra boxes were not for use while underway; they were tied up and secured on the 01 level of the house while the vessel was underway.
- 8.9.11. A picture of the extra lifejacket boxes, taken on February 17, 2021, showed that each box held 10 lifejackets.

Figure 49: Extra lifejacket boxes (Exhibit 202)
