UNITED STATES COAST GUARD

**REPORT OF INVESTIGATION INTO THE
CIRCUMSTANCES SURROUNDING THE MULTIPLE
RELATED MARINE CASUALTIES AND
GROUNDING OF THE**

MODU KULLUK

ON DECEMBER 31, 2012

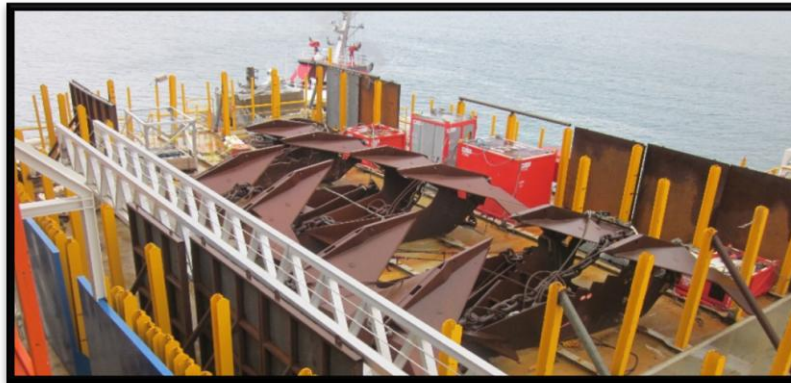
30. While not addressed in the towing plan contingencies, the KULLUK was equipped with a 15 ton “LWT” type survival anchor and the associated diesel powered anchor windlass, chain (900 feet) and ground tackle used to secure the anchor in the stored or deployed position. The additional 5 anchors specified in the plan (see above) were stored on the rig and would require the use of the onboard crane(s) for deployment. As such, they would only be available for mooring in sheltered waters or in favorable weather conditions due to the limitations in using the cranes in a higher sea state.

Figure 7: Five anchors stored aboard the KULLUK before transit. These were for use when the towing operation reached the Seattle Area while the KULLUK awaited dock space availability. (USCG Photo)

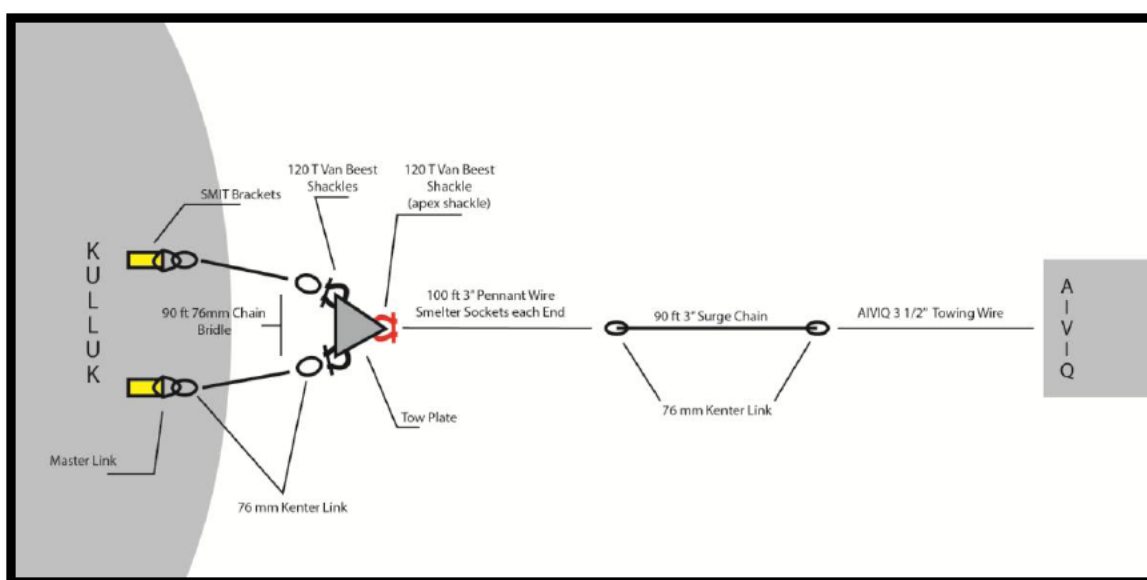
Figure 11: Diagram of towing configuration utilized in the KULLUK/ AIVIQ tows throughout 2012. (USCG developed)

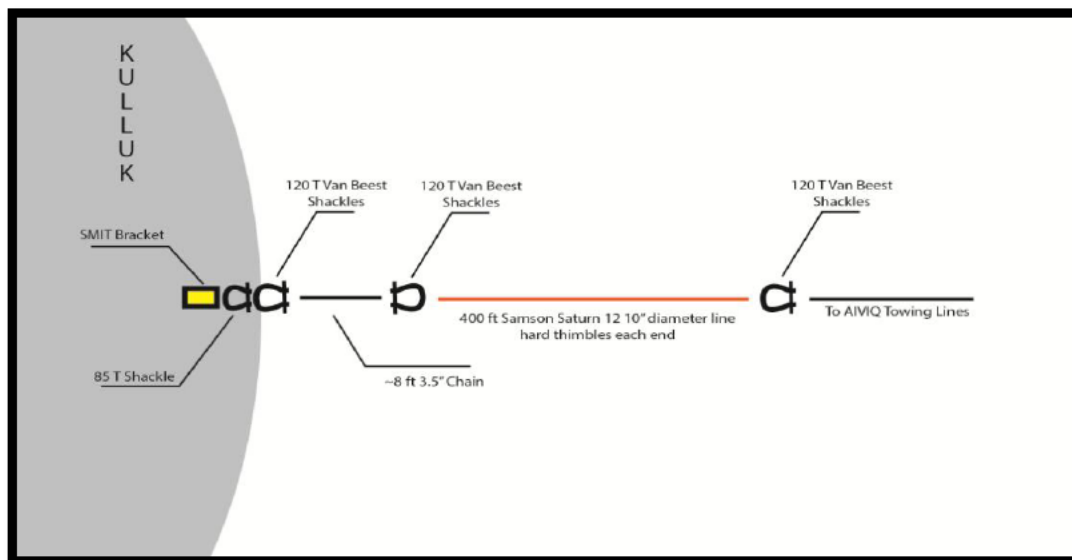
41. The KULLUK was equipped with an emergency towline, designed for use should the primary towing configuration fail. Figure 12 is based upon the actual configuration of the emergency towline configuration for the tow of the KULLUK in December 2012 as detailed in testimony from vessel crewmembers and inspection of the equipment utilized. At the terminus end of the Saturn® 12 line there is an eye with a thimble³⁷ lashed into the eye. A shackle then connected the equipment to the assisting vessels towline. The emergency towline was configured so that it could be easily deployed by the KULLUK crew as necessary.

Figure 12: Diagram of Emergency Towline as designed for use when under tow. (USCG developed)

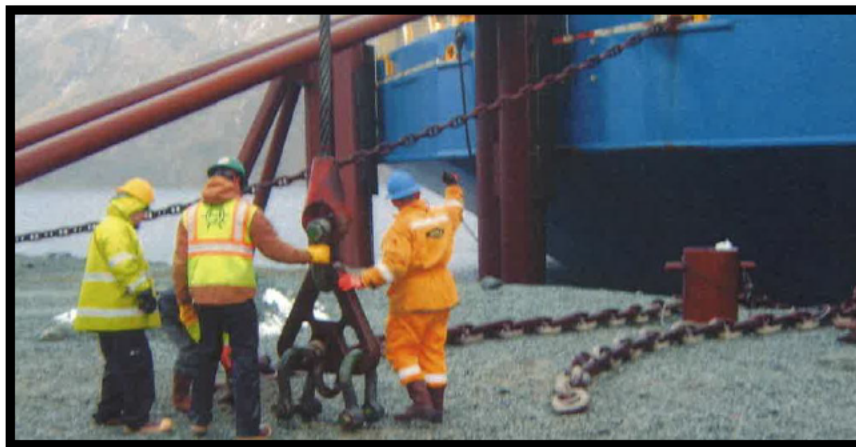
Figure 14: Preparing to Connect the Towing Plate to the Bridle Legs (Photo courtesy of GL Noble Denton, Mr. █████)

62. Using an OSI yard crane, the towing plate was maneuvered using the connected pennant wire and shackle as to allow shore side personnel to connect the two bridle chains to the towing plate, by way of shackles. Locking nuts were placed on the shackles and they were properly secured with cotter keys. See Figure 14. Once the shackles were connected, the towing configuration was raised by KULLUK's cranes into a standby position for connection to the AIVIQ once away from the dock.

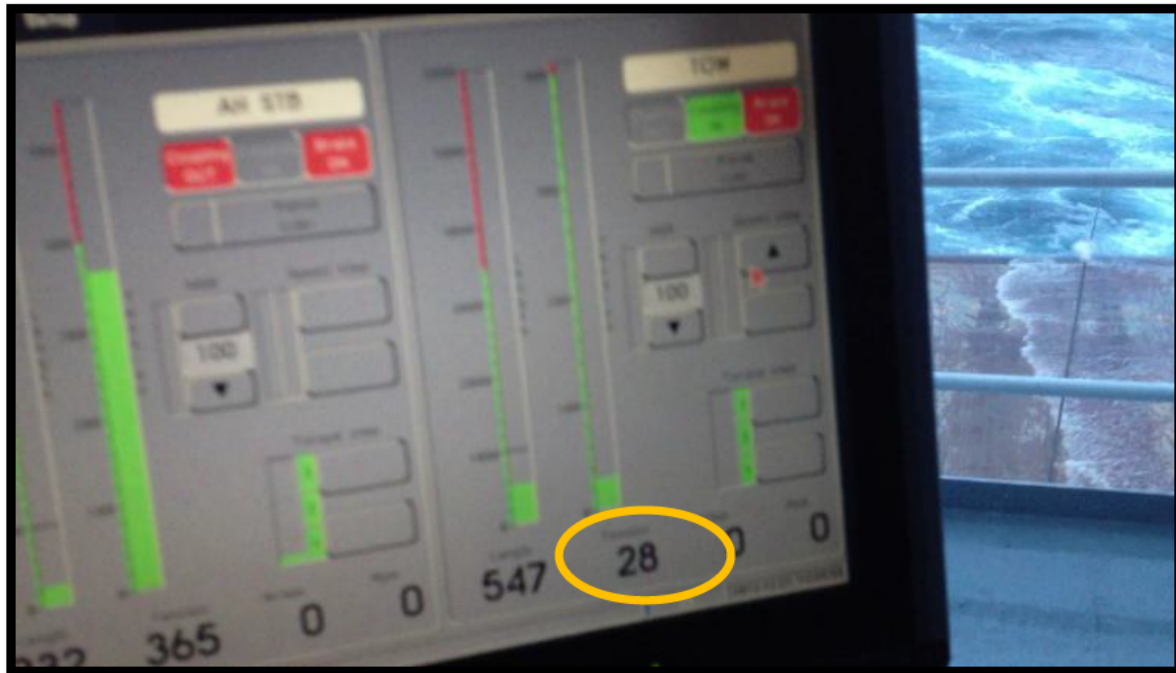
83. The 3rd Mate, Mr. ██████ took a cell phone video of the tow from the winch control station located in the after portion of the AIVIQ’s pilothouse during the morning hours of December 27, delivering this data to investigators during the formal hearing. The video shows the AIVIQ’s main deck, towline and KULLUK under tow. The video also pans down to show the winch control computer monitor, which displays the length and tension of the main tow wire. As the video shows the strain tension cycling up and down, displayed as a graph and numerically, ██████ states “*of course I’ll have to sit here and wait an [expletive] hour for this now.*” With the towline slack coming off the stern rollers on the AIVIQ’s back deck, the tension reading shows 35 tons. It then rapidly rises, as seconds later the tension from the towline increases to a maximum of 228 tons. As the tension reading increases quickly from 35 to 228 tons, he adds “*Here we go.*” Finally he adds “*That is a good quality piece of wire.*” The tension quickly falls to a low of 28 Tons. The video also shows that the length of the AIVIQ’s main towing wire to be 547 meters (1,794 feet). While the exact time the video was taken is unknown, the daylight evident in the video indicates that it occurred following sunrise, which was 0953 hrs. Figures 18 and 19 contain screen captures of this video.

Figure 18: Screen capture from video showing tension reading of 28 tons on main tow drum. (Cell phone video screen capture provided by Mr. [REDACTED] AIVIQ Mate)

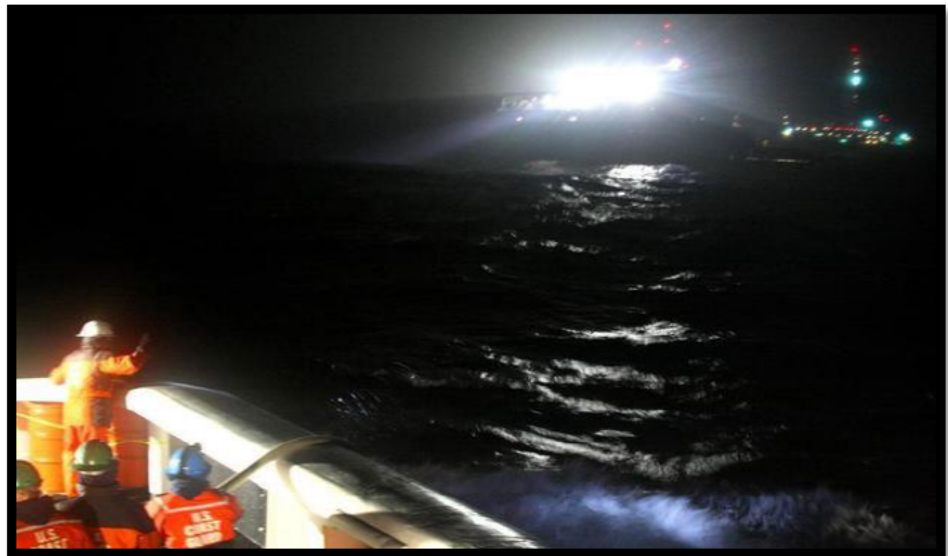
Figure 25: The crew of the USCGC Alex Haley attempt to pass the towline to the bow of the AIVIQ. Bright lights are located on the bow of the AIVIQ and the KULLUK is in the distance at the far right of the photograph. (USCG Photo)

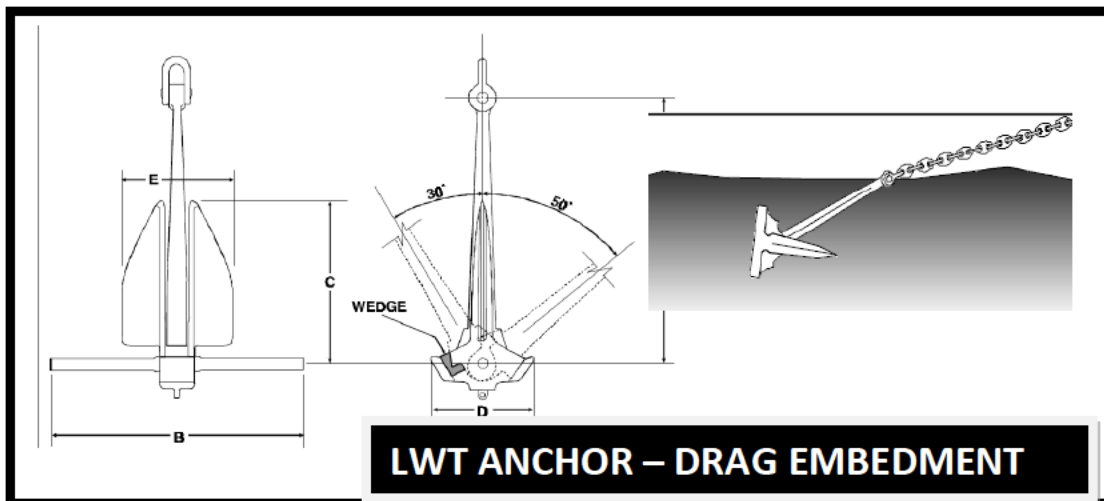
Figure 29: Diagram of a LWT anchor of a similar type carried aboard the KULLUK. The survival anchor was a 15 ton anchor. (Diagram U.S. Navy Towing Manual composite)

119. The KULLUK was fitted with one survival anchor which was fitted with the typical ground tackle for a ship's anchor such as hawsepipe, brake and securing device. The windlass for the anchor was located in a compartment on the KULLUK and the chain led out from the windlass onto the deck and then through a hawsepipe to the sea below. The anchor and windlass are located near the starboard quarter of the KULLUK, near the "stern" on the main deck in relatively close proximity to the helicopter deck area which was on the opposite end of the vessel from the main towing equipment, or the "bow" of the KULLUK.

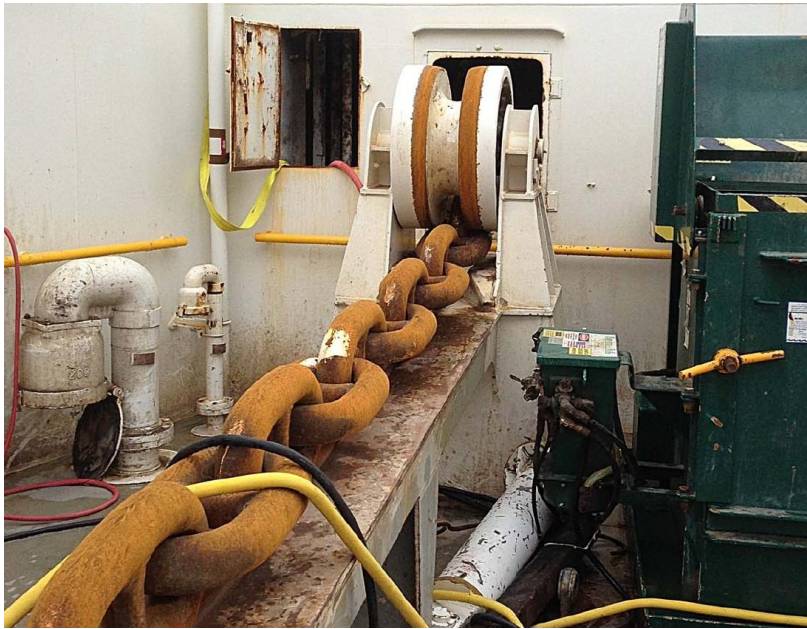
Figure 30: The anchor chain for the survival anchor leading out of the windlass room towards the hawsepipe. (Photo provided by Shell)

120. After the towing gear failure that occurred on December 27 the anchor was reported to have been dropped on two occasions. In one occasion this was as the result of a miscommunication between the KULLUK OIM and Tow Master and the crew of the KULLUK in a high stress situation. The anchor was released then quickly recovered. At this time the anchor was lowered to a reported depth of approximately two to three shots of chain or approximately 180 to 270 feet.

121. In the second occasion the OIM reported that the survival anchor was intentionally deployed to the bottom and was retrieved approximately six hours later. At this time the towing operation was near Albatross Bank a relatively shallower area of water 12-40 fathoms with a rocky bottom and areas of broken gravel. Nearer to the shore the water deepened with a mud bottom. According to the Van den Haak R study⁸² the LWT anchor is not ideal for coarse gravel or rocky bottom. When the anchor was retrieved the OIM reported that he believed the anchor was on the bottom and as evidence he said the last links of chain were “shiny” which he attributed to dragging on a rocky bottom. This statement is supported by HSE Technician [REDACTED] in his interview statement.

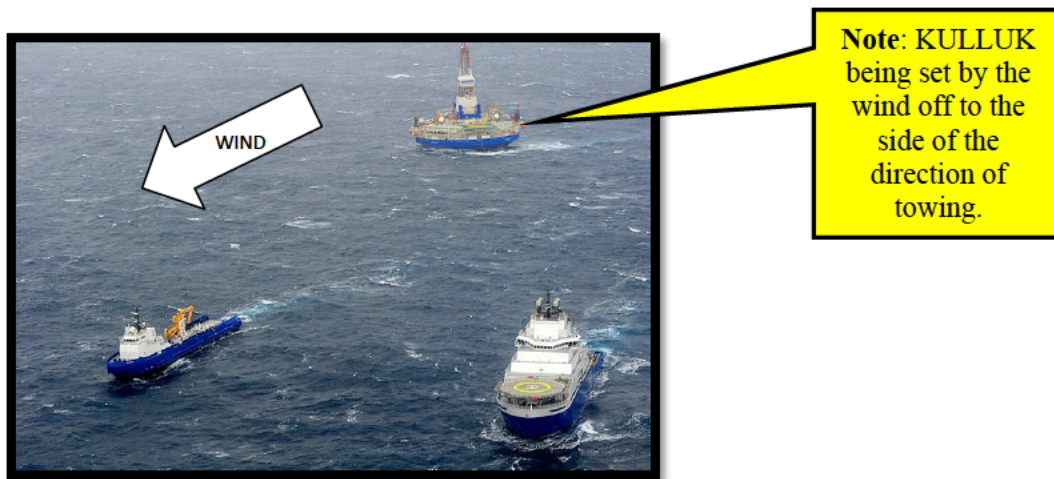
131. After daylight, the NANUQ successfully used a line throwing gun to pass a messenger line to KULLUK. This line was connected by KULLUK crew to the eye of the #8 mooring wire, which was in a sling on the main deck. Following connection, the NANUQ retrieved the #8 wire from the KULLUK and connected it to their 2 ¼ towing wire using a 150 ton shackle with

appropriate fastening. The tow was made fast at approximately 1130 hrs and the connection was made without surge or shock gear in the tow line. The grommet was not utilized at the request of the Tow Master because there was no testing or strength rating information available for this component. With the AIVIQ and NANUQ both towing the KULLUK, both vessels are able to make forward progress against the sea and wind conditions in a southerly direction, away from Sitkalidak Island.

Figure 32: NANUQ on the left and AIVIQ on the right side of the photo with the KULLUK under tow in the distance (USCG Photo)

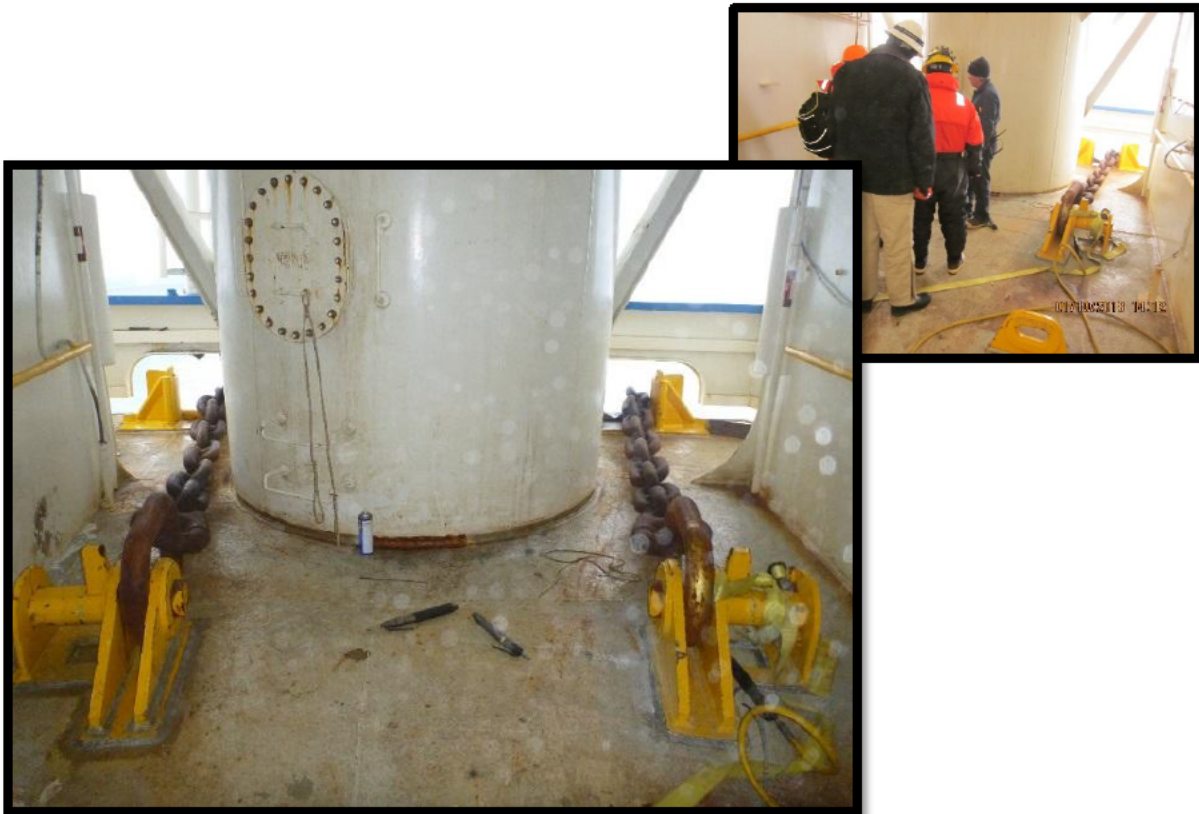
Figure 49: Photo of towing bridle connections to Smit Brackets (*USCG Photo*)

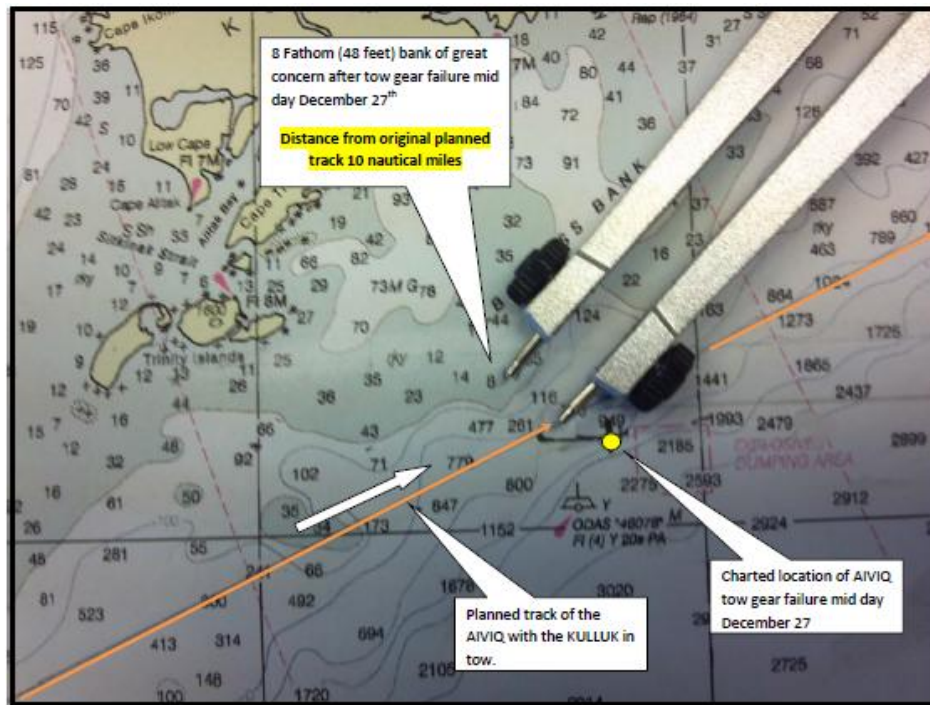
25. In hindsight, this route's proximity to shoal water and land masses proved to be a critical factor in the towing and response operations. At the time of the shackle failure, the KULLUK was approximately 40 miles from the closest point of the islands of Kodiak Island and less than 10 miles from Albatross Bank. The loss of the AIVIQ's engines and extreme weather moved the KULLUK north toward these hazards. This planned route denied the proper sea room necessary should a towline fail or the towing vessel experience a mechanical breakdown, particularly with no assistance or additional towing vessels onsite. Additionally, should the tow need to heave to in the event of a weather event, there was little safe water available to ride out storms.

Figure 50: Chart showing planned track line for towing of KULLUK demonstrating close approaches to land and other hazards. (USCG Developed)

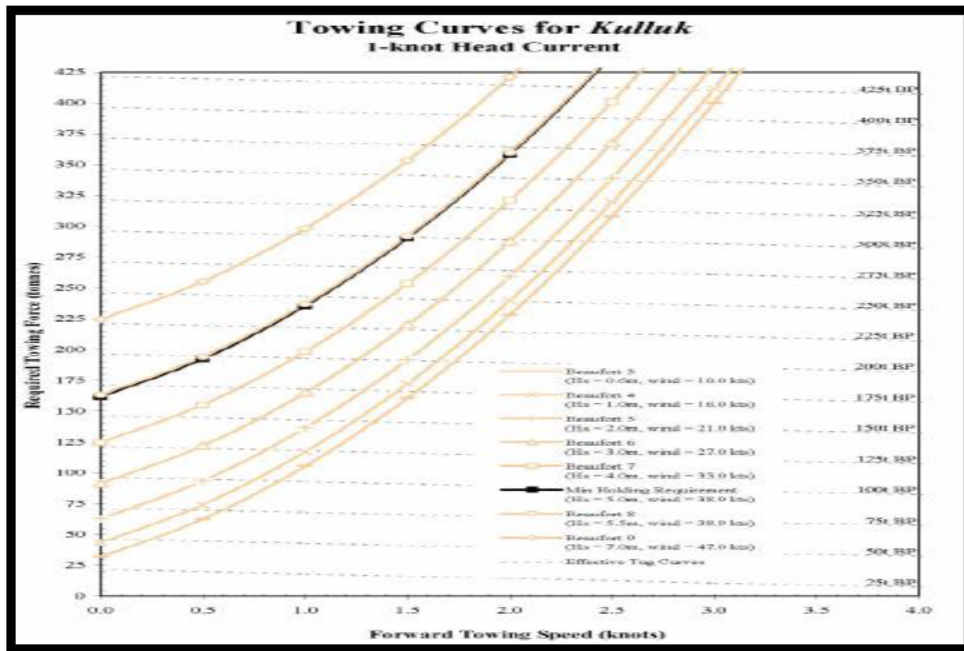
31. The 2010 study contains towing resistance curves for Beaufort 3 through 9 weather conditions. The 10% exceedance level for the December 2012 tow indicates 9.2 meter seas and 44.6 knot winds. These weather conditions are similar to Beaufort 9 storm conditions, being 2.2 meters above Beaufort 9 seas and 2.4 knots below Beaufort 9 winds. Referencing figure 52, extracted from the study, the bollard pull necessary to maintain position in a 1 knot current would require 225 tons of effective bollard pull by the towing vessel. Referencing the same document, a 200 ton effective bollard pull would be necessary under the same circumstances with no current. It should be noted that the prevailing currents along the southern coast of Alaska are out of the east, meaning that the KULLUK would most likely be towed into the current.

32. After analyzing the data, the AIVIQ would be capable of generally maintaining position with the KULLUK in tow during Beaufort 8 weather in 5 meter seas and 40 knot winds while encountering a 1 knot current, with all forces acting against the tow into the wind and seas. In weather conditions in excess of this standard, as predicted by the Metocean study, the AIVIQ could not be expected to maintain position, and would be pulled astern by the forces acting on the KULLUK. In the Alaskan maritime environment towing operations that are experiencing poor weather do at times allow themselves to be pulled astern until the weather subsides. These tow planners build sea room into the planning to allow for the weather. In the case of the KULLUK towing operation for December 2012, this would be an unacceptable risk considering the length of tow, the near shore routing, and the fact that, as the Metocean data suggests, this weather may occur over 10% of the tow transit.

Figure 52: Towing Curves (Tow Resistance) for the KULLUK with 1 knot head current as provided by Global Maritime 7/6/10 (Provided by Shell, Shell Alaska "Bollard pull calculations for Towing KULLUK from McKinley Bay to OSI South Reef Dock, Captains Bay, Unalaska Island, Aleutian Islands" GMH-6565-2575)

34. Given the Gulf of Alaska weather patterns, the practice of relating bollard pull requirements with anticipated weather, particularly for longer voyages where weather cannot be accurately predicted, is prudent for longer duration voyages. The application of additional bollard pull capabilities, among additional towing vessels also provides a level of redundancy in the event of tow gear or mechanical failures. In addition to these benefits, multiple vessels allow a "sharing" of towing gear loads, where in a worst case weather scenario, no vessel would be required to exert their full bollard pull capabilities to maintain control of the tow, reducing the stress on towing equipment utilized.

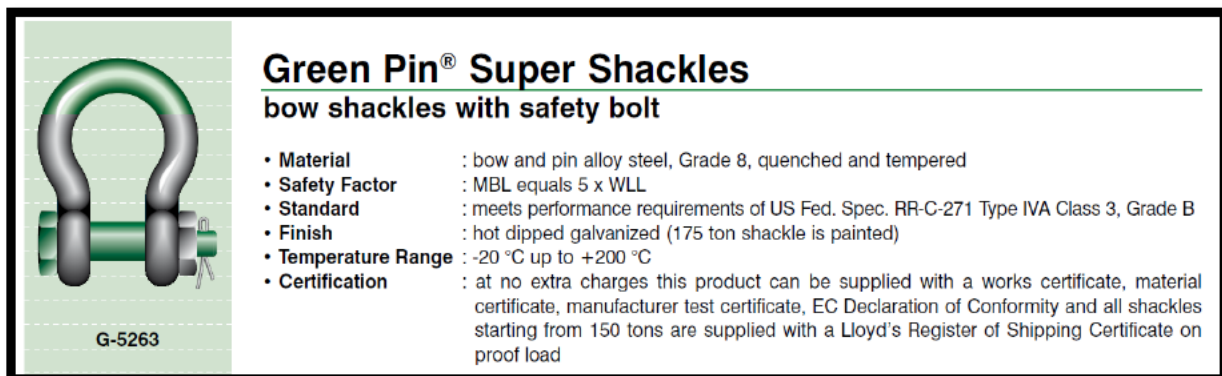
Figure 54: Description of Van Beest Green Pin Super Shackles from the manufacturer’s catalog. (*Van Beest product catalog available on the internet*)

38. The apex shackle that failed at approximately 1135 on December 27 has been identified as a Van Beest Green Pin Super Shackle.⁹⁵ It was one of six that were incorporated into the tow to replace the 85 ton shackles originally intended. As all the remaining 5 shackles were from the same "YP" manufacturing batch, it is assumed that the missing shackle is of that batch as well. During the investigation, Shell provided documentation that suggests that these "YP" batch shackles were purchased from Van Beest in 2007.⁹⁶ The work and usage history of the shackles could not be definitively ascertained, other than they were incorporated as part of the KULLUK towing configuration since July of 2012. Testimony suggests that these shackles may not have seen usage prior to this time.

“The Working Load Limit should be applied in a straight pull and overloads should not be applied. Side loads should be avoided as the products are not designed for this purpose and the application of a side load may significantly decrease product life. The Working Load Limit for the product corresponds to static use. In case of dynamic use (breaking, accelerations, shocks), the effective stress on the product increases significantly which can lead to product failure”⁹⁷

41. The Proof Load (PL) of this shackle is listed by the manufacturer as 240 tons, or twice the WLL. The U.S. Navy Towing Manual defines the Proof Load of shackles as “the load at which no permanent deformation is observed after the load is released.” Shackles are often tested to their Proof Load prior to distribution by the manufacturer, and Van Beest conducts such tests for all Super Shackles batches prior to sale.

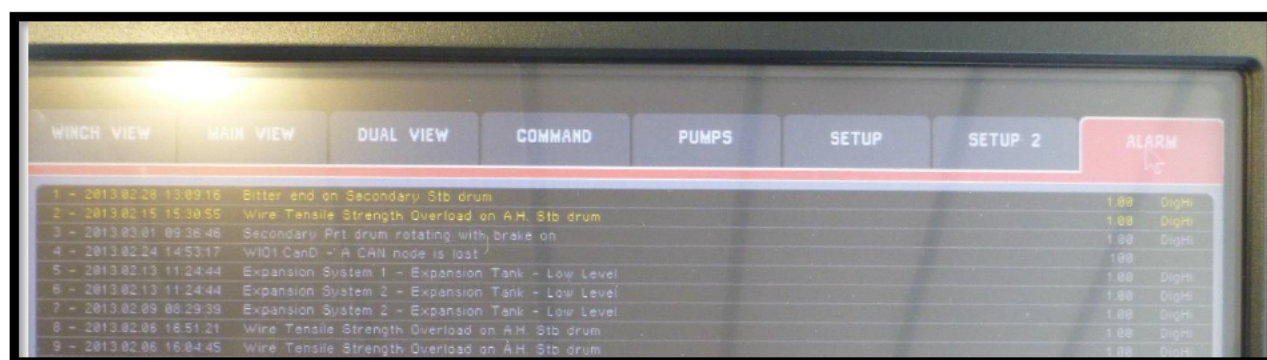
Figure 59: Towcon alarm screen indicating alarms received on the bridge monitor, requiring acknowledgement of the bridge officers. Alarms indicated are for a later time period than investigation scope. (USCG Photo)

69. The AIVIQ’s towing winch system contained an advanced computerized monitoring and control system manufactured by Rolls-Royce called the Towcon RT. This system contained a means to monitor strain/tension of the towline (in Tons), tow line length, hydraulic pressure, among others, and would alarm should any of the pre-set limits be exceeded. With respect to tension monitoring, the user could easily set any strain/ tension limit by which an alarm would be activated. No user set tension settings were established, and the only high tension alarm active was a manufacturer set alarm that would activate upon reaching 50% of the tensile strength of the main tow drum. The tensile strength was set prior to the voyage at 600 tons, indicating that the alarm would activate at 300 tons of tension. See Figure 58.

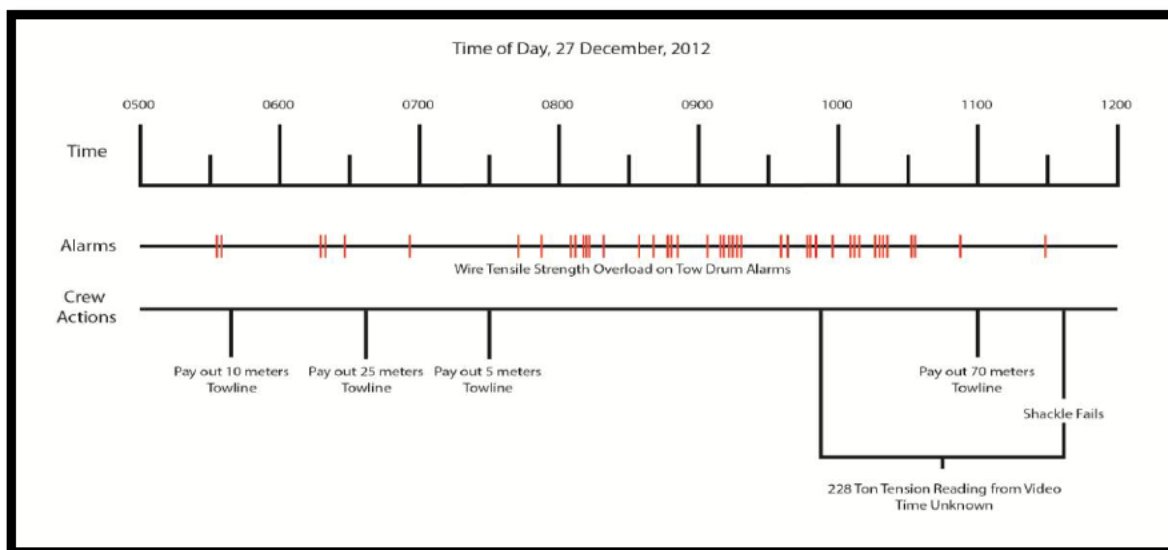
Figure 60: Summary of main towing drum data for the morning December 27, 2012 indicating time, alarms received towline length and shackle failure.¹⁰⁷ (USCG analysis)

76. The following figure was created to demonstrate the relationship between the Towcon alarm logs and actions taken in accordance with the vessel’s logs.

78. As configured, the shackle that failed incurred the full load of the towline between the KULLUK and AIVIQ. The bridle shackles on either side of the towing plate generally shared the load. From the findings, the tow winch strain monitoring system logged 38 separate occasions during the morning of December 27 of towline loading over 300 tons. Additionally, video evidence from the 3rd Mate [REDACTED] on watch shows load fluctuations from 28 to 228 tons within the period of a few seconds, providing further proof of extreme fluctuations in the towline tension while towing the KULLUK. This event would not be logged in the towing system, so it is unknown on how many occasions the readings were high but went unrecorded as an alarm as they did not meet the 300 ton alarm threshold.

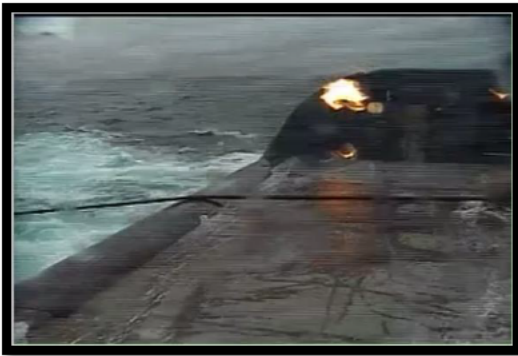
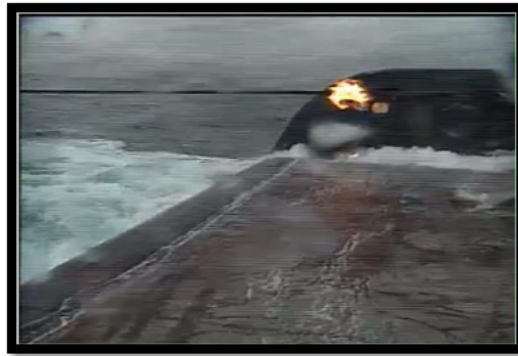
Figure 61: Starboard aft CCTV stills showing fluctuations in towline tension. Still on left shows lower tension at 10:12:42. Still on right shows high tension at 10:12:48. (*AIVIQ CCTV Provided by ECO*)

77. Examination of the CCTV aboard the AIVIQ and monitoring the towline indicates “snatching” (tensioning/loosening cycle) of the tow wire cyclically over a period of time, indicating dynamic loading to the towline and towing accessories. Periods of lower tension are indicated as the tow wire rides on the stern roller. Periods of higher tension are indicated as the

tow wire goes taut and comes off the roller and is suspended into the air above the deck. Higher tensions are also indicated by a loss of catenary between the towing vessel and tow.

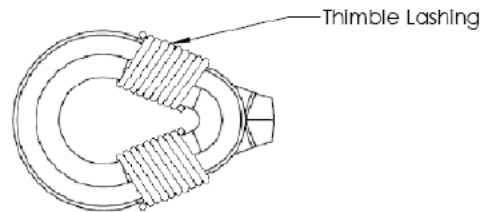
Figure 74: Diagram of the end of the emergency towline with Codura® abrasion protection and metal thimble lashed into place (*Courtesy of the Sampson Rope Technologies, Inc.*)

118. The failure of the apex shackle was discussed previously in the analysis. The emergency towline was a capable 400 foot line, possessing a breaking strength of over 400 tons. Testimony indicates that the AIVIQ attempted to maintain a lower tension on the line during the course of the tow, and Towcon data retrieved for the time period indicate that the tension never reached 300 tons during usage of the line. The failure occurred at the AIVIQ side of the towline at the eye end of the emergency towline. Codura® chaff protection was provided in the area of the eyes in the end of the towline consisting of the abrasion resistant material around the line itself and a steel thimble held in place with lashings as detailed in the illustration below.
