MARINE ACCIDENT REPORT

**EXPLOSION AND FIRE ONBOARD
THE U.S. MOBILE OFFSHORE DRILLING UNIT
GLOMAR ARCTIC II IN THE NORTH SEA,
130 NAUTICAL MILES EAST-SOUTHEAST
OF ABERDEEN, SCOTLAND
JANUARY 15, 1985**

NTSB/MAR-86/03

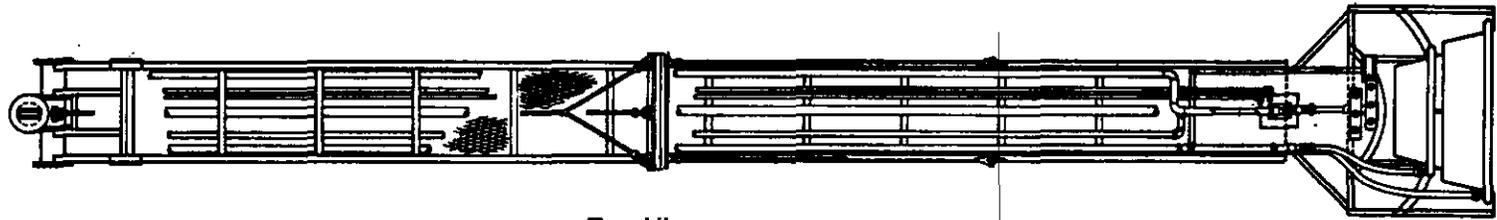
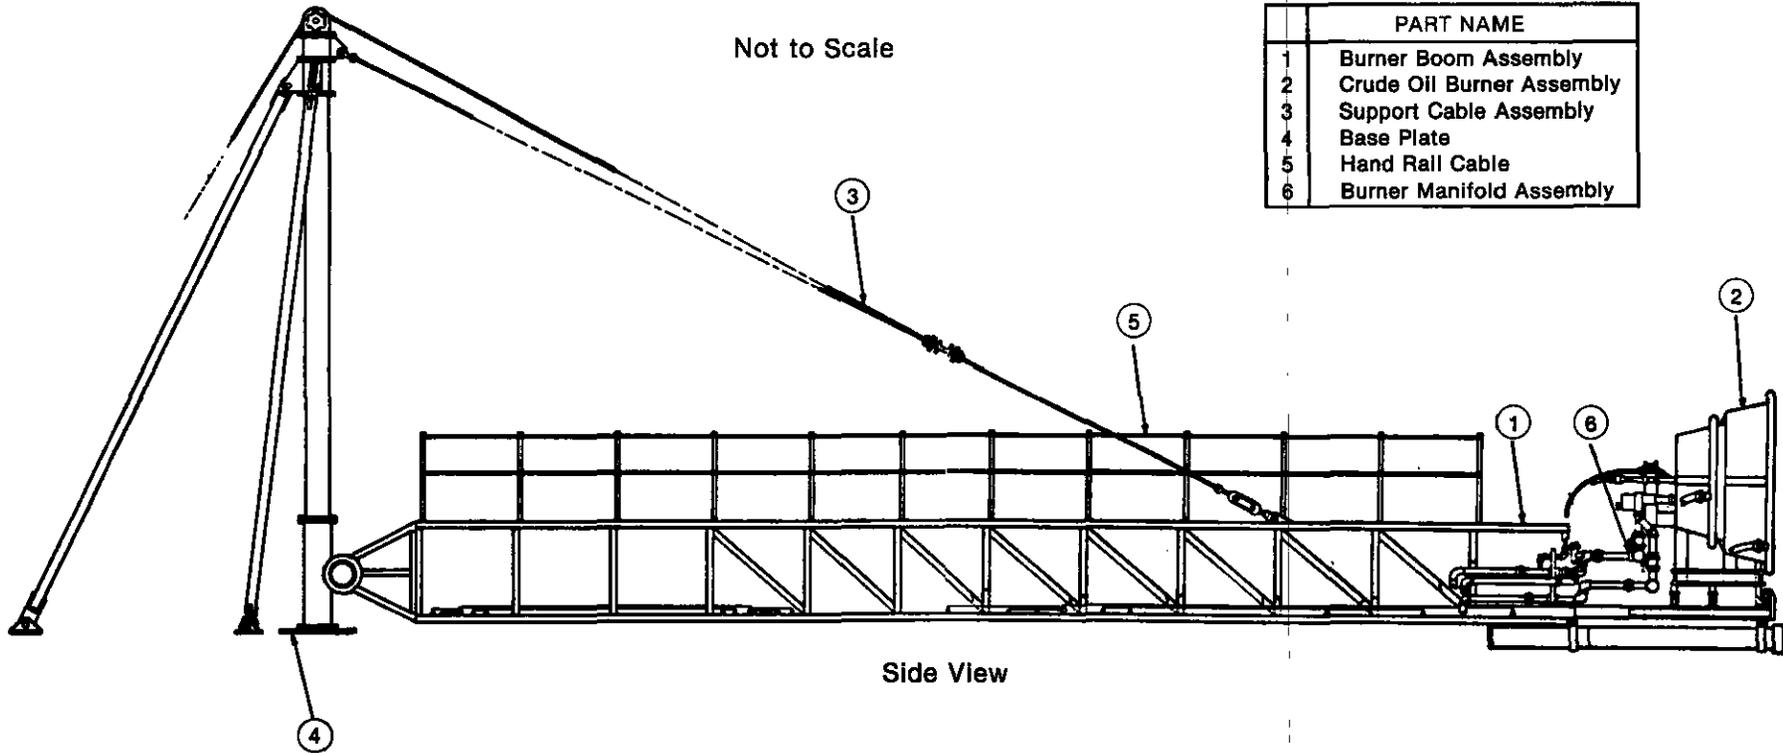
Figure 2.--Burner boom.

Burner Booms.--The GLOMAR ARCTIC II was fitted with two 70-foot-long steel burner booms, one each on the port and starboard sides of the main deck (see figure A-1, appendix A, and figure 2) with one end of the boom attached to a pivot point at midships. The booms were fabricated and installed during the MODU's construction and were a part of the vessel's permanent equipment. Each burner boom provided support for the crude oil, atomizing air and water pipelines and the crude oil burner assembly located at the boom's extreme outboard end. With the use of the pivot, the boom could be oriented to suit the wind direction and keep the flame's heat and smoke away from the MODU. When the burners were not in use, the booms could be brought in and secured alongside the MODU's main deck.

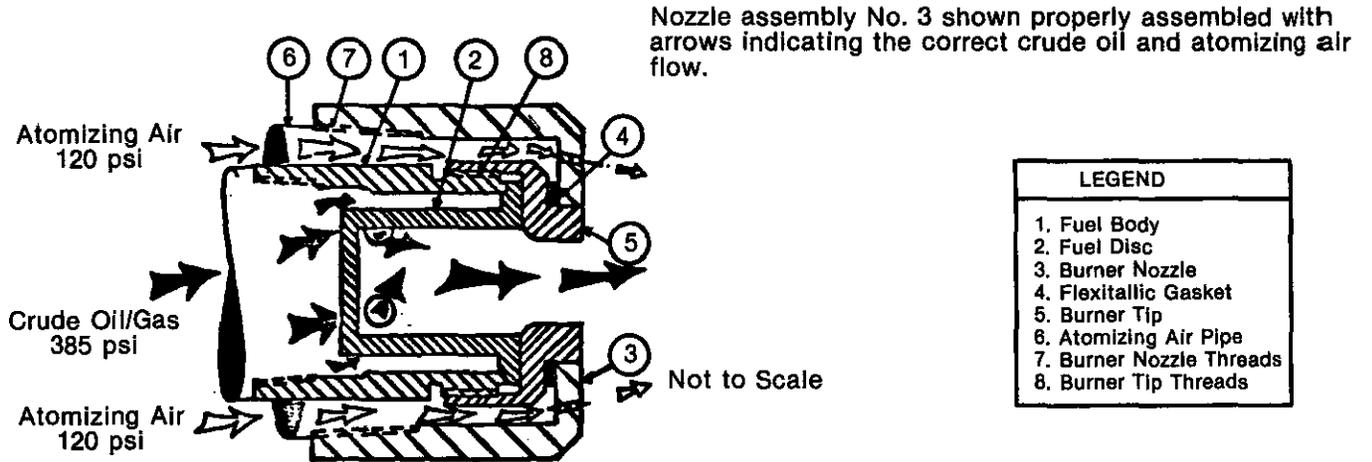
FIGURE 6-A—CORRECTLY ASSEMBLED

Otis Company drawings of the properly assembled burner nozzle unit clearly show that the faces of the burner nozzle and burner tip are flush and level with each other when assembled properly. (See figure 6-A.) The dimensional checks of the nozzle assembly and its components showed that over 1/4 inch of clearance existed between the No. 3 burner nozzle face and the improperly recessed burner tip face, which should have been an immediate visual indication to the well test crew that the compression gasket was not seated properly within the assembly and that the nozzle assembly was misassembled. (See figure 6-B.) With a misassembled nozzle assembly and an improperly seated compression gasket, crude oil/gas pressure against the fuel disc could transfer tensile and bending stresses to section 'YY' of the underside of the burner tip. Although neither the burner tip material nor the sharp inner shoulder radius separately or together probably
