# **NATIONAL TRANSPORTATION SAFETY BOARD**

## **MARINE ACCIDENT REPORT**

**CAPSIZING AND SINKING OF THE  
UNITED STATES DRILLSHIP  
GLOMAR JAVA SEA  
IN THE SOUTH CHINE SEA  
65 NAUTICAL MILES SOUTH-SOUTHWEST  
OF HAINAN ISLAND,  
PEOPLE'S REPUBLIC OF CHINA  
OCTOBER 25, 1983**

**NTSB/MAR-87/02**

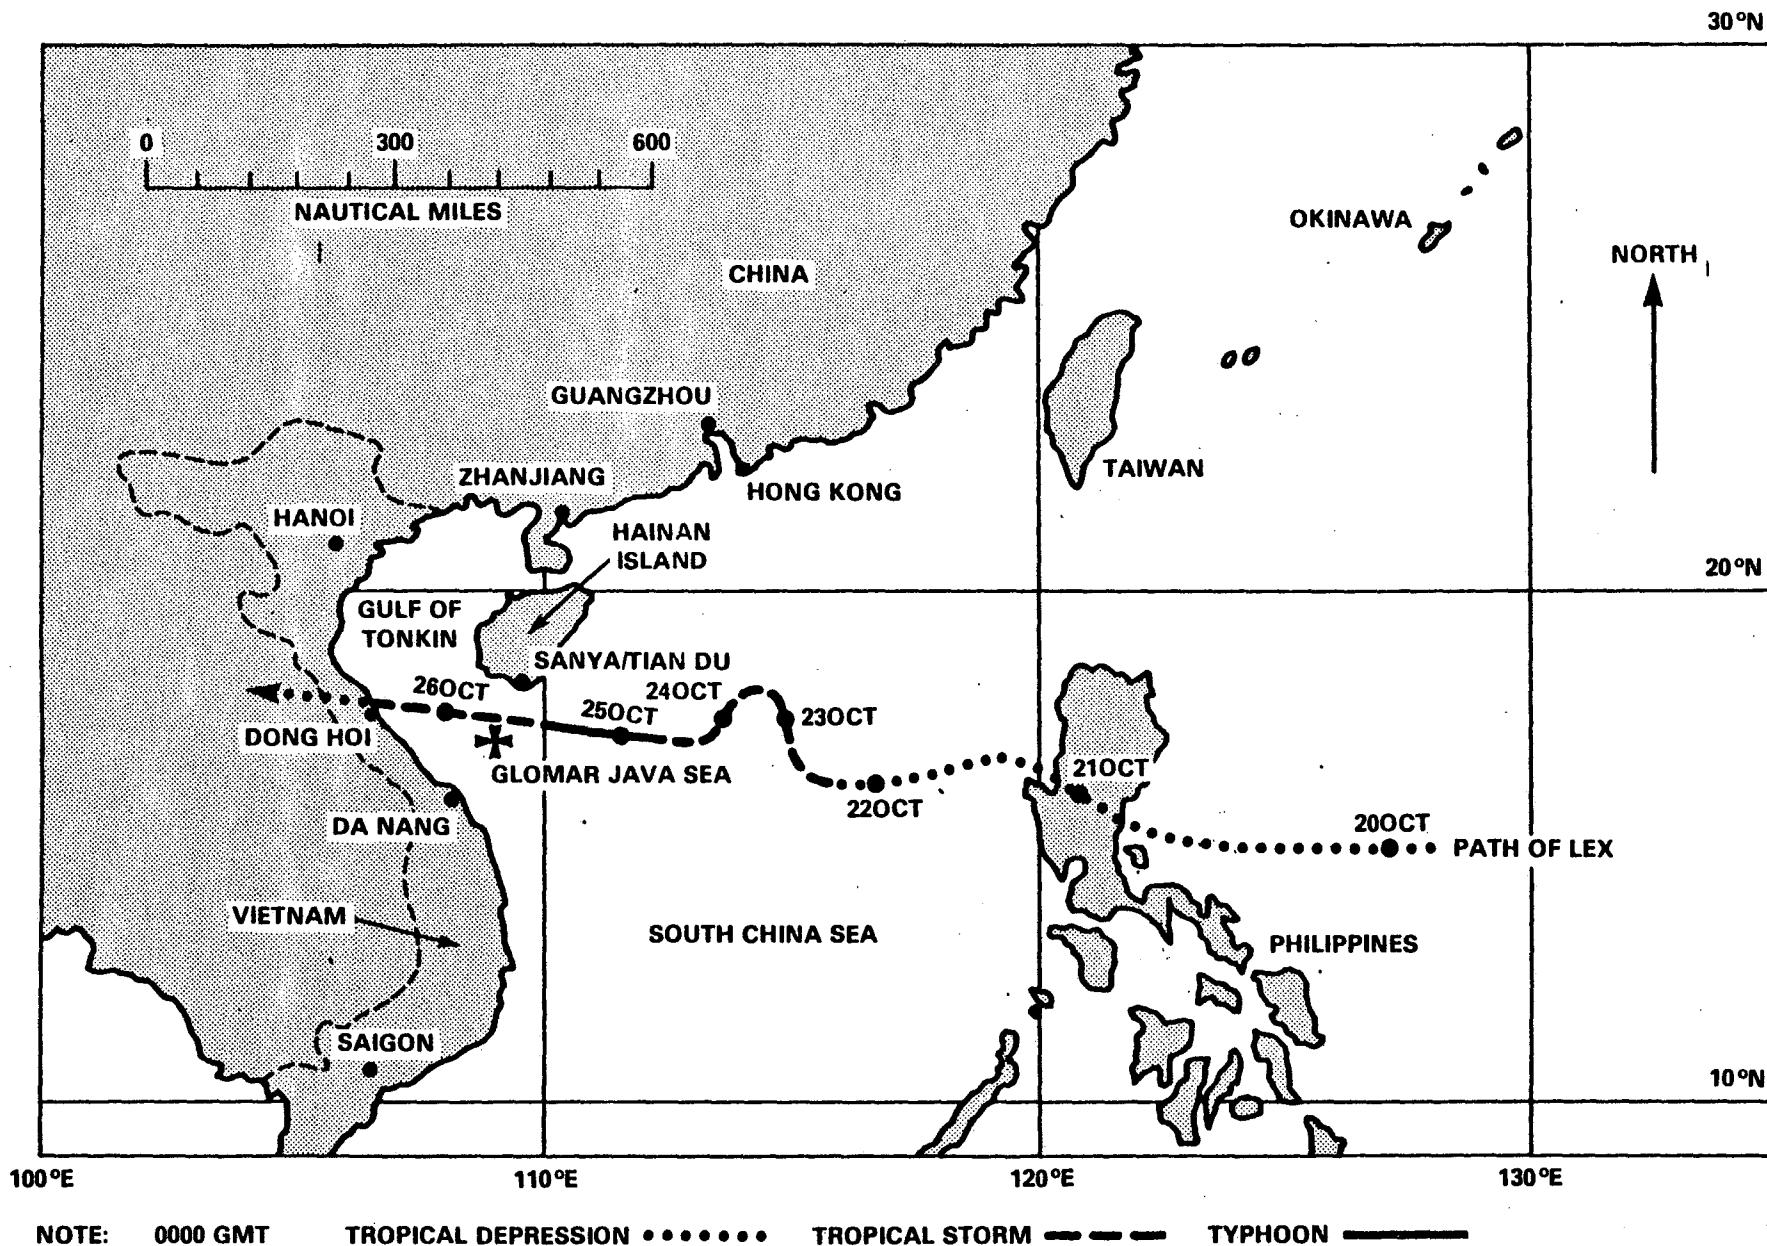
Figure 2.--Location of GLOMAR JAVA SEA and path of LEX (as reported by the U.S. Joint Typhoon Warning Center, Guam) during October 1983.

At 0357 on October 26, the USAF RCC at Kadena Air Force Base on Okinawa (see figure 2) was notified by the USCG in San Francisco that the GLOMAR JAVA SEA was listing 15° at position 17°17' N. latitude 108°53' E. longitude, was in the path of Typhoon LEX, and had not communicated with anyone since 2346 on October 25. About 0500, Kadena called Global Marine in Houston to obtain a detailed description of the drillship, the vessel's call sign--WFDS--and information on the drillship's radios and radio frequencies. After obtaining this information, Kadena issued an urgent marine information broadcast requesting any information regarding the GLOMAR JAVA SEA and attempted unsuccessfully to contact the GLOMAR JAVA SEA via a WC-130 airplane which was within 300 nmi of the last known position of the drillship.

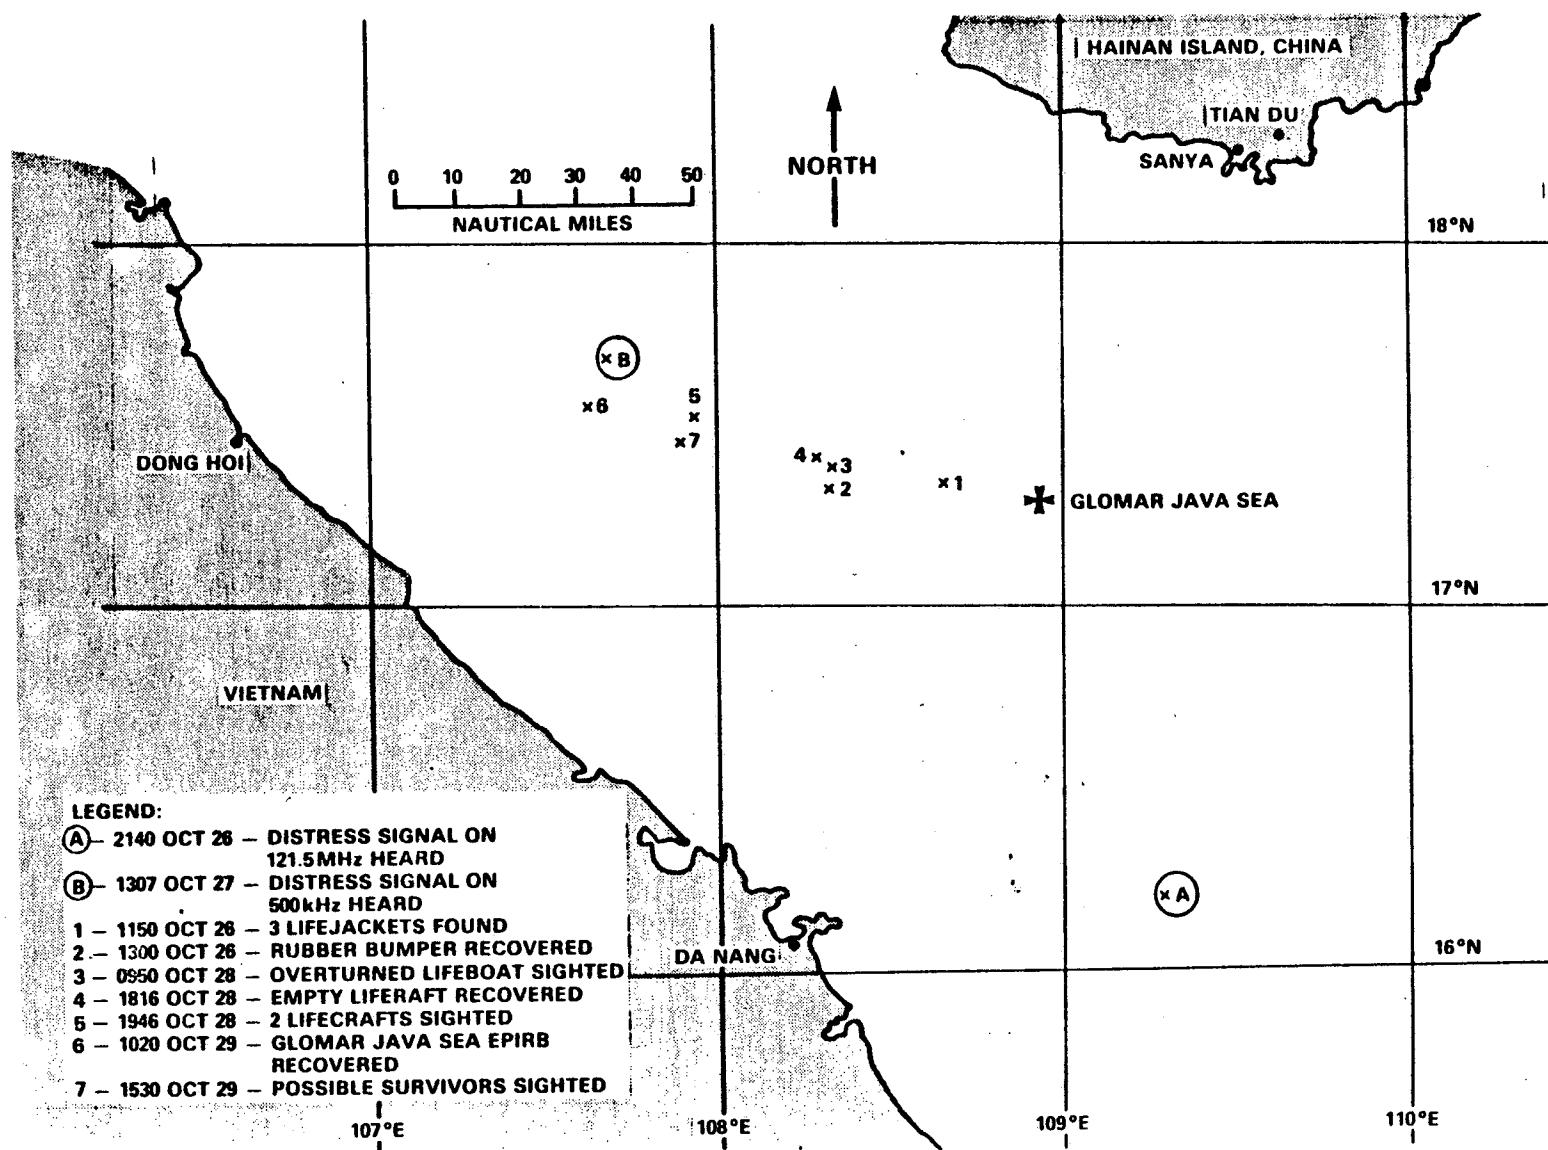
Figure 3.—Search and rescue effort from October 26 to October 29, 1983.

At 0430 on October 27, a commercial airplane reported to the Hong Kong Marine Department that an intermittent distress signal on 121.5 MHz was heard at 2140 on October 26 about 60 to 70 nmi east of Da Nang, Vietnam. This information was passed on to Kadena. It was later determined that a distress signal transmitted from that location could not have come from the GLOMAR JAVA SEA's emergency position indicating radio beacon (EPIRB). At 0643 on October 27, Kadena alerted its search and rescue airplanes and at 0747 launched a P-3 airplane with an estimated time en route of 3 hours. The P-3 spent 6 hours searching the drill site using a 25-nmi track spacing at an altitude of 300 to 400 feet. The area covered was bounded approximately by 14°30' N. latitude on the south, 30 nmi off the Vietnam coast on the east, 18° N. latitude on the north, and 110° E. longitude on the west. Due to the poor weather conditions, most of the unsuccessful search was conducted by radar. During the afternoon of October 27, a Singaporean ship about 200 nmi southeast of Saigon, Vietnam (see figure 2), en route from Dubai, United Arab Emirates, to Kobe, Japan, reported to the Marine Department of Hong Kong that it had received a distress signal on 500 kHz at 1307 on October 27. The distress signal included the GLOMAR JAVA SEA's call signal, WFDS, and a position of 17.41° N., 107.42° E. (about 70 nmi to the northwest of the well location). (See figure 3.) A vessel was sent to locate the source of the signal, but it was not found.
