## **MARINE ACCIDENT REPORT**

**EXPLOSION AND FIRE ABOARD THE  
U.S. MOBILE OFFSHORE DRILLING UNIT  
ZAPATA LEXINGTON  
GULF OF MEXICO  
SEPTEMBER 14, 1984**

**NTSB/MAR-85/11**

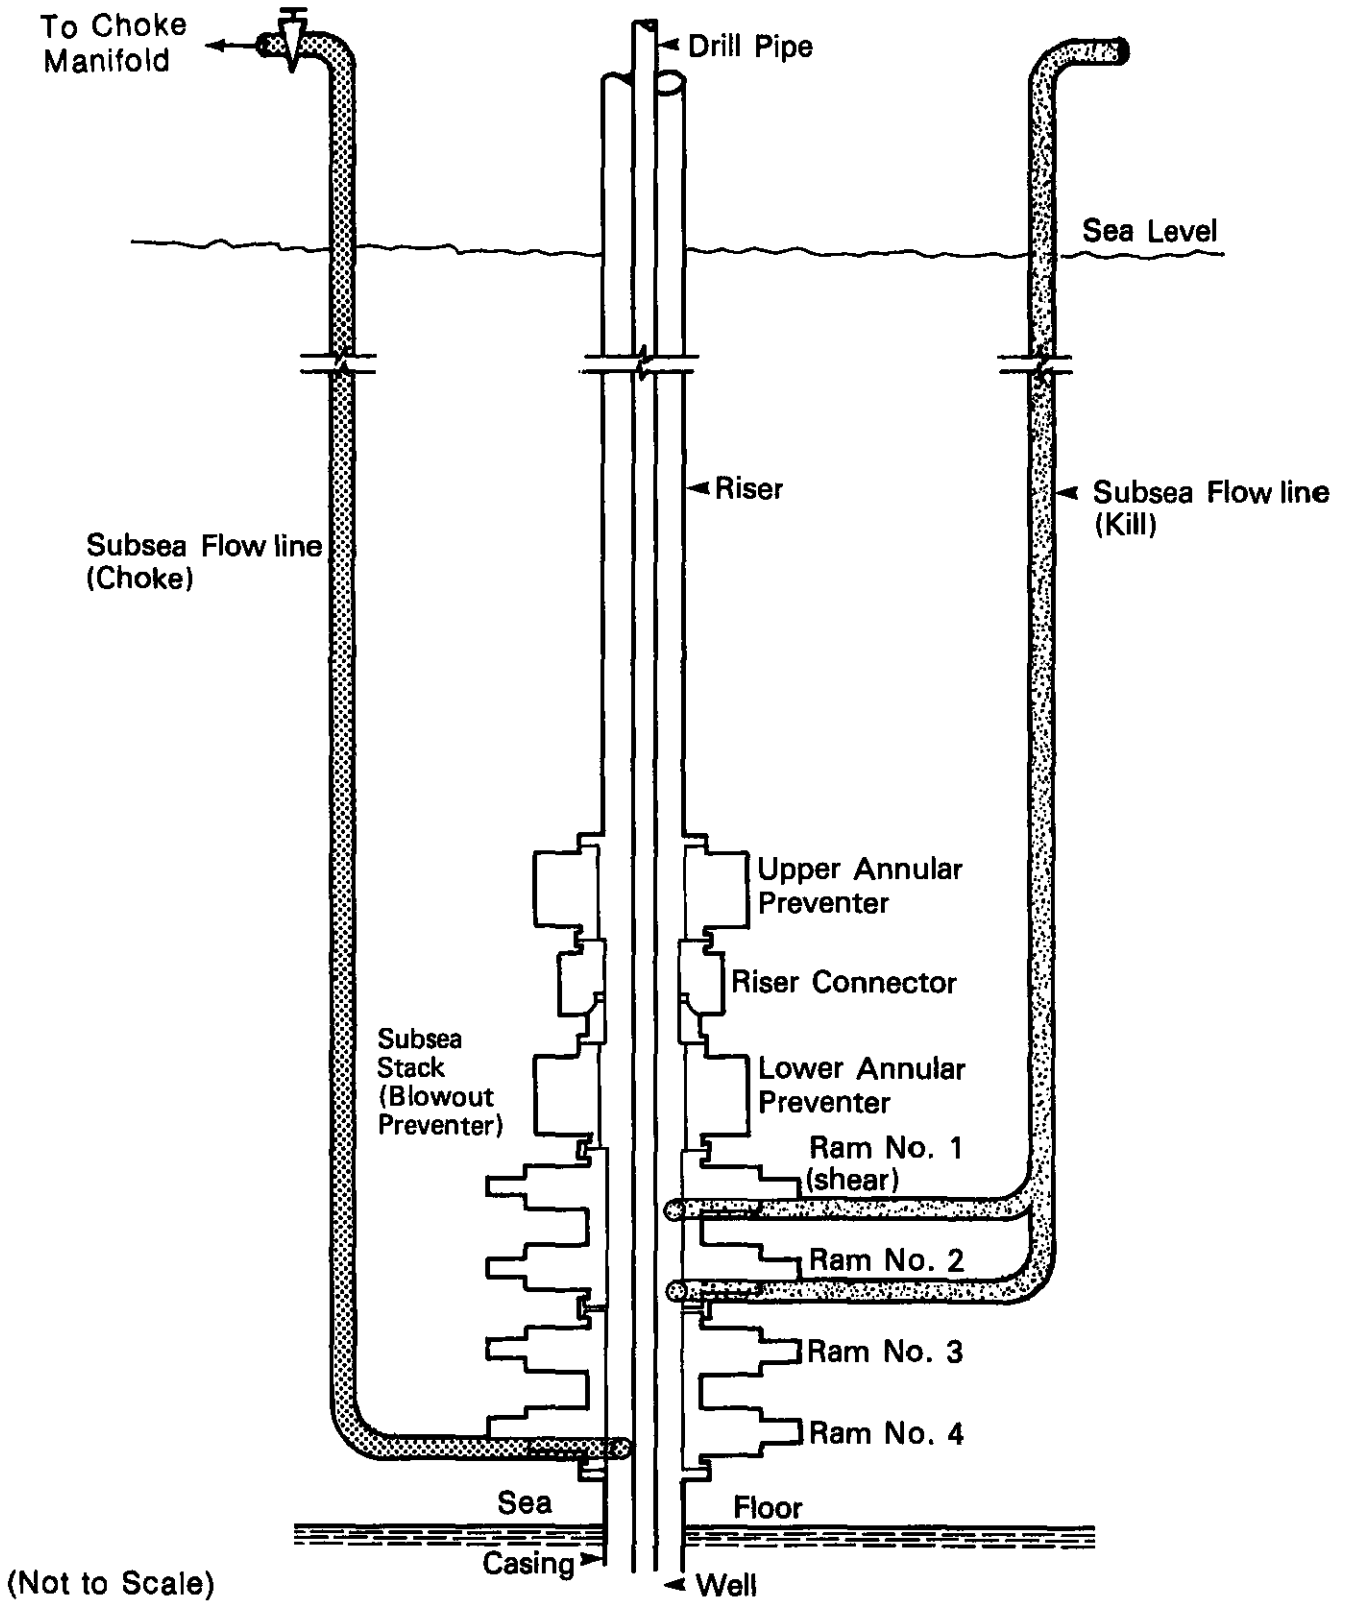
Figure 3.--Diagram of blowout preventer (BOP), marine riser, and subsea flowlines of the ZAPATA LEXINGTON.

Shortly after 1030, the drilling crew started a procedure to evacuate any trapped gas that might be remaining in the blowout preventer and the marine riser [18]. The drilling crew had closed the No. 3 pipe rams (see figure 3). In the process, gas under pressure entered the marine riser and as it rose to the surface expelled drilling mud from the marine riser. Shortly after noon, Conoco's representative left the drill floor and went to a lower deck to observe the mud returns at the gumbo box [14] where drilling mud is exposed to the atmosphere during the recycling process. Anticipating that gas-cut mud [13] would appear in the gumbo box (see figure 4), the Conoco representative instructed two rig crewmen to spray water over the area to wet and cool any gas that might be released, meanwhile keeping the senior toolpusher on the drill floor informed by telephone. The on-duty driller, the assistant driller, a floorhand, and a cleaner/painter were also on the drill floor. The cleaner/painter and the floorhand were washing mud from the bulkheads and decks and a stair landing outside a drill floor entry. Another floorhand was tending the equipment in the shale shaker [22] room, located below the drill floor level.
