PROCEEDINGS OF THE MERCHANT MARINE COUNCIL UNITED STATES COAST GUARD

Vol. 1 June 1944 No. 6

Proceedings of the MERCHANT MARINE COUNCIL

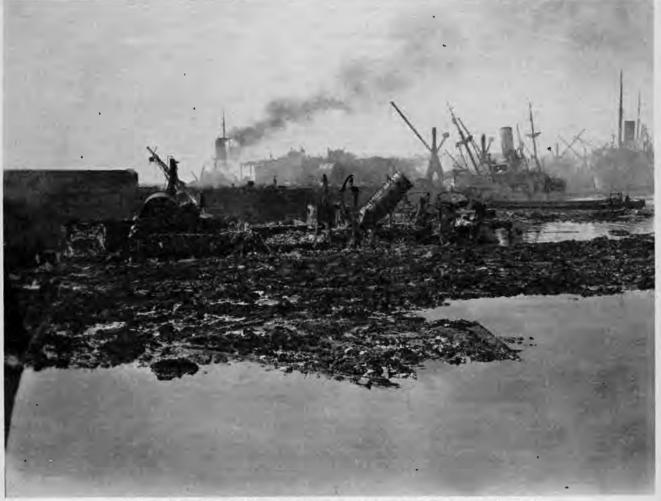
Bombay Harbor showing destruction of ships and docks. Burned cotton bales are afloat.

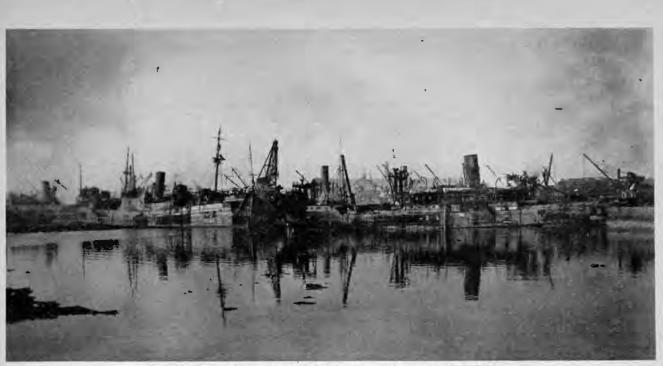
Burned out vessels standing after the explosion and fire at Bombay Harbor.

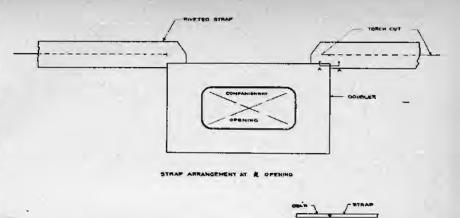
SECTION A-A

5. Some of the newer vessels have already had their hatch corners reinforced during construction and no additional hatch corner reinforcement should be provided on such vessels. One of the approved types of reinforcements should be found in or placed in the corners of Nos. 2, 3, and 4 hatches in the upper deck of every Liberty ship.
