PROCEEDINGS OF THE MERCHANT MARINE COUNCIL UNITED STATES COAST GUARD

October 1949

No. 10

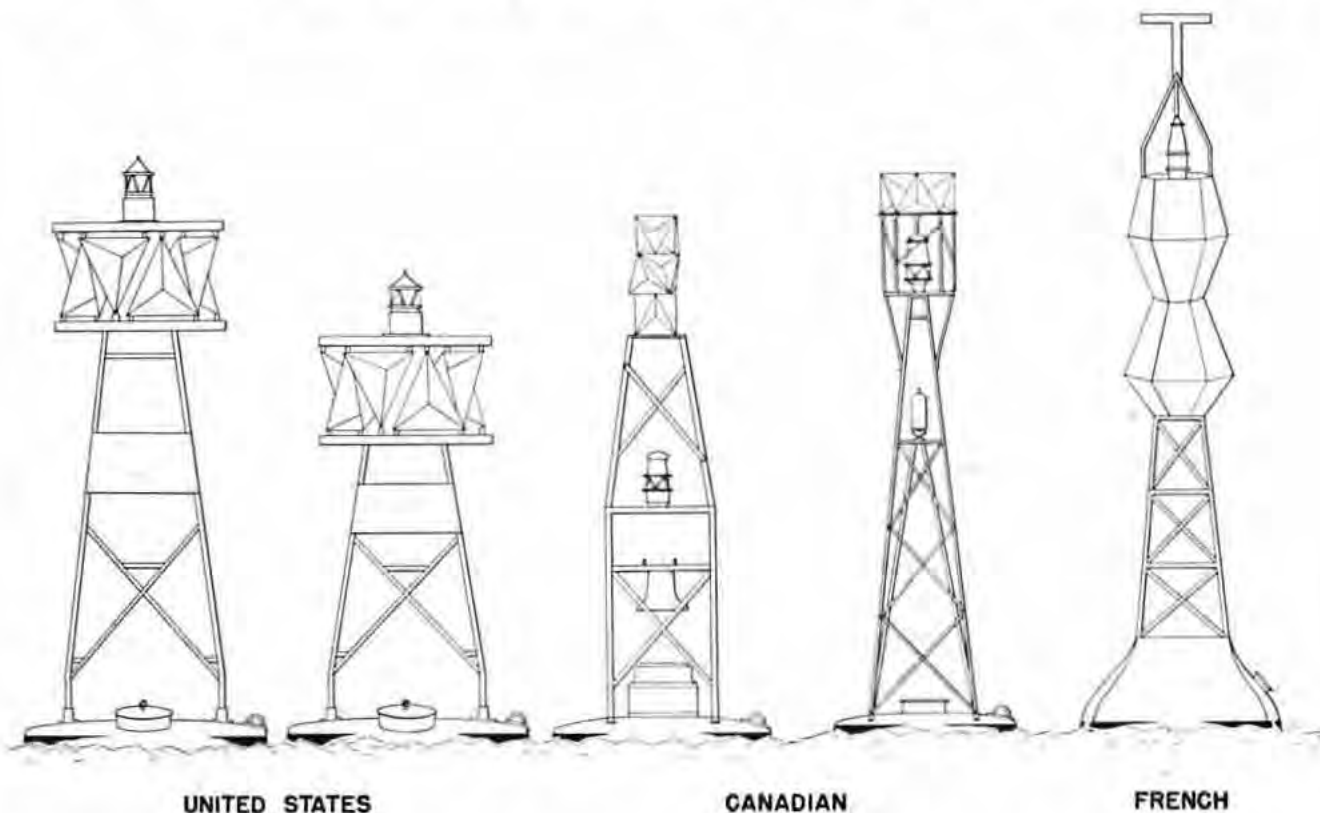
OUTLINE DRAWINGS OF VARIOUS
RADAR REFLECTORS

NO SCALE

Several foreign countries are actively engaged in programs designed to provide similar radar reflector buoys in their local waters as aids to radar navigation. Of the countries known to be working on the problem all are employing electro-mechanical reflection devices of one kind or another such as plane, trihedral, or polyhedron shapes. These shapes are usually mounted in various cluster patterns as illustrated in figure I.
