PROCEEDINGS OF THE MERCHANT MARINE COUNCIL UNITED STATES COAST GUARD

September 1954

No. 9

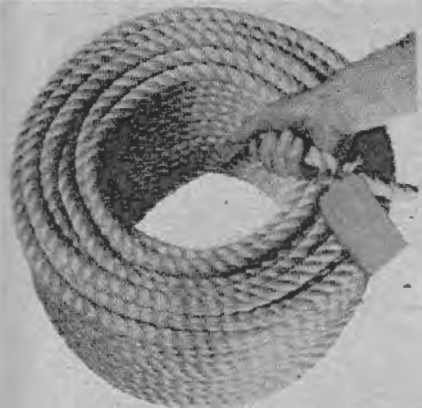
Coil of rope, stripped of wrapper and lashings to show clearly how first turn comes off the bottom of the coil. If uncoiled any other way, rope will kink and tangle.

Generally new rope is unwound through the eye in the center of the coil in a counter-clockwise manner, with the end to be unwound next to the deck. However, if the rope doesn't unwind easily the coil should be turned over and the rope drawn through the other end. (See fig. 1.) The wisdom of uncoiling a rope in this manner is easily seen if you have ever watched a seaman uncoil a rope from the outside of the coil, with kinks and bends all over the deck.
