PROCEEDINGS OF THE MERCHANT MARINE COUNCIL

Vol. 14

April 1957

The Nautical Chart—Basic Aid to Navigation.....	47
MSTS Has Lowered Rates.....	49
Seamanship—Prudence—Rules of the Road.....	50
Plot—For Safety.....	52
Scotch Boilers.....	54
Emergency Communications Instructions.....	58

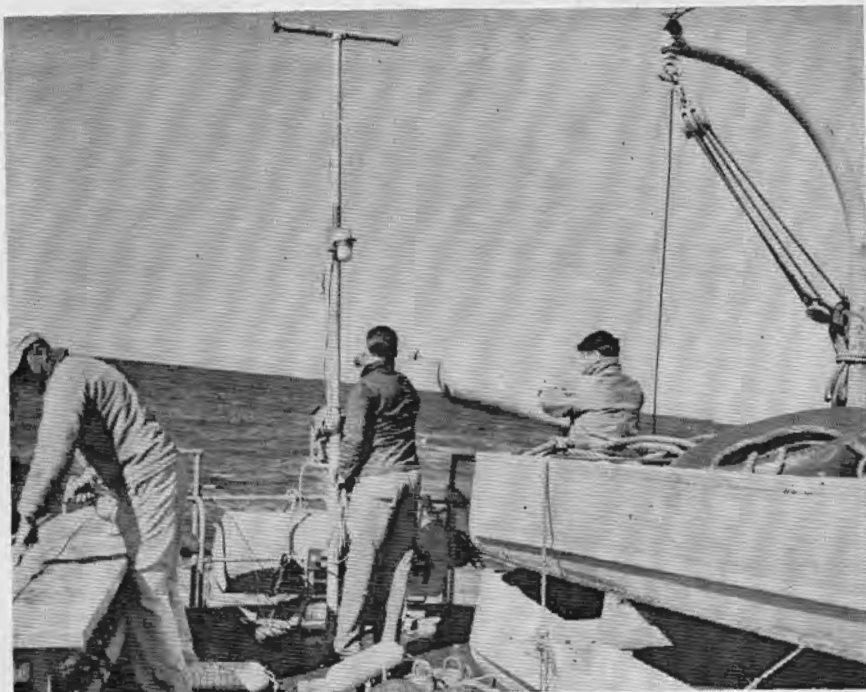
DECK SCENE aboard a U. S. Coast and Geodetic Wire-Drage Launch as the crew prepares to launch apparatus for searching out underwater obstructions.
