PROCEEDINGS OF THE MERCHANT MARINE COUNCIL

June 1957

SECTIONAL HEADER TUBE REPAIRS

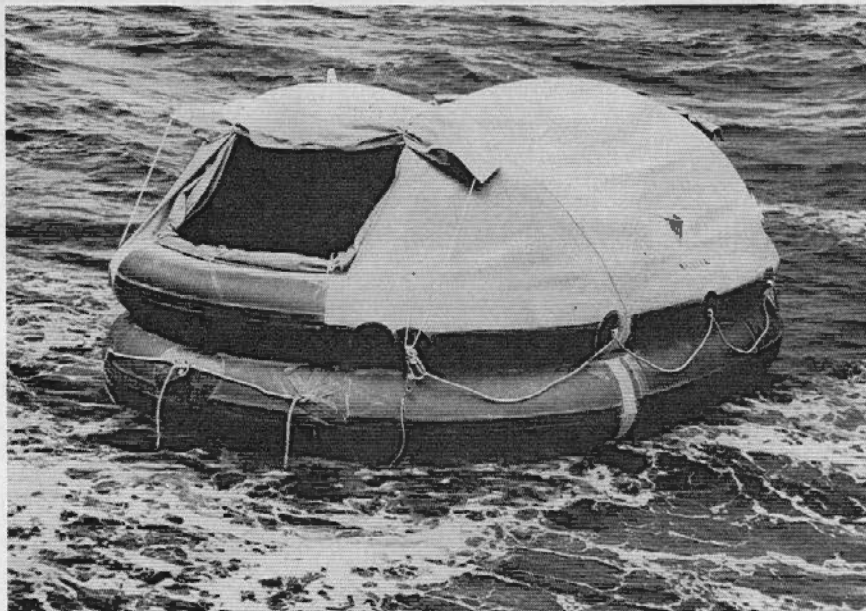
FOUR MEN were adrift for 58 hours in this Elliott 6-man "Cutter" Inflatable Liferaft.

"During Saturday the wind remained light and the sea calm, but during Sunday the wind freshened to force 5 and the sea became broken. No vessels were sighted throughout the whole of Sunday. On Sunday morning it was noticed that the arch tubes were slightly soft and the raft was, therefore, pumped up with the hand bellows for the first time. Two pumps were required for the bottom chamber and arch tube structure.

chamber were pumped up again. Shortly afterwards, and for no apparent reason, the floor deflated. On a subsequent examination ashore no damage could be found which might have caused the floor to deflate. A detailed examination will have to be carried out in conjunction with the Ministry of Transport Surveyor.
