# PROCEEDINGS OF THE MERCHANT MARINE COUNCIL

Vol. 14

July 1957

No. 7

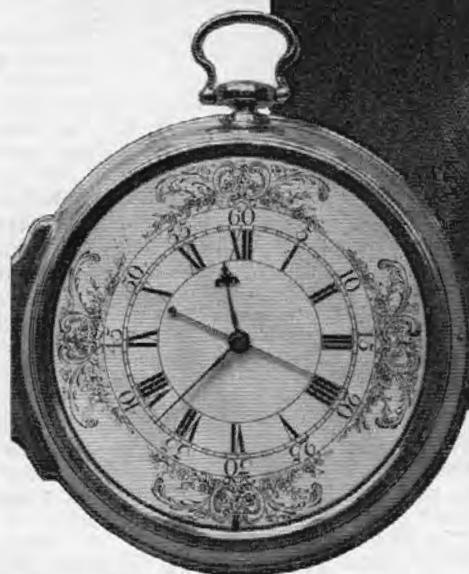
**Chronometer No. 4, completed 1769. Actually a large watch, it was instrument which actually won the Board of Longitude's prize.**

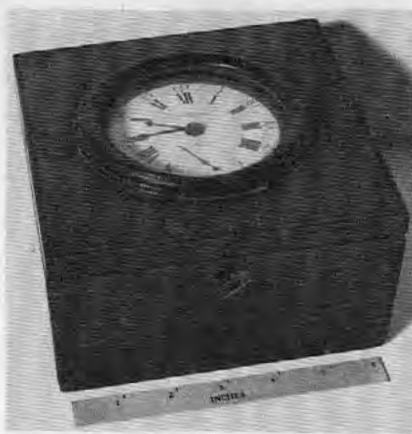
Chronometer by John Arnold, circa 1780.  
Courtesy Mariners Museum

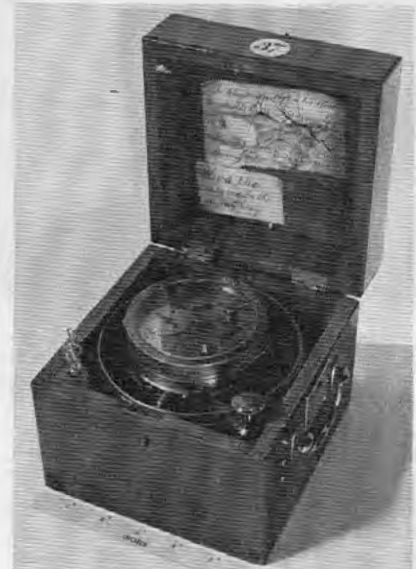
Chronometer No. 37 by Ferdinand Berthoud.  
Made in 1785.

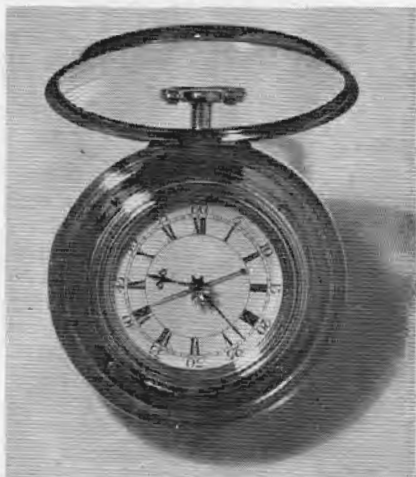
Chronometer No. 5, a later improvement on No. 4.

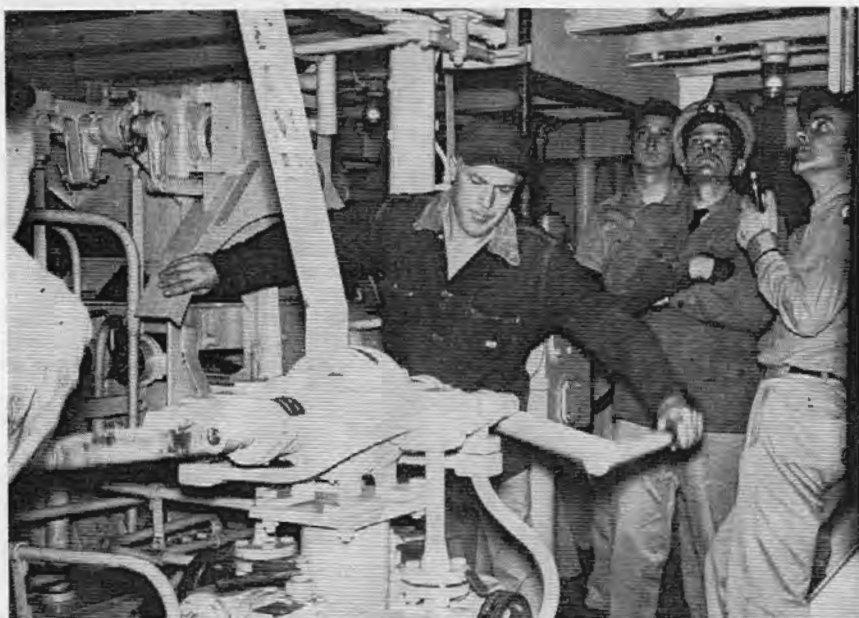
structions in at least half-inch letters and figures shall be posted in the steering engine room, relating in order, the different steps to be taken in changing to the emergency steering gear. In the picture below, courtesy *United States Lines*, a group of key personnel aboard the *SS American Scout* are taking part in an emergency steering casualty drill which is held periodically aboard this ship. In this manner, deck as well as engine personnel can see at first hand how the changeover is made.

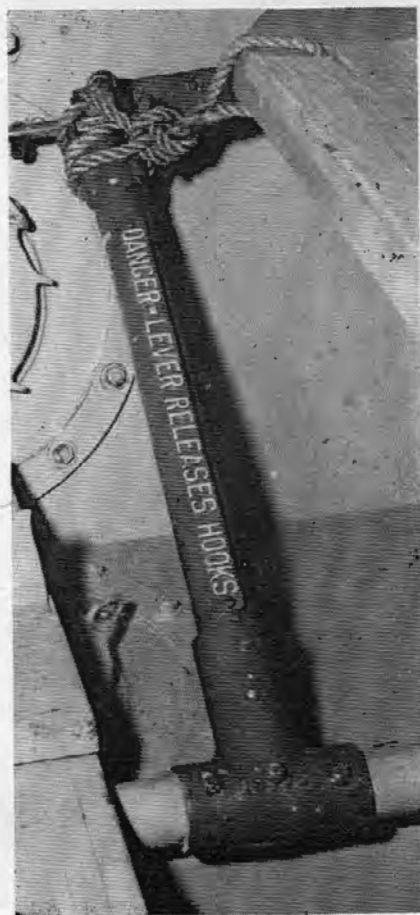
SEEN ABOVE is a Rottmer type release gear handle properly secured in place by toggle pin and several turns of small line to prevent the inadvertent operation of the installation.

Another safety feature is provided by preventer bars which act not only as an automatic mousing device but also permit the release of the falls when the lifeboat is water-borne in the event the gear is not operable. This mousing feature is advantageous when lowering the lifeboat since a premature release of either end of the boat due to a slack in the falls caused by sea conditions cannot occur. The feature is also desirable when retrieving a lifeboat since the link under the block can be thrust into the hook without fear of subsequent unhooking.
