PROCEEDINGS

OF THE MERCHANT MARINE COUNCIL

UNITED STATES COAST GUARD
Vol. 15, No. 11 • November 1958

"A REVIEW OF CASUALTIES"

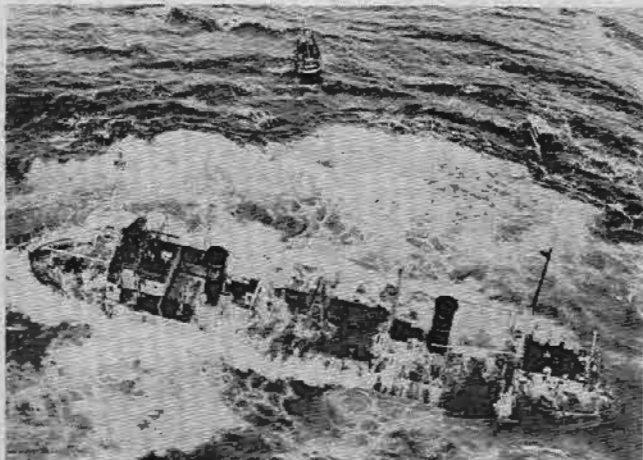
SINKING AFTER COLLISION with the Norwegian freighter *Thorshall*, the Army Corps of Engineers dredge *William T. Russell* is snapped in this on-the-spot photograph near the entrance to the Coos Bay, Oregon, bar. Four men aboard the dredge were lost. Photo Courtesy Ward Robertson.

The second major casualty, in chronological order, occurred on September 10, 1957 when the Army Engineers dredge *William T. Russell* sank in Coos Bay, Oregon, after being struck by the outbound Norwegian freighter *Thorshall*. Four men aboard the dredge were lost. The report by the Marine Board of Investigation has been received and is under review at Headquarters. As is customary, the facts found and the final action of the Commandant will appear in the *Proceedings of the Merchant Marine Council*.

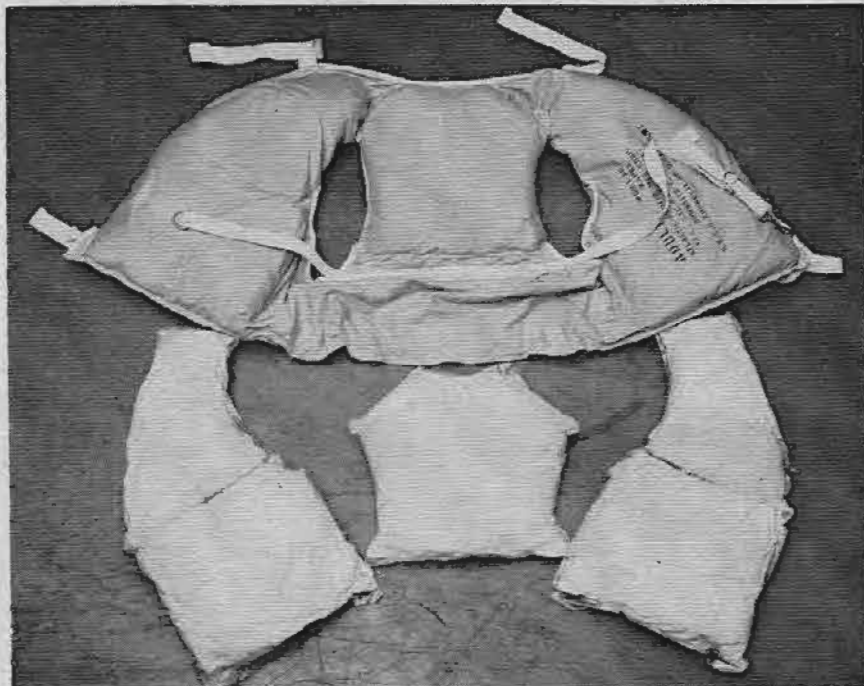
COAST GUARD APPROVED life preservers manufactured since September 24, 1958, must have the kapok or fibrous glass filler fitted in a plastic envelope. The top part of this photograph illustrates a complete Model 3 life preserver, and the bottom part shows the plastic encased pads prior to insertion. Previously approved life preservers may be placed in service and/or continued in service as long as in good and serviceable condition.

Since 1955, protective covers of vinyl plastic film have been required for the buoyant material in all kapok or fibrous glass buoyant cushions and buoyant vests approved for use on pleasure motorboats, and all approved

vests and cushions made since that date under Coast Guard Specifications 160.047 and 160.048 have such gasoline and oil resistant buoyant inserts. Coast Guard Specifications 160.002 and 160.005 covering kapok and fibrous glass type life preservers for general use on merchant vessels and motorboats have for a number of years contained requirements for models both with and without the plastic pad covers, but production of these life preservers has for the most part been confined to those models without such pad covers.

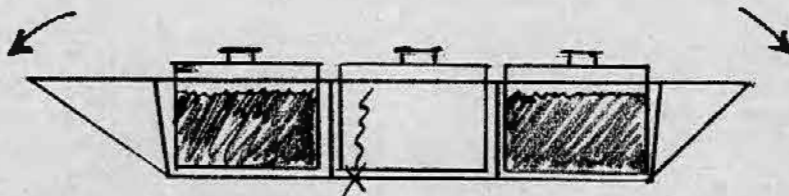
Figure 2.

The water in the rakes was estimated at 4 feet each. The weights corresponding to these soundings are 15 tons forward, 10 tons aft. (Figure 2.)

1949—a clear, quiet day in June on the Illinois Waterway. A hopper type tank barge is just about unloaded. To strip the tanks aft, water is pumped into the stern rake compartment. Next day, to level the barge and establish the necessary bridge clearance, water is pumped into the forward rake. It is then intended to add water to the tanks as ballast, but before this can be done, the barge breaks at a point 4 feet aft of the forward pair of tanks. (See Figure 1.)

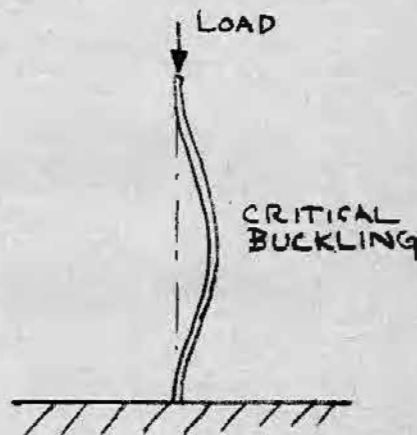
The technical name for this type of failure is "elastic instability," a scientific term for the well-known principle that "you can't push a wet noodle."

Although the vessels apparently possessed adequate section modulus, and hence should have had sufficient longitudinal strength, they were poor in a matter of detail—in the manner in which the stress was to be absorbed. The fracturing of the independent tank straps indicates that the tanks were providing some of the missing fore and aft rigidity of which the bottom plating was incapable when the barges were in a hogging condition, as all were at the time of failure. With the right load combination to produce hogging, and a little corrosion, the absence of longitudinal members to stiffen the bottom plating permitted the plating to buckle under the compressive load.

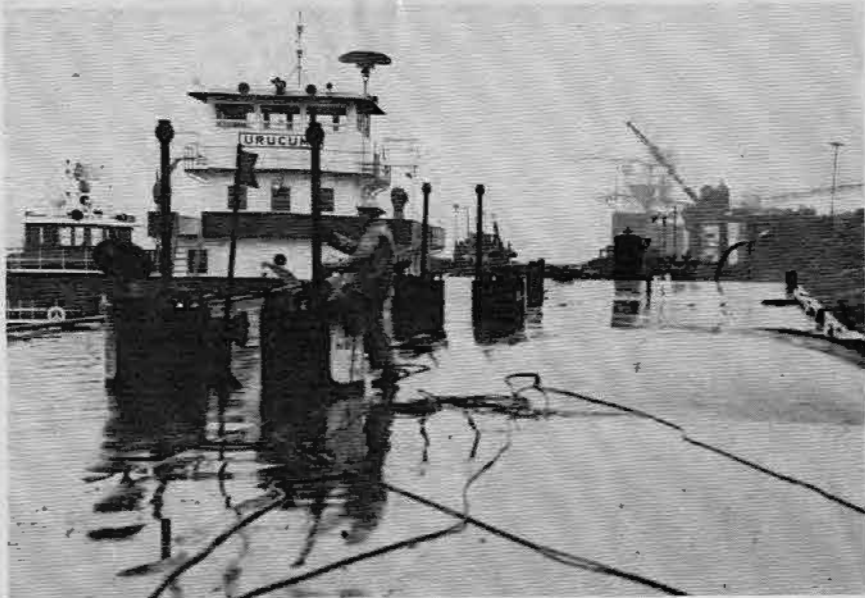
CLAD IN SOU-WESTER and oil skins, a Coast Guard inspector prepares to enter a tank barge to determine the cause of the swelling seen in this picture.

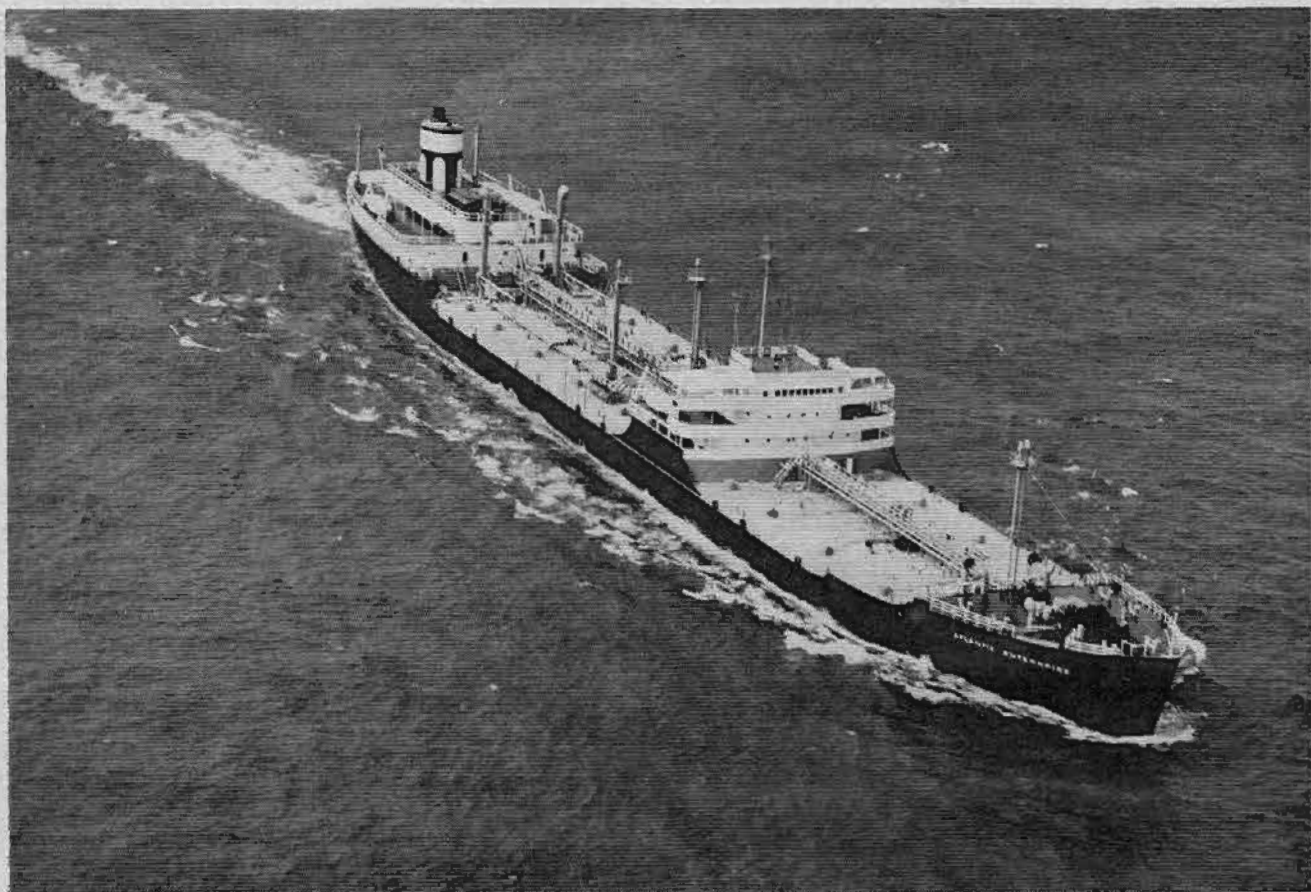
S/S ATLANTIC ENTERPRISE

PARTICULARS

- Length overall—641 feet.
- Length between perpendiculars—615 feet.
- Beam, molded—84 feet.
- Propulsion—single-screw turbine—14,850 SHP, max.—13,500 normal.
- Contract speed 16.5 knots at 100 RPM.
- Total cargo capacity—251,000 bbls.
- Gross tonnage—18,347.
- Net tonnage—11,995.
- Builders—Sun Shipbuilding & Drydock Company.
- Home port—Wilmington, Del.
- Keel laid—May 14, 1957.
- Launched—March 26, 1958.
- Delivered to the Atlantic Refining Company July 11, 1958.
- Estimated cost of ship—\$10,000,000.
- Official number—276911.
- Signal and radio—Call letters KALC.
