# PROCEEDINGS

OF THE MERCHANT MARINE COUNCIL

UNITED STATES COAST GUARD

Vol. 16, No. 4 • April 1959

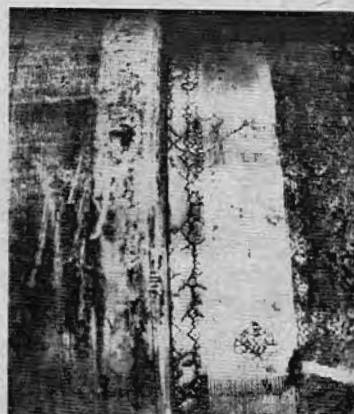
Figure 3.

(a) Combined bending and torsional fatigue accelerated by corrosion through leakage of sea water into the propeller-cum-tailshaft assembly. A typical example is shown in figure 3, and the depth to which this form of cracking can extend without complete fracture is vividly shown in figure 4.

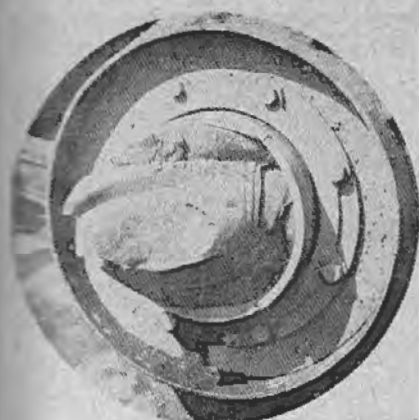
Figure 5.

(b) Fractures in the shaft at the forward end of the keyway, caused by stress concentration at this point through the propeller being a poor fit on the large end of the cone. An example of this type of failure is shown in figure 5.

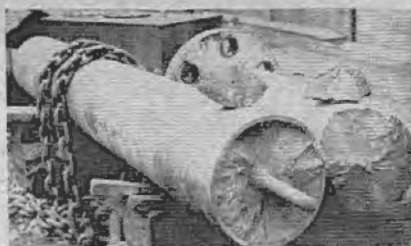
Figure 6.

(c) Fractures in the shaft at the forward end of the liner, especially in shafts which have a journal and plummer block in their length. An example of such a failure, which occurs through combined bending and torsional fatigue accelerated by sea water leaking from the stern gland, is shown in figure 6.
