# *PROCEEDINGS*

OF THE MERCHANT MARINE COUNCIL

UNITED STATES COAST GUARD  
Vol. 17, No. 7 • July 1960

# LOCAL RAIN WARNING BY MARINE RADAR

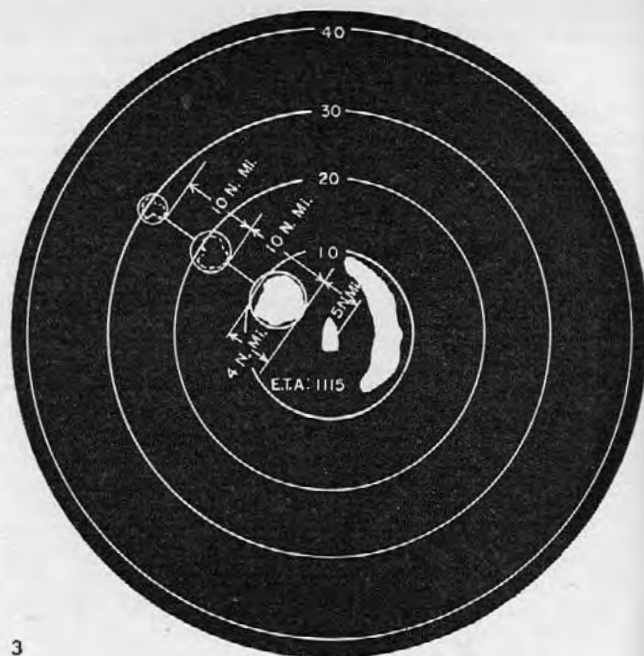
Fig. 3

In figure 3, the same situation prevails, and the same plotting technique was used. In this case, a shower echo was first observed on the radarscope at 1000 hours, and by 1100 it had become evident that the present course of the shower would take it directly over the vessel. To find the speed of the shower, distances from the ship to the leading edge of the echo were measured either by estimation from the fixed range rings on the radarscope or direct measurement with the movable range ring. It was relatively easy in this case since the difference between the radar range at 1000 and at 1030 was 10 nautical miles, and the echo was approaching. The speed was 10 nautical miles in 30 minutes or 20 knots, a speed slightly higher than average for middle latitudes. Comparison of the 1100 with the 1030 plot indicated again a speed of 20 knots, and, since at 1100 the leading edge of the echo was 5 nautical miles away with a speed of 20 knots, the leading edge should arrive over the ship in 15 minutes. Moreover, range measurement indicated the distance from the lead-

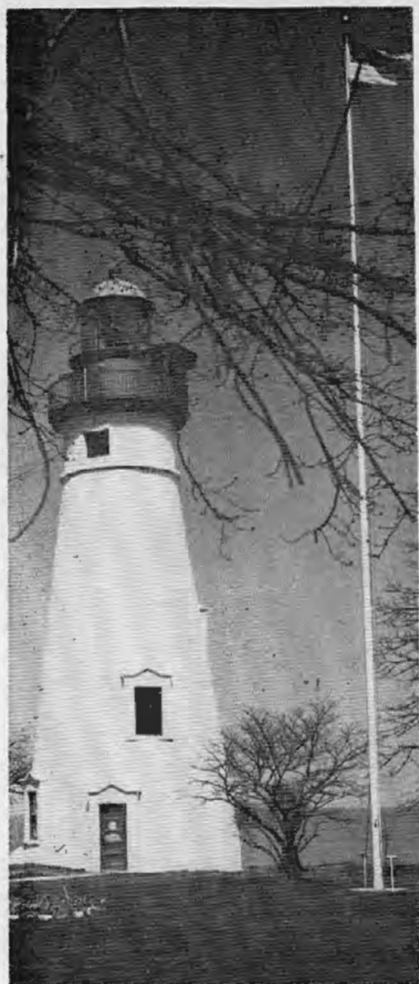
**MARBLEHEAD LIGHT STATION**, its white conical tower reaching 70 feet to the top of its lantern from the ground, stands on the northeast end of the point of the South Passage to Sandusky Bay, Lake Erie, Ohio. Its 350,000 candlepower light flashes red every 10 seconds for 3/10 second intervals from a height of 67 feet above low water, and can be seen at a distance of 16 miles.

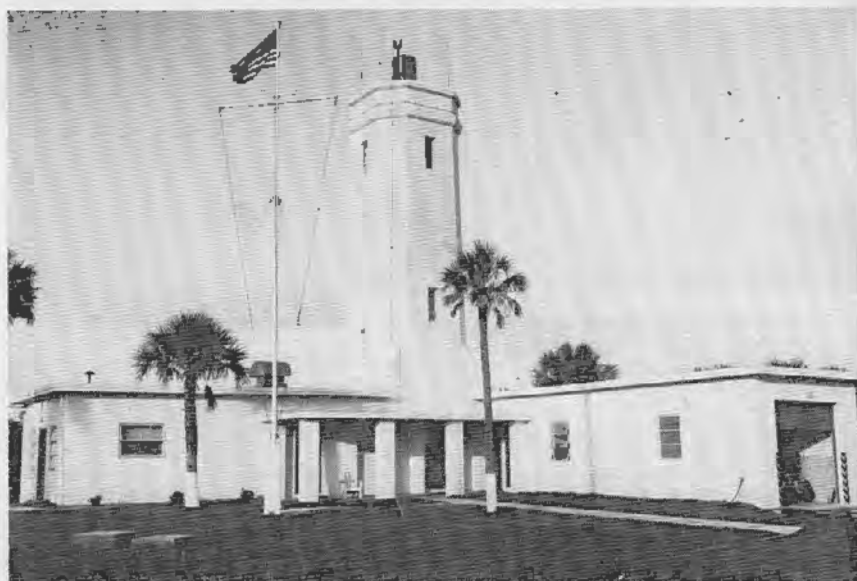
ONE OF THE U.S. COAST GUARD'S newest aids to navigation is the St. John's Light Station, located at Mayport, Fla., about three-quarters mile south of the mouth of the St. John's River.

The light station began operation in the fall of 1954, at the discontinuance of old St. John's Lightship, which had served since 1929 as a warning to mariners of the dangerous approach to the river entrance. The new light station includes a reinforced lighthouse of modern architectural design and two matching concrete-block quarters building for the four crew members and their families. It also includes a remote radio beacon antenna located at the river entrance, and St. John's Fog Signal which is built on a submarine site several hundred feet seaward of the end of the South Jetty, one of two parallel jetties protecting the river entrance.

The lighthouse is equipped with a revolving airways-type light beacon, a 25 kva emergency engine-generator, radiobeacon transmitting equipment, and control apparatus for the remote fog signal.

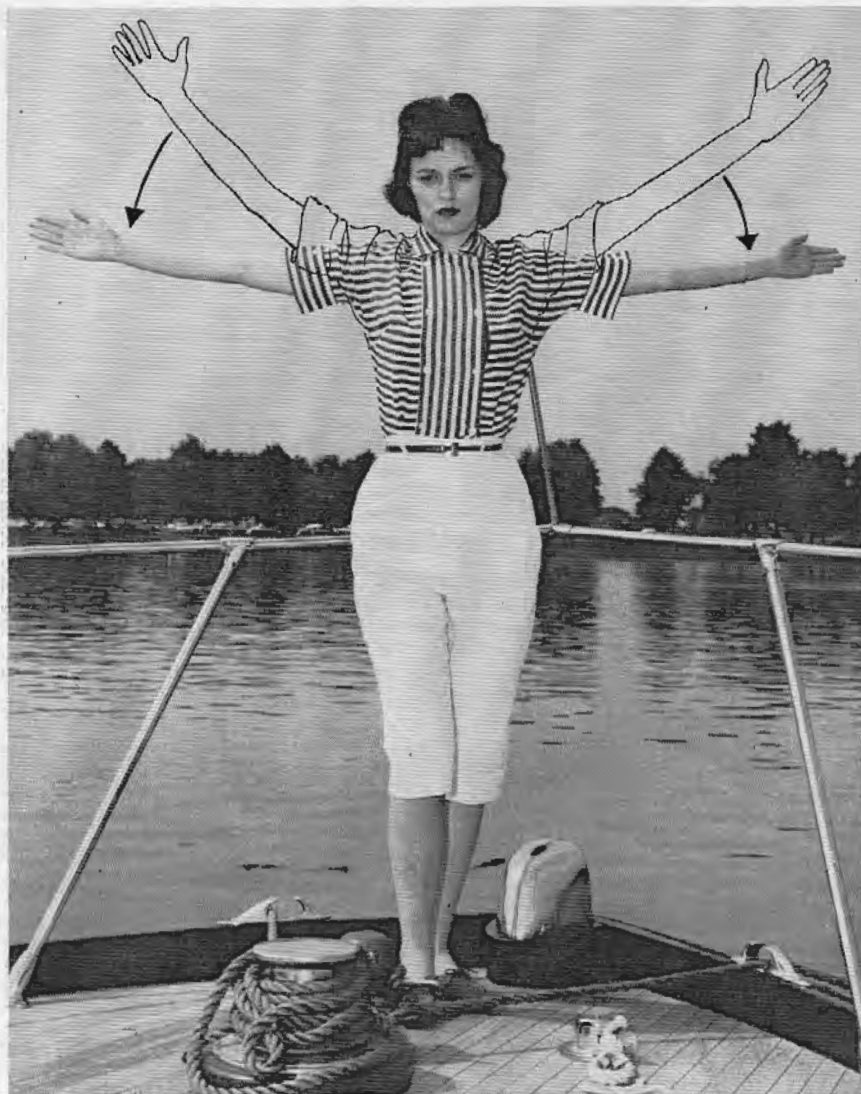
THE COAST GUARD after its recent public hearing, adopted a manual distress signal for daytime use. The signal illustrated in the photographs above is made by slowly and repeatedly raising and lowering the arms outstretched to each side.
