PROCEEDINGS

OF THE MERCHANT MARINE COUNCIL

Vol. 18, No. 1 • January 1961

OCEAN VESSELS IN THE ST. LAWRENCE SEAWAY

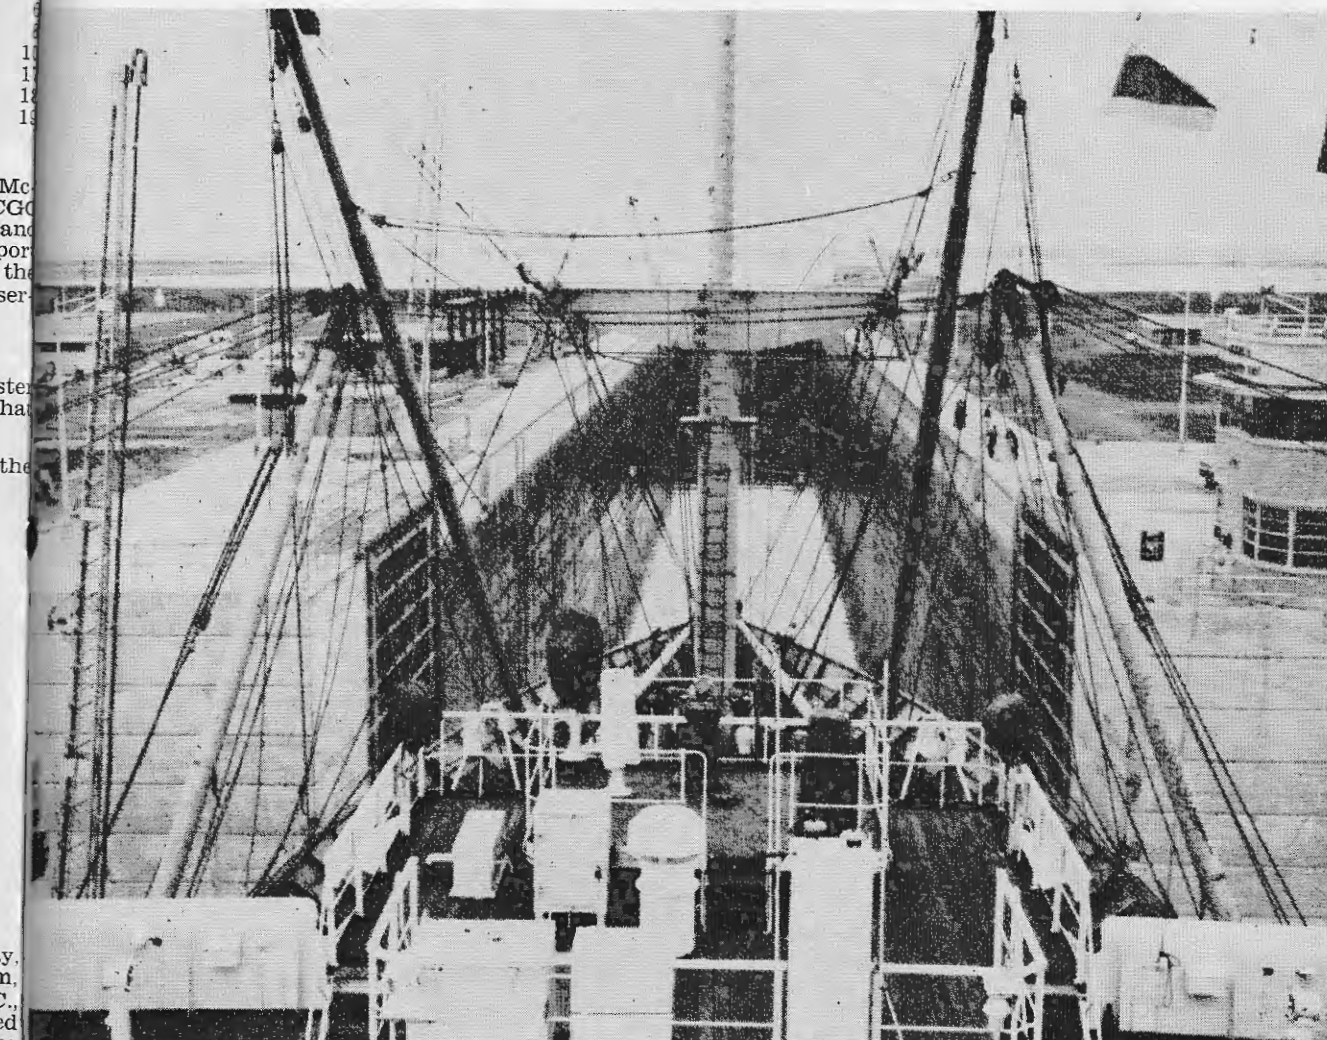
THE OCEAN EVELYN enters Eisenhower Locks in the above picture by Captain Preede. Lock guard gates at let in open position.

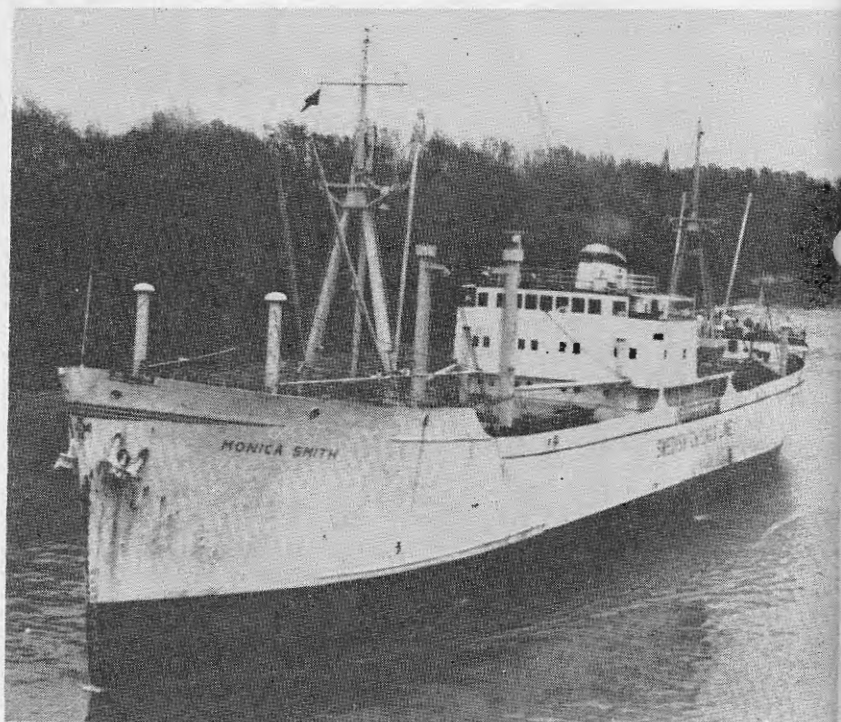
MONICA SMITH, small oceangoing vessel fitted with rubbing bars for Seaway transit.

As will be seen in the picture of a a-going vessel the *Monica Smith*, many vessels are being fitted with rubbing bars to protect the hull during passage through the locks. These bars are only effective along the sides of the vessel—they do very little good at the bow and stern. On the laker *T. R. Wilson* the rubbing bars are carried around the bow. This is effective due to the difference in construction of the bows of these ships. The *Keystone State* was provided with thirty additional portable fenders and the increased numbers should be placed on all ships in future.

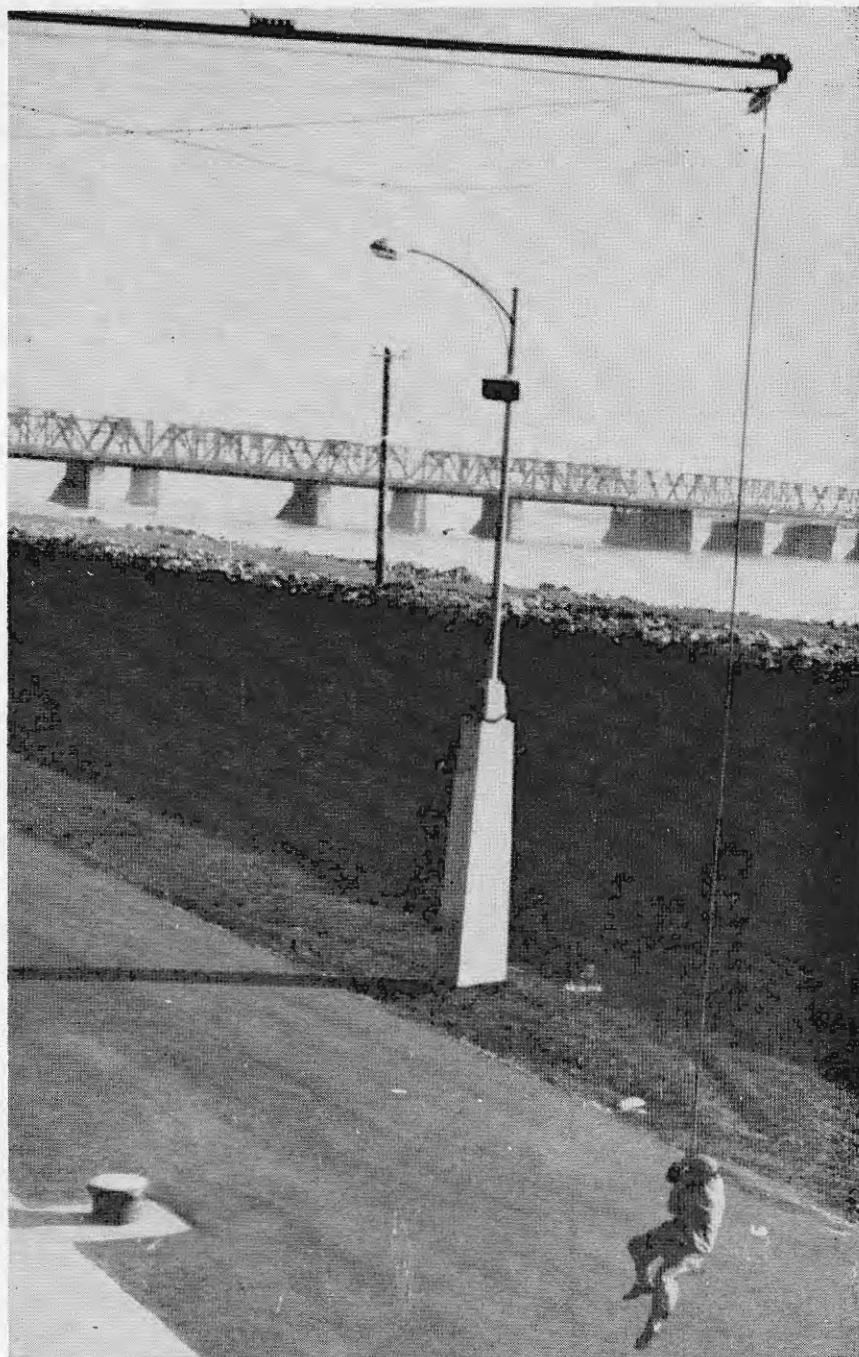
SHIP'S LINE tender landing on lock wall at St. Lambert Lock.

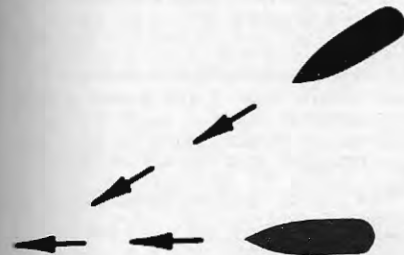
8. If in overtaking another vessel as sketched, you occasionally saw her mast lights and green side lights:

- The other vessel must keep clear of you
- You and the other vessel share equally the responsibility for keeping clear
- You should assume that it is your duty to keep clear

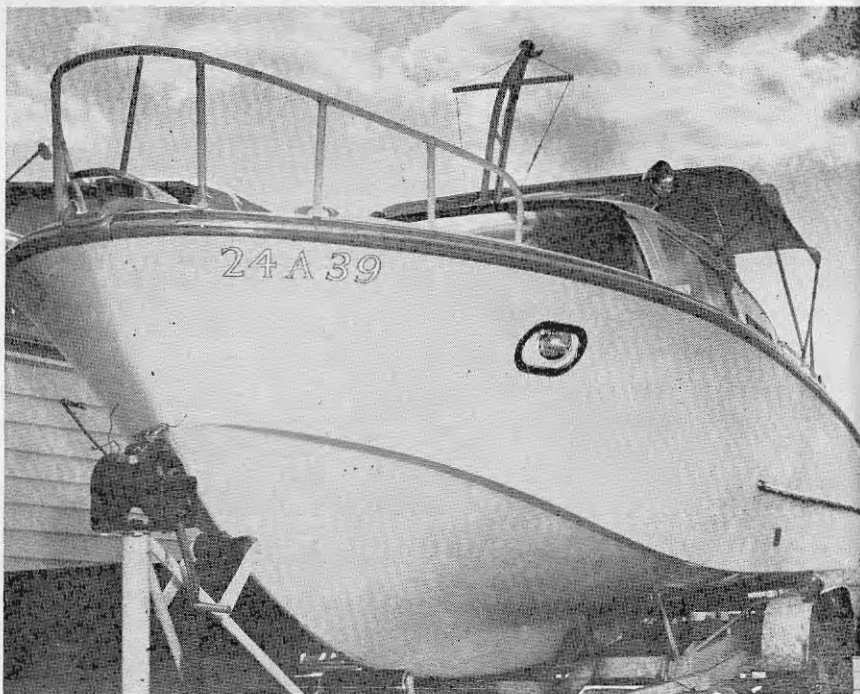
THE POSSIBLE USE of automobile headlights, flashing running lights and the like raises many questions. At present there does not appear to be sufficient information available to justify any conclusions as to their desirability or acceptability.

Parabolic reflectors directing light straight forward as on cars give a fairly good indication of heading, especially when a slight haze defines the beam from the headlights. Where horizontal distance between headlights is standard, ability to discern proximity of a vessel may be enhanced. Our modern small boat sailors, accustomed to the ubiquitous motorcar, find such a lighting system familiar. They also benefit from the improved illumination of the water ahead of the small boat which may have to thread its way through narrow channels, other boats, and even swimmers. It must be noted that such lights are subject to the same

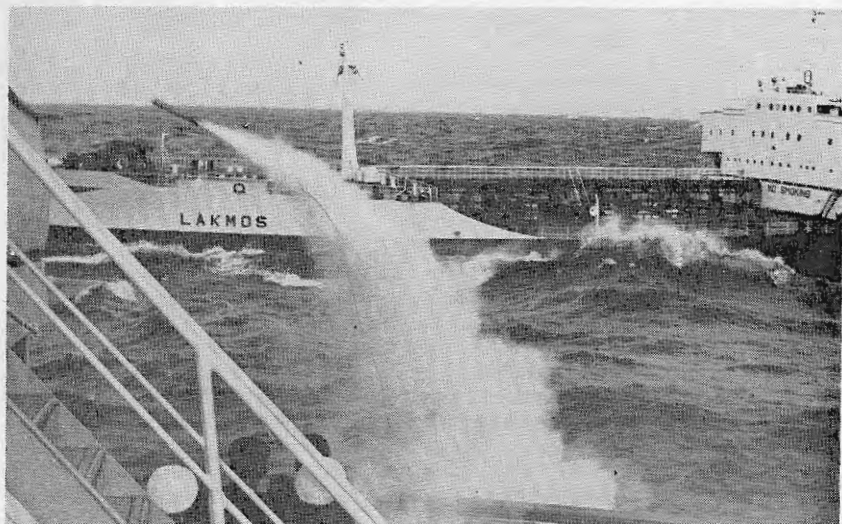
A ROCKETLINE is fired from the Italian Line's luxury liner *Vulcania* to the Greek tanker *Lakmos* during an emergency at sea. A crewman on the *Lakmos* was seriously ill and needed immediate medical attention. The heavy seas made it impossible to lower a boat and the needed medicines and medical instructions were passed to the *Lakmos* via the line. Photo courtesy of Italian Line.

to transport the sick seaman to the *Vulcania*. The assistance, therefore, would have to be limited to the furnishing of appropriate medicines and medical instructions. At 1300 the *Vulcania* took up a position near the *Lakmos* for rocketline transmission. Two attempts were foiled by extremely strong winds, but at 1442 rocketline communication was established between the two vessels and a package containing medicines with appropriate medical instructions was sent to the *Lakmos*. Captain Urciuoli of the *Vulcania* asked the Greek ship if the Master desired further assistance and was told that everything was satisfactory. The *Vulcania* then resumed her regular course to Halifax on her next port of call.
