# PROCEEDINGS

Vol. 20, No. 11 • November 1963

NOTES ON INSPECTION AND REPAIR OF WOODEN HULLS

THE DESIGN OF INFLATABLE LIFERAFTS FOR SURVIVAL AT SEA

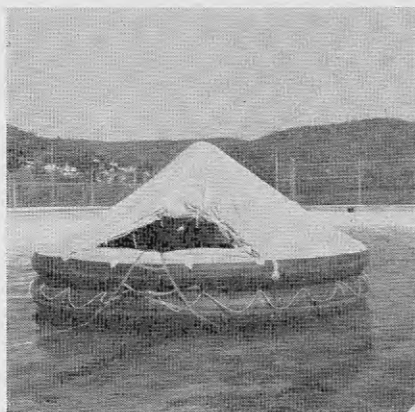
TWENTY man liferaft.
